TRANSPORT STATEMENT

**Anaerobic Digestion Plant No 2
Melton Ross Quarry, North Lincolnshire**

Prepared for: Singleton Birch

SLR Ref: 403.V64401.00001
Version No: FINAL
March 2023

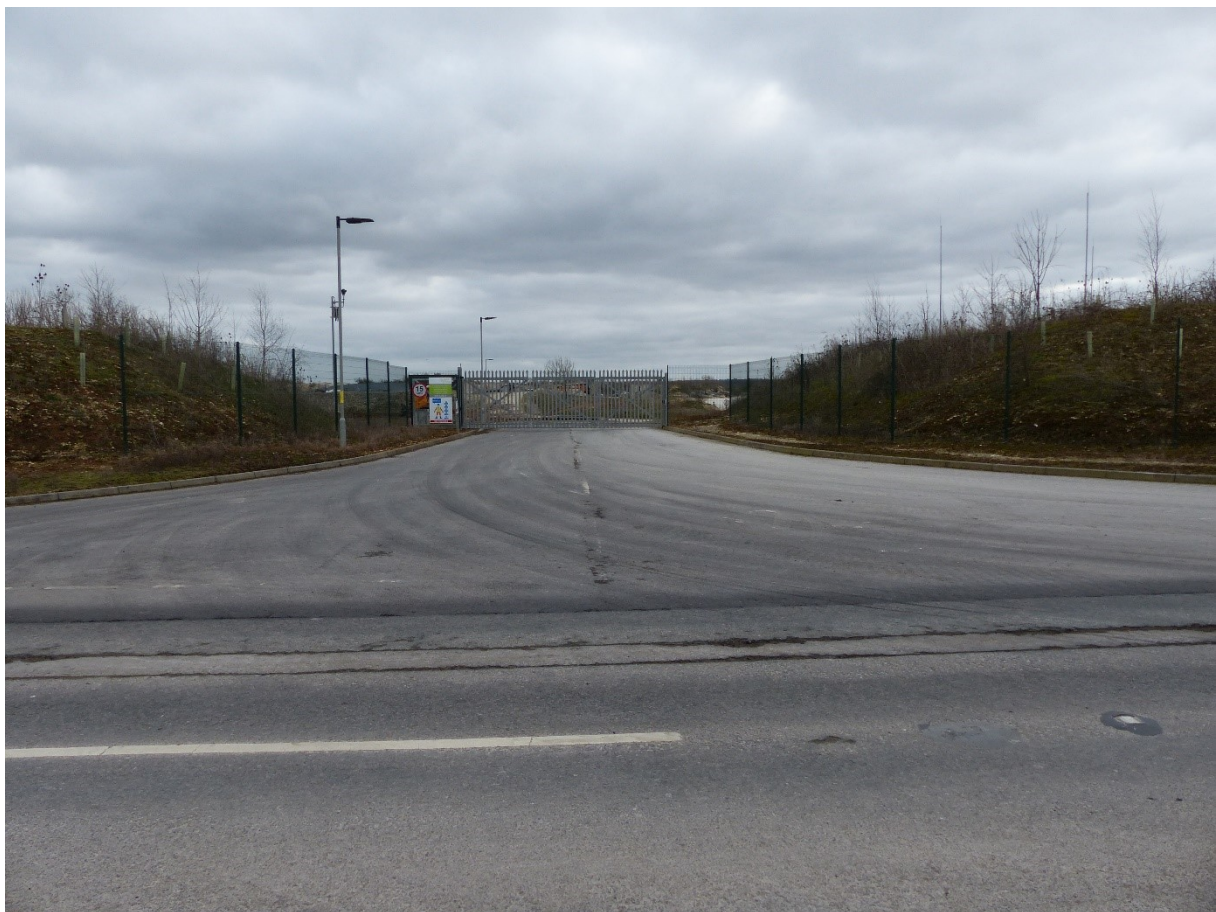
Figure 3-1
Existing Site Access off B1211

Figure 3-1 looks south-east toward the site access from the vicinity of the north-eastbound lane of the B1211 carriageway.

As visible in the above photograph, the northern site access is configured for access by oversized vehicles including heavy goods vehicles, dump trucks and tractor pulled trailers; both corner radii are extremely wide with the kerblines commencing to widen at a point approximately 17 metres back from the edge of the B1211 carriageway. Also visible within the photograph are instances of street lighting and road signage.

It is noted that there are no footpaths, however, the access is strictly for access by HGVs and other large vehicles/mobile plant machinery and as such this is not considered a deficiency.

The Site Access comprises a simple priority junction configured for HGV usage with generous corner radii on ingress and egress; additionally the egressing lane operates a 'stop' line rather than a give way line at the B1211 carriageway edge.

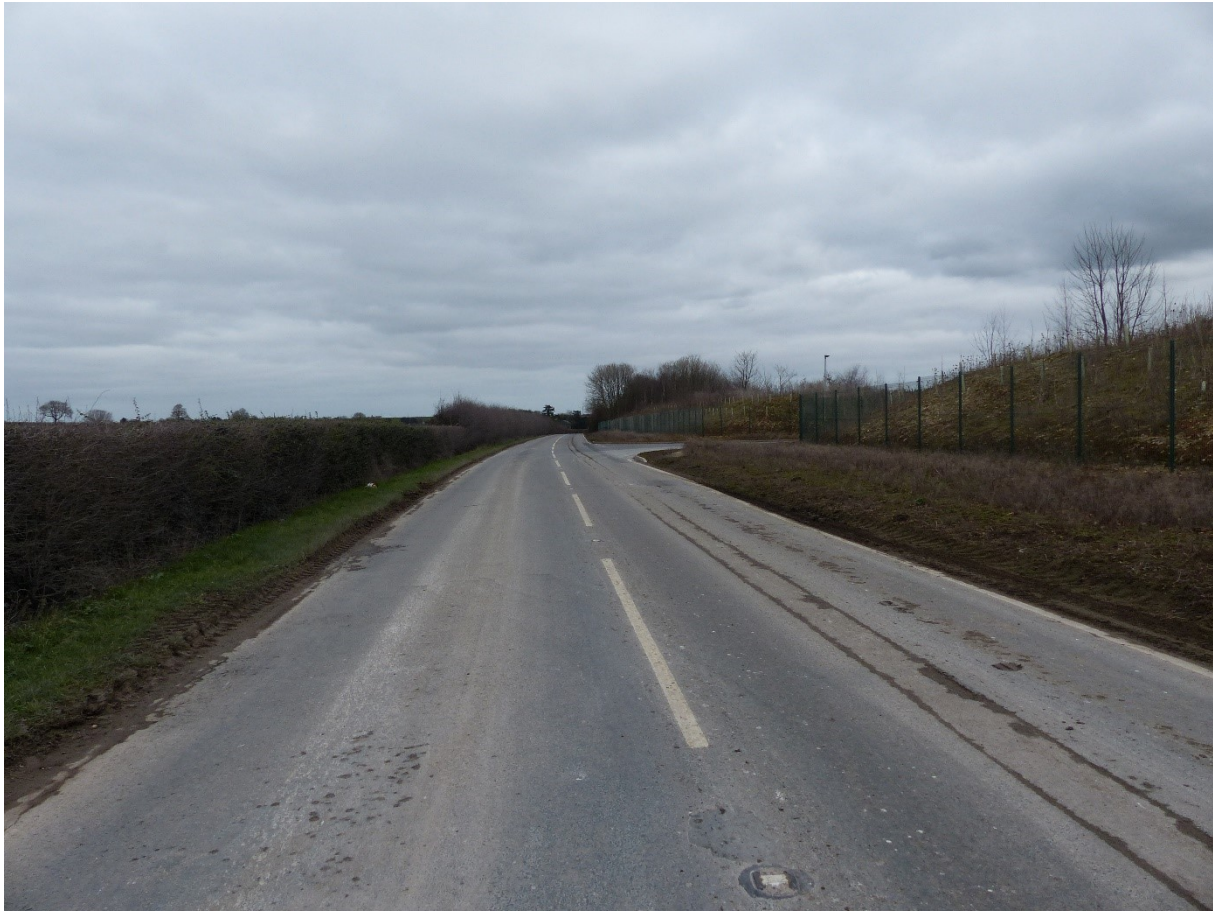
Figure 3-2
B1211, Vicinity of Site Access

Figure 3-2 looks north-east along the B1211 carriageway toward the vicinity of the Site Access.

The photograph above shows a typical view along the B1211 carriageway in the vicinity of the Site Access to the existing and proposed AD plants. The carriageway at this location is typical of the B1211 in relevant proximity of the application site with a width circa 7.0 metres, central road marking and grass verge flanking the northern edge; the southern edge comprises soil screening mound.

The condition of the carriageway surface is typical of a road serving an active quarry site with signs of minor wear; however, no serious defects were observed during the course of the SLR site audit undertaken in March 2023 either at this location or along the length of the B1211 in relevant proximity of the Site Access.

The B1211 between the A18 and the HGV access is approximately 7.0 metres wide and appears to have been widened to accommodate site traffic. This section of road is regularly cleaned by a road sweeper operated by the applicant. To the north of the existing site access, the carriageway narrows to around 6.5 metres and is surrounded on both sides by 1.0 metre grass verging and mature hedgerow. A soil screening mound containing semi-mature trees follows the site boundary on the eastern side of the carriageway.

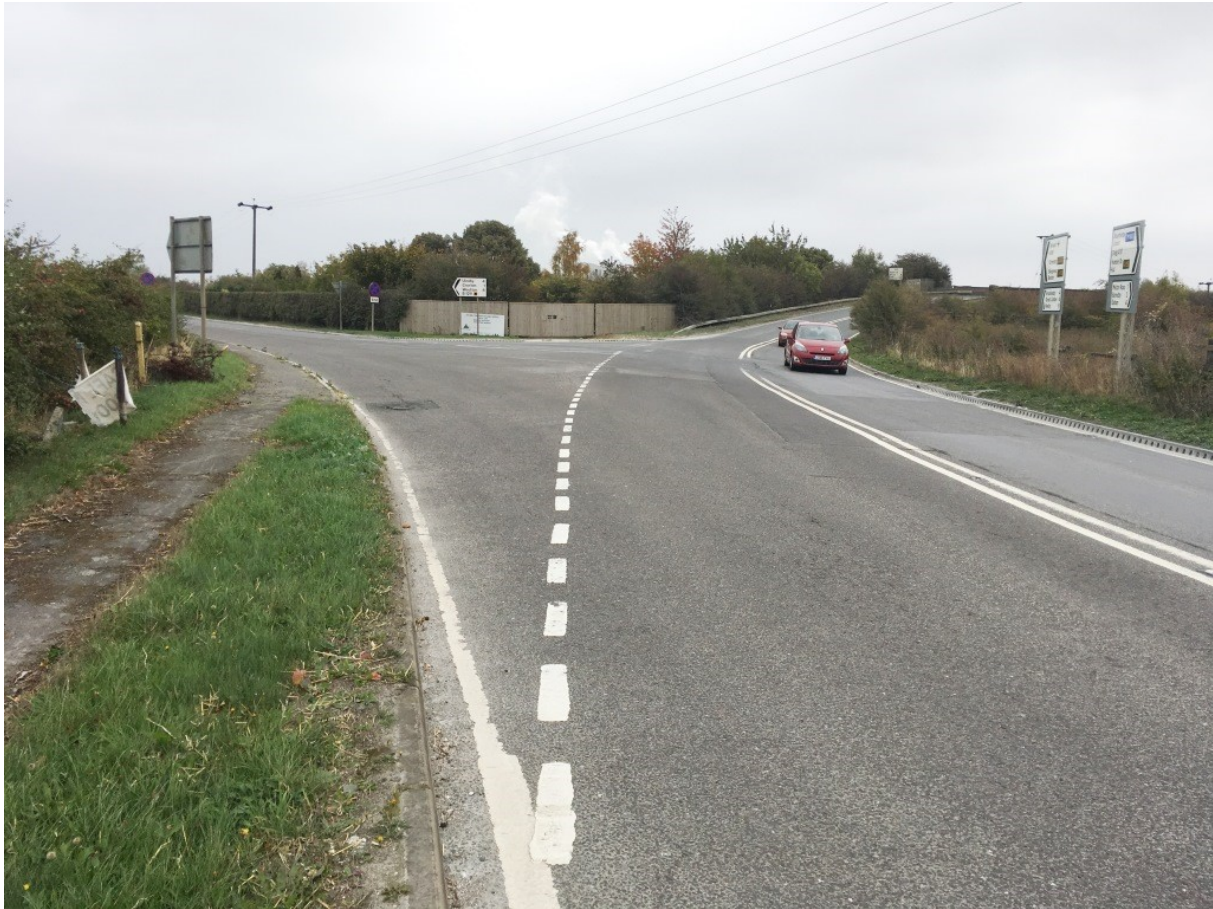
Figure 3-3
B1211 / A18 Priority Junction

Figure 3-3 looks north-east across the B1211 / A18 priority junction give-way line from the southern extremity of the ingressing corner radius.

As visible in the above photograph the junction between the A18 and B1211 is extremely large in terms of the area at the mouth of the junction and the length of the give-way line which measures approximately 55 metres; the give way line spanning the ingress (at the foreground of the photograph) measures around 33 metres.

The A18 at the point of the junction is approximately 7.5 metres wide. The central road markings in the vicinity of the junction comprise double solid lines prohibiting overtaking. The junction is kerbed and a footpath is located to both the north and west.

The junction is located approximately 100 metres west of a rail bridge, which limits visibility both to and from the junction. Visibility to the east from 4.5 metres behind the major road is approximately 100 metres to the nearside kerb. Visibility is restricted by the vertical and horizontal alignment of the road; visibility from the height of an HGV cab would be slightly improved. Forward visibility to the junction for westbound traffic is also approximately 100 metres and limited by the crest of the rail bridge and the brick walls located on each side. The lack of forward visibility on the approach to the rail bridge necessitates that traffic travels relatively slowly through this section and less than the permitted 40mph speed limit.

Visibility to the west from 4.5 metres behind the major road is approximately 120 metres to the nearside kerb and is restricted by the horizontal alignment of the carriageway and the hedgerow within the northern verge. Visibility to the centre of the carriageway is improved at approximately 140 metres. Forward visibility to the junction for eastbound traffic is approximately 140 metres and is restricted by the hedgerow within the northern verge.

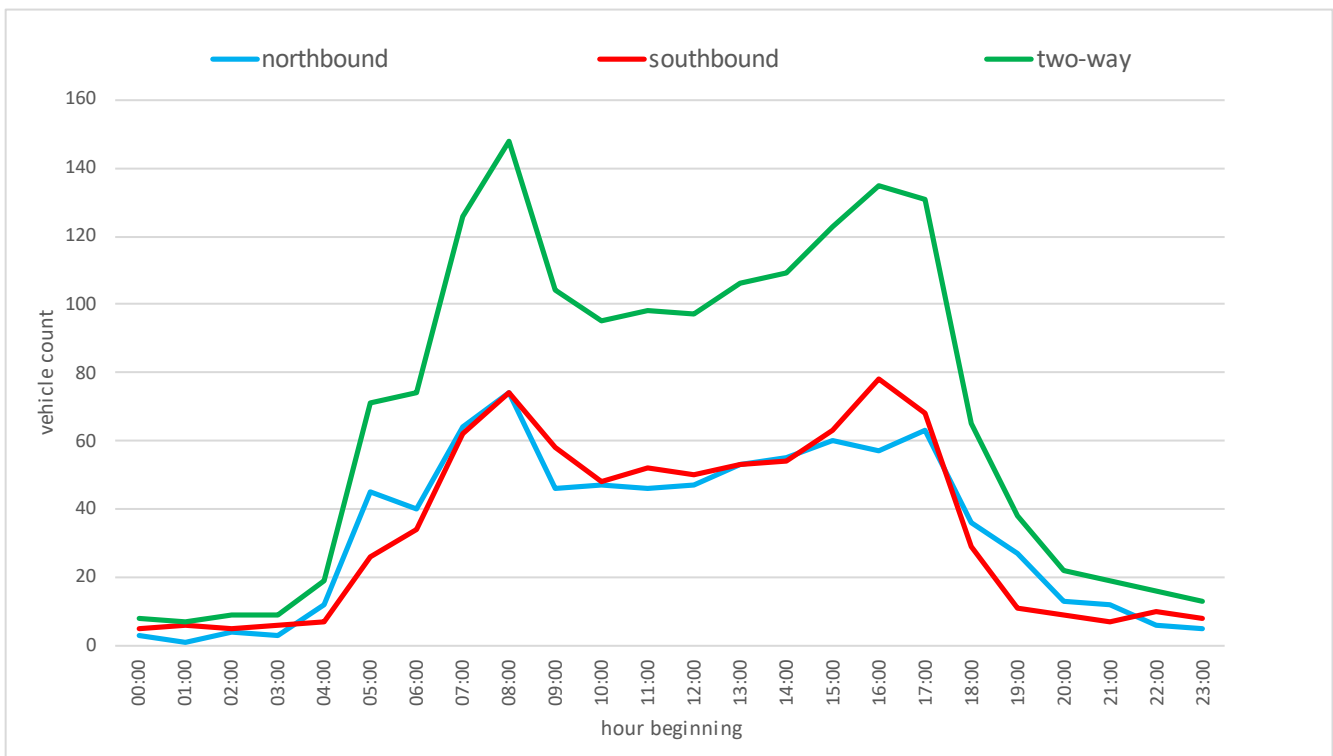
Figure 3-4
Average Weekday Total Traffic Profile Graph

Within the graph outbound traffic values are represented by the red series, inbound by the blue series, and the sum of those two values at any given time index is represented by the green series ('two-way' traffic).

The above Figure 3-4 shows clearly defined AM and PM peak periods in keeping with a typical tidal model.

It can be observed that the levels of traffic moving in either direction are similar. The average AM peak of 148 movements occurs at 08:00hrs; the average PM peak of 135 movements occurs at 16:00hrs. No pronounced inter-peak is present; however this is not uncommon for a road of this type.

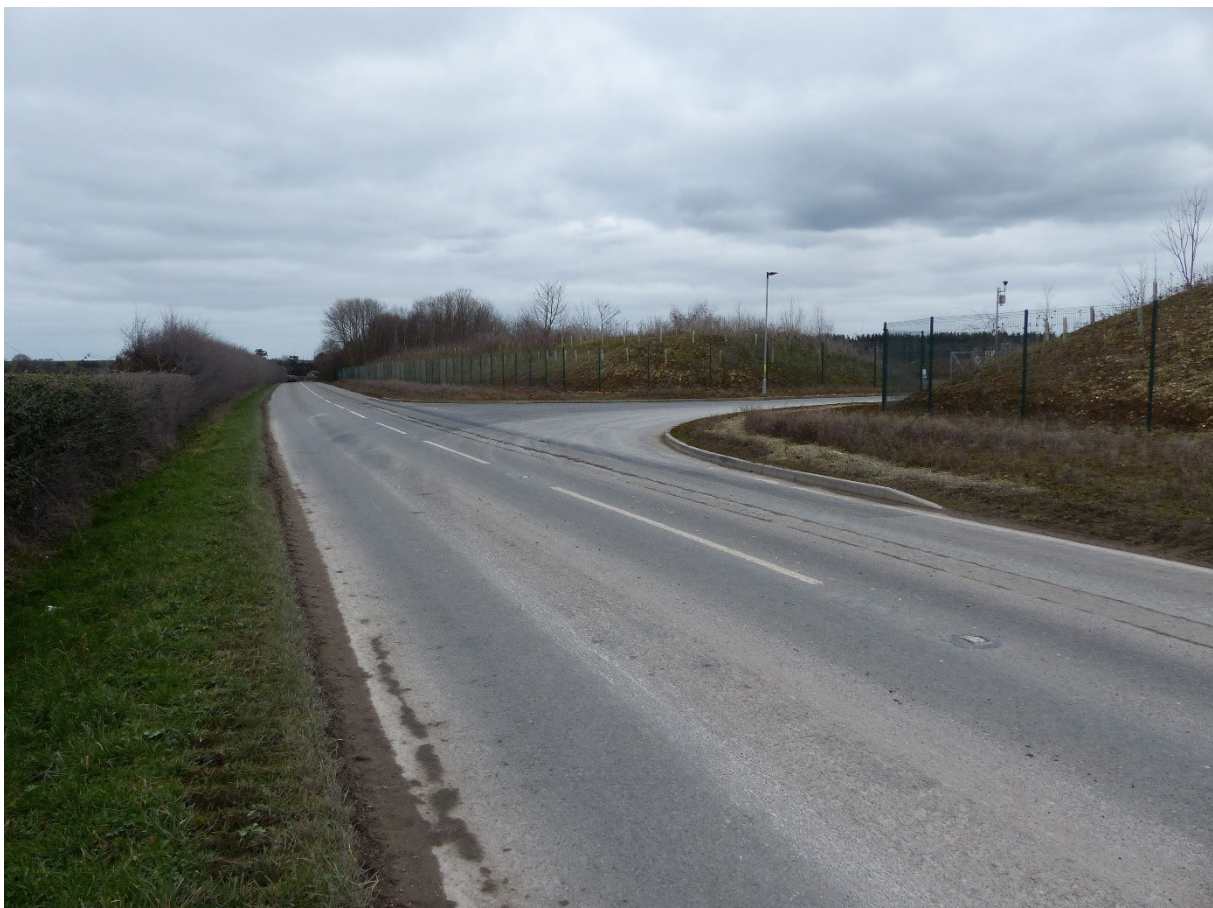
Figure 5-1
Existing Site Access off B1211

Figure 6-1 looks north-east toward the existing access off the B1211 at the northern vicinity of the Melton Ross Quarry complex.

The carriageway at this location is wide, level and free from excessive wear or serious defect; forward visibility is of a good standard in either direction.

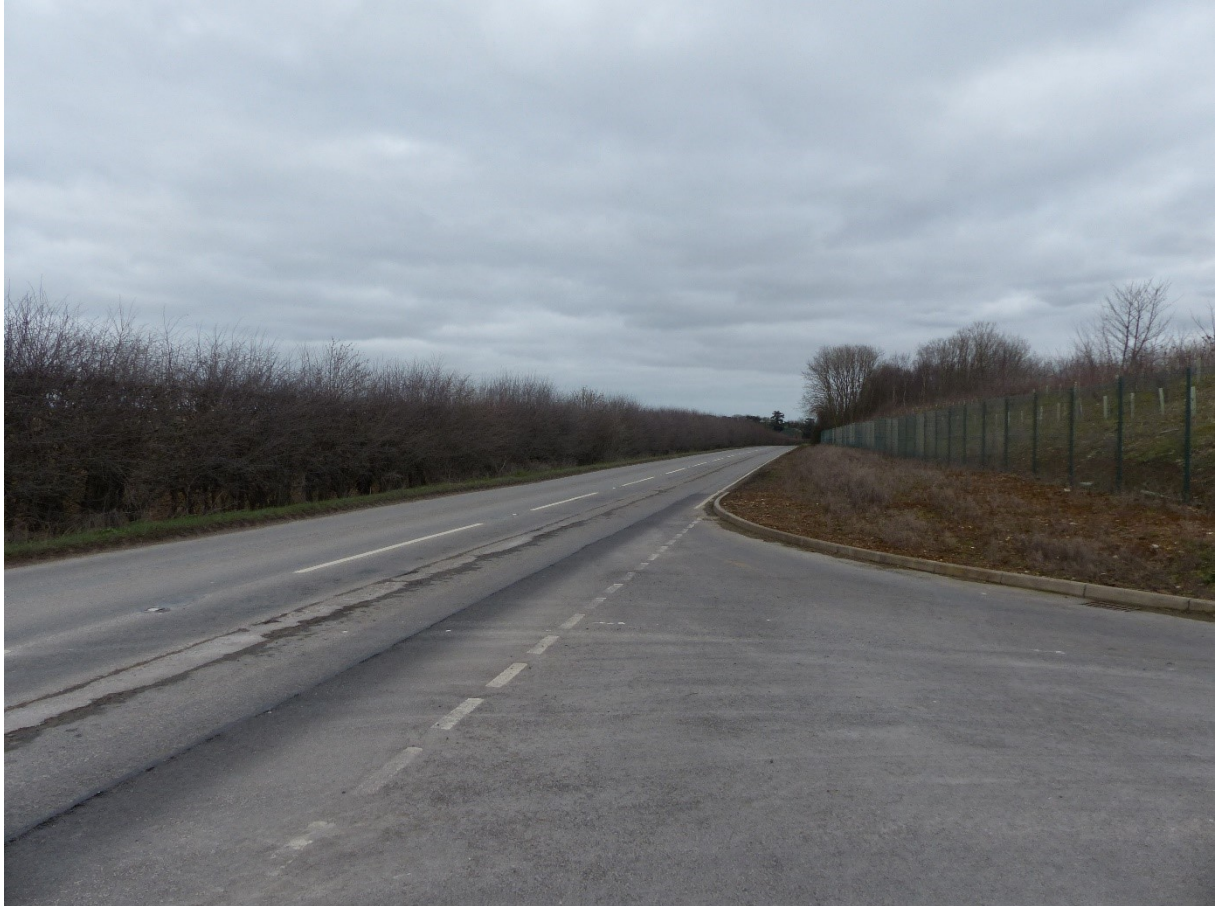
Figure 5-2
Visibility on Egress to the Right

Figure 6-2 looks north-east/right on egress of the site access onto the B1211.

As visible in the above photograph visibility on egress to the right/north-east is available far in excess of the requirements and is entirely unobstructed owing to the relative lack of trees, shrubs and other vegetation along the verge flanking the south-eastern edge of the carriageway.

As demonstrated within the photographs above at Figures 6-2 and 6-3 visibility at the site access junction is free from obstruction in both directions on egress from the access onto the B1211; additionally, it is notable that the vast majority of vehicles egressing at this location would have raised cabins affording drivers/operators a visual advantage.

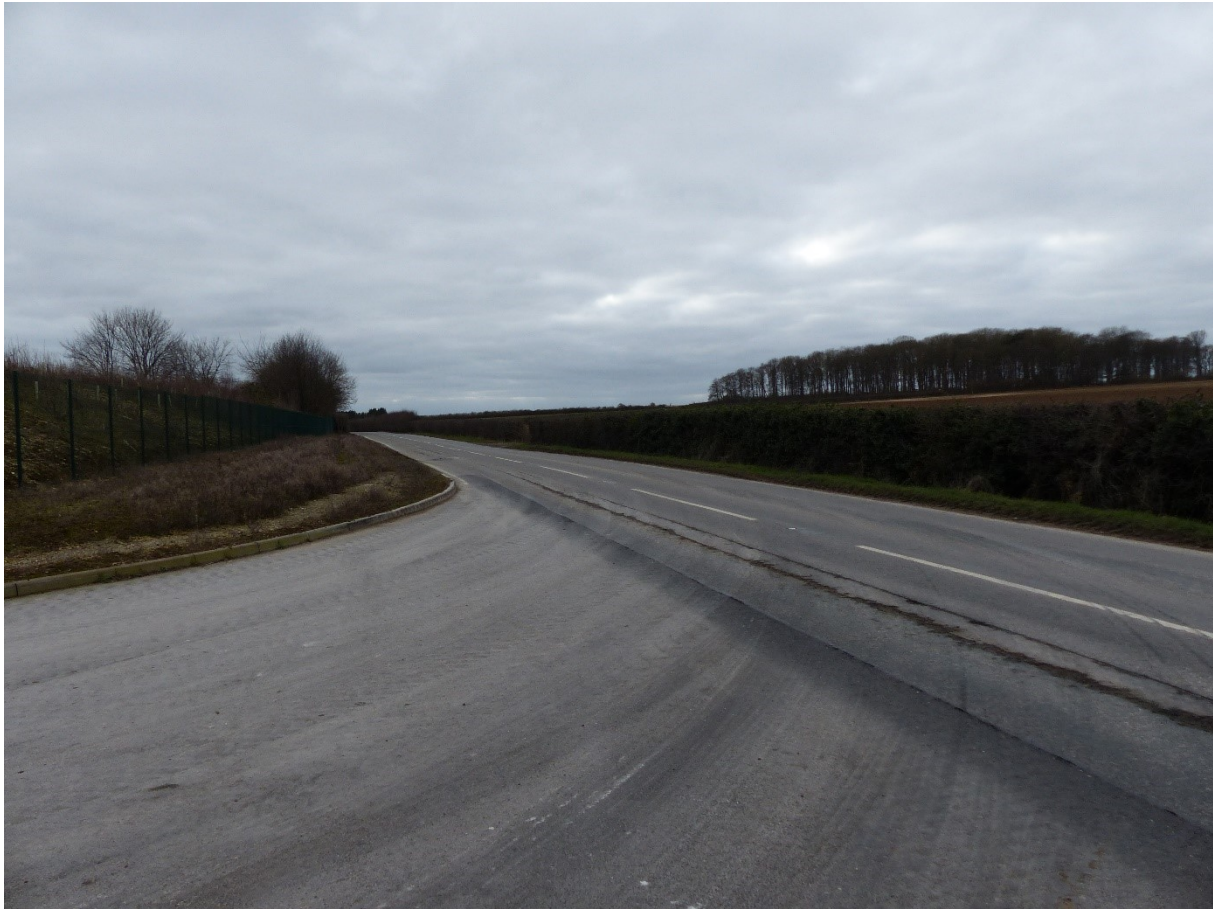
Figure 5-3
Visibility on Egress to the Left

Figure 6-3 looks south-west/left on egress of the site access onto the B1211.

As visible in the above photograph visibility on egress to the left/south-west is available far in excess of the requirements and is entirely unobstructed owing to the relative lack of trees, shrubs and other vegetation along the verge flanking the south-eastern edge of the carriageway.
