Elsham Hall, Lincolnshire

Heritage Impact Assessment

Project Reference: 22-036

Produced for Jonathan Hendry Architects

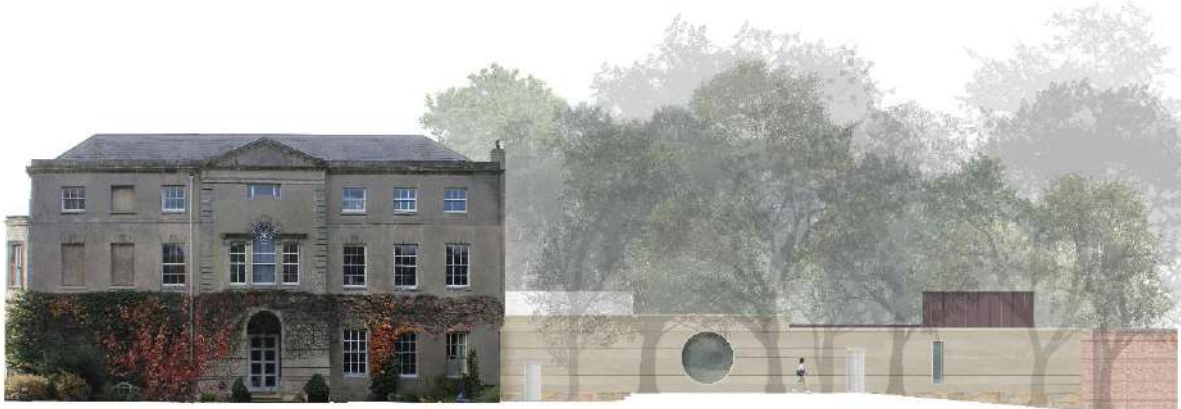
Figure 10: Proposed elevation study

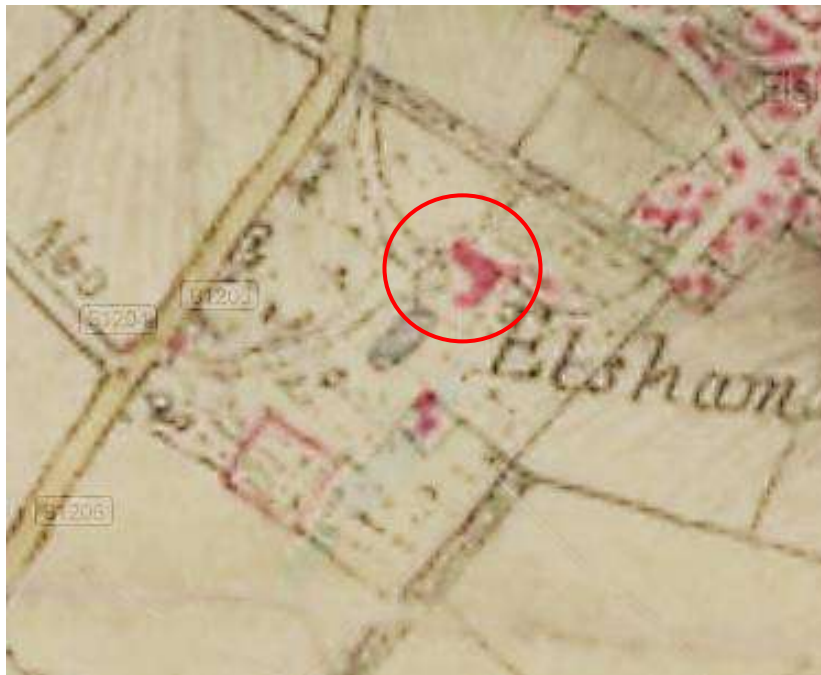
Figure 15: Map of Brigg by Charles Budgen (1819), approximate Site location circled in red (Copyright British Library Board).

- 2.1.64 The Site at this time (Figure 15) sits within a square area of enclosed gardens/parkland extending south-westwards and finishing roughly adjacent to Elsham Road. Contained within the gardens at this time was what appears to be a walled garden to the south-west, along with an outbuilding in the central section of the park. A small lodge-type building is located within the park on the southern side of what is now the B1206. There appear to be at least three approaches to the hall, from every corner of the park bar the southern corner. Although slightly unclear from the map, it appears that a fourth route also leads from the north-east. A lake is depicted to the south of the hall, centrally located within the park. The hall at this time is depicted as a rough L-plan with a slight projection to the rear on the southern-most section. The orangery is also mapped to the east of the house.

2.1.69 It seems that as part of this scheme of works, there were also significant alterations made to the wider grounds of the hall with the expansion of the grounds, extensive landscaping and the construction of new buildings. In comparison to the relatively small grounds depicted on the 1819 map (Figure 15) which had a south-western boundary line finishing roughly parallel with Elsham Road, by the time of the 1887 map, the boundary had been extended much further south-west and also to the north-east. The fishpond was significantly expanded and a coach house and stables were constructed, along with a threshing barn and adjoining cartshed/workshop/stable/granary ranges. Kennels were also built to the north of the house as well as to the south near the new stables. Areas and avenues of trees can be seen across the estate, indicating landscaping had been undertaken.

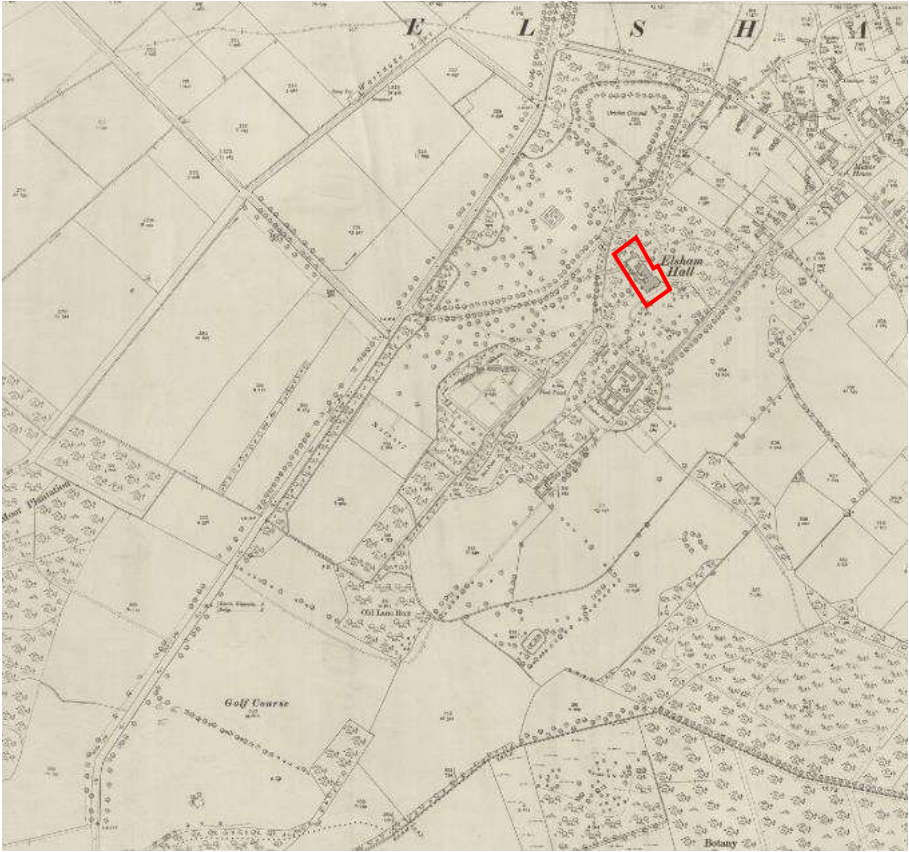
Figure 18: Lincolnshire XX.1 Ordnance Survey (OS) map, 25-inch, revised 1906 and published 1907, approximate Site location outlined in red

- 2.1.71 The next Ordnance Survey (OS) mapping published in 1907 (Figure 18) shows the layout of the Site unchanged, apart from the fact that the glass-roofed structure on the eastern elevation of the house is now shown as solid brick construction. Further changes have occurred within the wider area, with a cricket ground now sitting to the north of the estate and Elsham golf course to the south.

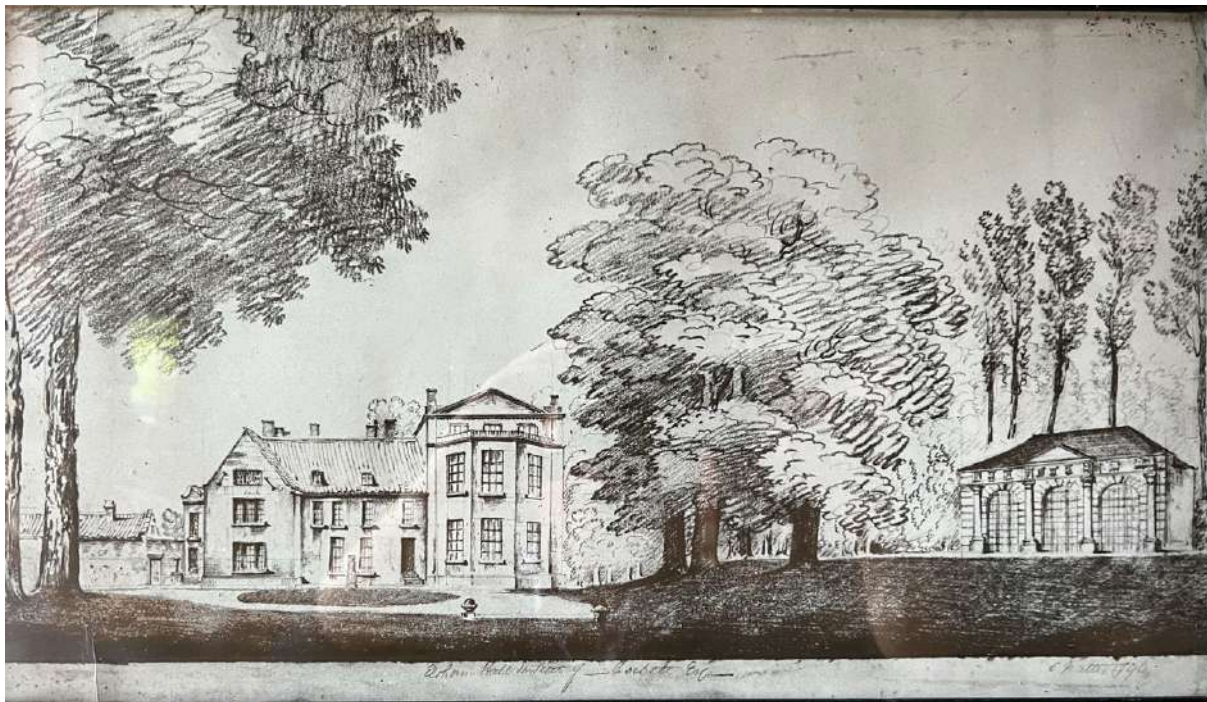
Figure 21: A sketch of Elsham Hall as viewed from the south (1796), seen on Site visit on 22/09/22

3.1.6 As evidenced in the Historical Development (Section 2), it appears that Elsham Hall has at least 17th if not potentially 16th century origins. An early drawing of the hall from 1796 (Figure 21) corroborates the idea of an older house subsequently remodelled in the 18th century. The drawing shows the earlier phase of the hall to the west (LHS) with the newly added wing to the east (RHS). The fact that this elevation of the house was chosen to be depicted as well as the turning circle located directly to the front of the hall suggests that this was, at the time, the main elevation of the hall with the entranceway consisting of an unusually small doorway located off-centre in the central bay. The eastern section of the front elevation with its steeply pitched roof and protruding gable with horizontal window openings is distinctly earlier in appearance than the western section with its much more polite style reflective of Georgian architectural fashions. To the west of the house is depicted another bay protruding westwards. Adjoined to this bay is a wall with a gateway which is attached to an outbuilding structure with a small chimney.

3.1.7 The second phase of works occurred in the early to mid-19th century, with the eastern wing being further extended to the north with a 2-storey extension and a glass-roofed extension added to the 18th century wing, likely added to create a grander entrance compared to the small doorway seen on the southern elevation in the 1796 image (Figure 21). Ordnance Survey

- 3.1.35 Externally the south frontage is the building's principal elevation, and appears to have always acted as such throughout the building's many phases of construction (See Figure 21 and Figure 23). However, before the 1930s which saw the replacement of the 18th century west wing, the elevation had always been an asymmetrical one. Today the matching pair of projecting bays to the right and left, separated by a two storey central range, results in a consistently Neo-Classical and symmetrical façade of high quality. This symmetry is only interrupted by the smooth rendered finish of the 1930s left hand bay which contrasts with the fine coursed stonework of the remainder of the façade. Photographic evidence (Figure 27) shows that the bay, and the corresponding 1930s west wing, were originally faced with a stucco render with incised coursing lines designed to replicate the ashlar of the 19th century elements. Sadly this

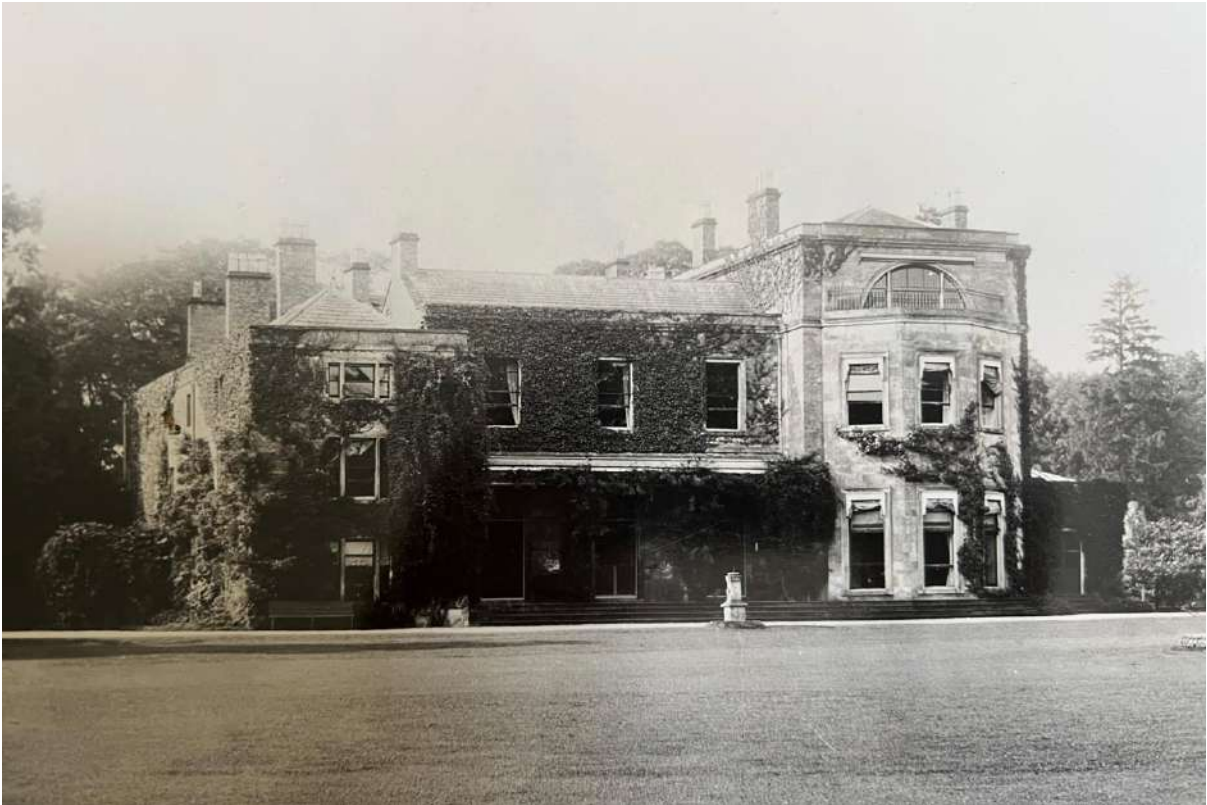
Figure 23: Likely early 20th century photograph of the south elevation of Elsham hall showing the 19th century changes to the hall, seen on Site visit on 22/09/22

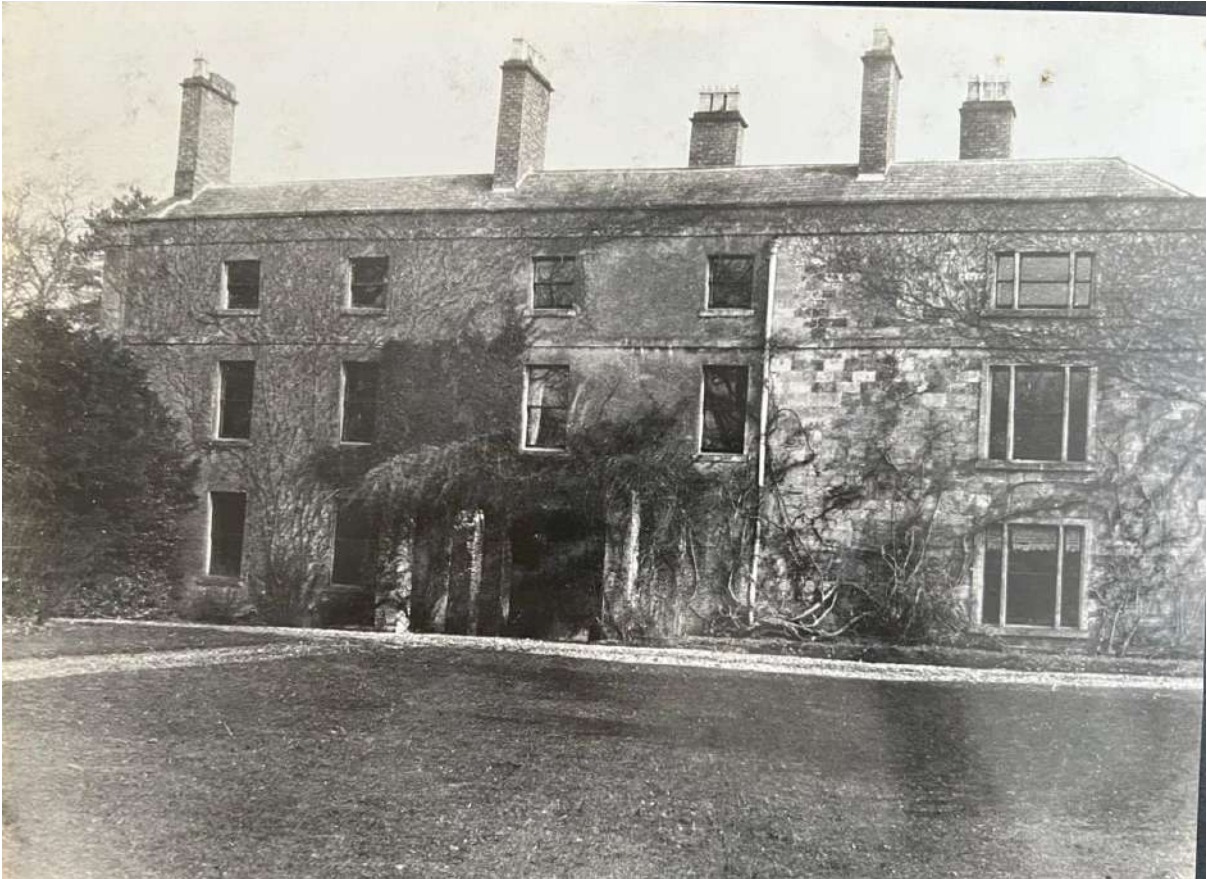
Figure 24: Likely early 20th century photograph of the western elevation of Elsham Hall showing the two different phases of the extension, seen on Site visit on 22/09/22

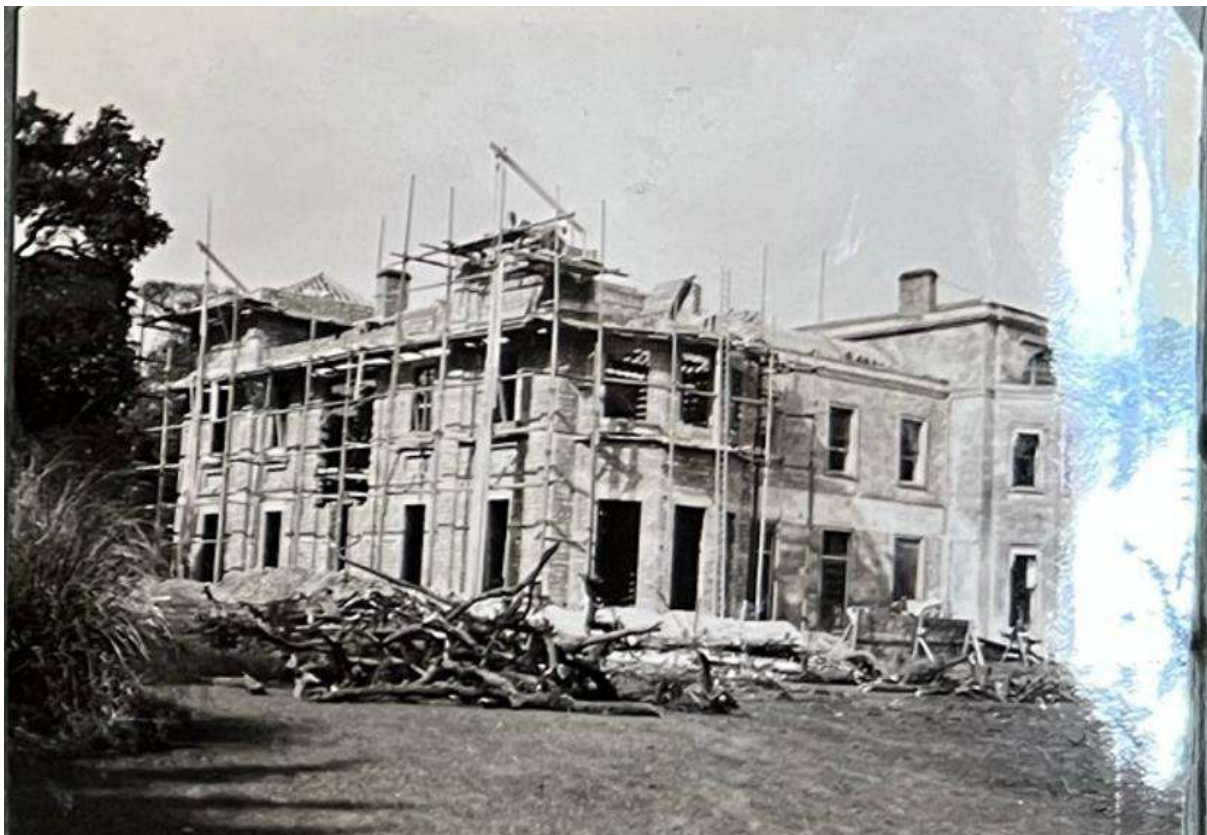
Figure 26: Photograph taken during the 1930s works to the house showing the rebuilding of the west wing after the previous wing's demolition, seen on Site visit on 22/09/22

- 3.1.8 During the 1930s, the hall underwent a significant period of change and remodelling after purchase by the Elwes family. The works cost approximately £20,000 and were finished in July 1934 (Kingsley, n.d.). The west wing, said to have been extensively damaged by dry rot, was completely demolished (Figure 26) and rebuilt (Kingsley, n.d.), including the addition of a Gothic oriel window (Figure 27). The southern elevation of the western wing was modelled to mirror the southern elevation of the eastern wing, which had its three windows reinstated (which had been removed in the 19th century) (Figure 28). This created a symmetrical form to the southern elevation, although the western wing was built in brick with render, creating a curious contrast between this wing and the stone constructed east wing.

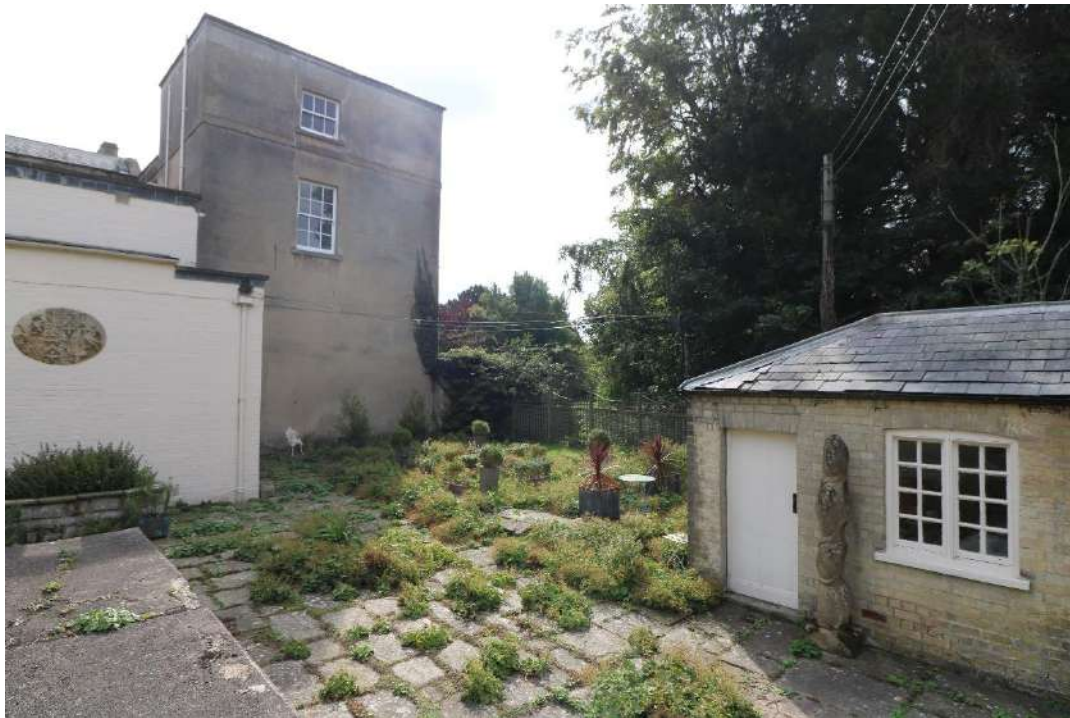
Figure 31: The position of the demolished north west service wing. The single storey building to the right is a 19th century game store.

3.1.11 The single storey north west service wing was demolished down to ground level and the area where it once stood is now paved. The rear elevation of the hall was rendered to match.

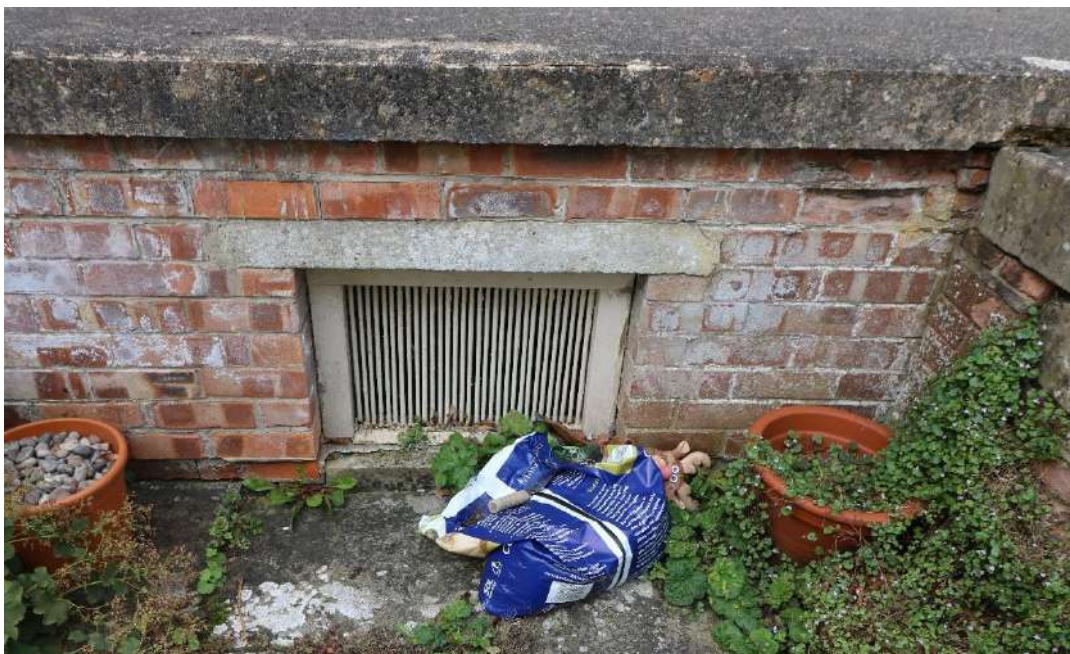
Figure 32: The air vent at the rear of cellar Chamber 2. Note the projection above ground level and the concrete capping over.

3.1.12 However, when the more substantial north east service wing was demolished, concrete slabs were cast over the vaulted cellars that remained in situ. The cellars are not entirely subterranean and project above ground by approximately 1 metre (Figure 32), thus resulting in raised 'terrace' areas which roughly follow the extent of the demolished wing (Figure 36, Figure 37). At the northern end of this area, the sunken 18th century 'wash yard' was retained as the main point of entry to the cellars (Figure 34, Figure 35).

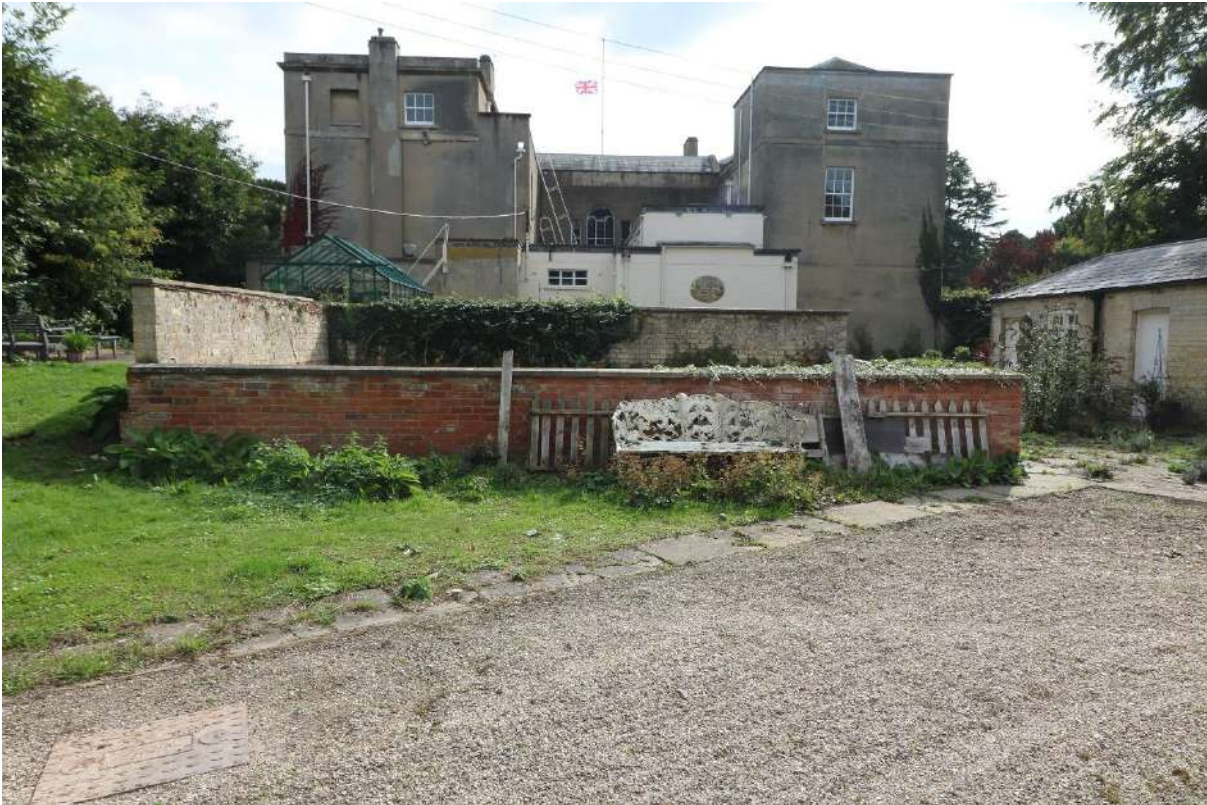
Figure 34: View south towards the north elevation of the Hall. The low wall in the foreground forms the parapet to the sunken wash yard.

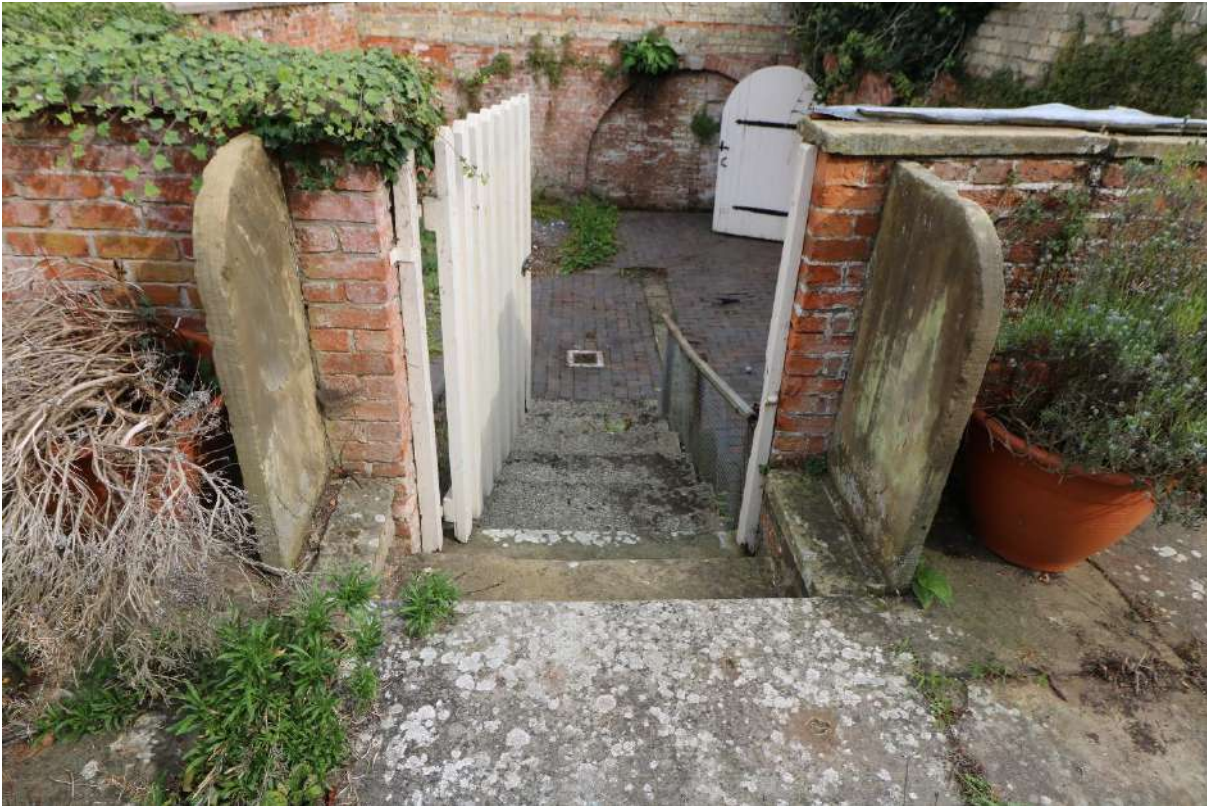
Figure 35: The entrance gate at the west end of the wash yard.

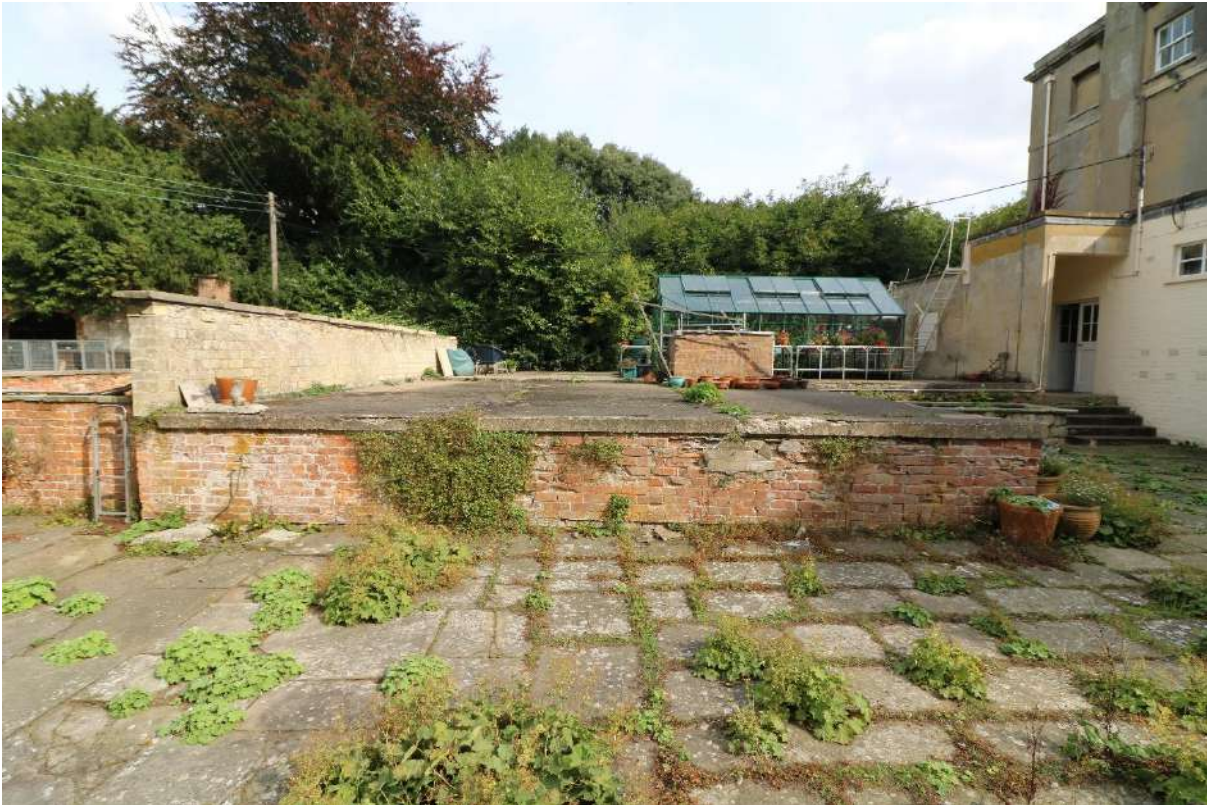
Figure 36: View east over the concrete capped cellars. The rear entrance to the Hall is on the right of the image.

- 3.1.13 Following the demolition of the north east wing, a small, flat roofed extension was added to the north east corner of the Hall to house a new boiler room and oil store (Figure 36, Figure 38). Alongside this a new vestibule and steps were built providing access from the rear of the Hall to the exterior.
- 3.1.14 The 20th century also saw changes to the L shaped range of outbuildings which enclose the rear courtyard. At the eastern end of the range three modern garages were built to replace the earlier outbuildings (Figure 39).

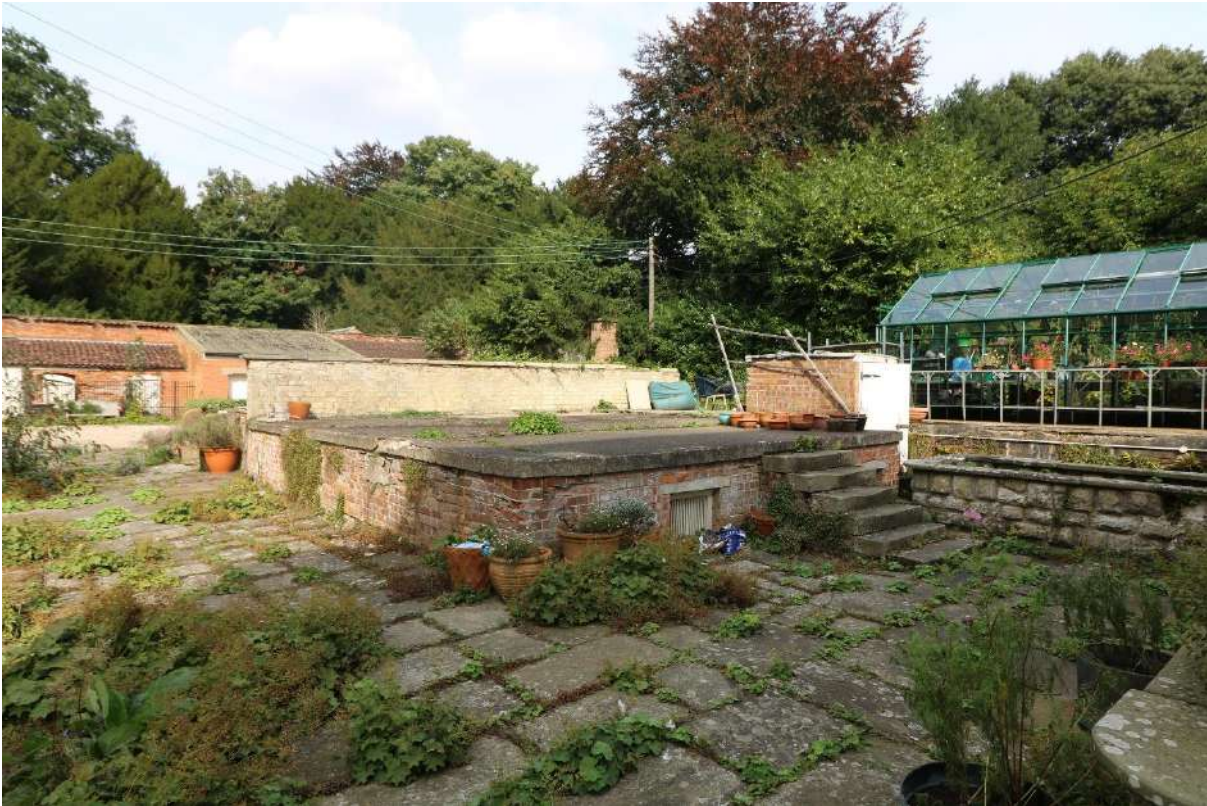
Figure 37: View north east over the concrete capped cellars.

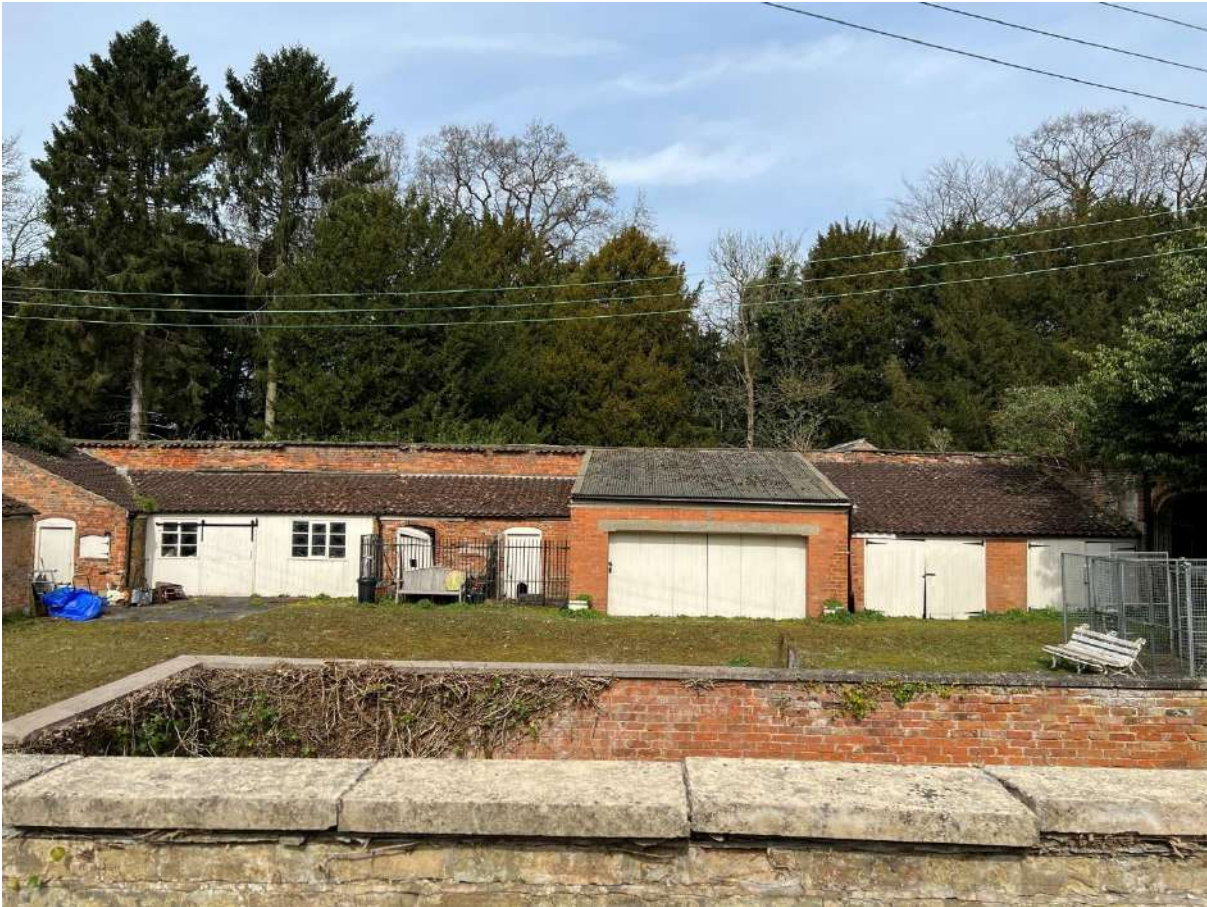
Figure 39: The modern garages built to replace earlier outbuildings at the east end of the service courtyard.

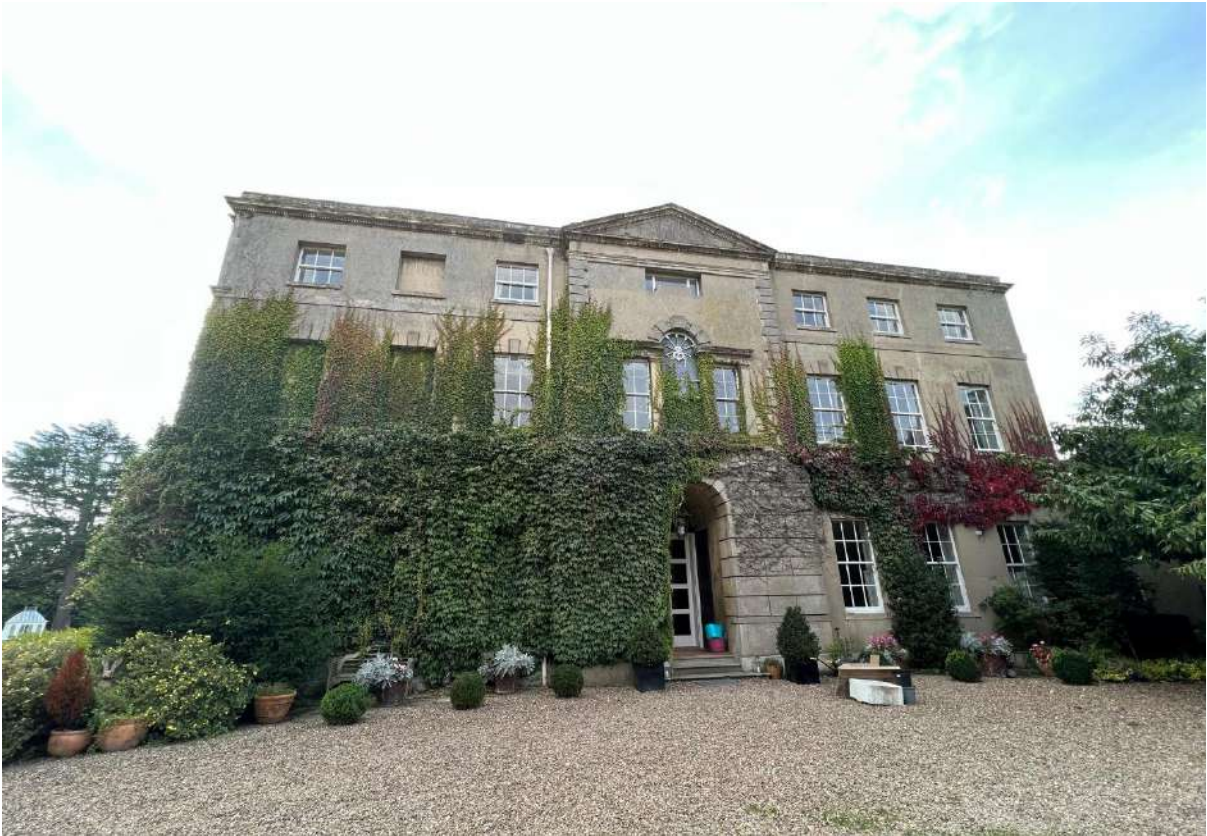
Figure 40 The east front of Elsham Hall in the present day.

- 3.1.36 The East frontage (Figure 40) contains the principal entrance to the Hall and was also heavily modified in the 1930s to introduce a symmetrical classical façade with a clear hierarchy of vertically arranged openings and a rendered finish. A projecting central bay with rusticated stucco base, quoins, venetian window and pediment frames the entrance and complements the design and ornamentation of the south elevation. The blind windows introduced on the left-hand side of the elevation to provide balance and symmetry are now largely obscured by climbing vegetation.

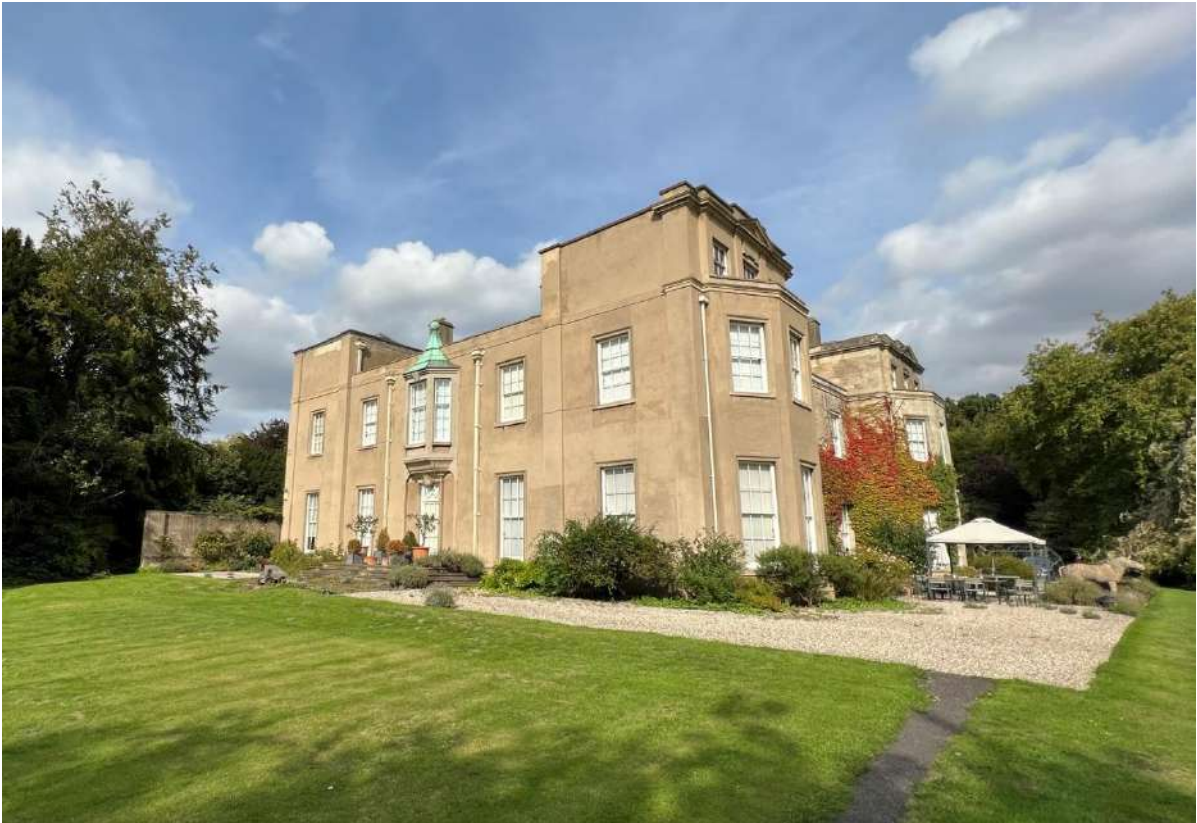
Figure 42 The west front of Elsham Hall in the present day.

- 3.1.37 The West frontage (Figure 42) is also a symmetrical arrangement and features a central glazed door surmounted by an oriel window with copper roof and ball finial, vertically arranged sash windows with moulded surrounds, corner pilasters and cornicing. The stucco finish which once emulated the ashlar of the south frontage has unfortunately been replaced by a smooth render and architectural details such as the recessed panels below the first floor windows and the blind panels to the second floor have also been deleted. While the façade still possesses a good level of architectural integrity, the replacement render finish has detracted from its aesthetic – designed value.

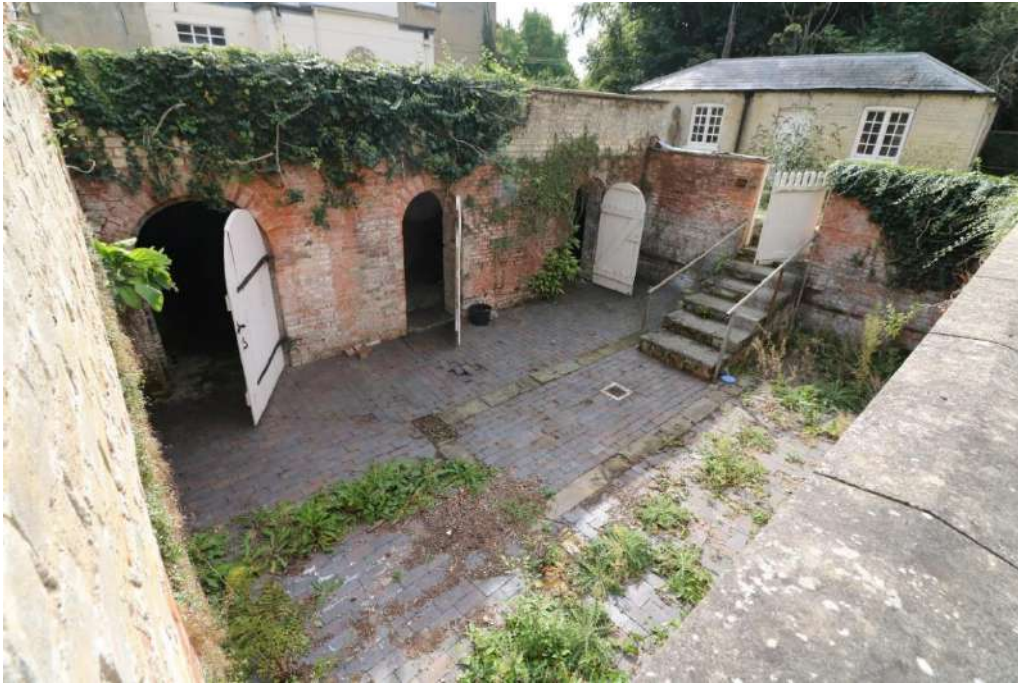
Figure 45 View over the wash yard looking south west.

3.1.17 The wash yard is a rectangular space measuring approximately 9 metres long by 6 metres wide. The floor of the yard is set approximately 1.8 metres below ground level and is surfaced predominantly in blue engineering bricks which appear to be of 19th century date. In the centre of the space is a rectangular stone threshold and a drain. Historic maps and plans indicate that the yard once had a lean-to pantile roof around its edge and there is still evidence in the stone threshold for the position of the original posts that supported this.

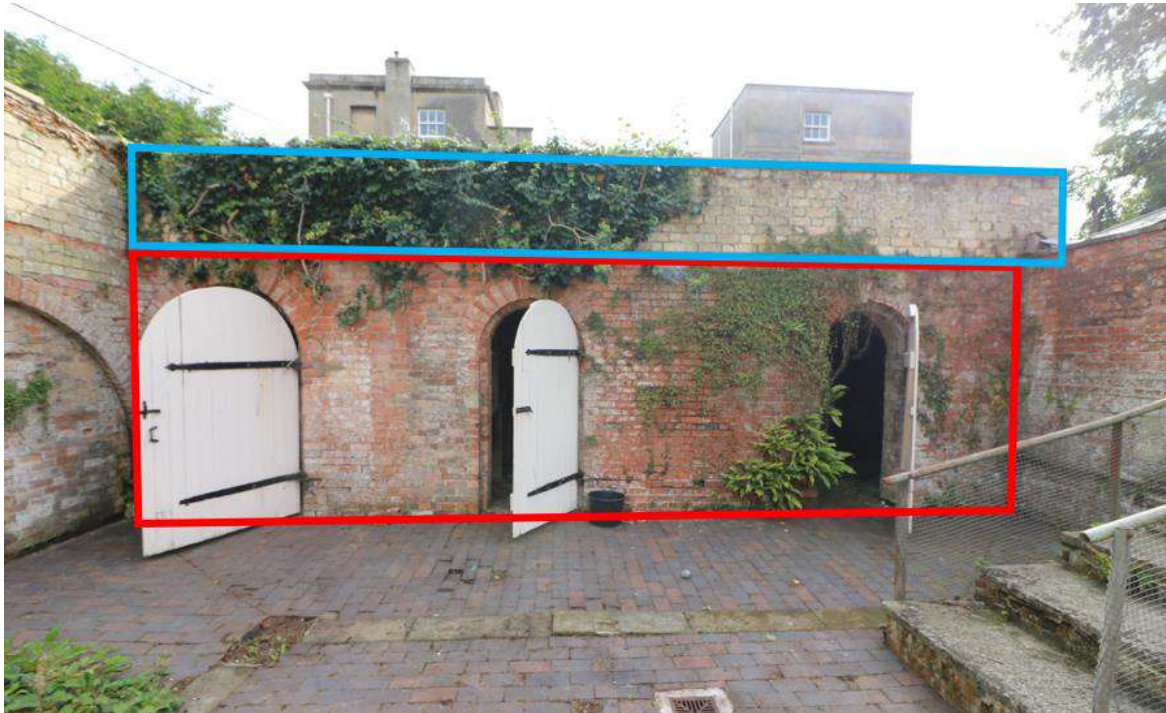
Figure 47 The south wall of the wash yard. The 18th century phase is marked in red and the 20th century brick parapet marked in blue.

3.1.18 In the south wall of the wash yard (Figure 47) there are three arched brick openings. The two right hand openings are narrow and each provides leads to a single vaulted chamber. The left-hand opening is wider and provides access to the remainder of the cellar range. Each doorway has a modern ledged and braced door with earlier iron strap hinges and pintols. Above the doorways is a raised parapet of 20th century buff brickwork which prevents falls from the raised terrace area to the south.

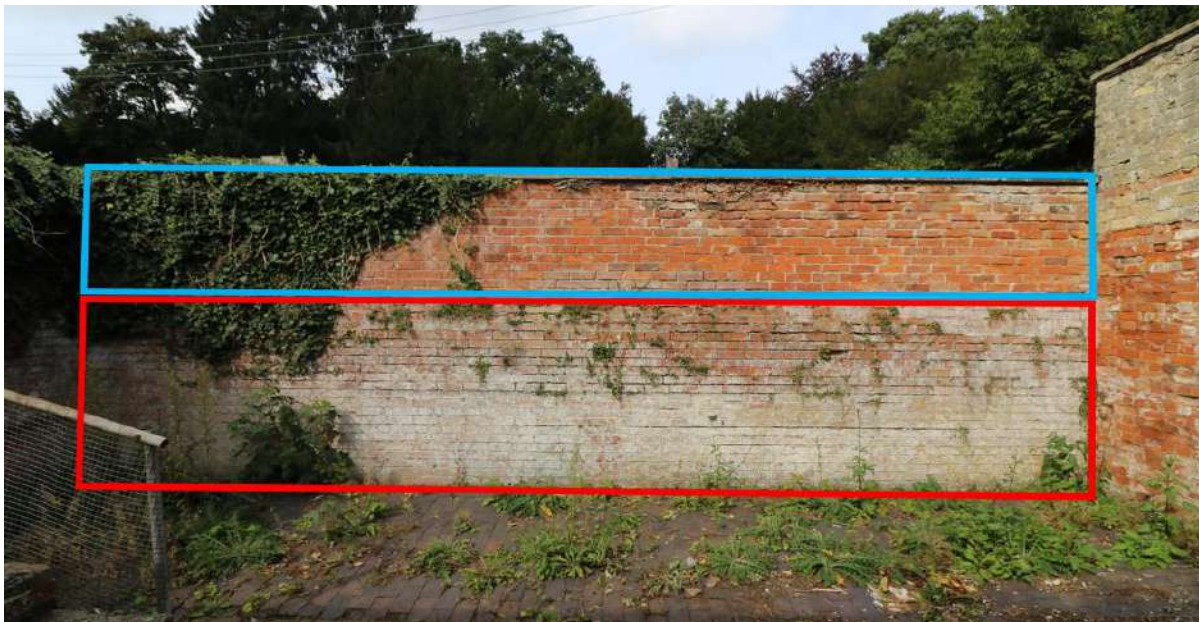
Figure 49 The north wall of the wash yard. 18th century fabric marked in red and 20th century fabric marked in blue.

3.1.20 The north wall of the wash yard is the most plain in character with 18th century brickwork laid in English bond up to around 1.8 metres high and a reconstructed parapet of 20th century brickwork above.

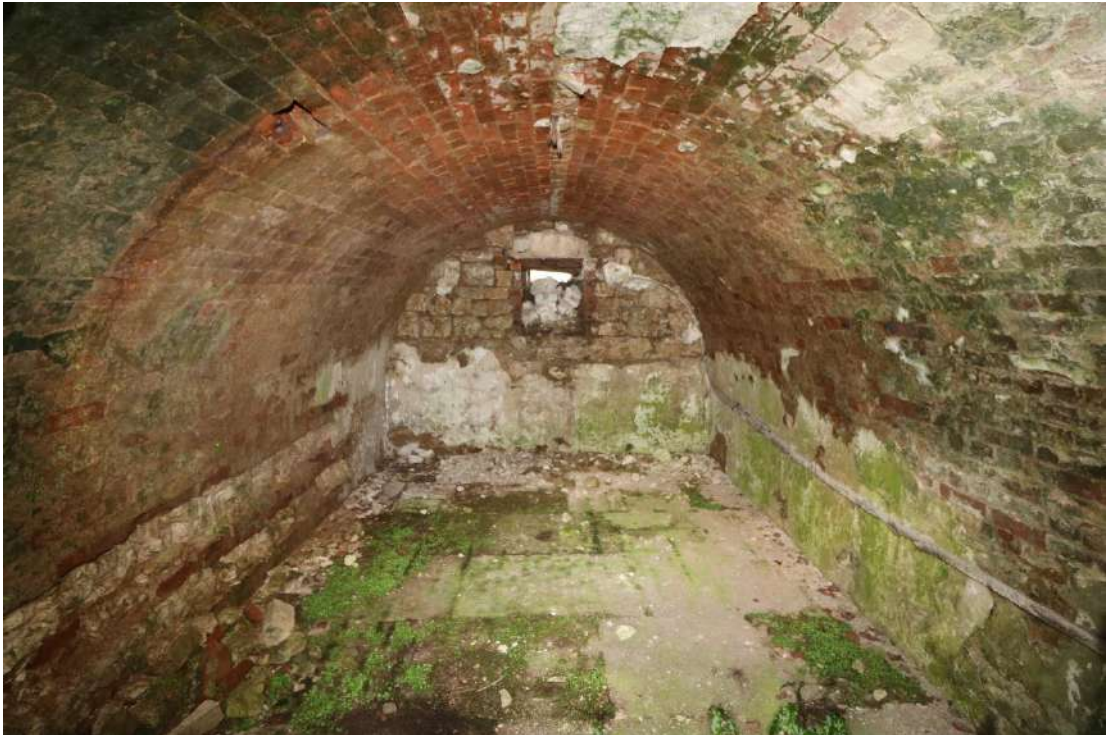
Figure 51 The interior of Chamber 1

- 3.1.22 Chambers 1 and 2 are accessed from the wash yard are of a similar character. Both have semi-circular brick vaulted ceilings and include chalk stone blocks in coursed bands at low level. Their south walls are constructed from roughly coursed chalk stone blocks and each has a square air vent with metal grille which appears to postdate their original construction. The floors are paved with flagstones and Chamber 2 has in built shelving formed from stone slabs. There are patches of render over some areas of brickwork and Chamber 1 is in poor condition with the chalk stone blocks being particularly friable.

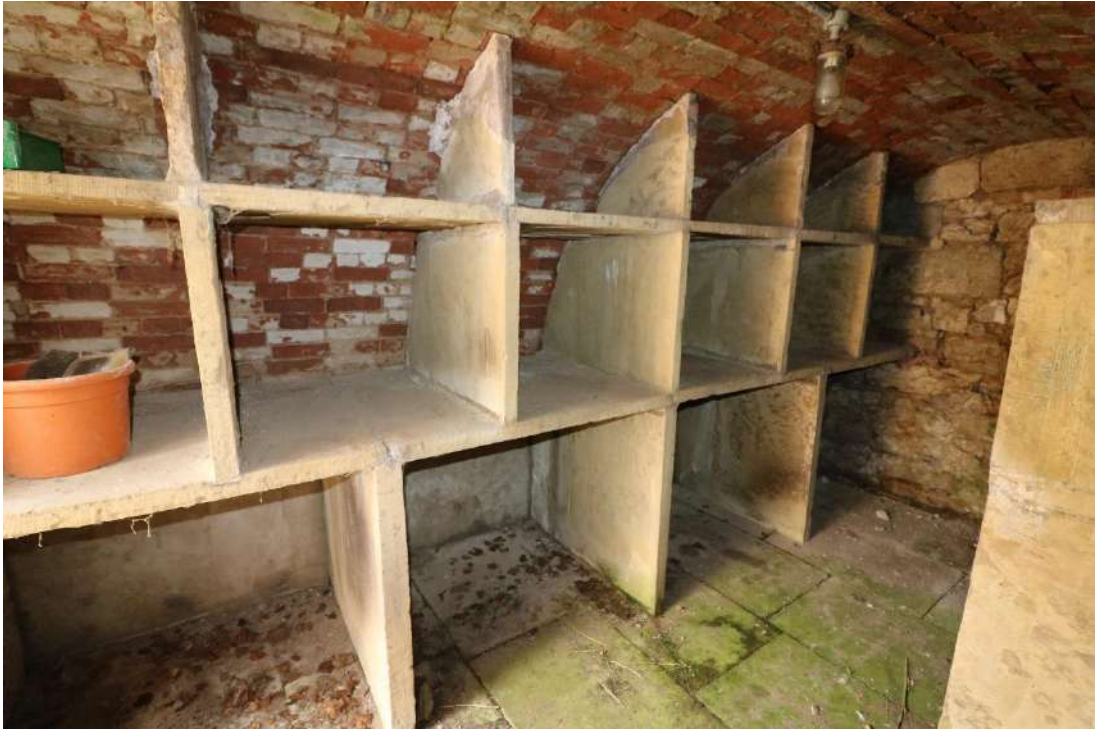
Figure 52 The interior of Chamber 2

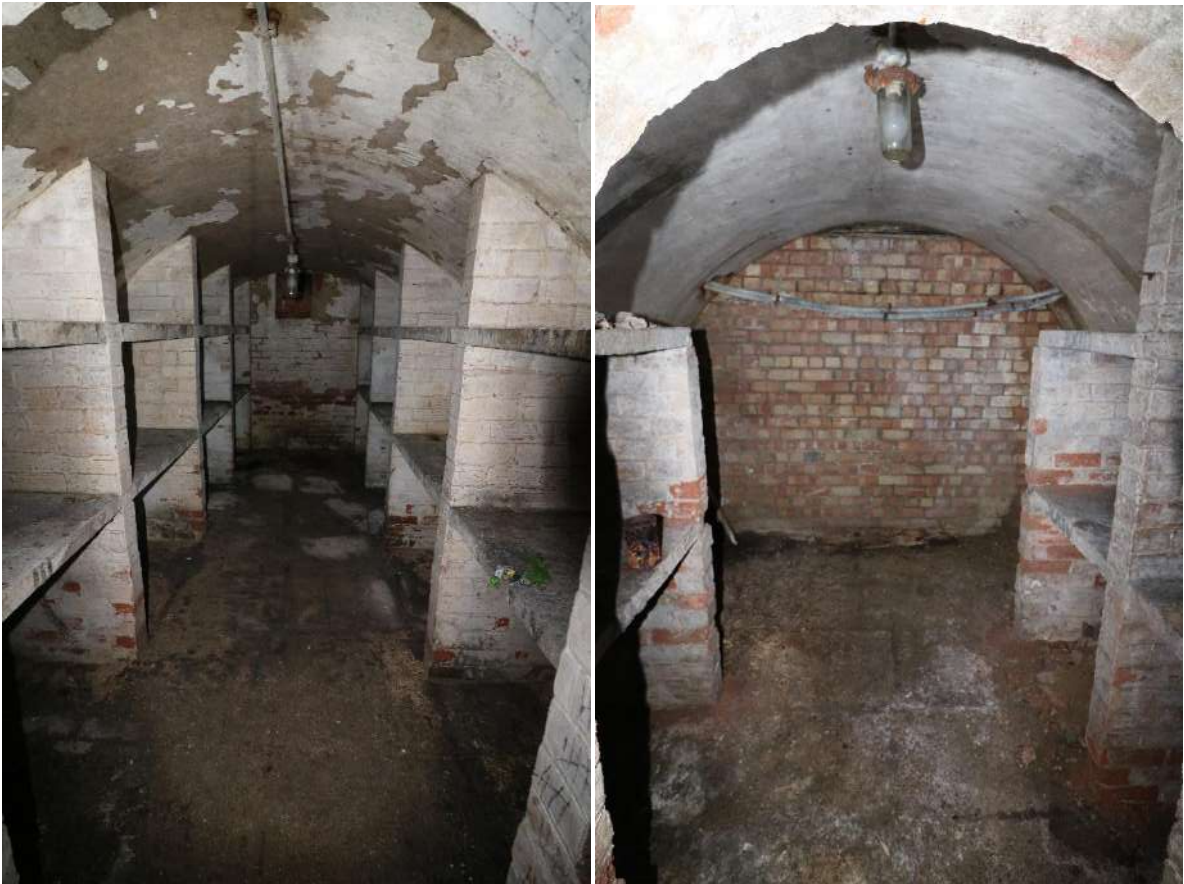
Figure 55 Chamber 3 looking north (left) and Chamber 4 looking south (right).

- 3.1.24 The lobby (Figure 54) is a square space with vaulted ceiling which provides access to Chambers 4, 5 and 6. These cellars are believed to have been constructed in a single phase during the 19th century as part of the east wing extension to the Hall. Chamber 4 (Figure 55) is the smallest of the three and contains 19th century brick and stone shelving. Chamber 3 (Figure 55) to the north of the lobby contains 20th century brick and stone shelving. Chamber 5 (Figure 56) to the east of the lobby is the largest and runs the full length of the cellar complex from north to south. It contains a pair of redundant modern water tanks and supporting brick piers. The ceiling vaulting in all three chambers is plastered and whitewashed and the floors surfaced with flagstones.

- 3.1.25 At the southern end of both Chambers 4 and 5 is a 20th century infill brick wall which suggests that the cellars once extended beyond this point and possibly linked with cellars beneath the upstanding parts of the Hall. At the north end of Chambers 3 and 5 the brickwork appears to be contemporary with the vaulting, but both have a partially infilled air vent cut into them at high level. It is not known where these vents lead, but it seems likely that a further chamber may exist or existed previously to the north. The arched brickwork in the east wall of the wash yard is further suggestive of this.
