Elsham Hall, Lincolnshire

Heritage Impact Assessment

Project Reference: 22-036

Produced for Jonathan Hendry Architects

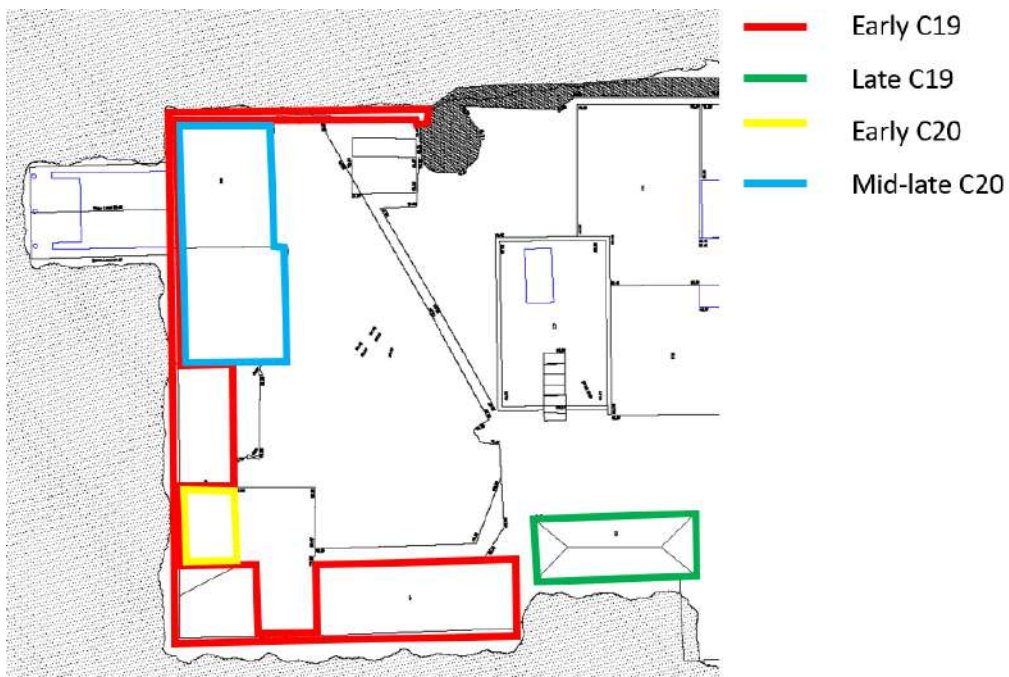
Figure 57: Phasing diagram for the courtyard outbuildings to the north west of the Hall

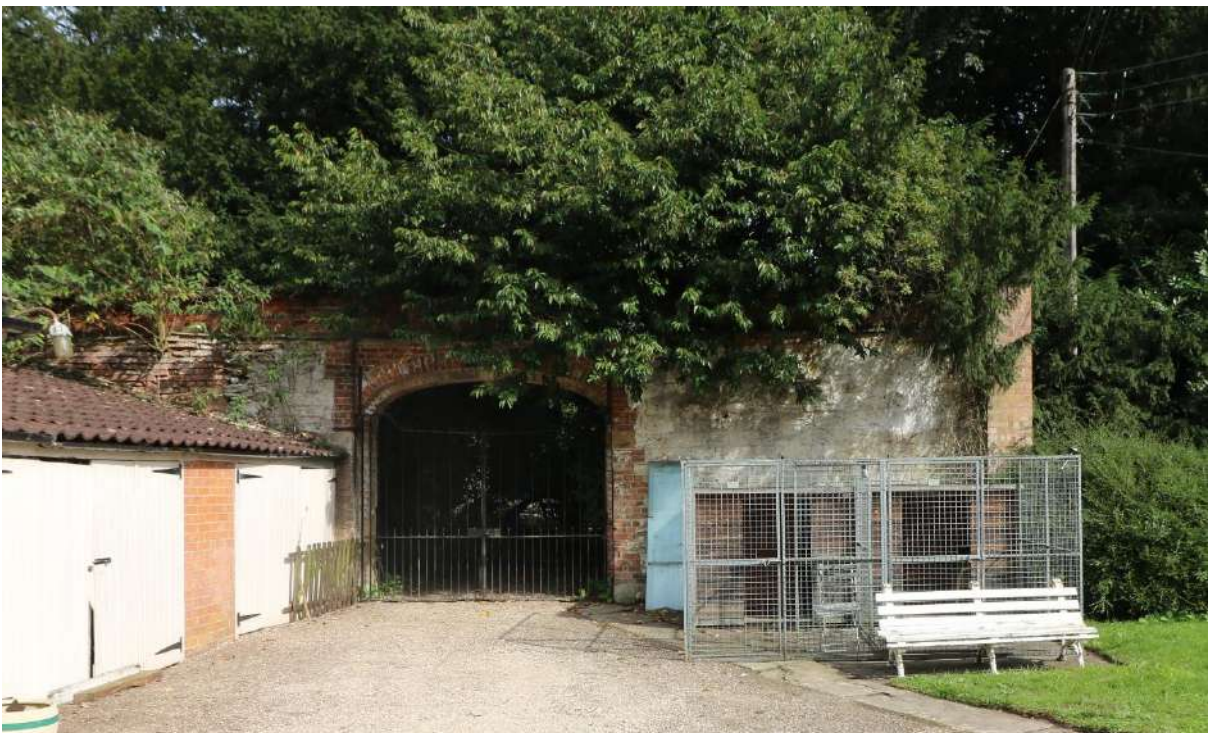
Figure 59: The east side of the courtyard showing the main entrance arch

3.1.27 On the east side of the courtyard the sense of enclosure is weakened by the gap left by the demolished East Wing. To the north of where this once stood, the tall courtyard wall continues northwards and includes an arched brick opening (Figure 59) which today serves as the main entrance to the yard. The sections of wall to the north and south of the arch include chalk stone blocks similar to those found in cellar Chambers 1 and 2. These are now heavily weathered and in poor condition.

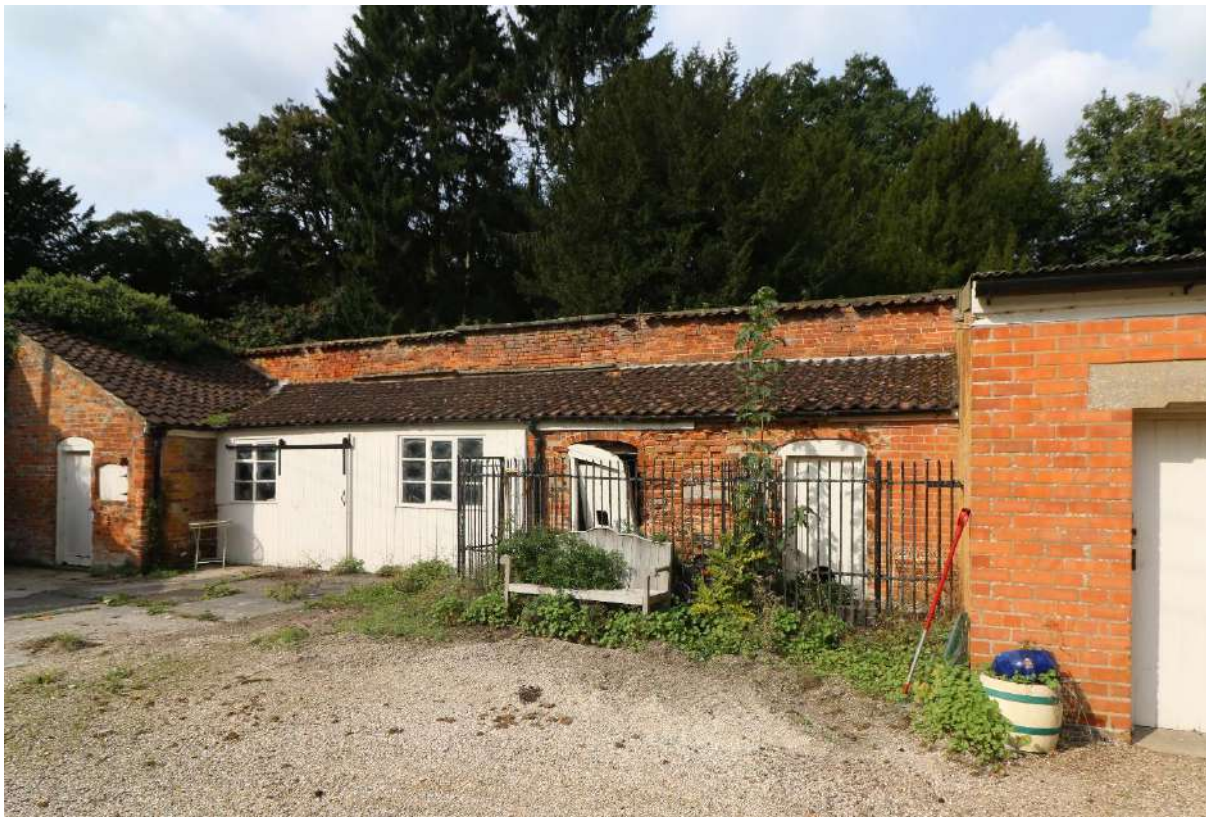
Figure 60: Outbuildings in the north west corner of the courtyard

- 3.1.28 The north side of the courtyard is enclosed by a tall brick wall of early 19th century date against which are a series of lean-to brick and timber outbuildings. In the north west corner of the courtyard is a square store building which leans against the west wall of the courtyard (Figure 60). This is contemporary with the boundary wall and is constructed of red brick with a clay pantile roof. It has a timber door and a hatch in its south elevation, both with arched brick lintels. The hatch has an original wooden door with iron strap hinges.

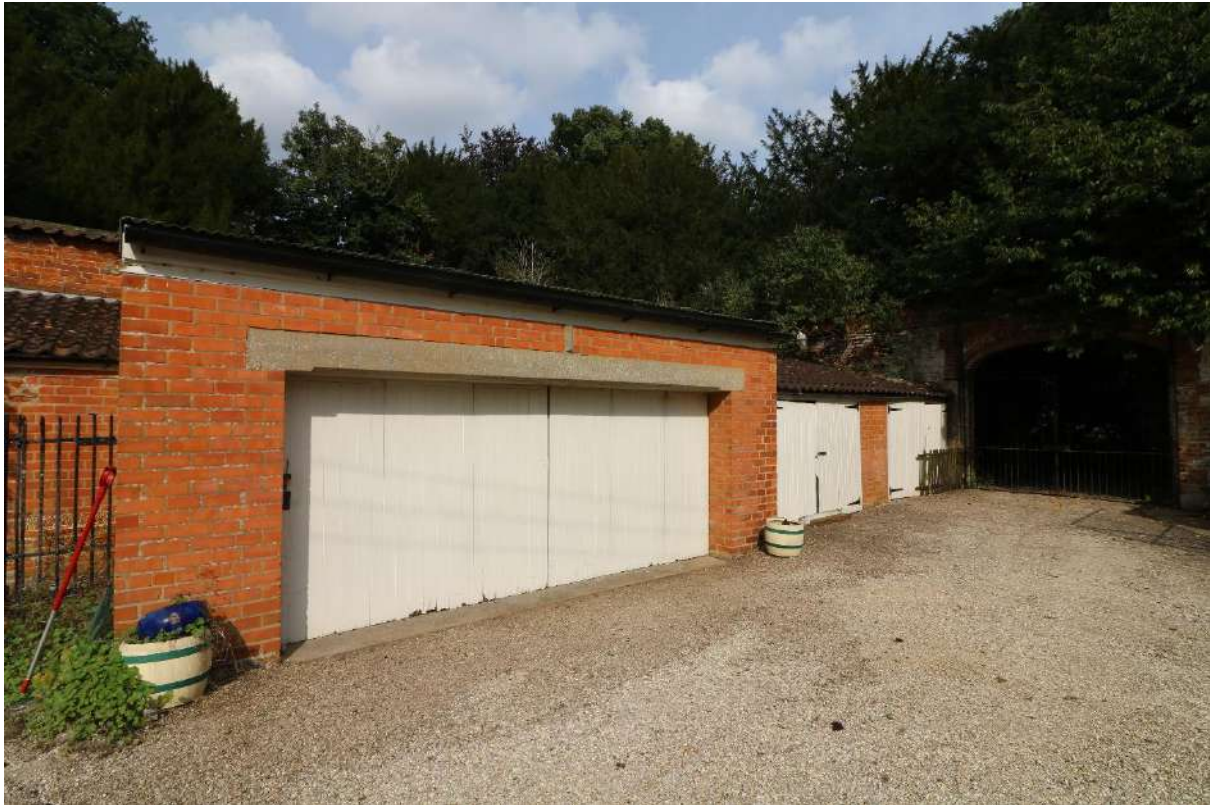
Figure 61: Modern garages in the north east corner of the courtyard

- 3.1.30 To the right again is a run of three modern brick lean-to garages (Figure 61) which date to the mid to late 20th century. The left hand garage has double width doors under a concrete lintel and has a deep plan form and a corrugated metal roof. The right hand pair of garages have pantile roofs and timber doors with strap hinges.

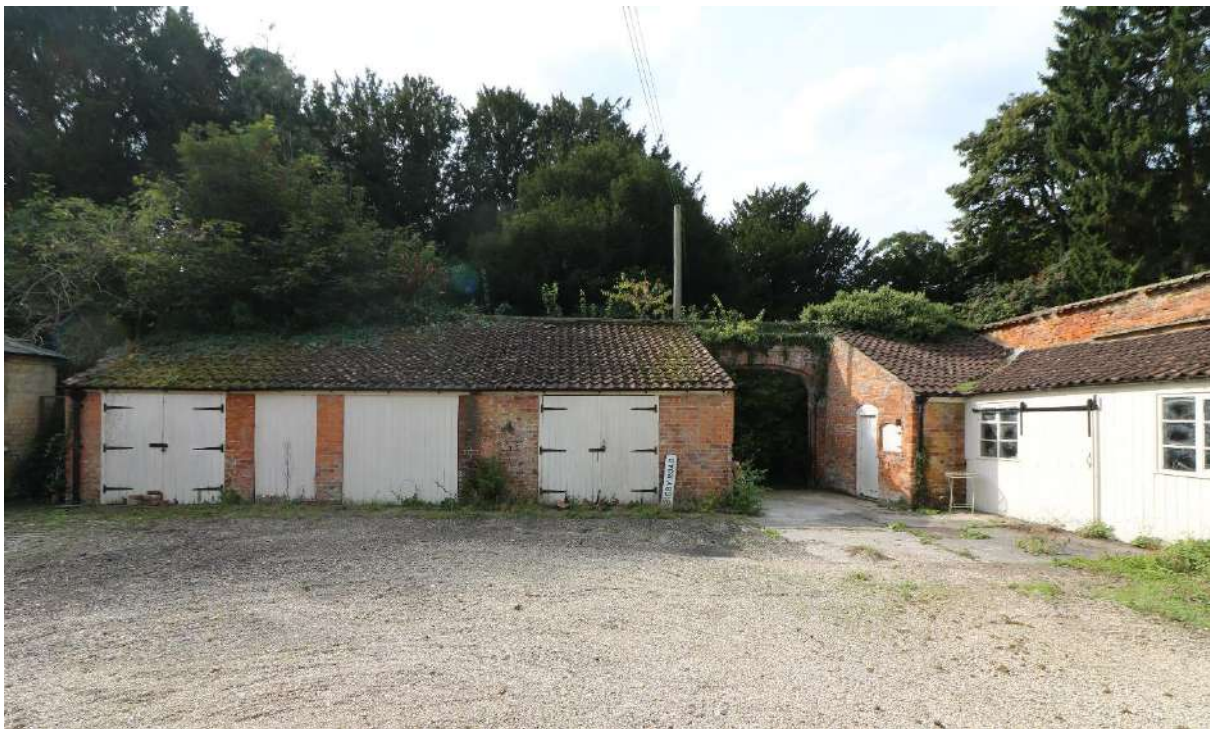
Figure 62: Outbuildings on the western side of the courtyard.

3.1.31 On the western side of the courtyard (Figure 62) there is a second arched opening which acts as a secondary access point. To the south of this is a rectangular run of early 19th century lean-to store buildings constructed in brick with pantile roofs. These have three double width openings and a single width opening. The left and right hand openings have modern double doors with strap hinges while the central two openings are infilled with timber cladding panels.

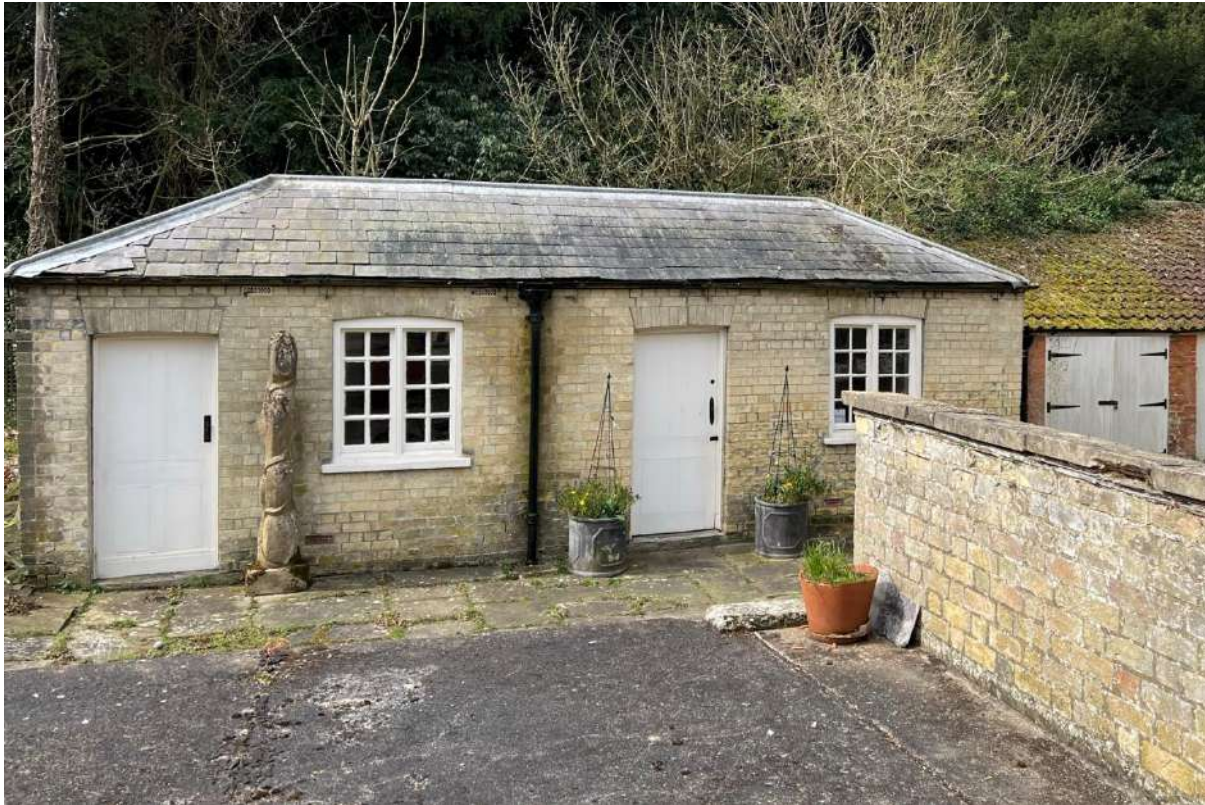
Figure 63: The game larder

3.1.32 In the south west corner of the courtyard, closest to the rear of the Hall is a free standing game larder constructed from English bond buff brickwork with a hipped slate roof. The larder is markedly different in character to the other more utilitarian outbuildings and is contemporary with the later 19th century phases of the Hall. It has timber panelled doors and glazing bar casement windows in brick arched openings and retains its cast iron rainwater goods.
