BUILDINGS

NORTHFIELD FARM

MAIN STREET, THORNTON CURTIS NEAR BARROW ON HUMBER

ENVIRONMENTAL ASSESSMENT RELATING TO DEVELOPMENT

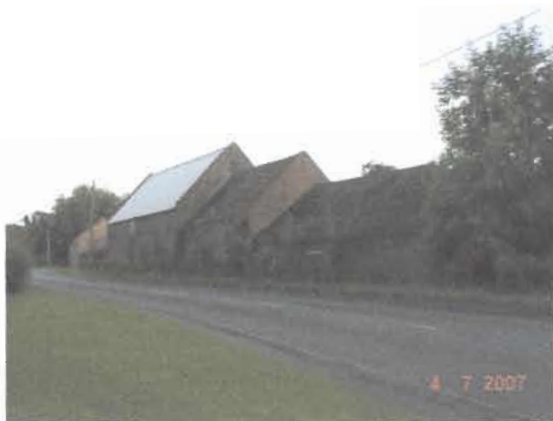
The buildings comprise a range of farm buildings in solid brick construction forming a part of the farmstead of Northfield Farm, and date from the 18th or early 19th century (Fig. 1). The current layout consists of buildings mainly on one storey only, but with a two-storey storage barn, stabling and adjoining granary in the centre.

Fig.1 Buildings on road side.

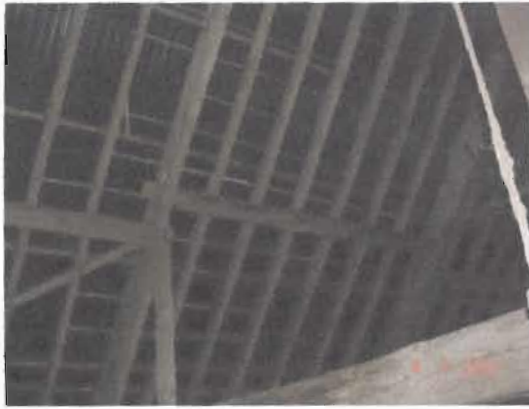
The quantities of spiders webs covering the walls and parts of the roofs of all the buildings appear to show (Figs.2 & 3) that there has been little disturbance by bats

either entering the cracks between bricks for hibernation or searching for insects. A small quantity of insect remains, usually butterfly wings, was found in the upper storey of the barn, but no further quantities of bat droppings that might indicate an active bat roost. These remains appeared to be associated with the large quantities of bird feathers and droppings near the open windows.

Fig. 2 Interior of barn upper floor.

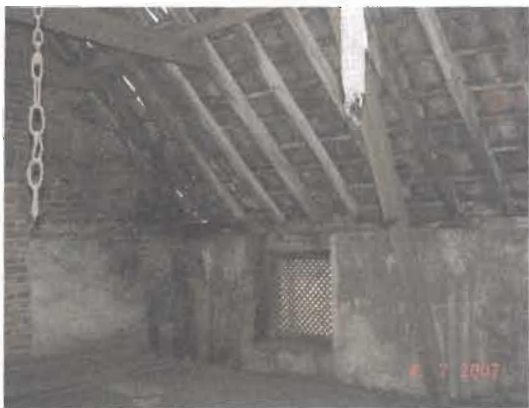
Fig. 3 Interior of granary upper floor.
