Geo-Environmental Desk Study

Addlesee Timber & Haulage Ltd, R/O 2 Sandtoft
Road, Belton, DN9 1PH

14th April 2008

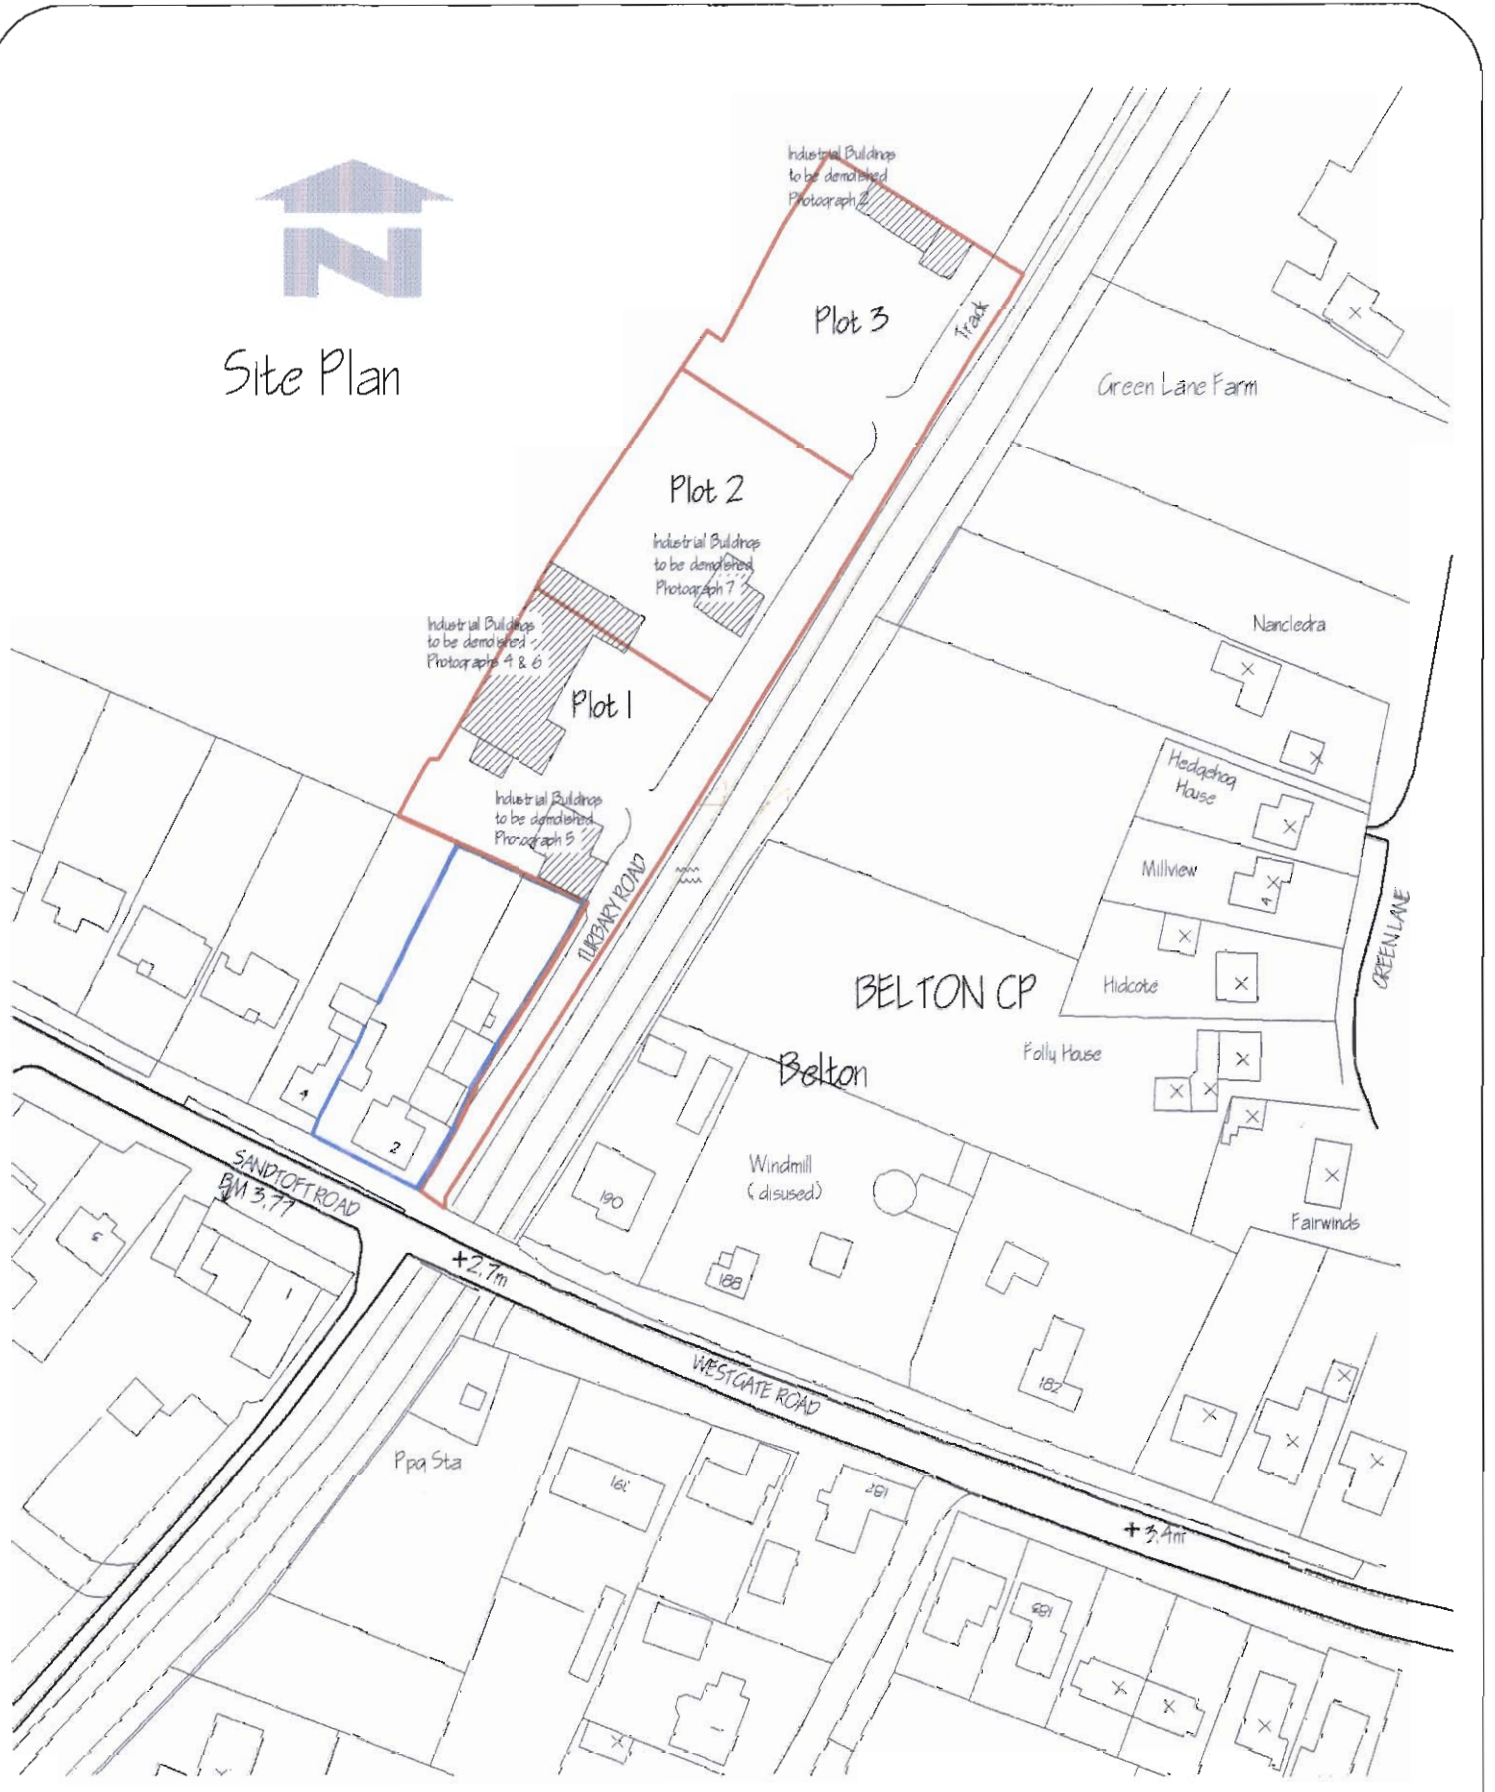
Howard J Wroot BSc MRICS Chartered Surveyor 240 Wharf Road, Ealand Scunthorpe DN17 4JN	Proposal	Change of Use from Industrial Site to Residential Development of 3 Building Plots		
	Drawing	Site Plan		
	Tel 01724 710688	Client	Addesee Timber & Haulage Ltd	
Fax 01724 710174	Date	18/4/08	Dwg No	1 of 1
Revision	Mob 07947 226577	Scale	1:250	Ref No 638-08

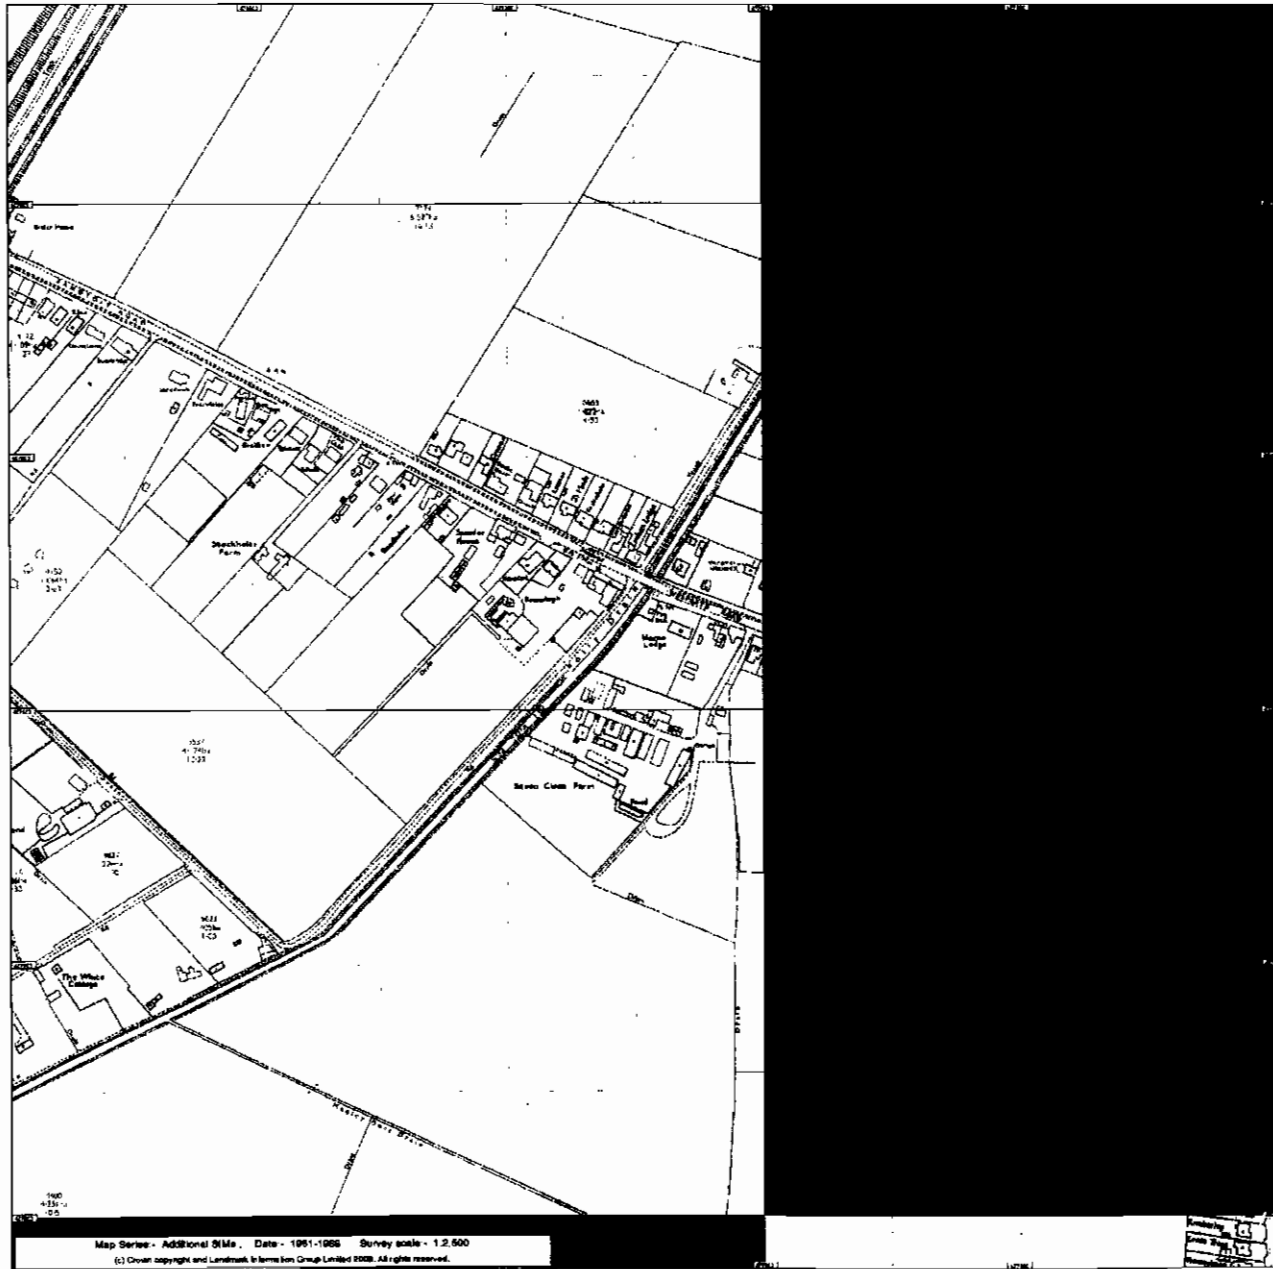
Landmark Historical Map
 Published Date(s): 1981-1989
 Originally plotted at: 1:2,500

The site showed little change since the map from 1956, the site and surrounding land remain undeveloped.
