Bat and Breeding Bird Survey Report

Site: The Groves
Adjacent to Trent side farm
Amcotts
Nr Doncaster
DN17 4AX

Date: October 2010

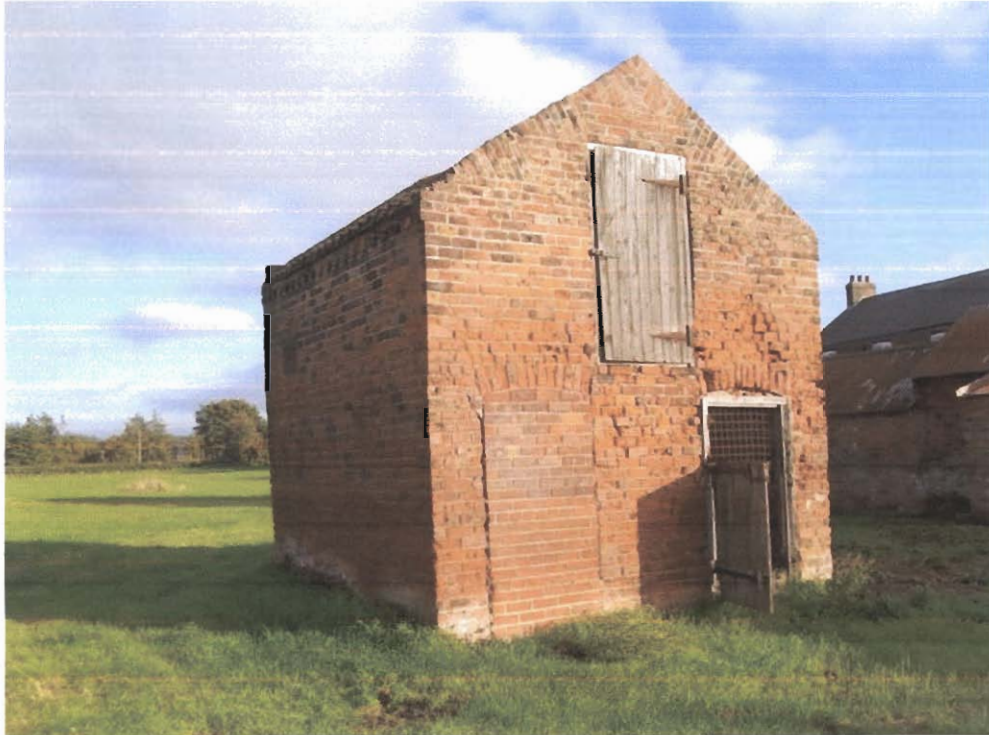
Appendix one: Barn two

A red brick pan tiled roofed barn currently used as a hay barn. The roof has partial under felting and loose or absent pan tiles opening the roof space to the elements. The interior is partially rendered eliminating space between brick work that bats could utilise. Evidence of long term historical water damage was observed within the barn. Externally the pointing between the brick work is largely intact. Subsidence within the eastern facing wall was recorded. Such areas could provide suitable access points for bats however all cracks were observed to be covered by heavy cob webbing indicating no activity.

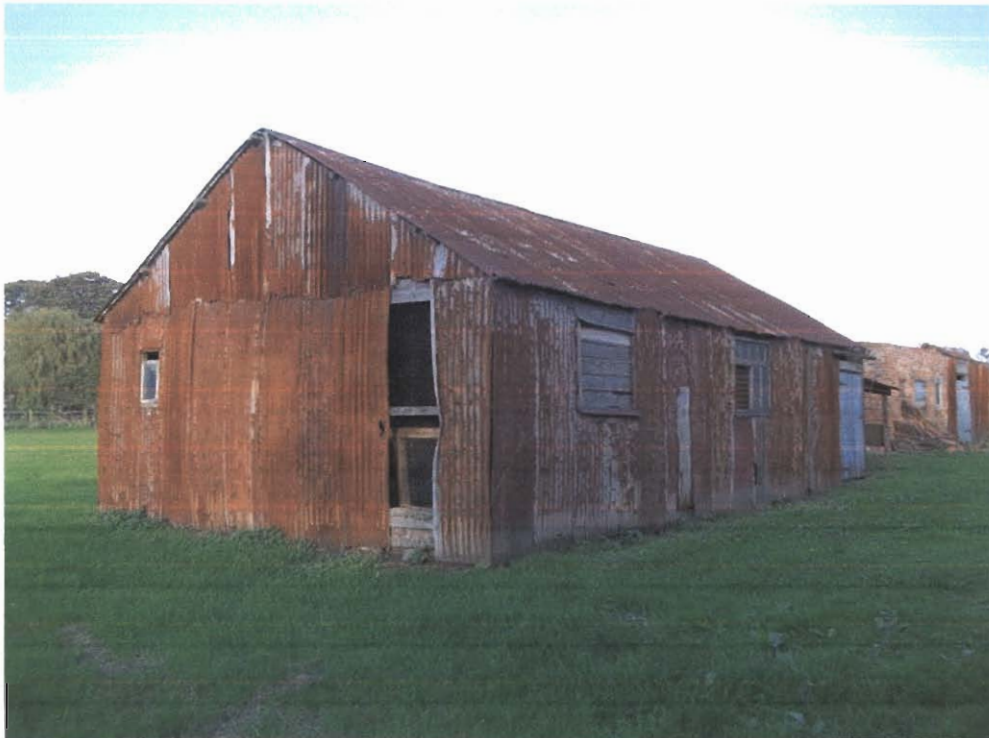
A barn constructed entirely from corrugated iron sheets. The windows and doors are all intact and no suitable access places for barn owl exist.

Appendix two: Barn six showing unsuitable conditions for bats

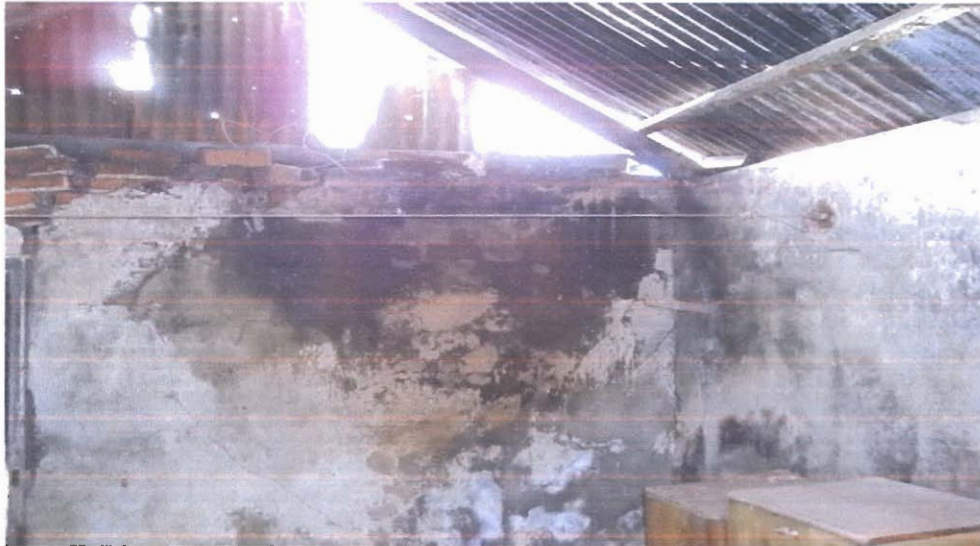
6.4 The structure of the properties provides very few places suitable for bats to utilise. Areas of the roof space have exposed to the elements through loose roof tiles. The majority of the barns show signs of water damage and historical dampness. Such conditions fail to provide the suitable constant temperatures bats require. The intact pointing and lack of cavity walls in these properties again provides few areas for bats to utilise.

Appendix three: An example of the internal brickwork rendering with signs of water damage evident.

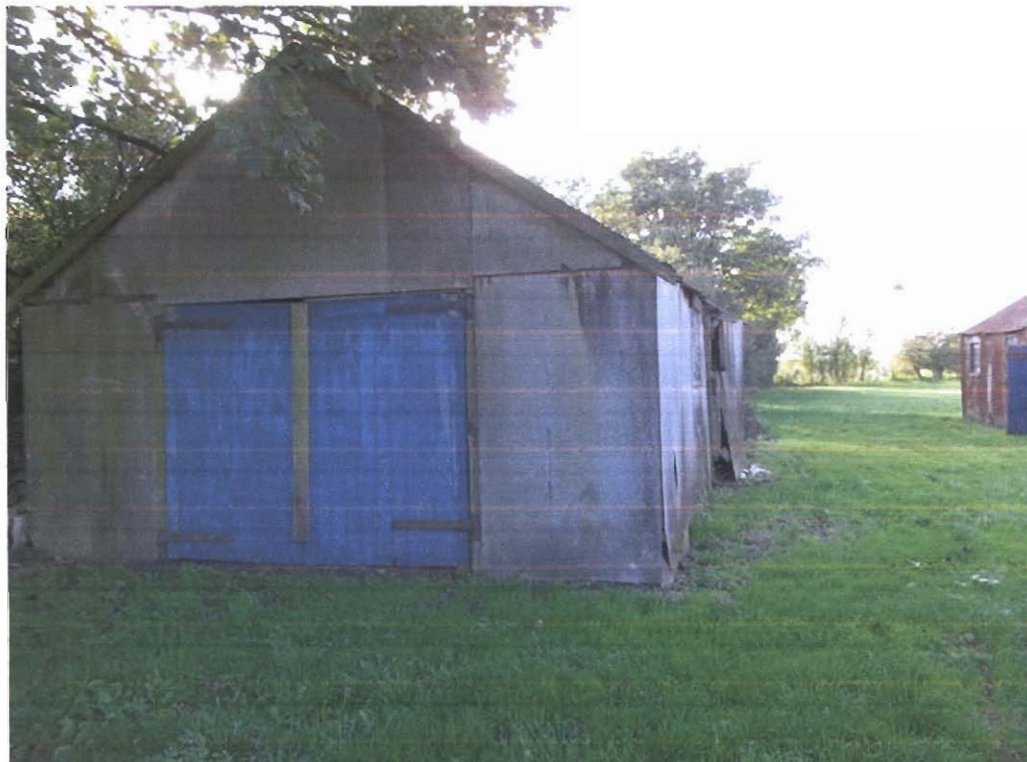
Appendix four: Barn five

A barn constructed from asbestos sheeting with a corrugated iron roof. The nature of these materials eliminates roosting potential for bats. The barn does have suitable access points and perching structures for barn owl.

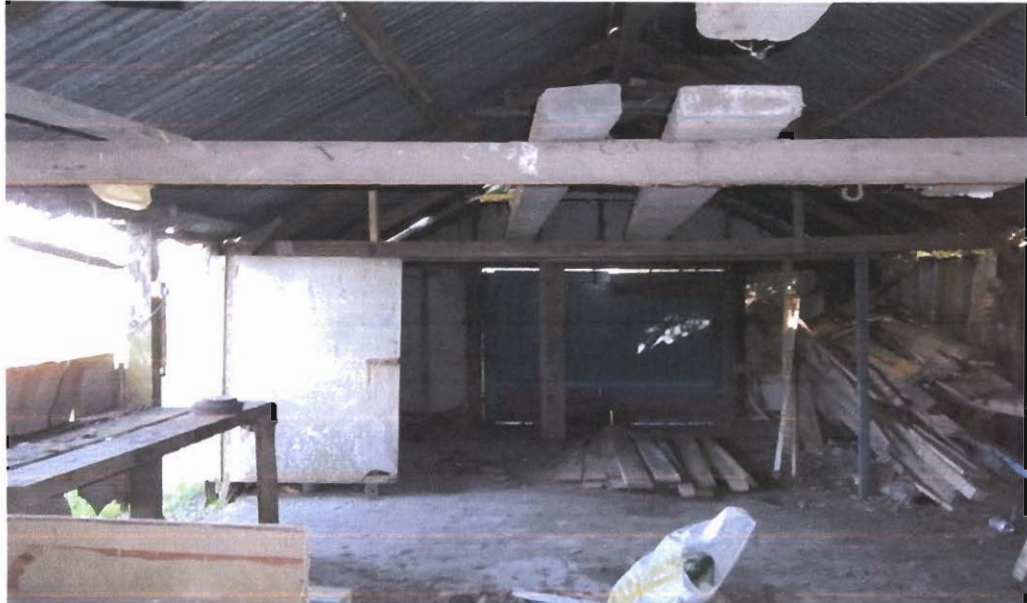
Appendix five: The interior of barn five

The structure and condition of the barns on site fails to provide suitable conditions for bats of all species. Only one barn (number 5) shows any suitability for use by barn owl. No field signs to indicate presence of any legally protected species were recorded.
