HORSE GATE FARM, NORTH END, GOXHILL,

NORTH LINCOLNSHIRE

ECOLOGICAL SURVEY

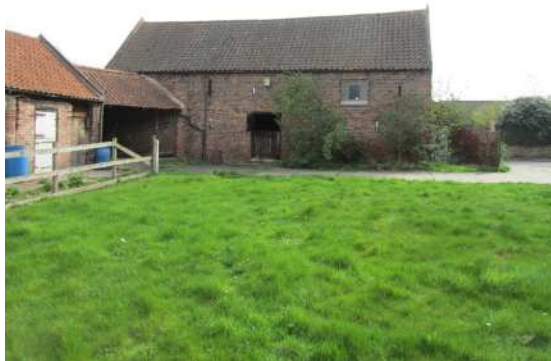
The buildings comprise a two-storey height barn, Building A, (Frontispiece), and two further ranges of single storey buildings, Buildings B&C, all formerly in agricultural use and built in solid 9in. brickwork and clay tiled roofs (Figs.1&2).

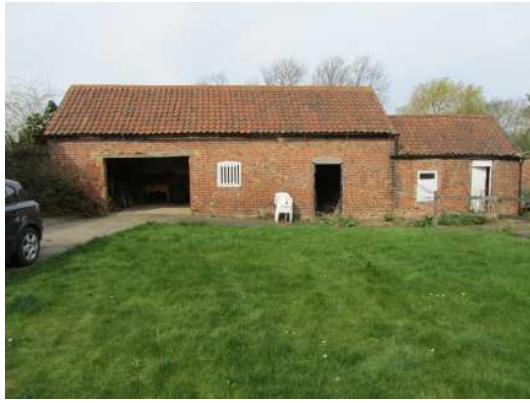
Fig.1 Western range. Building C.

Building C comprises an open fronted storage shed in traditional construction but with a more modern roof, recently replacing the original structure with new timbers and under-drawn with felt (Fig.6). This building showed no evidence of habitation by bats or birds.

At the north end of the main part of this building a second and smaller set of store-houses is in original condition. No evidence of habitation by bats or birds was found on any of the surfaces or potential access holes in walls or roof.

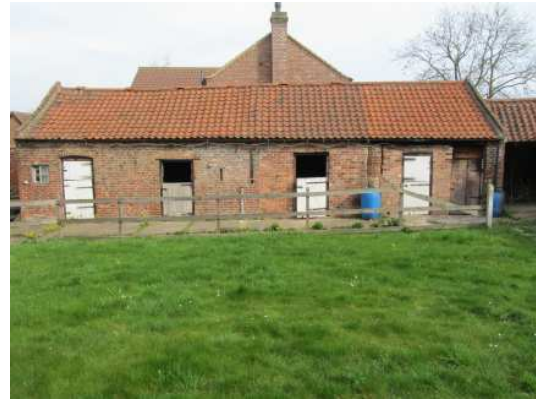
Fig. 2 Northern range. Building B.

Building B comprises a range of five small loose boxes for livestock and storage, and a small open fronted garage adjoining Building A. The walls are built in 9in. brick, partly rendered in cement on the inside. The western gable wall is showing signs of collapse, with some potential access holes to the inner spaces of the wall. In some areas there are small holes in brickwork or around window frames that could allow

access for bats into voids behind. Inspection of many of these holes showed no signs of use by bats or birds. Many of the holes were well covered with recent cobwebs. No droppings or other signs of bat habitation were found on any of the surfaces of floor or window cills in this area, although several butterfly wings were found randomly over the floor of the main area of the building. Several Swallow's nests and quantities of bird droppings were seen in the roof and floor over parts of Building B, with potential access through various doors and windows.

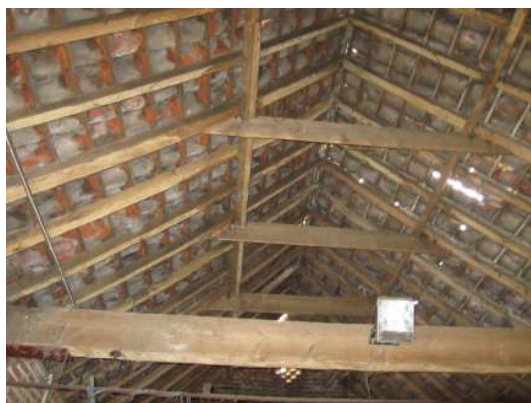
The Barn at Building A is a building of two storey height built in 9in. solid brickwork with a small lean-to extension, possibly former outside earth closet, at the south end. The walls have many holes and potential access points, through doorways and ventilation slots in the walls. Many of the ventilation slots had been blocked with plastic bags. The clay pantiled roof is in its original condition, with no plaster lath or other underlay to the tiles. There is minimal insulation within the roof area, giving poor insulation value for bats, which require a steady temperature for roosting or hibernation (Fig.3). The inside of the roof area is partly covered with undisturbed cobwebs, especially at the roof ridge, which would tend to indicate poor access or low activity by bats or birds within the roof void. The roof ridge is in good condition, with few external holes available for access by bats. The gable walls are built with verges projecting above the roof line, with tiles pointed up at the edge joint.

Fig.3 Roof of Barn A.

Inspection of the outer surfaces of the walls and the inside of the building showed no evidence of bat droppings or other markings on any of the potential access holes in brickwork or under the roof eaves and gables. There was no evidence of habitation by bats or birds in the small lean-to building. No evidence of habitation by Barn Owls was found.

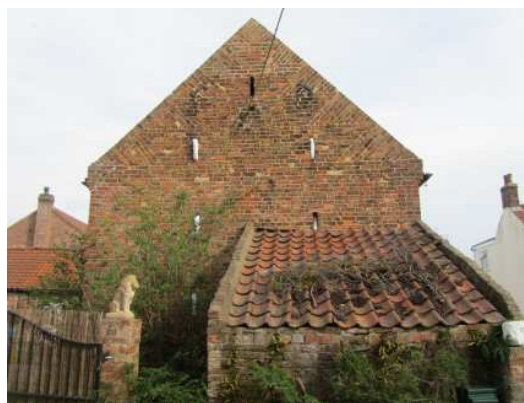
Fig.4 South gable and lean-to Building A.

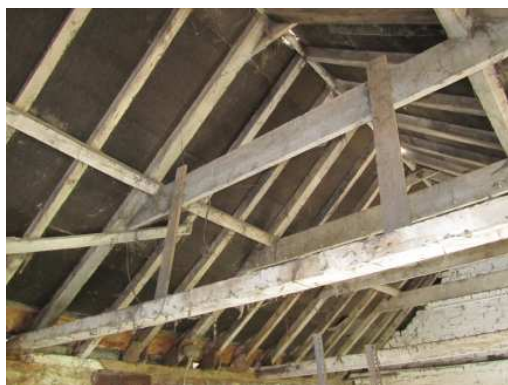
The roof is covered with clay pantiles, more recently re-covered and under-drawn with bituminous felt. The inside of the roof area was generally free of cobwebs, including around the ridge area (Fig. 5).

Fig. 5 Interior of roof in Building B.

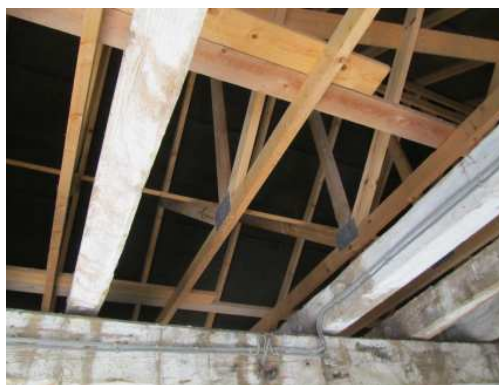
Fig.6. Interior of roof in Building C.
