# Protected Species Survey at 17 Greengate Lane, South Killingholme, North Lincolnshire DN40 3HB

June 2013

Andrew P. Chick MPhil  
Ecological Consultant

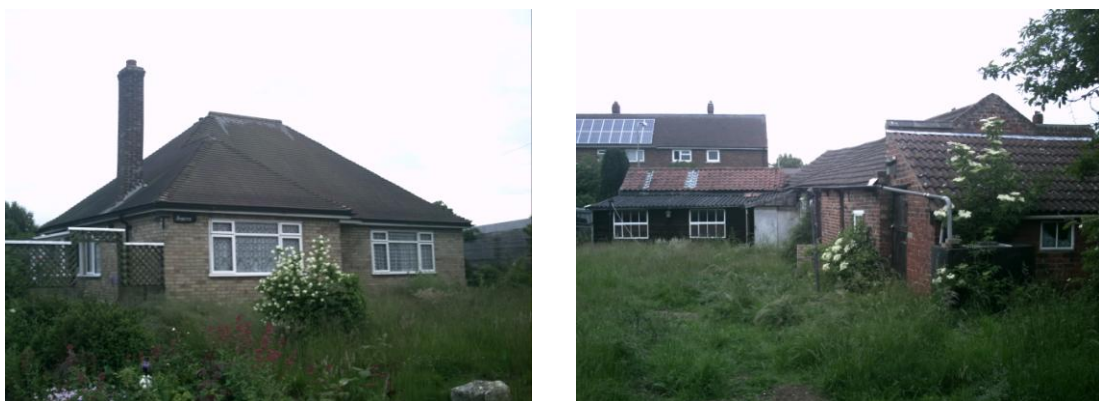
**Photograph 1: 17 Greengate Lane (left) and brick outbuildings (right).**

The bungalow is constructed of solid bricks, supporting a timber framed roof covered with Rosemary tiles. There is a single small roof void which is insulated and contains under felt throughout. The roof structure is generally in a good condition with no missing tiles. The internal ceilings are all present. Ambient light and draught levels were low. At the time of the

survey the ridge beam was extensively covered in cobwebs. Any soffits were tight fitting and all mortar joints sound.

An 'L' shaped arrangement of semi-detached buildings constructed of both solid bricks and single skin timber supporting a variety of timber framed roofs, both pent and apex covered with both concrete tiles and pantiles. The buildings are subdivided by internal brick walls, (some full height) and single skin timber walls into various compartments. There is no roof void present. All compartments are open to the apex and contain polythene or felt underlay throughout. The roof structure is generally in a good condition with little in the way of missing tiles and all mortar joints appear sound. At the time of the survey the ridge beam was extensively covered in cobwebs.

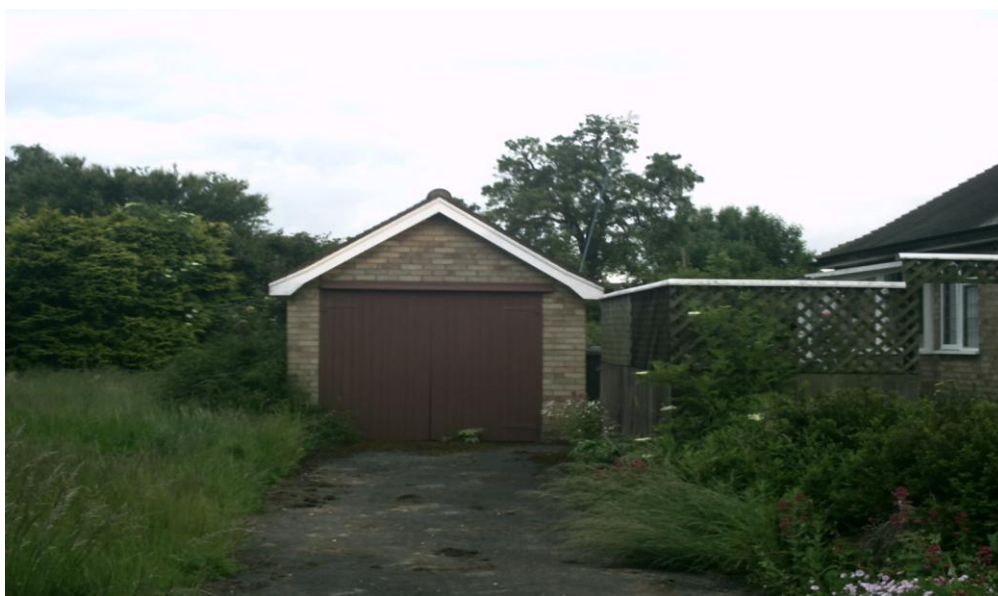
**Photograph 2: Garage – northern aspect.**

Constructed of solid bricks, the garage contains no wall cavity. A timber framed roof covered with Rosemary tiles is present. This is open to the apex with no internal ceilings and contains under felt throughout. All windows and doors are intact and tight fitting. The roof structure is generally in a good condition with no missing tiles. Ambient light levels are high but draught levels low. At the time of the survey the ridge beam was extensively covered in cobwebs. Again any soffits were tight fitting and all mortar joints sound.

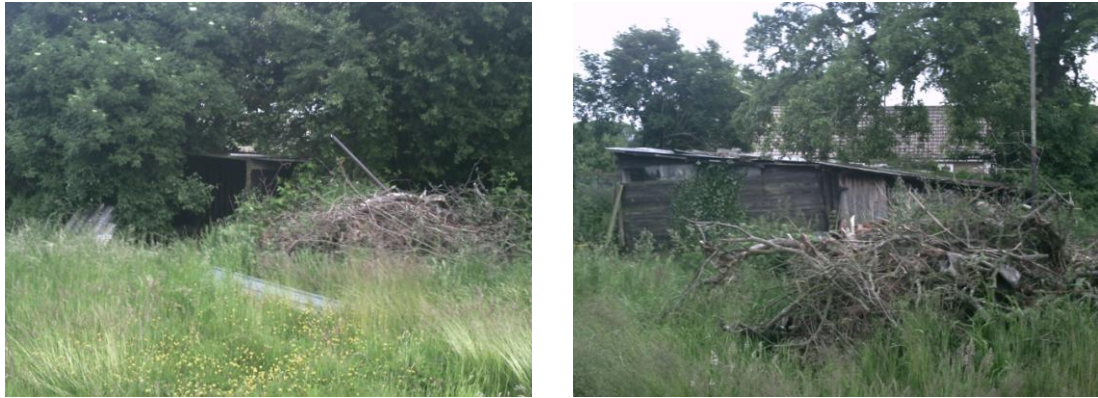
Photograph 3: Log store (left) and Poultry building 1 (right)

An open fronted, pent roofed, single skin log store, constructed of corrugated iron sheets is located adjacent to the eastern boundary, central to site. In addition, two detached single skin tongue and groove former timber poultry sheds are located at the southern end of the site. One covered by a pent roof, the other a traditional apex. Neither contain a roof void. The roofs are covered with either single skin corrugated roofing sheets or roofing felt. Only the building marked as poultry shed 1, (Figure 1) is in sound condition with low draught levels, complete glazing and snug fitting doors. The remaining buildings are in poor overall condition. High ambient light levels are present in all buildings.

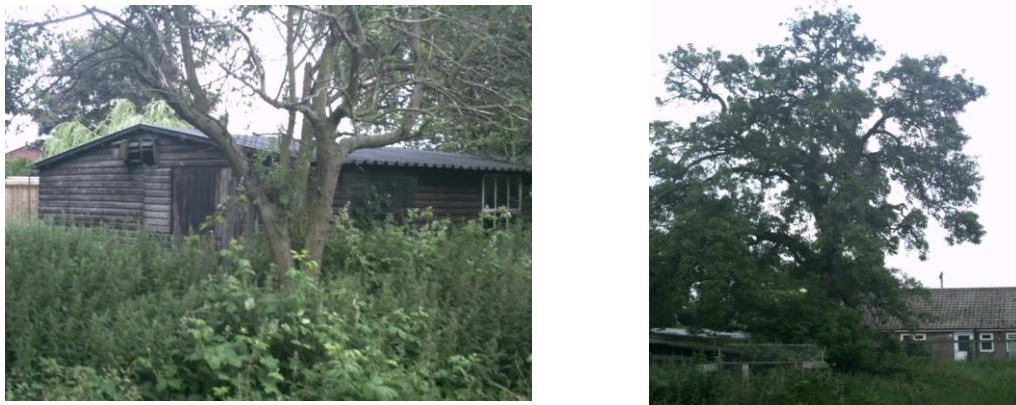
Photograph 4: Poultry building 2 (left) and the Pear tree (right)

Tree No.	Species, Field notes and description	Located within site	Suitability to bats	Score
T1	Pear Tree <i>Pyrus communis</i> Mature single stem tree with limited features of bat roost potential.	Yes	Low roost potential	Low
T2	Silver birch <i>Betula pendula</i> Mature single stem tree with no suitable features	Yes	No	Low
T3	Fruit tree <i>Prunus sp</i> Multi stemmed tree with limited features of bat roost potential.	Yes	No	Low

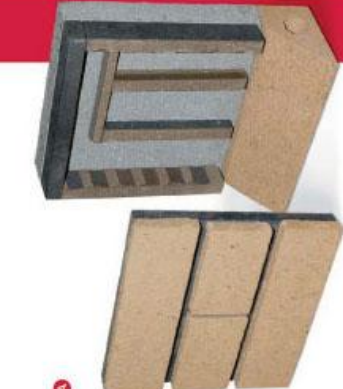
**A**

Eco Habitats for Bats - Technical Data: A	
Sizes	215mm x 215mm or 215mm x 204mm
Durability	F2/S2 - fully foot resistant

- Designed with the Pipistrelle Bat in mind
- Available in all brick types
- Attractive roof
- Discrete home for bats
- Various sizes
- Several roosting zones are created inside the box
- Bats are contained within the Bat Box itself
- Maintenance free as the entrance is at the bottom
- Ideal for new build & conservation work

- Bat roosting units (Schwegler type 1FE with back plate) to be incorporated within the design of any new buildings. Example images of these can be found in Appendix 3.

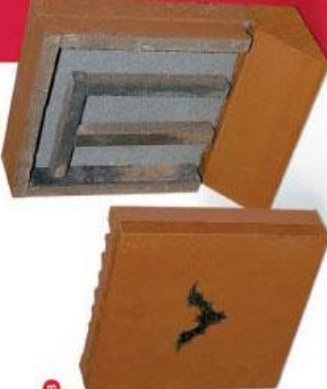
**B**

Eco Habitats for Bats - Technical Data: B	
Sizes	215mm x 215mm or 215mm x 204mm
Durability	F2/S2 - fully foot resistant
