# Protected Species Survey – Central Cottage, Market Place, Owston Ferry, North Lincolnshire

April 2016

Ecology & Forestry Ltd  
Foremans Cottage,  
Kelstern, Louth,  
Lincolnshire,  
LN11 0RG

Report Prepared by Rod Strawson BSc (Hons)

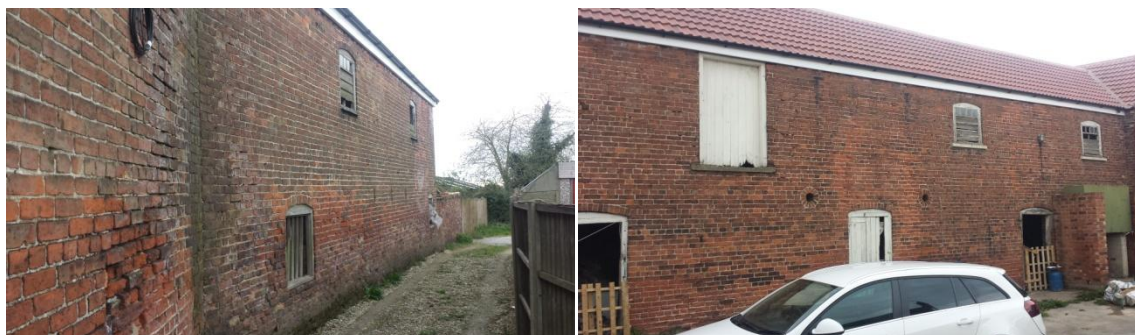
Photograph 1: Representative views from the north (left) and south (right).

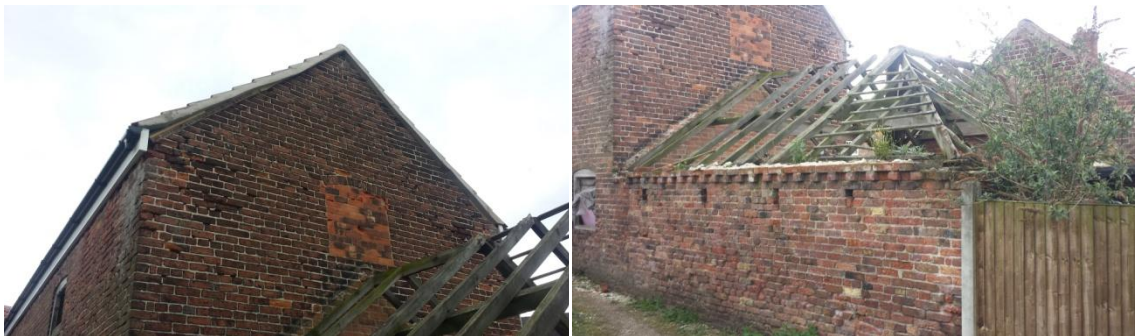
Attached at the western gable end is a single story, hipped, red brick extension which has experienced total roof collapse with only partial timbers remaining exposed to the elements.

**Photograph 2: Representative images showing the western gable end single storey extension.**

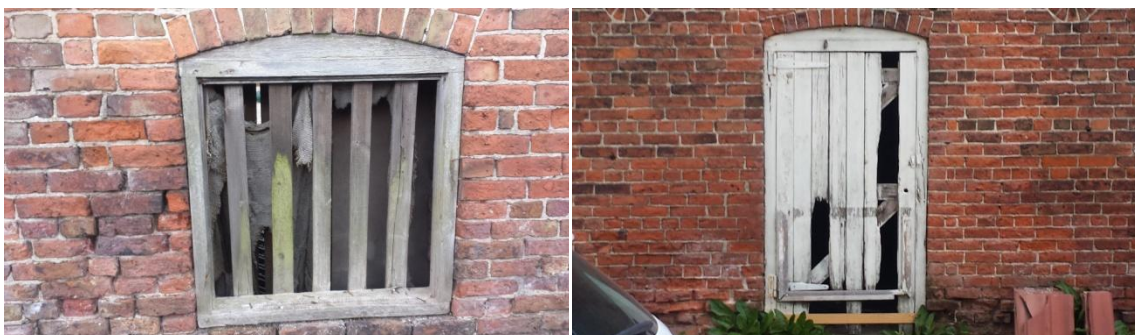
**Photograph 3: Representative images showing a window (left) and ground floor door (right).**

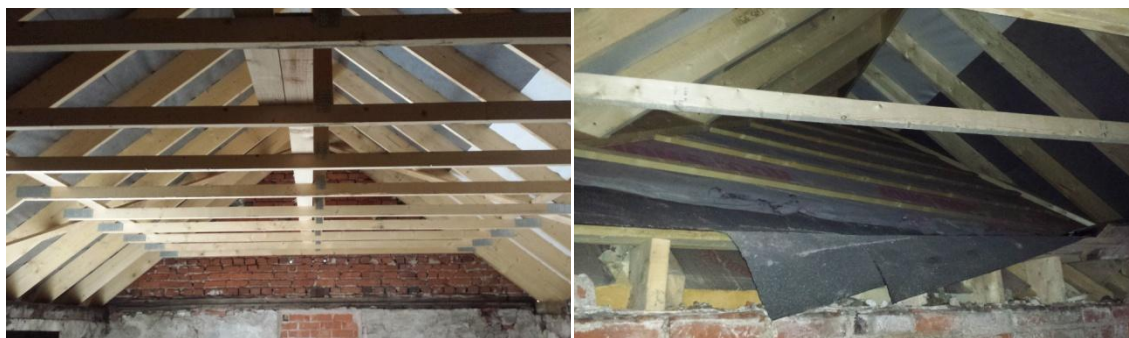
The former semi detached, two storey agricultural barn is constructed of solid bricks, supporting a timber framed roof covered with concrete tiles. The building physically adjoins a newly developed property to the north. Internal walls are part rendered. The equal pitched roof is in excellent condition, having been replaced in recent years. Any associated mortar pointing along the ridge and gable end is in excellent condition with no cracks or gaps present. There is no roof void, with the roof being open to the apex. It is not insulated but is under drawn with a breathable fabric membrane. All associated timbers appear to be new.

**Photograph 4: Representative images showing the internal roof structure of Main Building.**

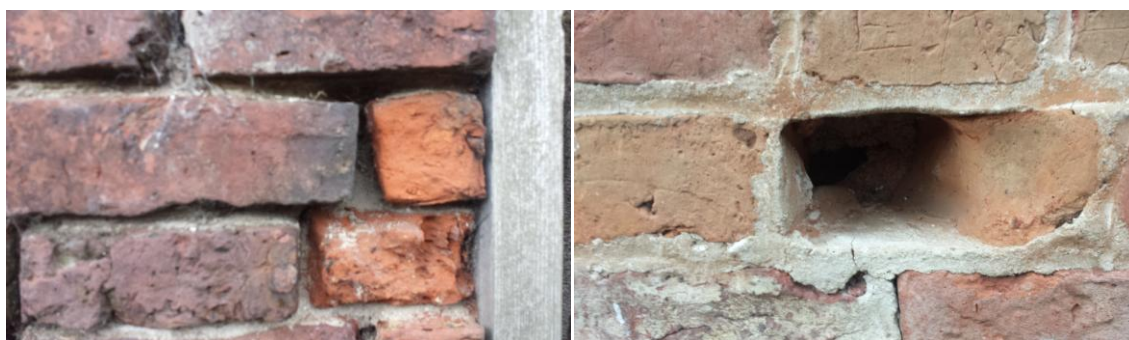
A number of settlement cracks, eroded mortar joints, absent bricks and similar structural defects are present.

**Photograph 6: Representative images showing age related defects in the brickwork.**

A number of niches suitable for use by a small number of/individual bats were identified on the external fabric of the building, in particular niches created by failed mortar joint between bricks, between wooden lintel and the brickwork, niches where the ceiling timbers tied into the brickwork and settlement cracks.

Some features were considered to offer potential for use by bats and these included gaps created by failed mortar joint between bricks. These features were considered particularly favourable for roosting by pipistrelle bats.

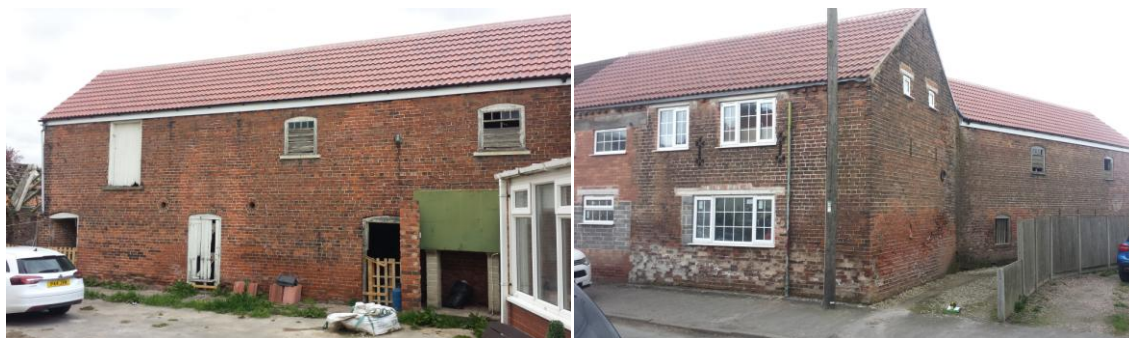
**Photograph 7: Representative views of the building from the south east (left) and north east (right).**

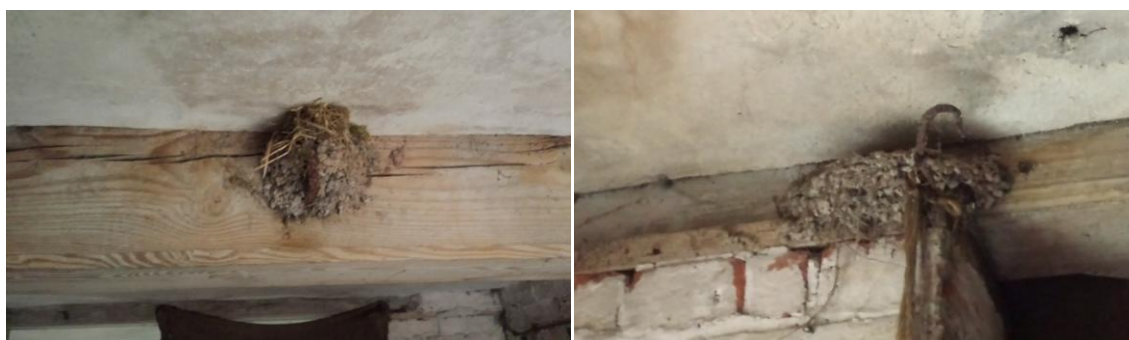
Some 10 old and disused nests of swallows were recorded throughout the ground floor of the building. 2 of these disused nests have since been adopted by wrens *Troglodytes troglodytes*.

**Photograph 8: Representative examples of recorded swallow nests**

Since the building is clearly used for nesting by species of common birds, any future redevelopment building work should ideally avoid the active nesting season. If work commences during the bird breeding season, a search for nests should be carried out before they begin, and active nests should be protected until the young fledge.

It would be advantageous therefore to make provision for nesting swallows within the new development. This can be achieved using specially designed nest ‘ledges’ or artificial nests, though care should be taken in the location of these so as to prevent the droppings creating problems in the future. As swallows prefer to nest inside built structures it can be difficult to incorporate such provision but possibilities could include having areas above garages, inside porches, or wheelie bin enclosures which can be designed to accommodate the birds without the resultant mess becoming a problem.

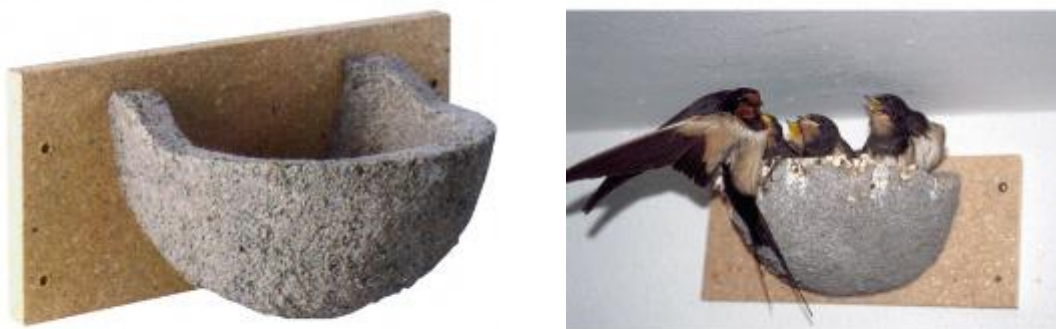
**Photograph 9: Schwegler No 10 Swallow Nest – constructed from WoodcretePLUS™ is a natural material made from a mixture of 75% wood sawdust, concrete and clay.**

In order to mitigate for the loss of swallow nesting areas, it is suggested that two swallow nest cups (Schwegler –No 10 Swallow Nest – shown below) be incorporated into the new design so that swallows can continue to nest on the site.

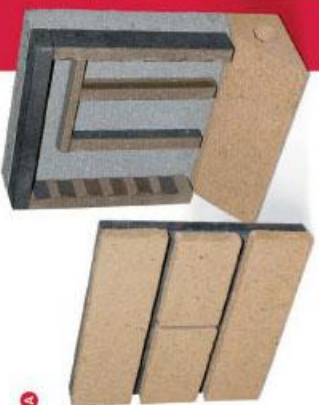
**A**

Eco Habitats for Bats - Technical Data: A	
Sizes	215mm x 215mm or 215mm x 290mm
Durability	F2/S2 - Fully Frost Resistant

- Designed with the Pipistrelle Bat in mind
- Available in all brick types
- Attractive motif
- Discrete home for bats
- Various sizes
- Several roosting zones are created inside the box
- Bats are contained within the Bat Box itself
- Maintenance free as the entrance is at the bottom
- Ideal for new build & conservation work

- A single bat roosting unit to be incorporated within the design of the new building. Example images of these can be found in Appendix 2.

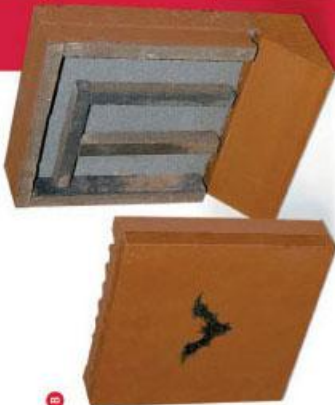
**B**

Eco Habitats for Bats - Technical Data: B	
Sizes	215mm x 215mm or 215mm x 290mm
Durability	F2/S2 - Fully Frost Resistant
