**Protected Species Survey of Outbuildings at Village Farm,  
Elsham Top, Wootton Road, Elsham Wolds, Brigg  
DN20 0NU**

**October 2017**

**Andrew P. Chick MPhil ACIEEM  
Ecological Consultant**

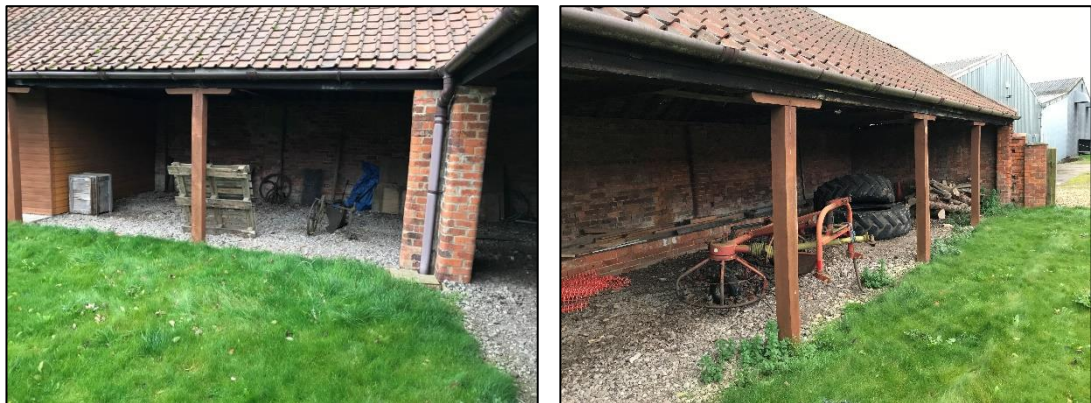
**Photograph 1: Representative images showing the open-fronted elevations.**

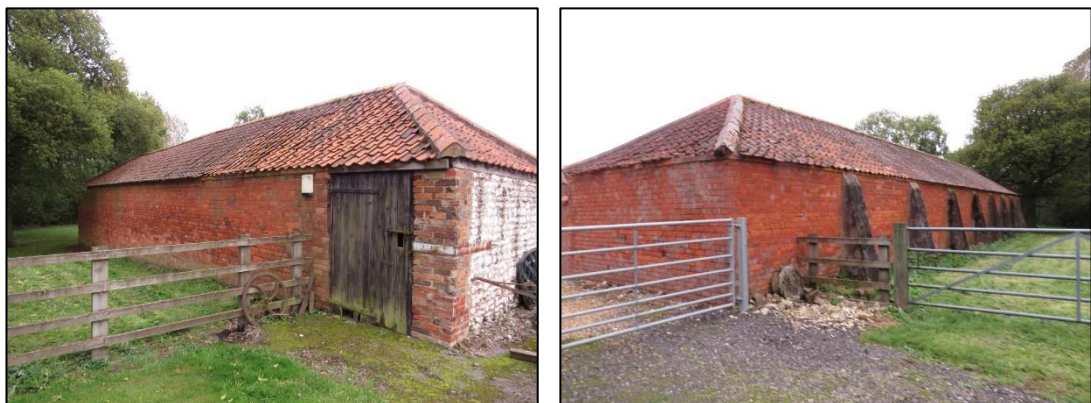
**Photograph 2: Representative images showing the rear elevations.**

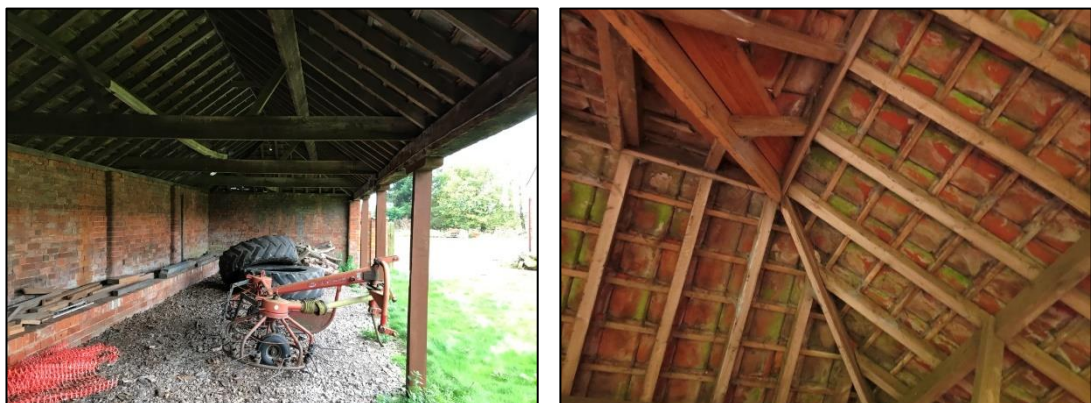
**Photograph 3: Representative images showing the internal ceiling and roof apex.**

Generally the brickwork was found to be in a good state of repair, with several sections appearing to have been repointed/repared and a number of the timbers repaired/replaced in the recent past (c10 years). At the rear of the building a series of concrete buttresses were found to be supporting the back wall, with occasional Maidenhair Spleenwort *Asplenium trichomanes* growing in the associated brickwork.

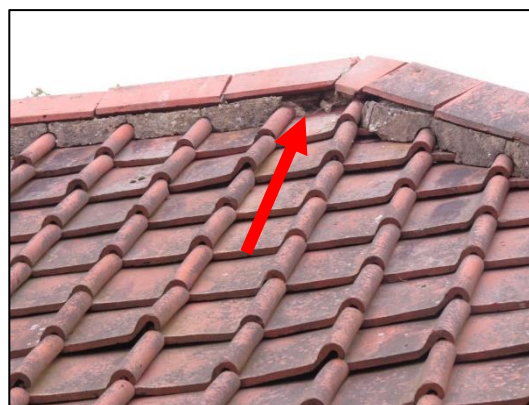
##### Photograph 4: Representative image of ridge tile.

The majority of the ridge tile is in a good state of repair. In a few places the bedding mortar is missing offering bats potential access. However, the underside of the ridge is exposed, with very limited roost potential.

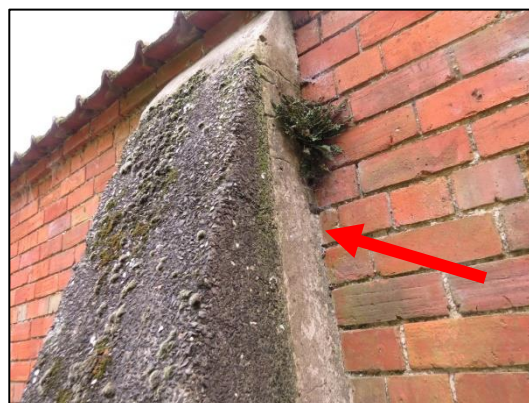
##### Photograph 5: Representative image of the concrete buttresses.

The rear wall of the eight-bayed section has a series of concrete buttresses. A detailed inspection found no gaps, cracks or niches between the concrete and the brickwork.

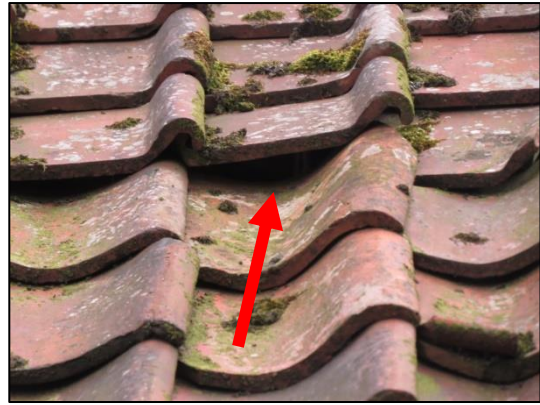
**Photograph 6: Representative image of clay tiles.**

There were occasional lifted tiles on the front and rear elevations of the survey building. However, the gaps did not lead to any internal void and there was no underfelt to provide a suitable roost area.

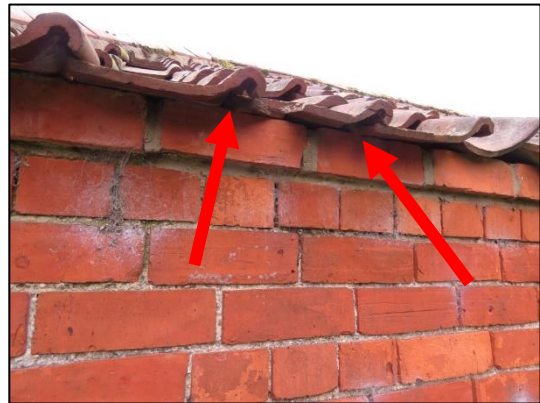
**Photograph 7: Representative image of the eaves.**

The eaves at the front of the building were formed with a timber beam. At the rear elevation there were no gutters and the tiles sat directly onto the brickwork. Occasional gaps between the brickwork and tiles were observed, but these lead directly to the wall plate with no internal void present.

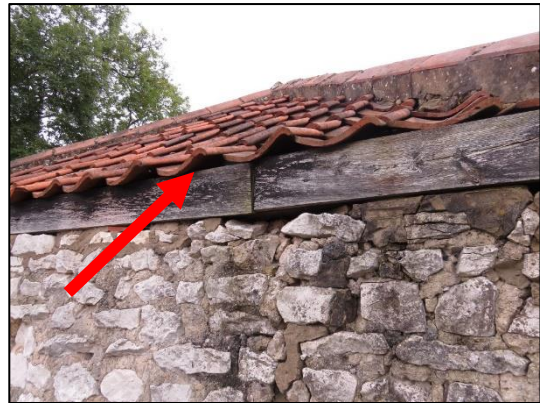
**Photograph 8: Representative image of the southwest gable end.**

The southwest gable end of the building is the only section with a traditional stone wall. There is a timber beam at the wall plate which was inspected. There was no evidence of use by bats.

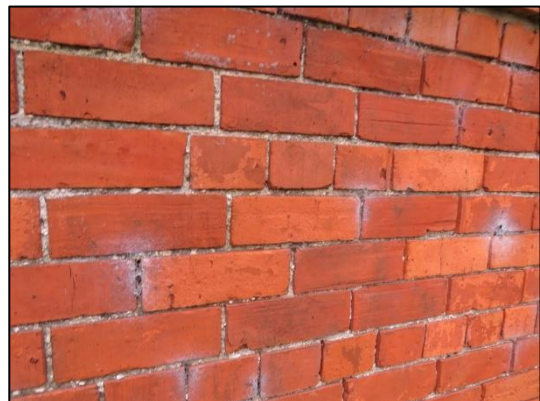
**Photograph 9: Representative image of brickwork.**

Generally the internal and external brickwork was in a good state of repair with very few gaps, cracks and no significant settlement cracks.

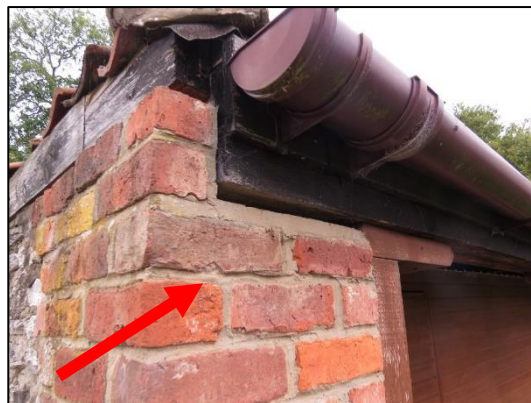
**Photograph 10: Representative image of brickwork**

In areas (particularly associated with the front elevation) the brickwork had been repointed consequently offering very limited potential to support roosting bats.

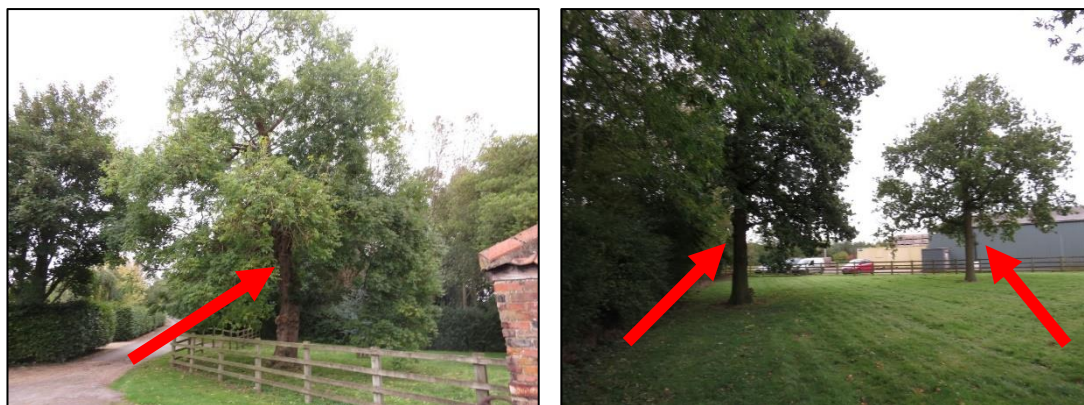
To the rear of the building and within the paddock area there is single mature ash [T1] and three mature pedunculate oaks [T2, T3 and T4]. Under the proposals none of the trees will be affected by the intended works. All four trees were assessed as having medium potential to support bats.

**Photograph 11: Representative images showing the ash [T1] (left) and two of the pedunculate oaks [T3 and T4] (right).**

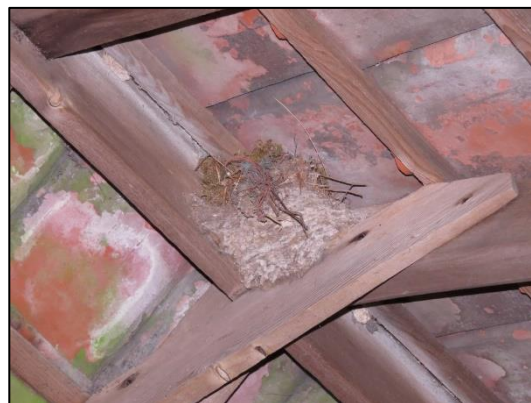
An old swallow *Hirundo rustic* nest which had subsequently been commandeered by a wren *Troglodytes troglodytes* was recorded in the roof apex.

**Photograph 12: Representative image showing an old swallow nest.**
