**HUMBERSIDE MATERIALS LABORATORY  
LIMITED**

**Site Investigation Report**

**For The Proposed Development on land to the**

**Northfield Road, Messingham**

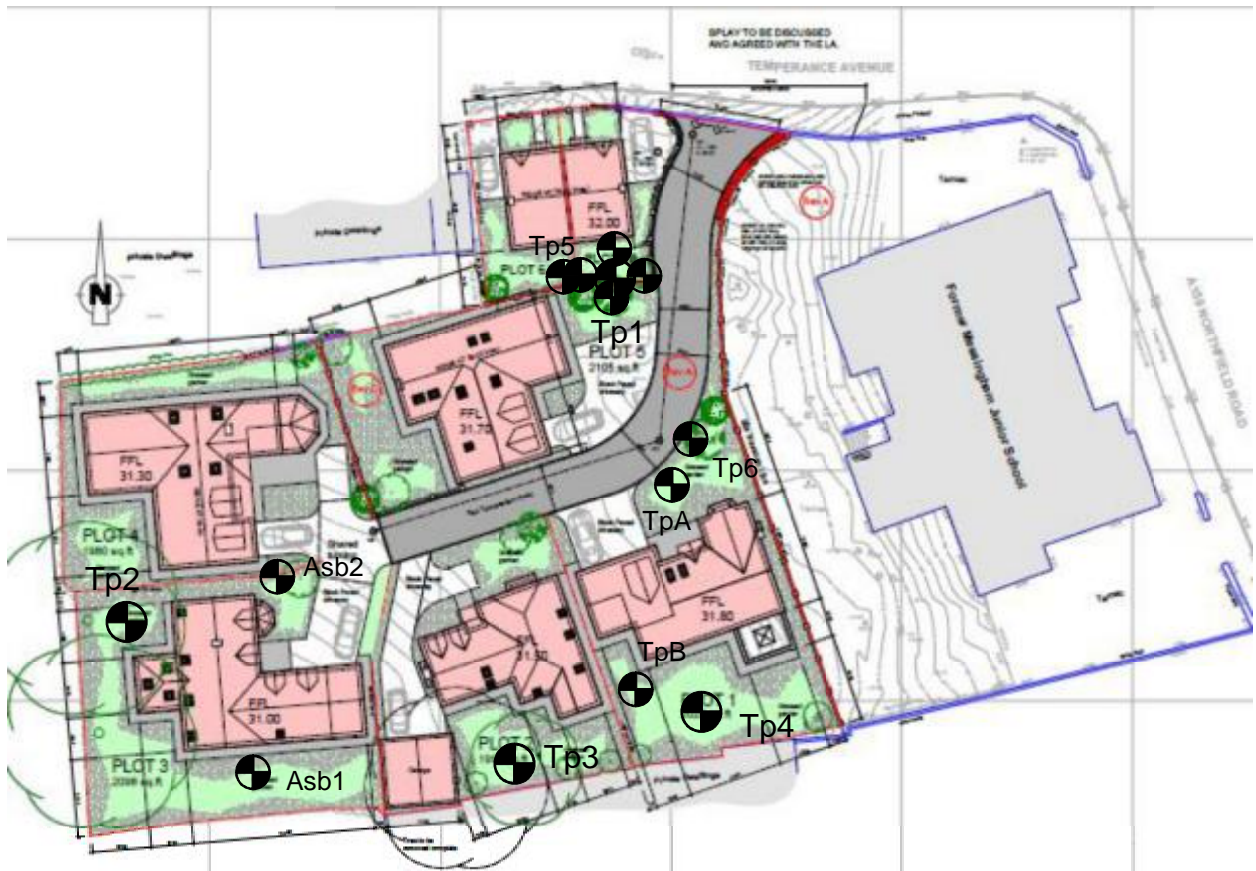
## SITE PLAN - BOREHOLE / TRIAL PIT LOCATIONS

Trial pit locations were agreed between the local authority and the HML engineer and were positioned to encompass the different areas of the site. Positions of exploratory holes were established relative to existing site features and the grid reference of each hole was measured and recorded. The approximate locations of all four trial pits are shown in the plan in Appendix A.
