**Protected Species Survey of Outbuildings at Village Farm,
Elsham Top, Wootton Road, Elsham Wolds, Brigg
DN20 0NU**

October 2017

**Andrew P. Chick MPhil ACIEEM
Ecological Consultant**

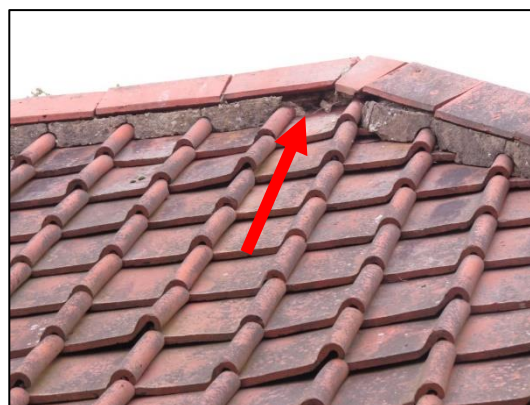
Photograph 4: Representative image of ridge tile.

The majority of the ridge tile is in a good state of repair. In a few places the bedding mortar is missing offering bats potential access. However, the underside of the ridge is exposed, with very limited roost potential.

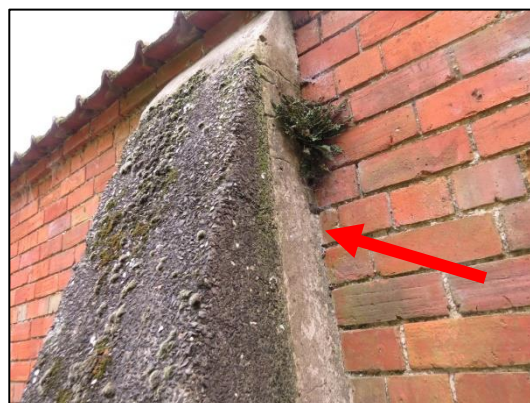
Photograph 5: Representative image of the concrete buttresses.

The rear wall of the eight-bayed section has a series of concrete buttresses. A detailed inspection found no gaps, cracks or niches between the concrete and the brickwork.
