Ref: 276/01/LA
Date: 8th June 2018

**BARN CONVERSION AND NEW STABLE BUILDING & MENAGE
HALDENBY GRANE, LUDDINGTON**

HERITAGE STATEMENT

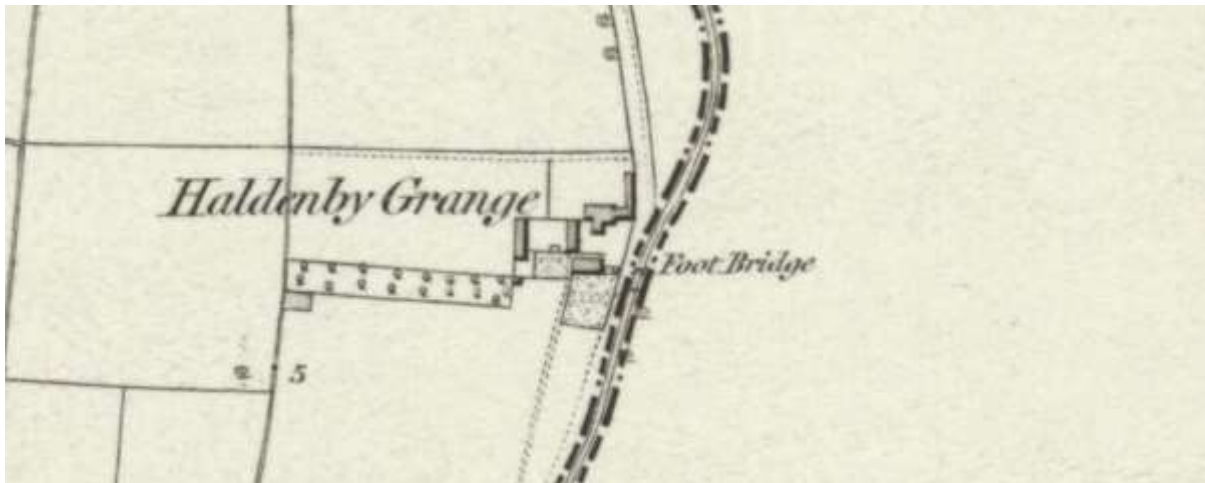
Figure 1: Ordnance Survey map 1854 issue

Haldenby Grange itself dates from the mid to late eighteenth century and appears to have been built at the same time as the adjacent barn (to which this application relates) and to a series of now lost outbuildings to the west and north of the barn. This grouping is illustrated on the 1854 Ordnance Survey map (see figure 1). This map shows the extant farmhouse running east to west and the extant barn and horse mill are shown to the north of this with a narrow range adjoining the eastern gable and running east before turning north alongside the road. Additional ranges of buildings are shown to the west of the barn running north to south and enclosing a yard. To the south of the yard

is a further enclosure with hatching possible indicating a metallised yard with feint diagonal lines. A garden to the south of the house remains unaltered to this day and the tree belt to the west remains partially extant although the boundaries have been blurred by modern field boundaries.

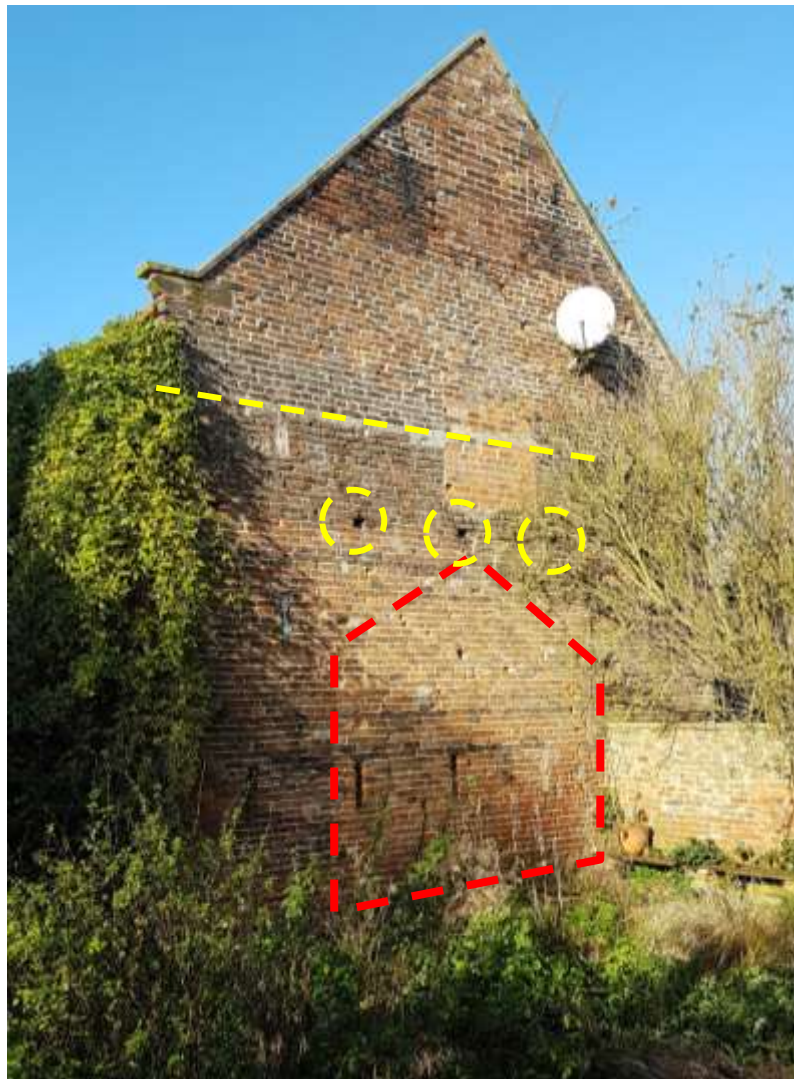
Figure 3: Photograph of the eastern gable of the barn with possible abutment of historic single storey pitched roof structure (highlighted for clarity).

The remaining buildings on the are less certain although the north-south range to the north east of the threshing barn has an open side which would suggest that this was a cart shed and that the east-west range to the south of this could therefore have been stable. There is some evidence for a single storey range in this location in the brickwork externally where a change in brick colour indicates that the central section was internal at some point in the past (see red line in Figure 3). The low level wall

running away from the eastern gable is likely to be the base of this now lost range at least for the first nine foot stretch until the brickwork indicates later rebuilding. Evidence of other more modern extensions will be discussed later.

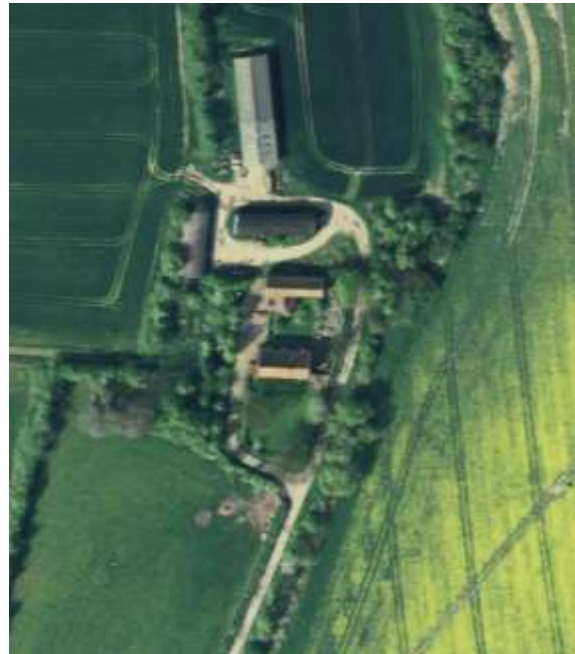
Figure 6: Modern satellite image (Google Earth)

late twentieth century with the extant modern steel framed barns also in this location which were originally used to house pigs and the north-south barn was granted permission for an extension in 1996 (2/1995/0780). These barns are still in agricultural use although Haldenby Grange Farmhouse and barn were empty in 1987 at the time of listing (see Figure 6).

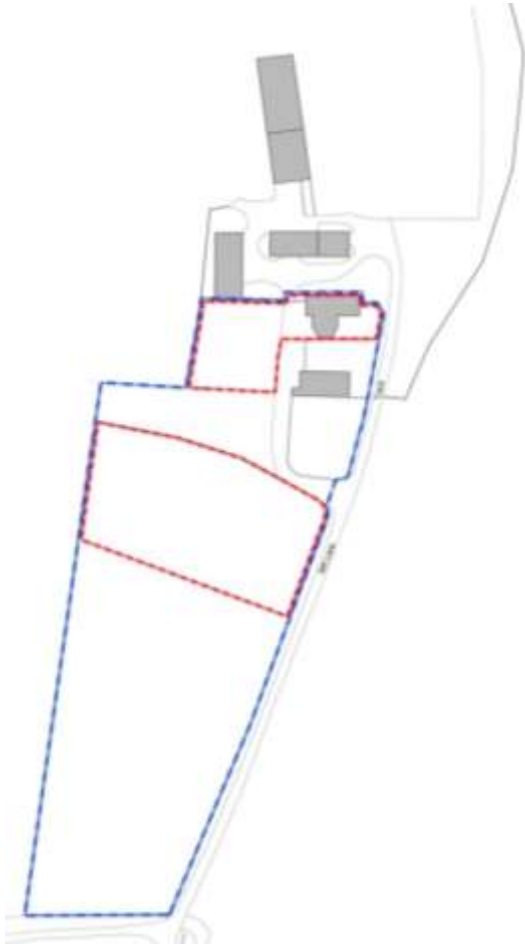
*Figure 7: Application site edged in red
(OS Detail Licence number 100022432)*

The application site comprises Haldenby Grange barn and horse mill along with adjoining land to the west and a separate parcel of land to the south west totalling 0.48 hectares. Access is via the existing driveway off Mill Road and leads past the Grade II Listed farmhouse in the first instance to the separately Grade II listed barn. Both structures dates from the mid to late eighteenth century. The barn is two storeys in height and there is a timber platform floor at the western end.

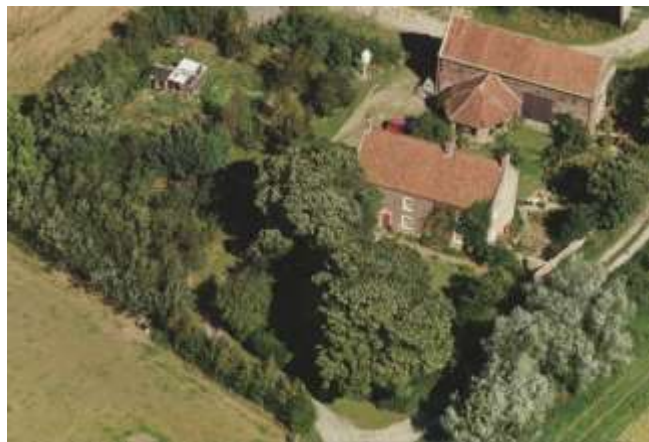
Figure 9: Aerial view of house with barn beyond (Zoopla, date unknown assumed 2012)

The barn forms the northern boundary of the applicants land with the modern farm buildings beyond in separate ownership. There is a low brick wall to the east that follows the side of the farm track that once followed the western bank of the old Don whilst the southern boundary of the application site is formed by the farmhouse (Figure 8). To the west is the access driveway and the remains of the east-west tree belt shown on the historic OS maps that has extended (whether by design or self seeding) over the old yard to the west and the surrounding ranges of farm buildings of which nothing now remains (see Figure 9).

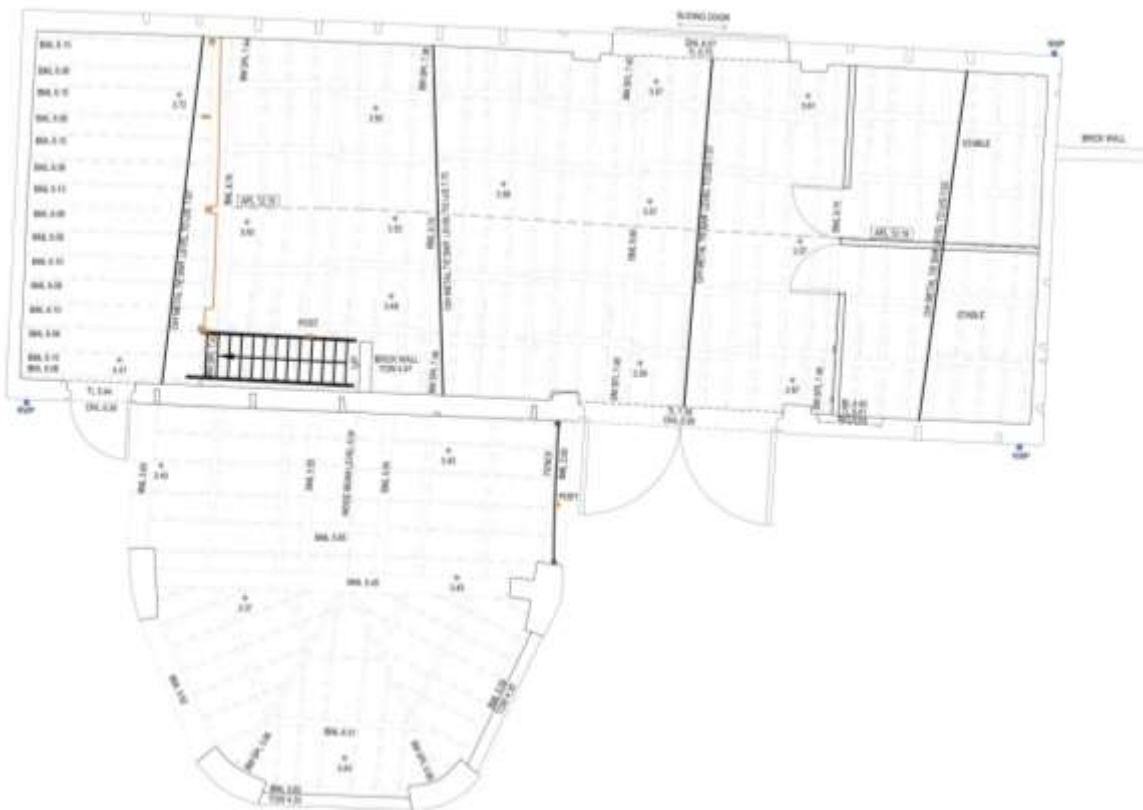
Figure 10: Measured ground floor plan of barn by MT Surveys (2018)

The layout of the barn is unaltered from the listing text and the 1990 repairs appear to have been faithful to the original construction and materials. There appears to have been substantial areas of re-pointing with a lime mortar mix although different periods of brickwork are still evident as are blocked openings. The barn measures 19.18m x 7.18m externally and is 5.36m to the eaves and 8.82m to the ridge with a roof pitch of 45°. Significant ivy growth obscures the west elevation.

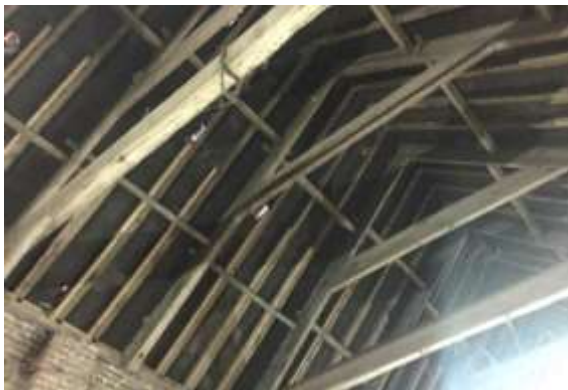
Figure 11: Roof structure showing trusses, tie bars and rafter strengthening

The roof is supported on a series of collar tied roof trusses at approximately 1830mm (6ft) centres (see Figure 11). Every other truss generally has a rafter tie in with a crude bracket arrangement extending approximately 1.9m down the wall. Rafters are at approximately 460mm (18") centres

supported on timber purlins and strengthening to rafters is evident with additional timbers inserted alongside the original presumably in 1990. The roof coverings have been installed over a bituminous felt underlay again presumably at the same time as the roof repairs and this is now at the end of its lifespan with multiple holes and tears. The entire roof structure is not original and probably dates from the early twentieth century when the farm was expanding. In addition to the roof structure there are four steel ties inserted across the building presumably to combat spreading of the walls due to inadequate roof structure. Whilst the adjoining horse mill provides restraint to the south, the north wall is a continuous run of masonry one and a half bricks wide and the only restraint is provided by the half brick thick buttresses either side of the wagon entrance and consequently the entire wall is approximately 240mm out of plumb. The bracketed ends of the trusses could also have been intended to alleviate spreading.

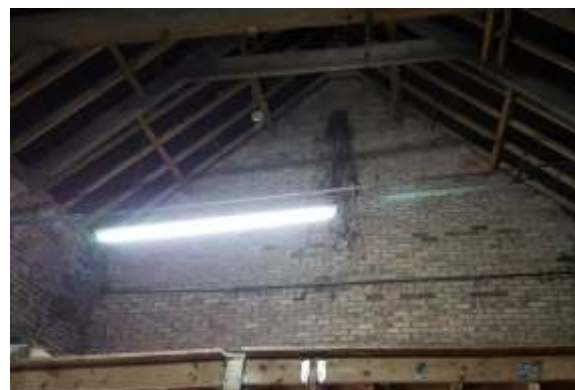
Figure 12: Modern brickwork to inner face of western gable

The only subdivision of the original barn is provided by two modern loose boxes at the eastern end (Figure 13) and a partial modern first floor western end. There is no evidence of any historic first floor in the barn although the upper section of the western gable has been rebuilt in the past with common bricks obscuring any evidence of this. The dense ivy coverage on the outside of this gable obscures the outer leaf and it is not clear if the whole gable has been rebuilt or just the inner leaf (Figure 12).

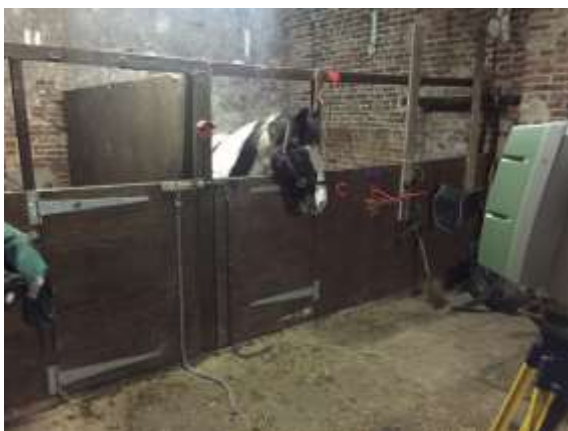
Figure 13: Modern loose boxes at eastern end of barn

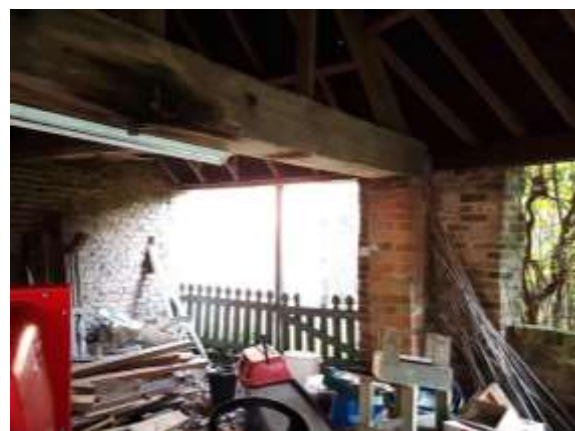
Figure 14: Internal view of horse mill

The horse mill like the barn has been re-roofed although the primary structure appears original although the rafters are more recent in date. Being open, the structure is presumably little changed however the brick piers to the corners have been strengthened internally with brick and a half wide piers under the beam bearings. The brickwork to these piers appears the same as that to the western gable in the barn indicating works occurred at the same time (Figure 14).

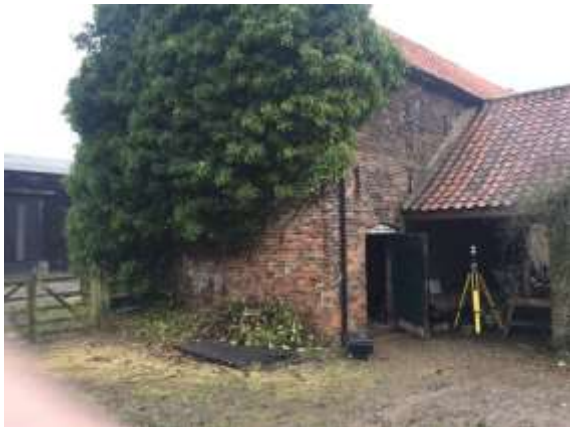
Figure 15: Abutment of horse mill with barn to south elevation

Little has changed between the inspection at the time of listing and the present day. The breather slits are blocked internally and the crossed end brackets of the steel tie bars are visible. Repointing around the roof abutment with the horse mill is evident (Figure 15).

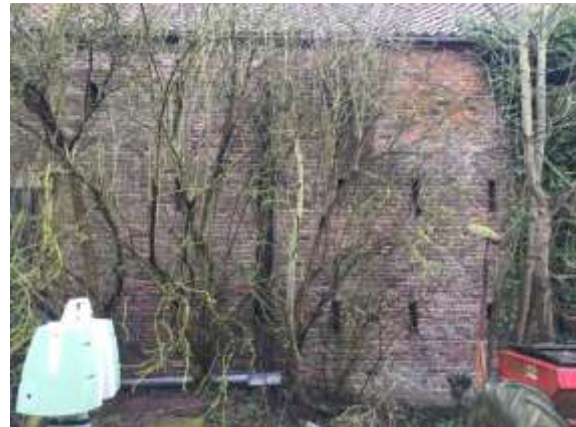
Figure 16: North elevation of barn obscured by vegetation with blocked pitching hatch

The north elevation is obscured by vegetation and displays evidence of re-pointing to the wall tops and the breather slits have been blocked internally. The pitching hatch is no longer present and was presumably walled up during renovation works in 1990. A paler brick patch indicates the location of the hatch below the eaves (Figure 16).

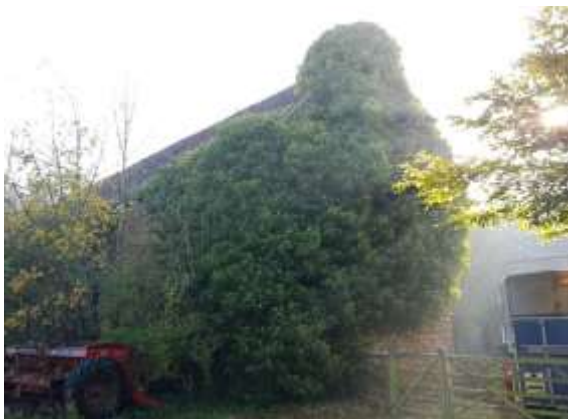
Figure 17: Ivy covering west elevation

The western elevation is significantly obscured by ivy although this has been cut back between the initial inspection by Shaw & Jagger Architects in November 2017 and the survey by MT Surveys in March 2018. On inspection the blocked doorway noted in the listing text was not visible externally although the survey indicates a blockwork infill toothed into the surrounding brickwork (Figure 15). The age of the doorway is not certain although it is likely that it is original as it provides access to the western yard area that was not possible via the doorway in the southern wall due to the granary staircase.

It is not clear from inspection whether the entire upper section of gable has been rebuilt due to the ivy coverage although what is certain is that the inner leaf at least is new brickwork. It seems likely that the entire gable was rebuilt (Figure 17).

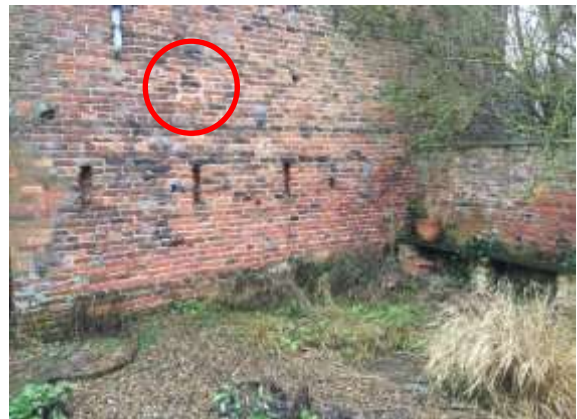
Figure 18: Brickwork to east elevation with blocked beam socket highlighted

The east elevation displays the most evidence of alteration and the possible location of the now lost eastern range can be seen as can the abutment with the timber framed extension from the late nineteenth or early twentieth century (Figure 3). There are two blocked hatches in the eastern gable and multiple areas of pointing that makes interpretation of phasing difficult. There is a blocked beam socket (Figure 18) where the eaves of the single storey range abutted the barn and this implies an open sided structure rather than a solid wall which is at odds with the historic OS mapping data.
