Phase 2 (Site investigation) report

Grange Farm, Thorn Bank, Wroot

Client: Howard J Wroot

Report number: 0700/4507/P/P2

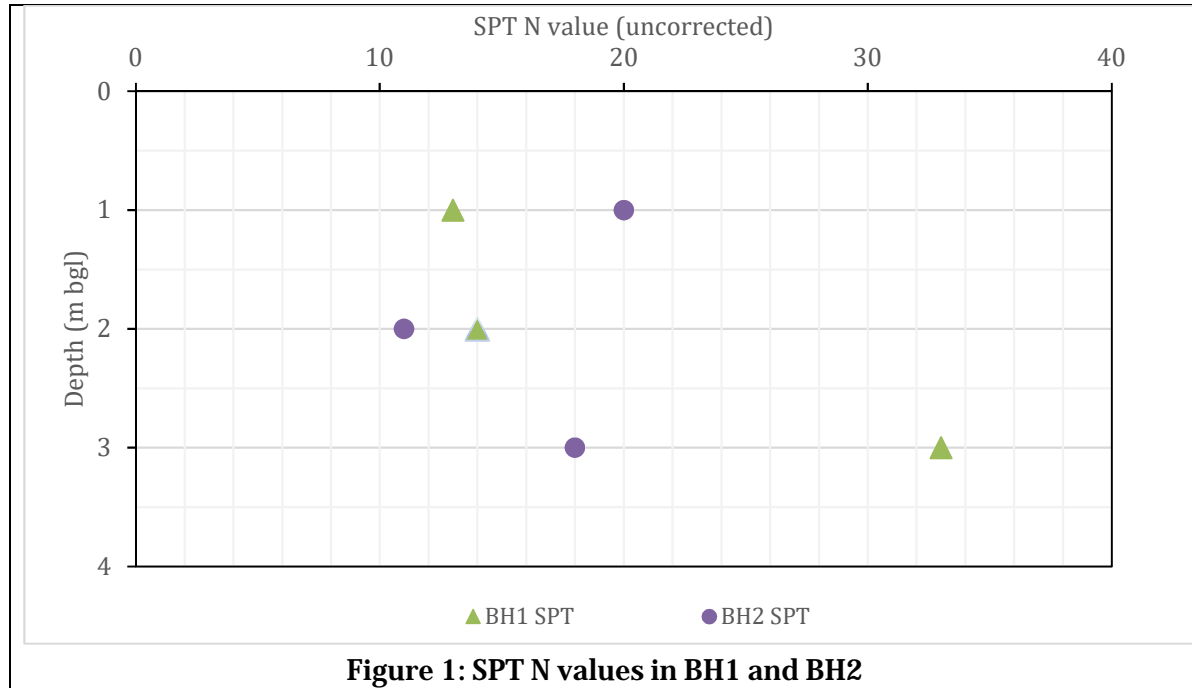
The relative density of the Sutton Sand was found to be medium dense. The results of SPTs (from 1.0m to 3.45m bgl) revealed uncorrected N values ranging from 11 to 33 blows, as shown below (in Figure 1). The SPT N values generally remained relatively consistent with depth. At shallow depths (<1.0m bgl), the sand could be loose to medium dense.

Based on the SPT results and the log descriptions, at depths of at least 1.0m bgl, the Sutton Sand is expected to have an angle of friction of between 30 and 36 degrees. The density index is likely to range from 35% to 65%.

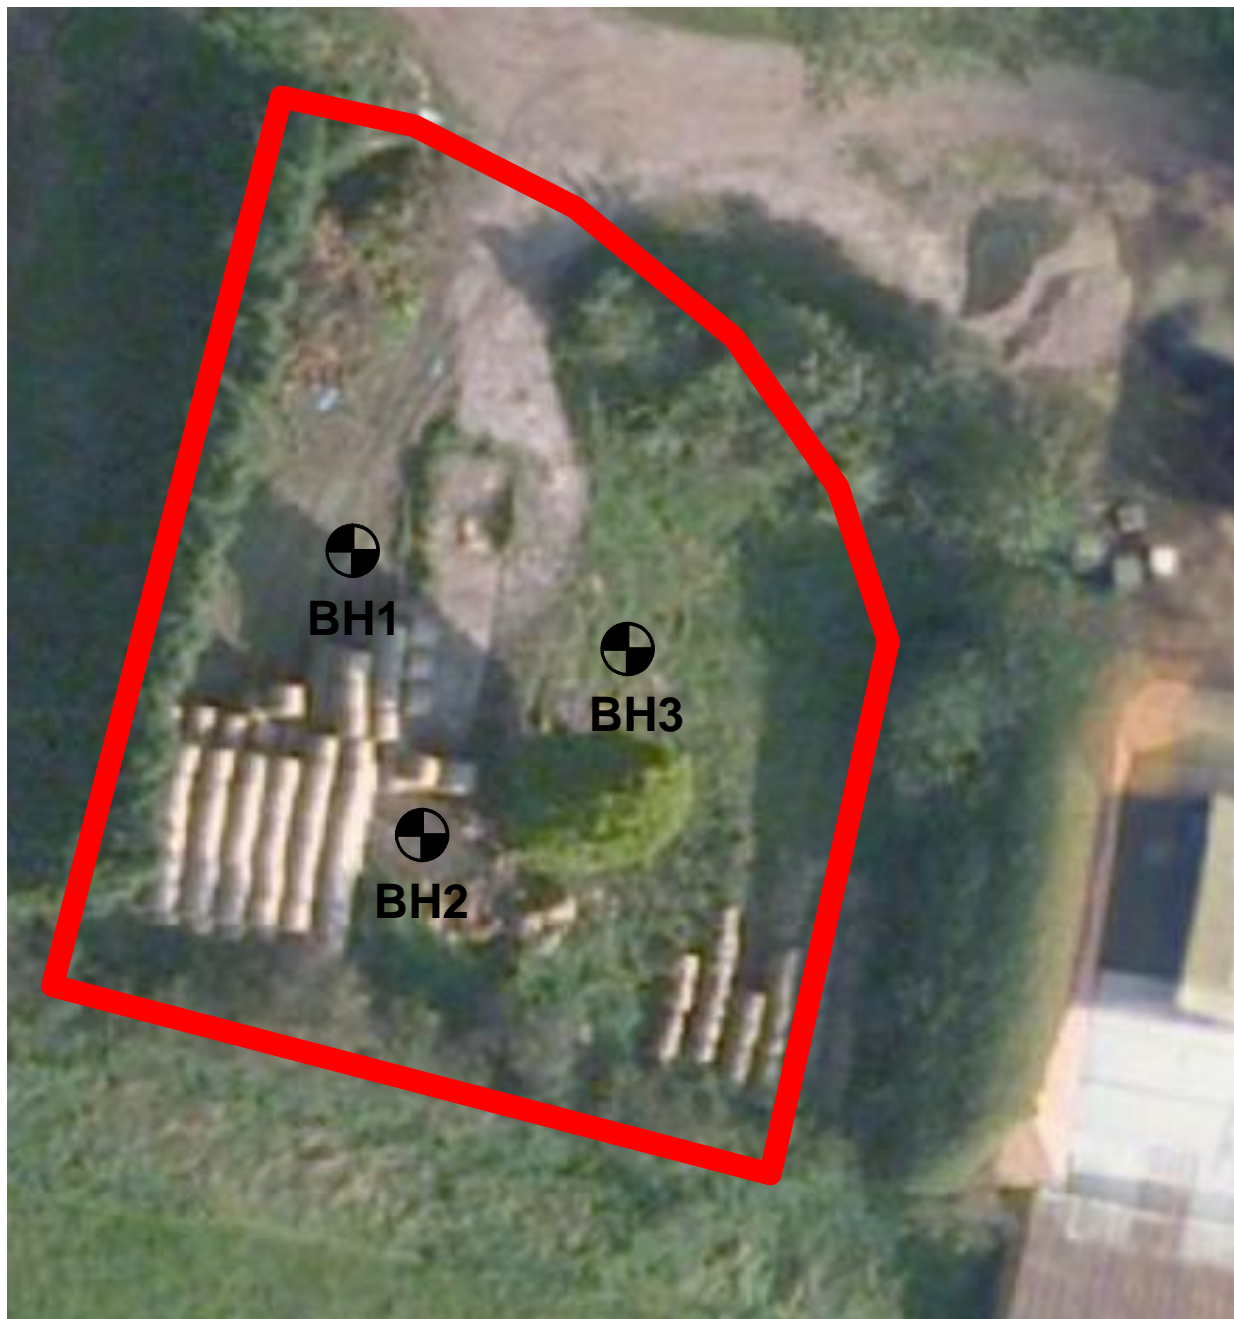
SITE PLAN - BOREHOLE / TRIAL PIT LOCATIONS

Approximate locations of all site works are shown in the exploratory hole location plan (in Appendix A).

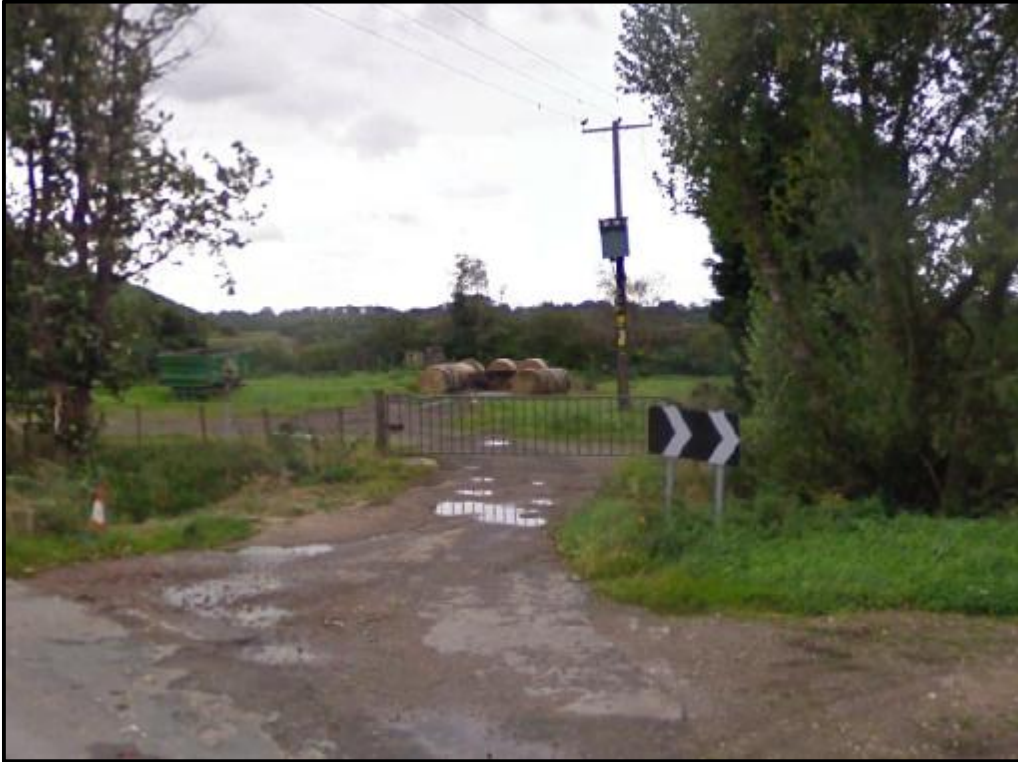
The site entrance seen from Thorn Bank road (view towards southeast)

The proposed site access is via an existing culvert/bridge over South Thorn Bank Drain from Thorn Bank road.

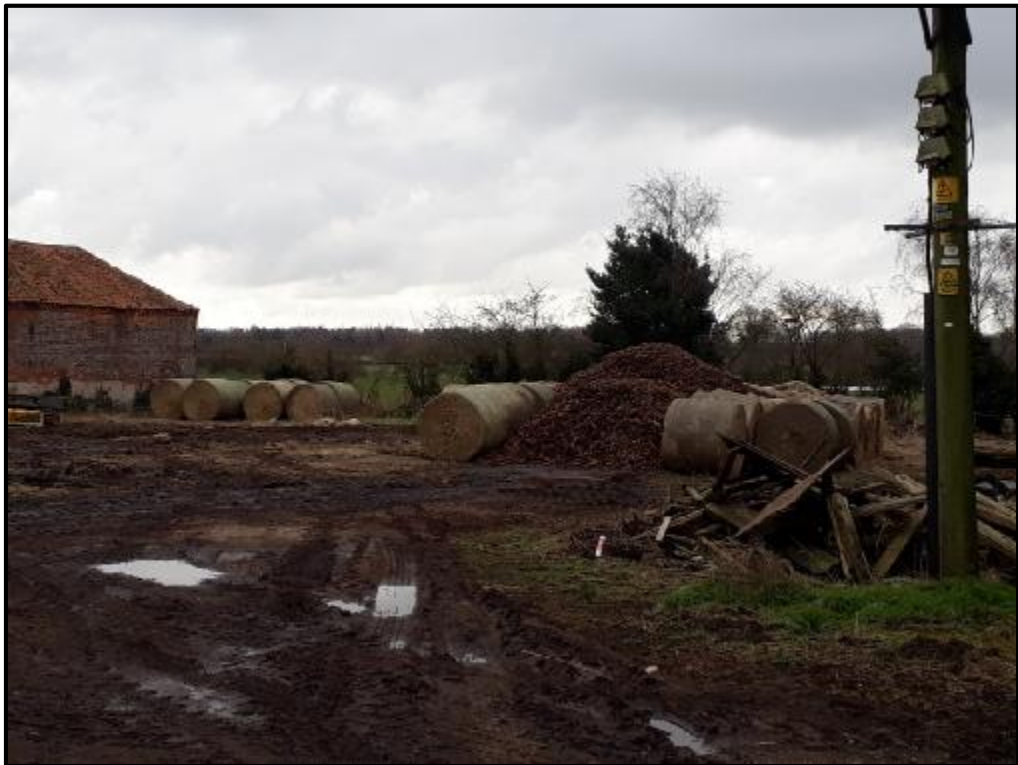
The site comprises the western end of the farmyard for Grange Farm. The site is essentially an open space with no buildings or other man-made features. The ground surface is mainly bare earth with some patchy gravel hardstanding.

The site appears to have been in general use as a farm produce storage area. At the time of the walkover survey it was being used to store straw bales and there was a stockpile of carrots present.

The site (view towards southeast)

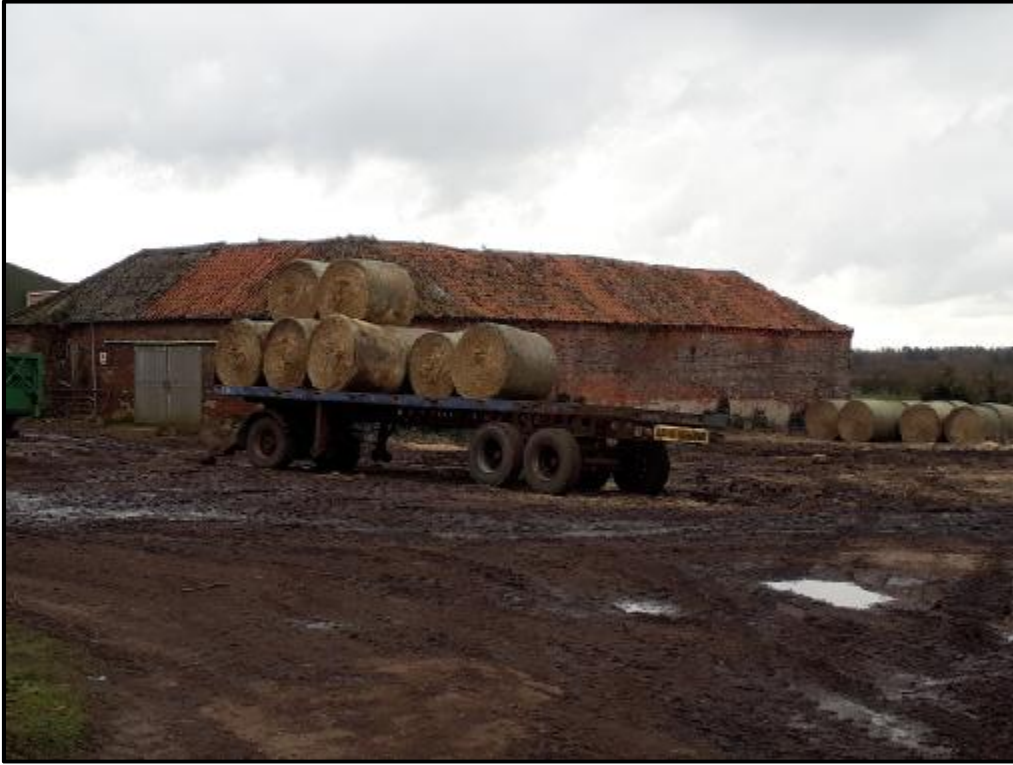
The site (view towards southeast)
