Site Investigation Report
For The Proposed Development
Sturton Nursery Sturton

Client: M Smalley

Date: January 2019
Report: 001/4720/P

SITE INVESTIGATION REPORT FOR
PROPOSED DEVELOPMENT
STURTON NURSERY STURTON

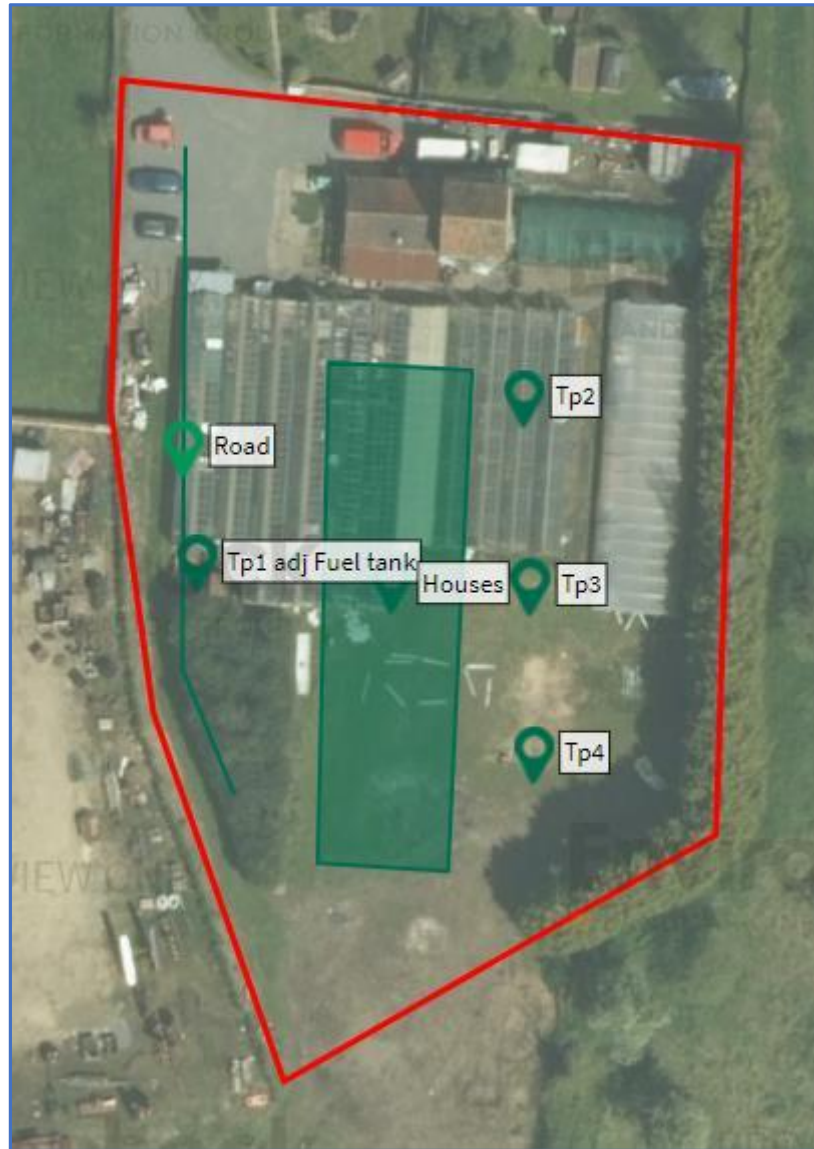
Schematic overview of scheme

It is proposed to develop the site by constructing 3 or 4 plots which will be west facing. The existing barn will be converted. An access road will run along the western boundary. No detailed plan is available at this stage.

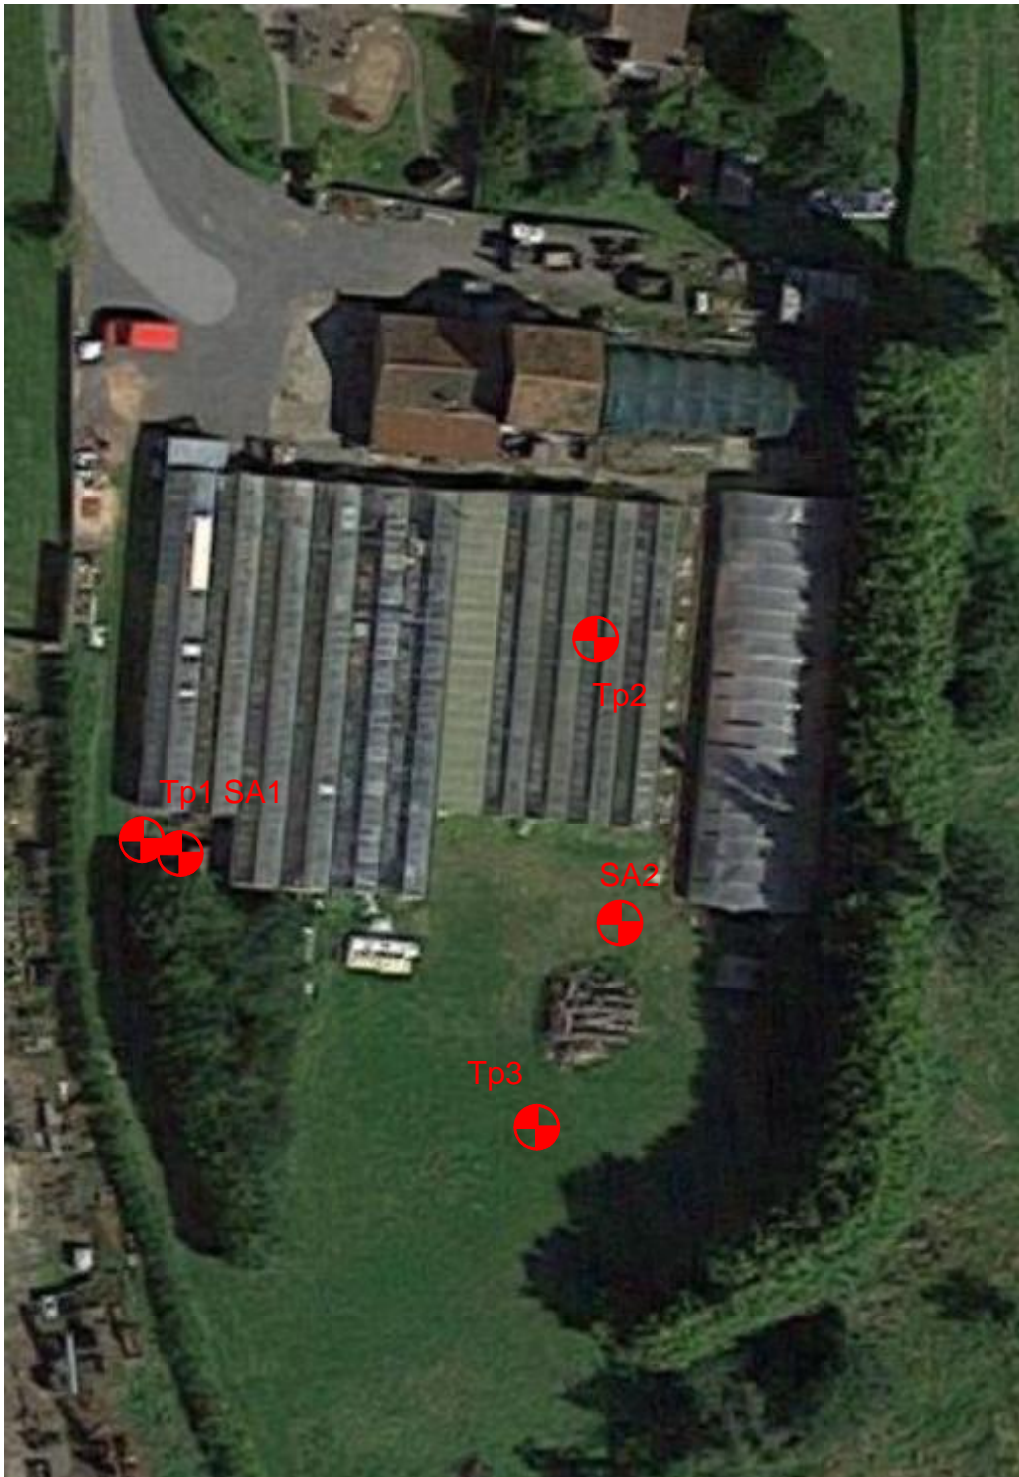
SITE PLAN - BOREHOLE / TRIAL PIT LOCATIONS

Trial pit locations were positioned with regard to the oil tank, with a further two in the rear gardens of the proposed houses. The soakaways were determined in trial pits to both the front and rear of the proposed houses. Positions of exploratory holes were established relative to existing site features.

The approximate locations of all five trial pits are shown in the plan in Appendix A.
