Validation report

9a Darwin Street, Kirton in Lindsey

Produced for C&K Builders (Mr K McCabe)

<i>Title:</i>	Phase 4: Validation report 9a Darwin Street, Kirton in Lindsey
<i>Client:</i>	C&K Builders (Mr Ken McCabe)
<i>Date:</i>	September 2020
<i>Report number:</i>	1166/4758/P/P4

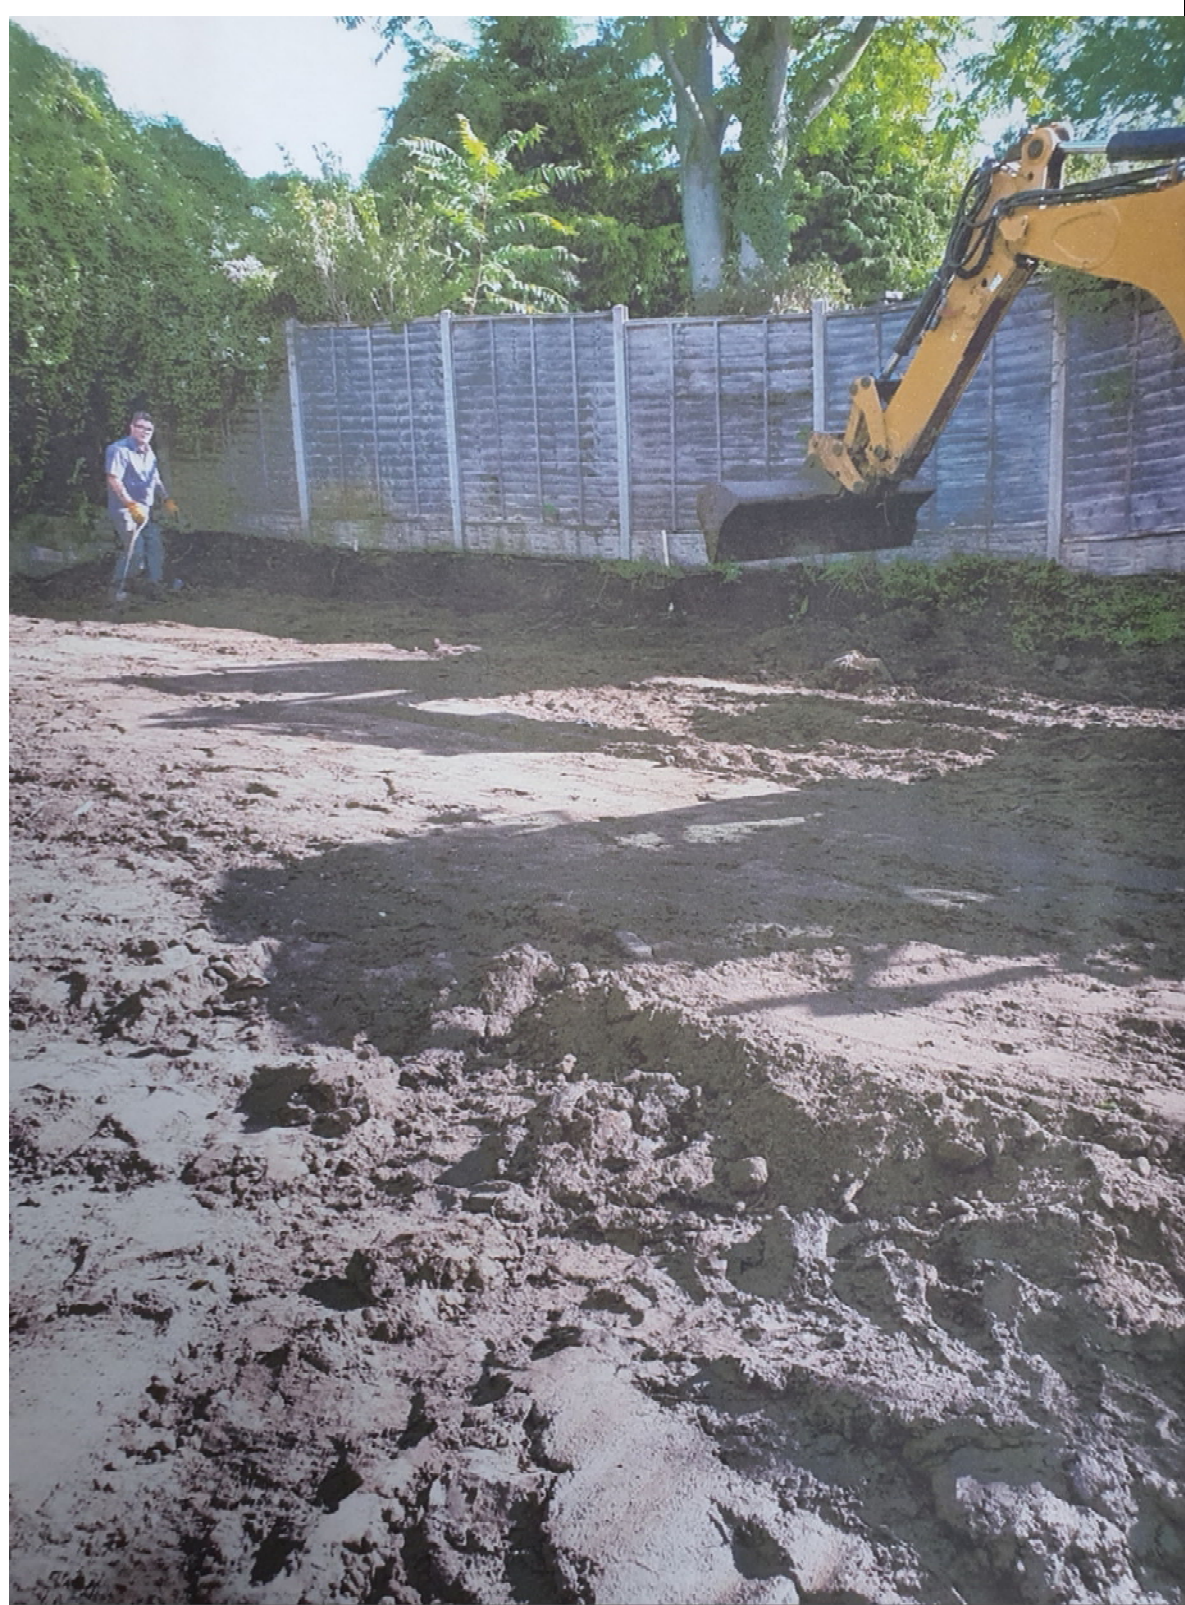
Made ground /soil removal from rear garden areas

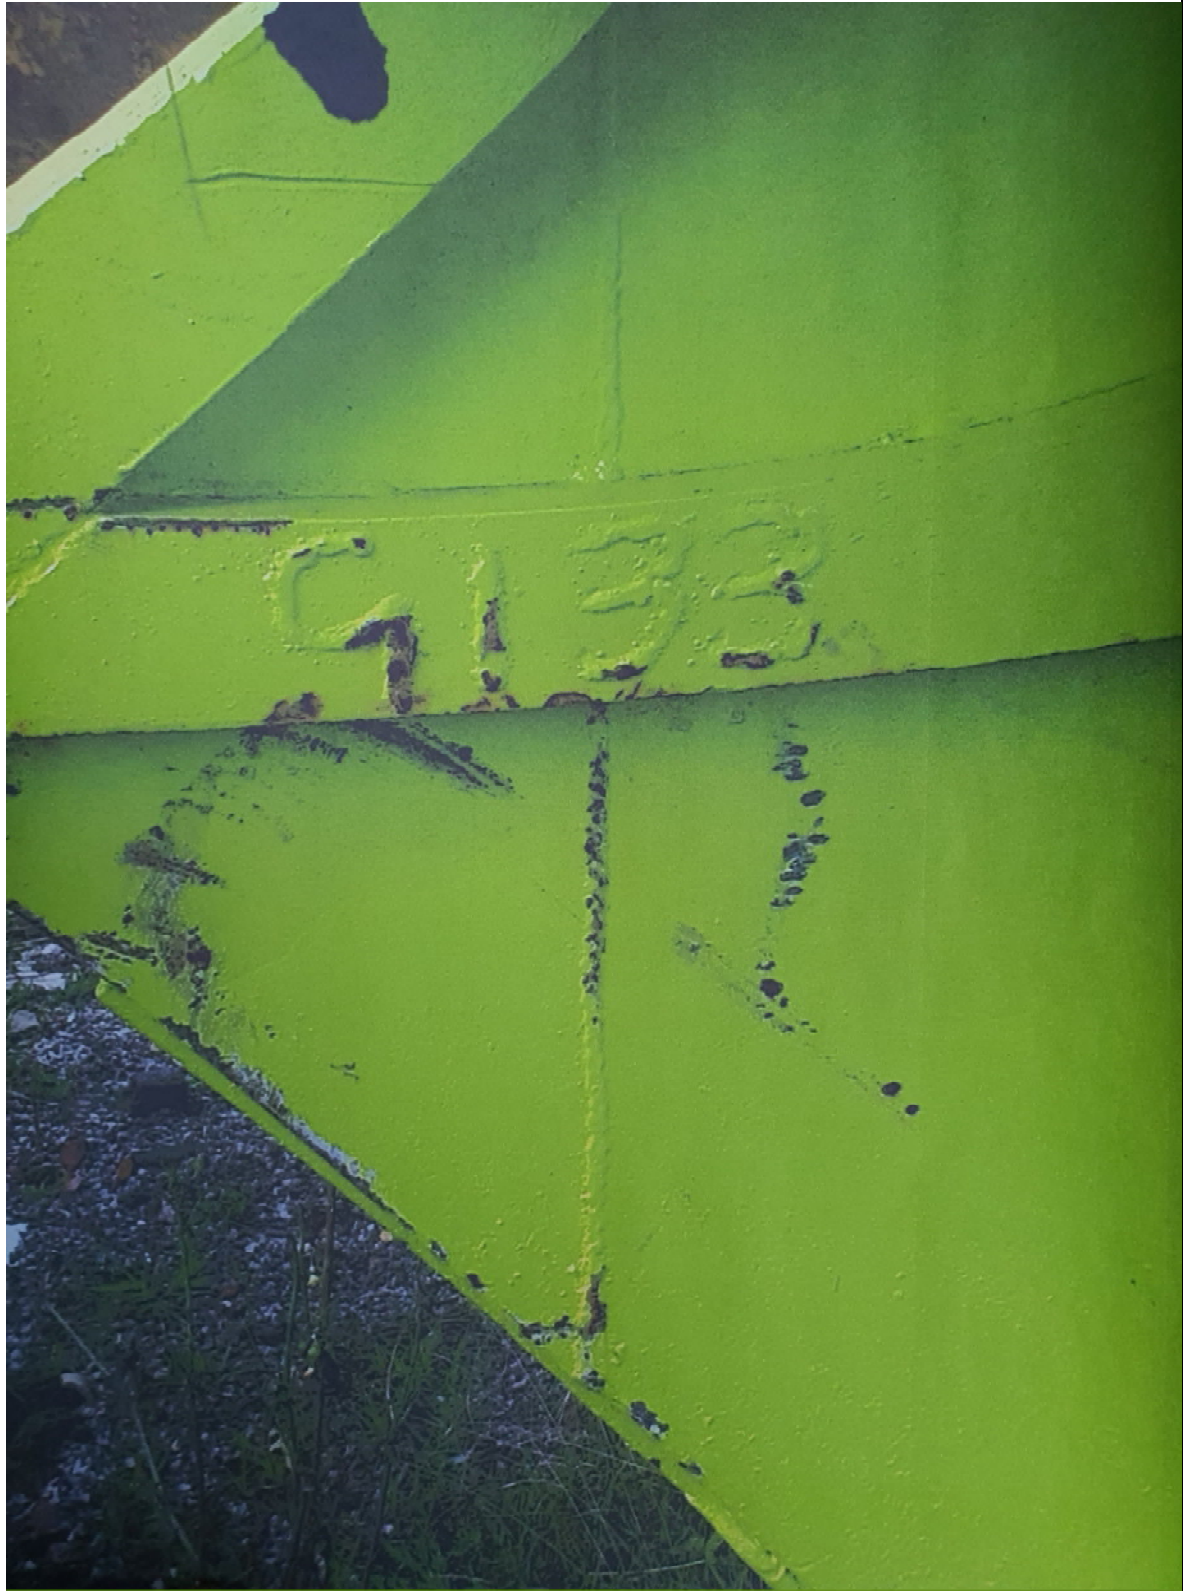
On-site waste skip serial number

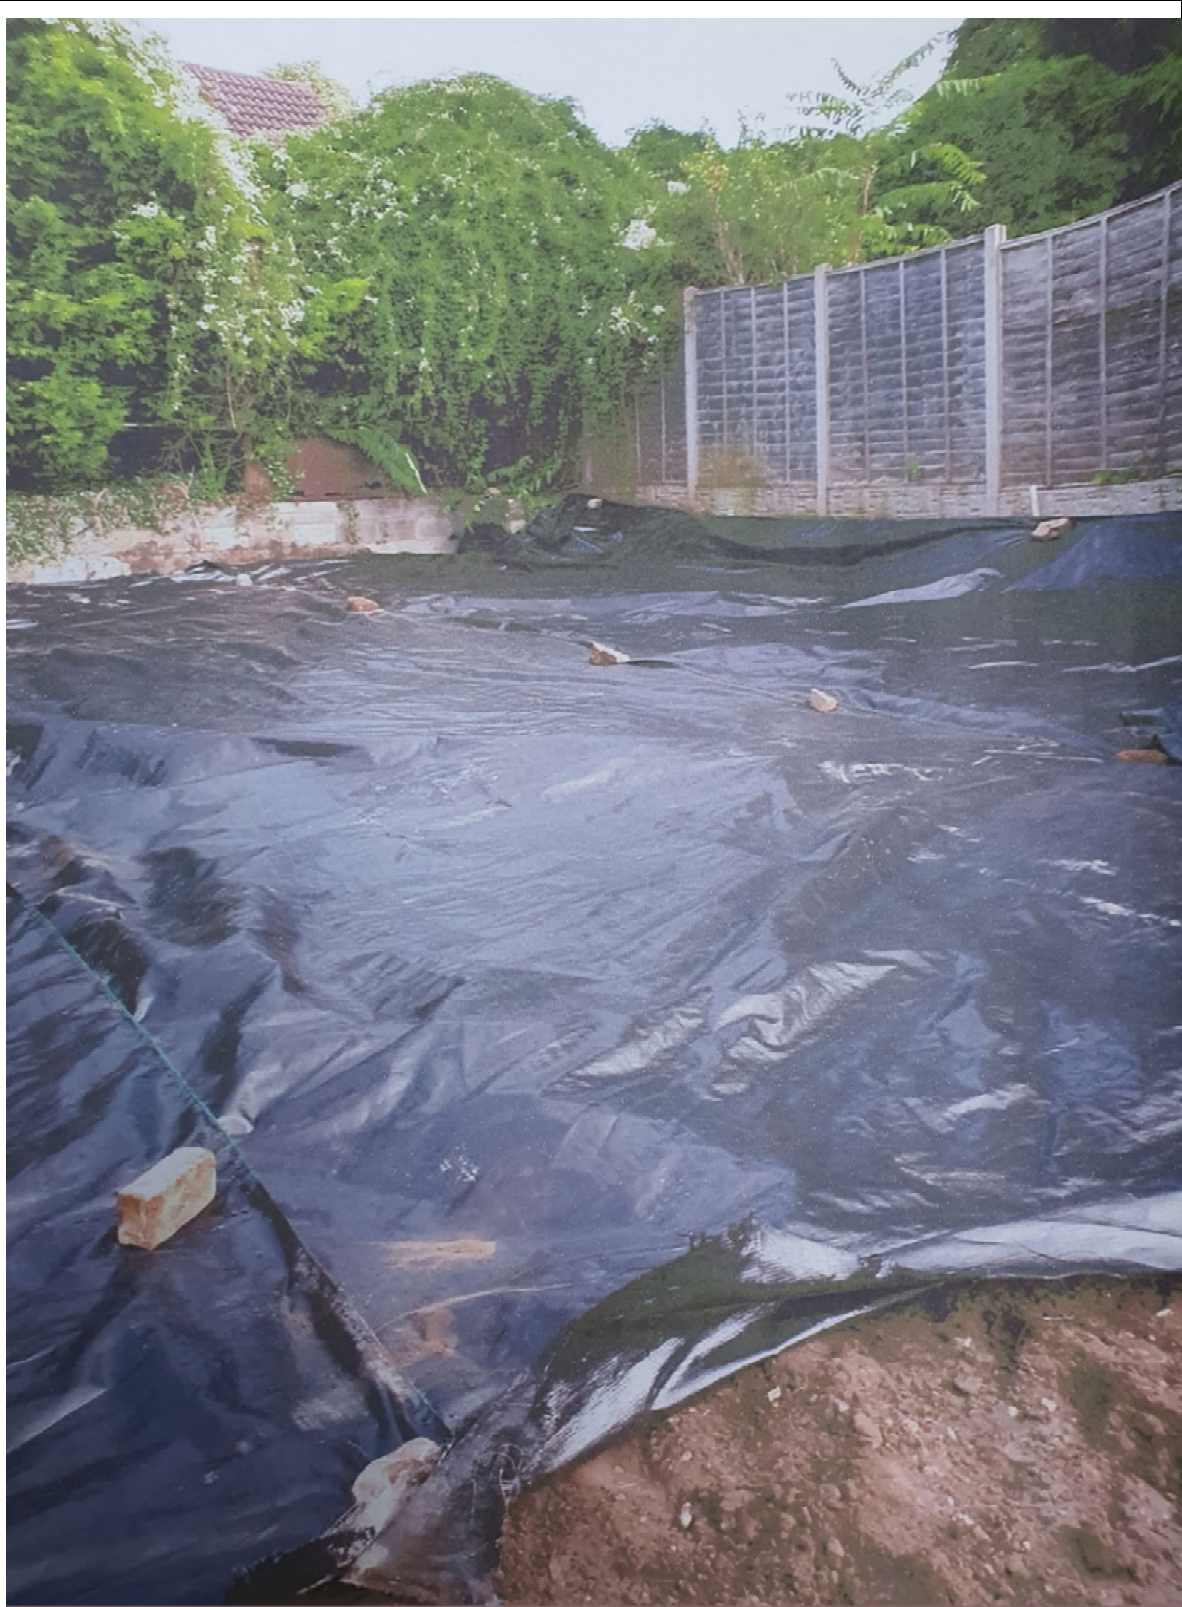
Placement of geotextile

A geotextile membrane was placed on the excavated areas within the gardens, photographic evidence of the membrane placement is included within section 4. The geotextile was sourced from Travis Perkins as a Wrekin woven geotextile Fastrack membrane, a delivery note is included within appendix C with Travis Perkins reference 09B82840.

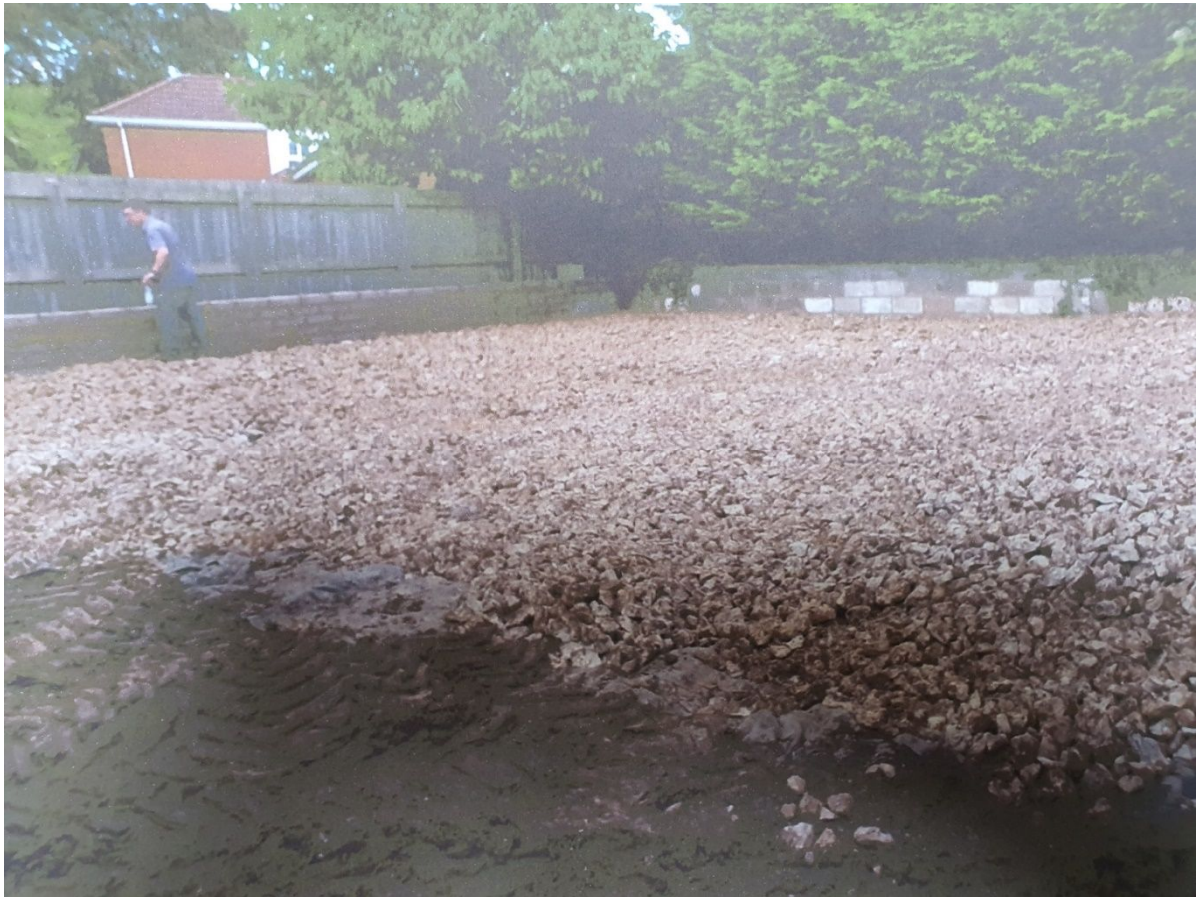
Placement of granular capillary break layer

Photograph within section 4.2 show the capillary layer to appear level with no major undulations indicating good level control. Trial pits within both plots were hand excavated on completion of the rear gardens to prove depths achieved, these were undertaken after seeding with some grass growth visible. In total three trial pits were excavated; these were evenly spaced throughout the garden areas. Locations of the trial pits are marked on the site plan within appendix A. The topsoil was excavated and placed to one side for sampling, this exposed the chalk granular capillary layer. The depth of the granular capillary layer was proven by further excavation to the geotextile layer. Table 3 below shows the depths encounter followed by photographic evidence.

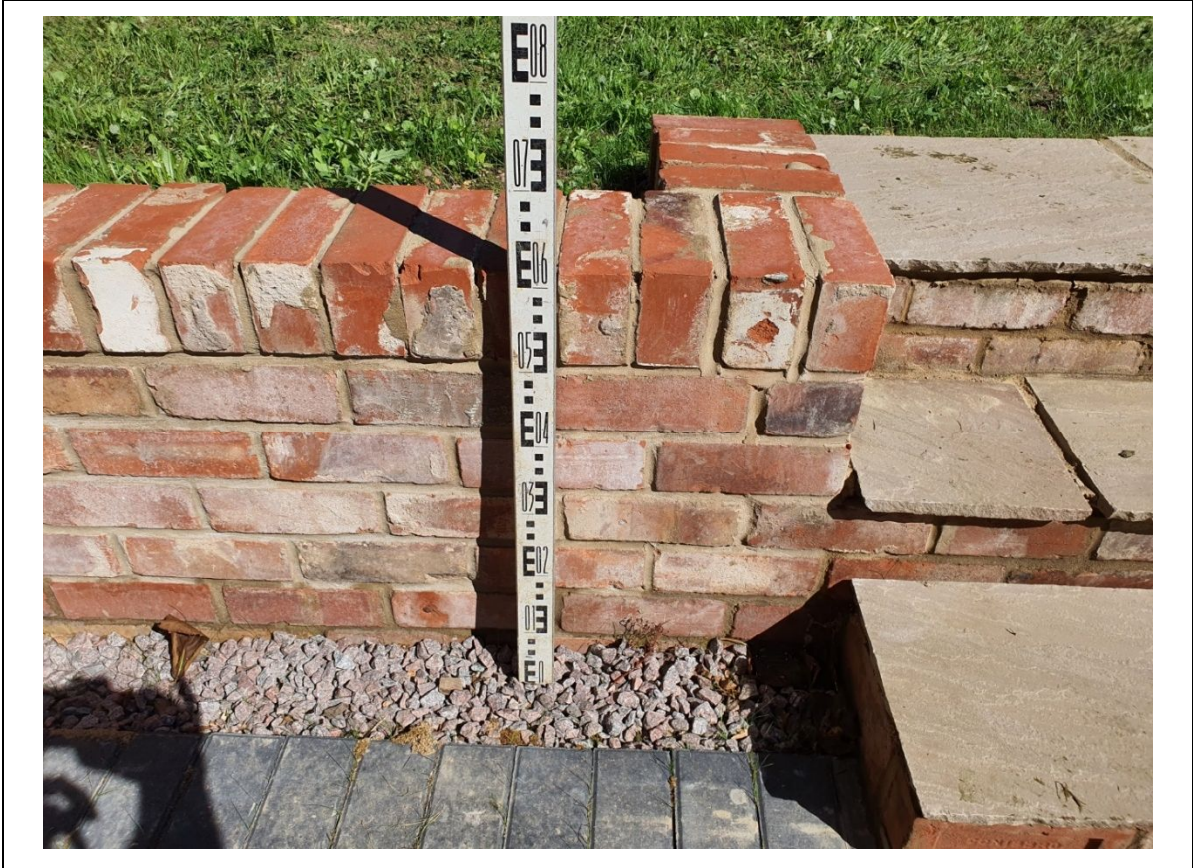
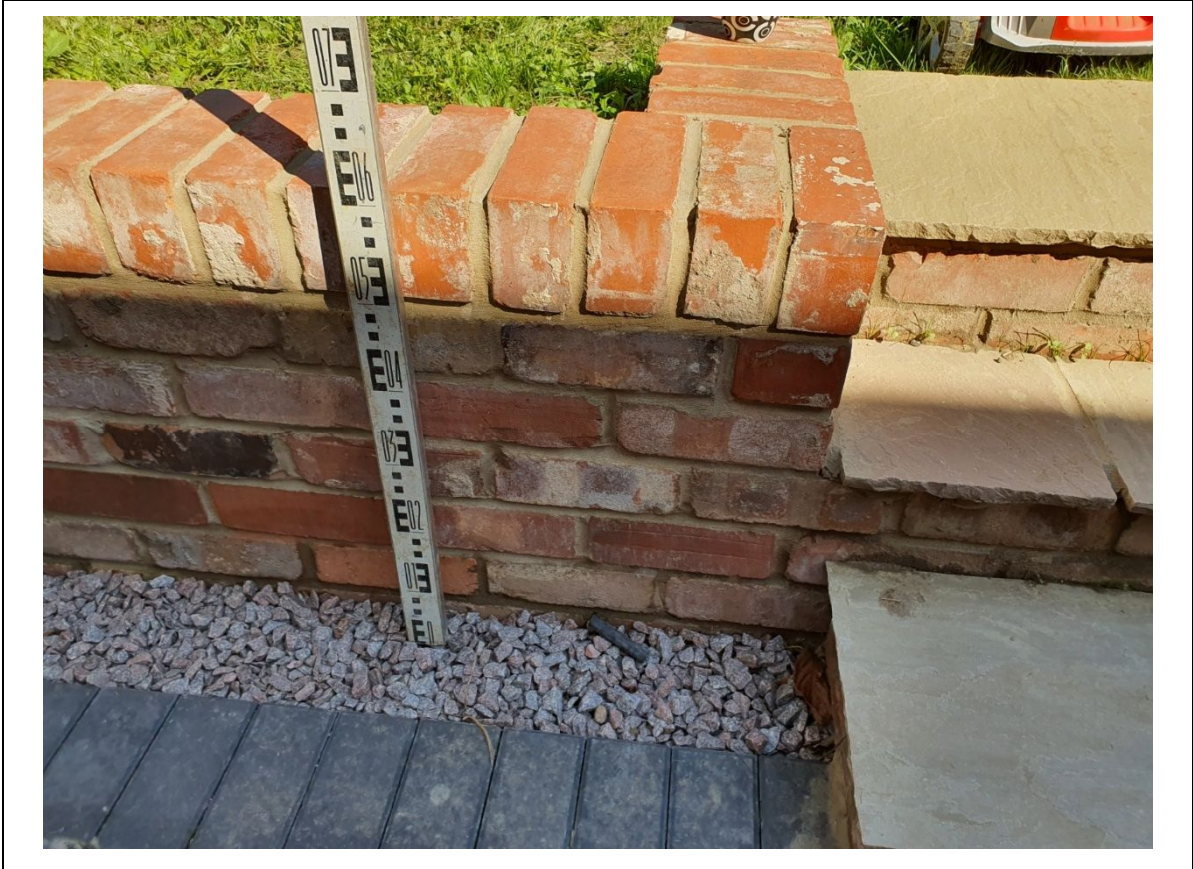
Construction of retaining wall

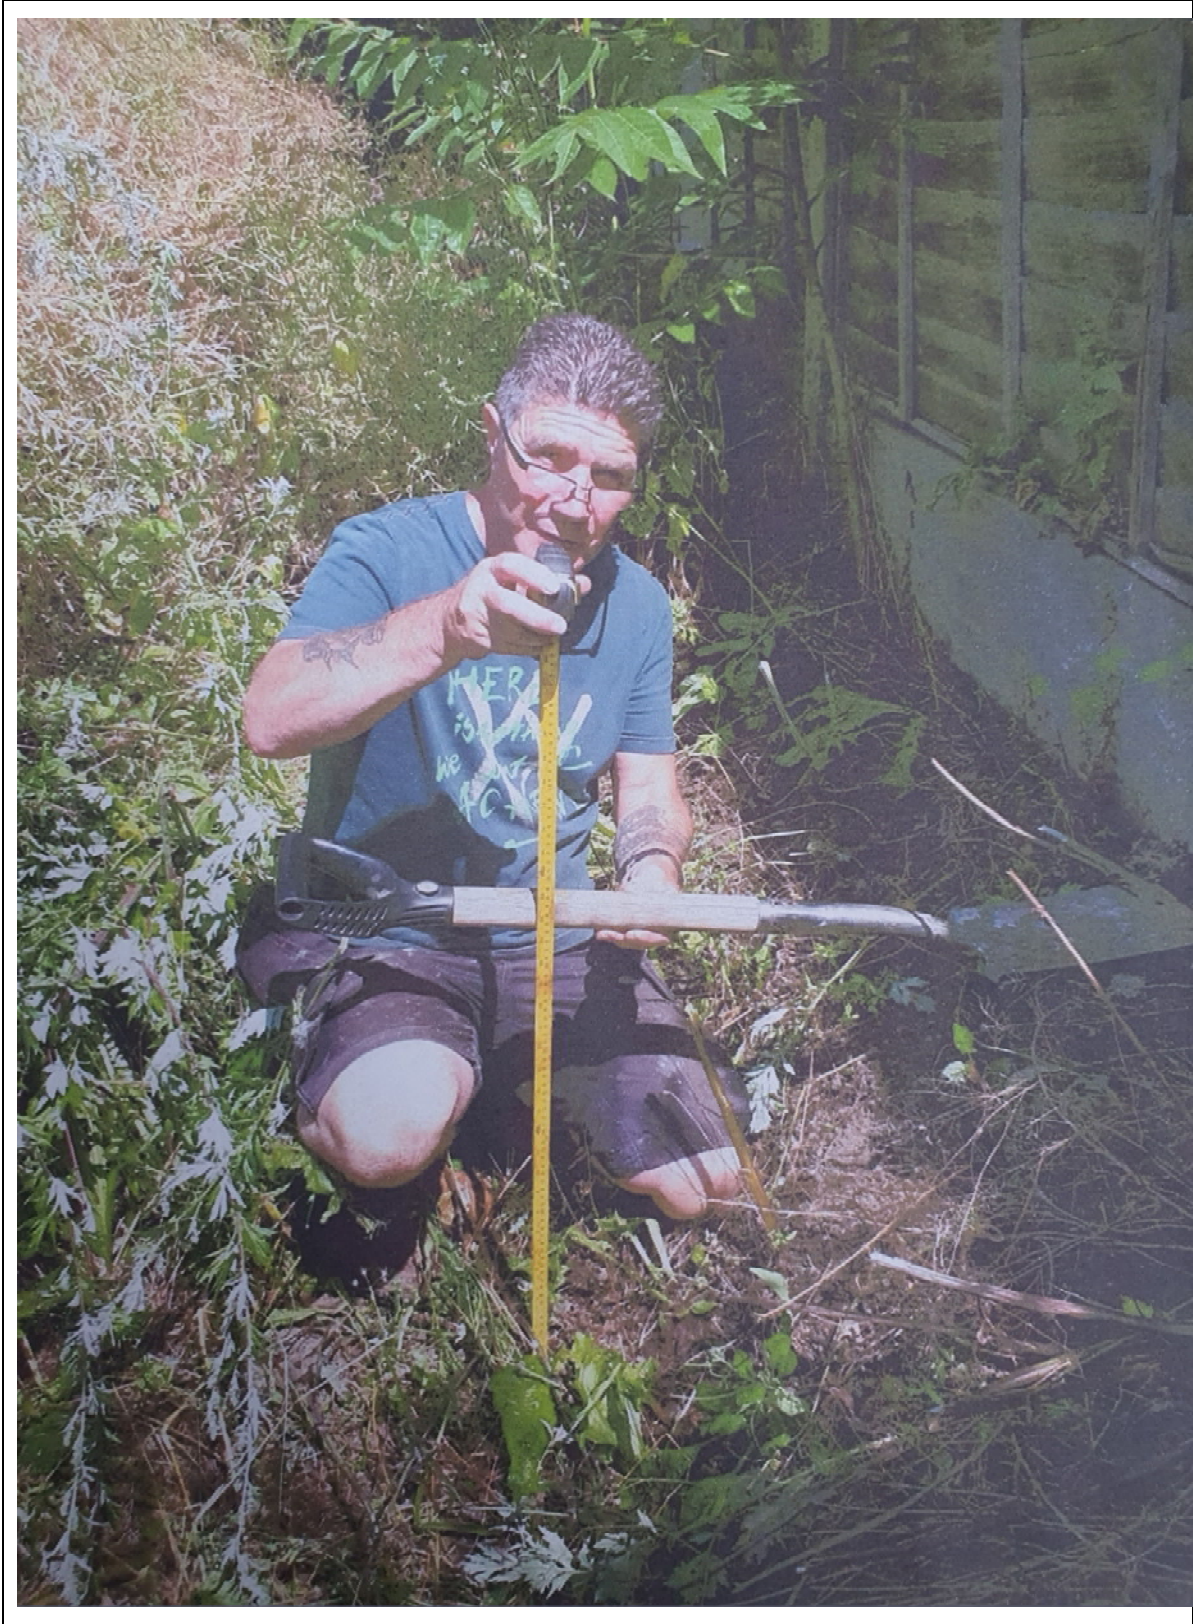
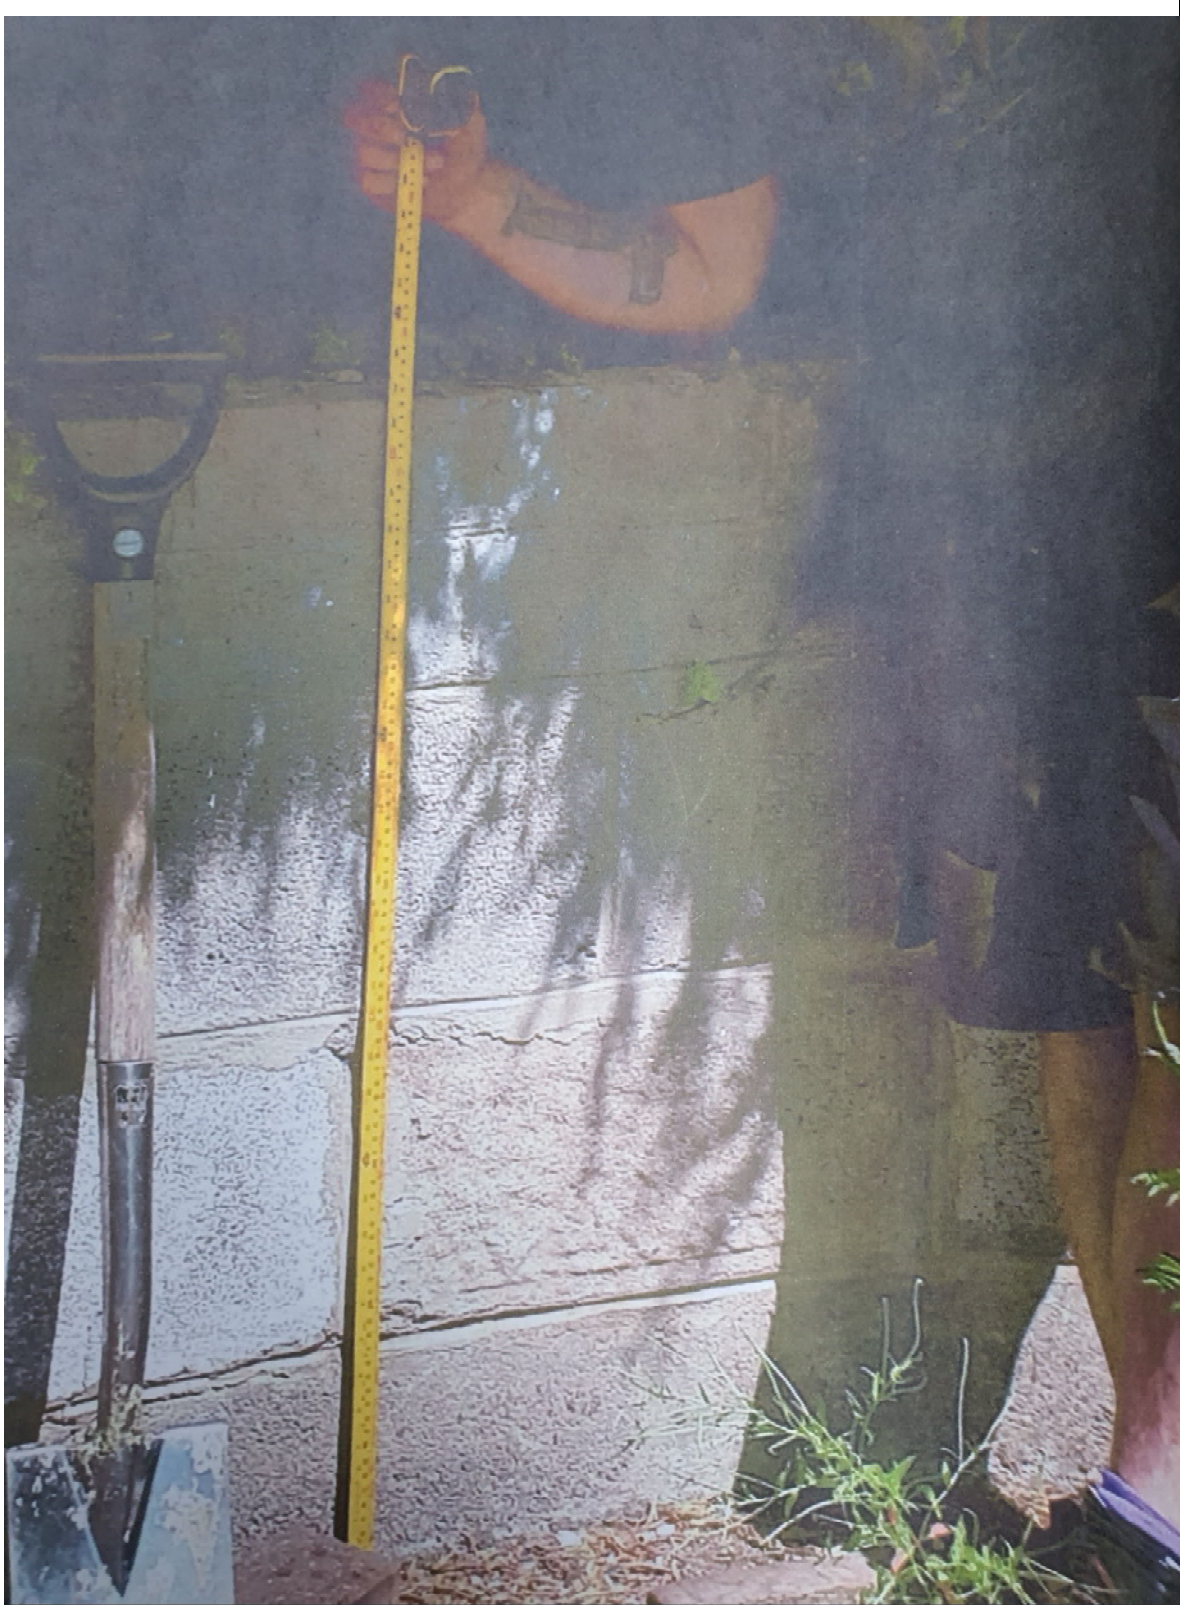
Evidence of level control

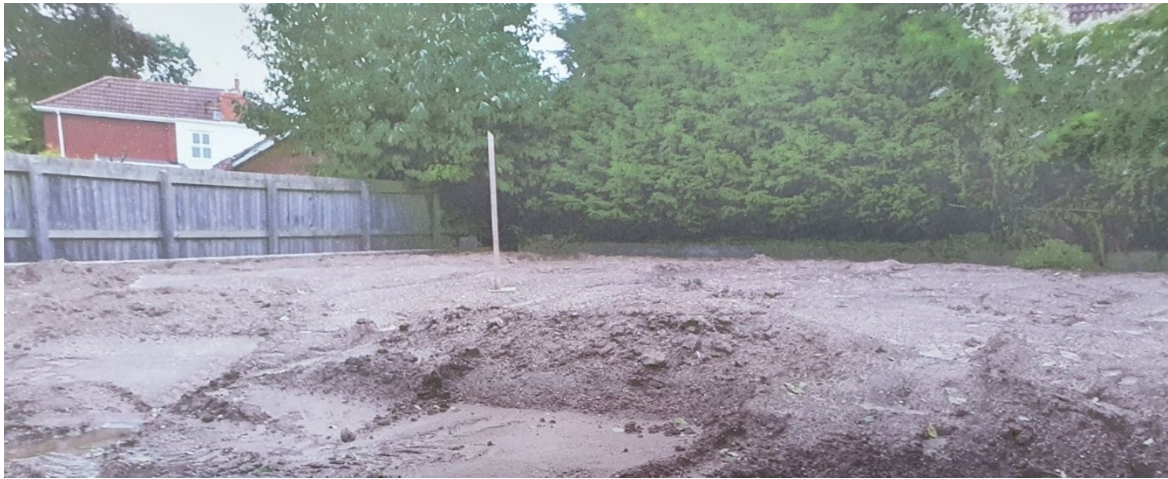
Placement of topsoil

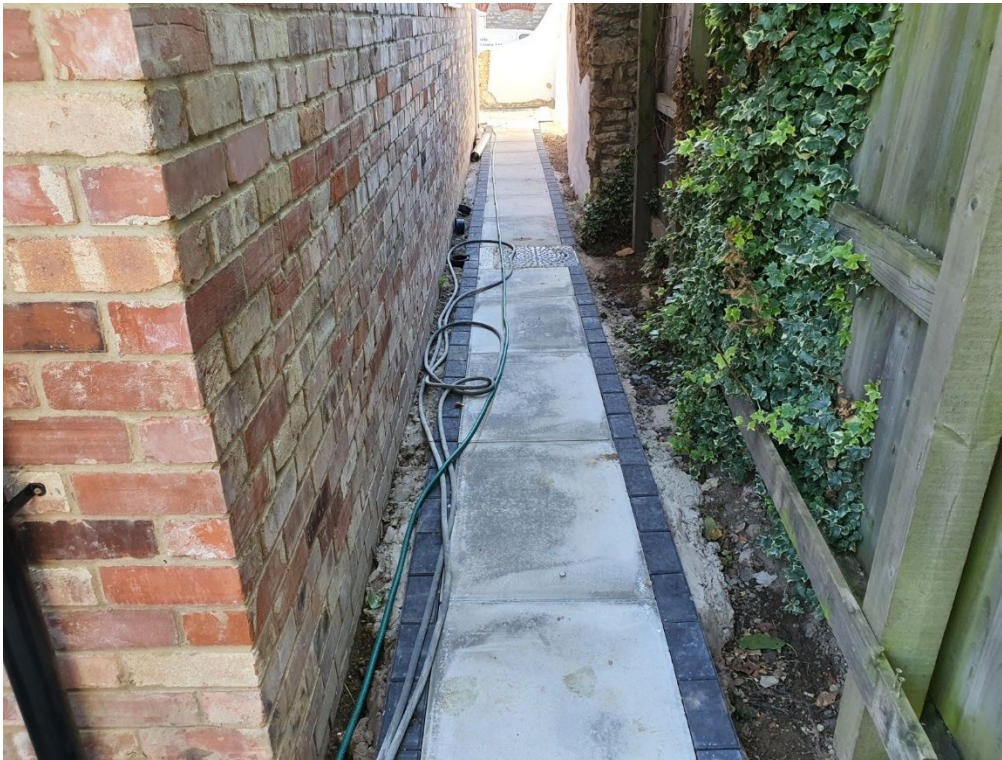
Plot 1 side walkway

Hardstanding to the rear gardens and side walkways included limestone and concrete cast slabs on 50mm down chalk granular fill supplied by Brianplant loaded from Singleton Birch, this included two deliveries on 23rd October 2019 totalling 37tonnes with conveyance note no's 11760 and 11761, a copy of the conveyance notes are included within appendix C.

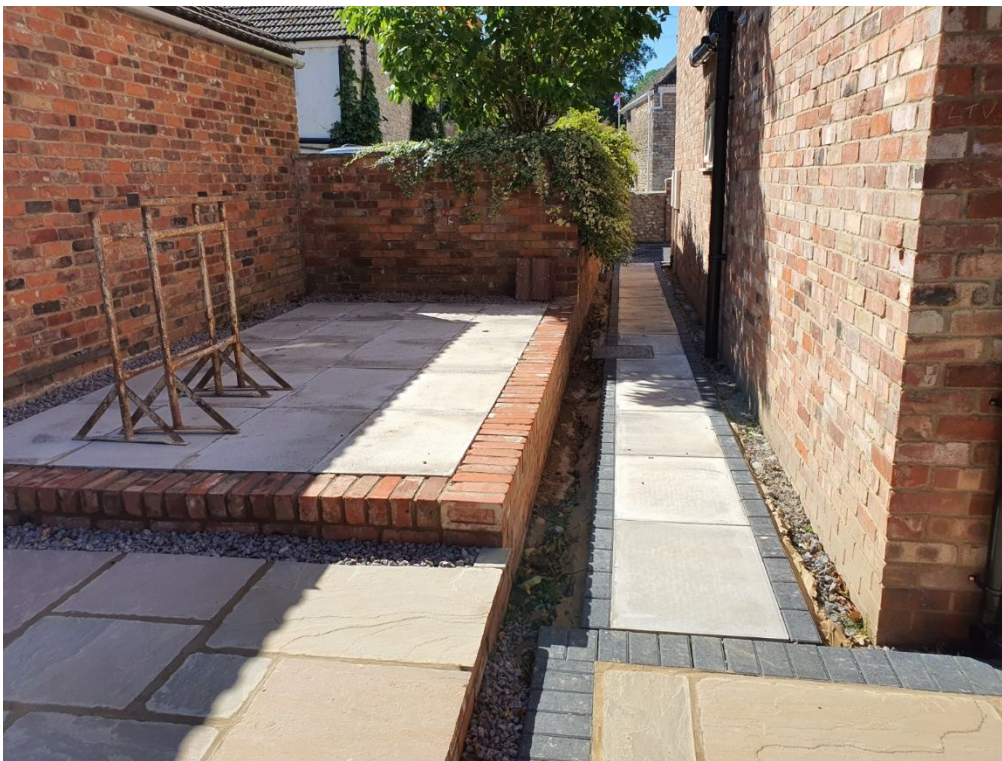
Plot 2 side garden area and walkway

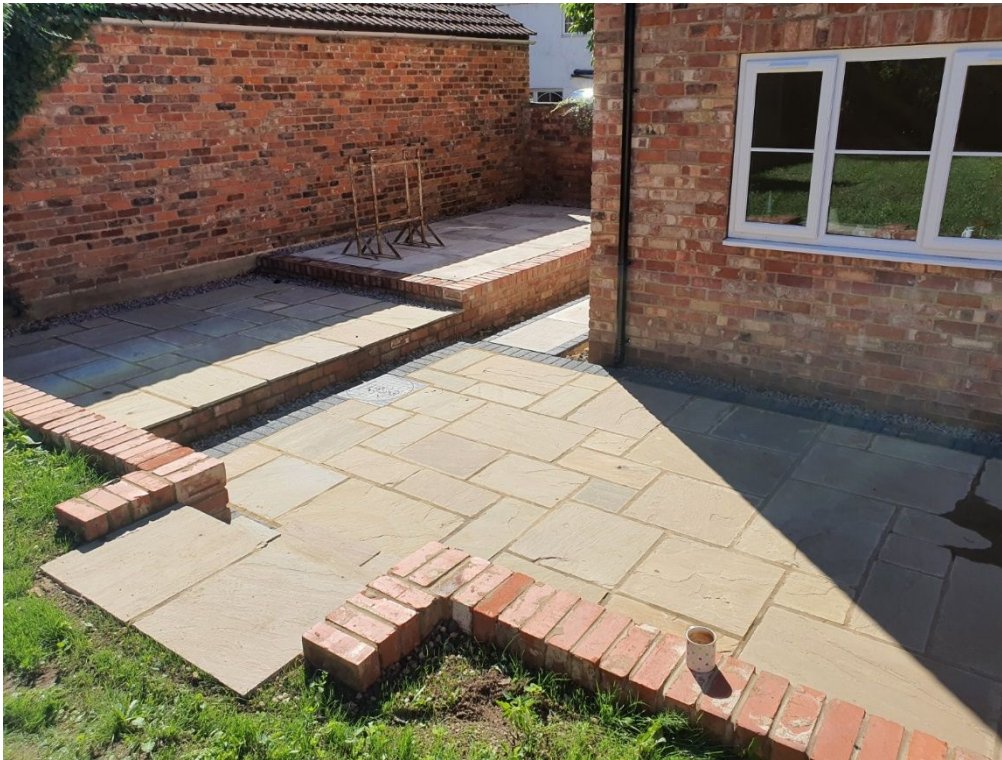
Plot 2 rear garden

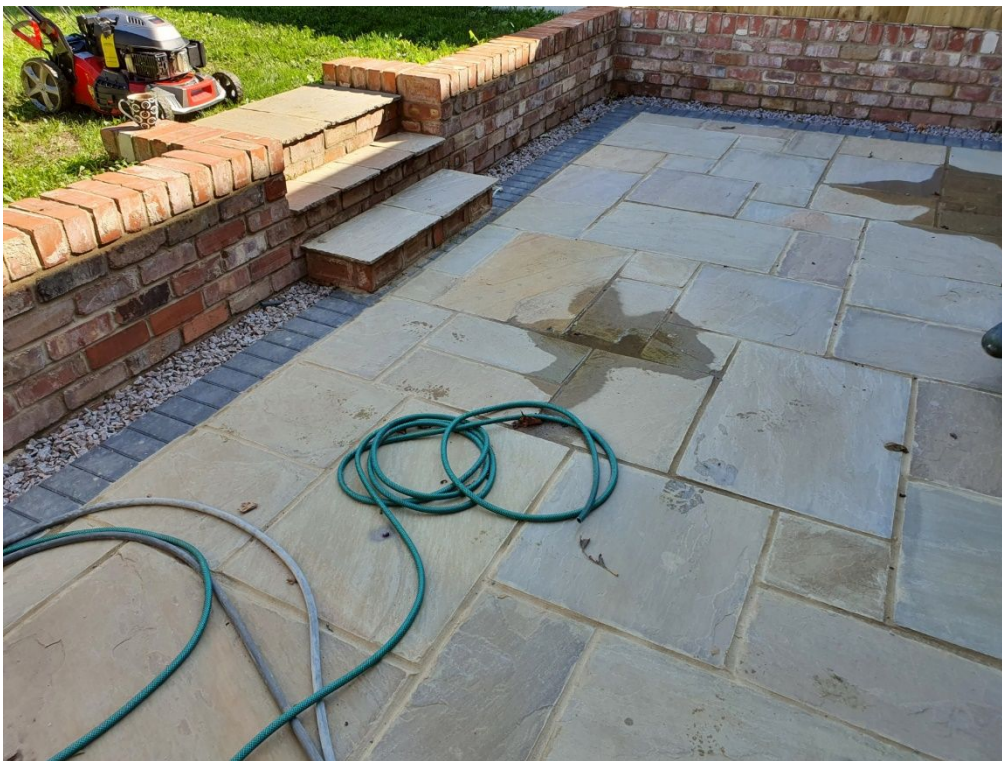
Plot 1 rear garden

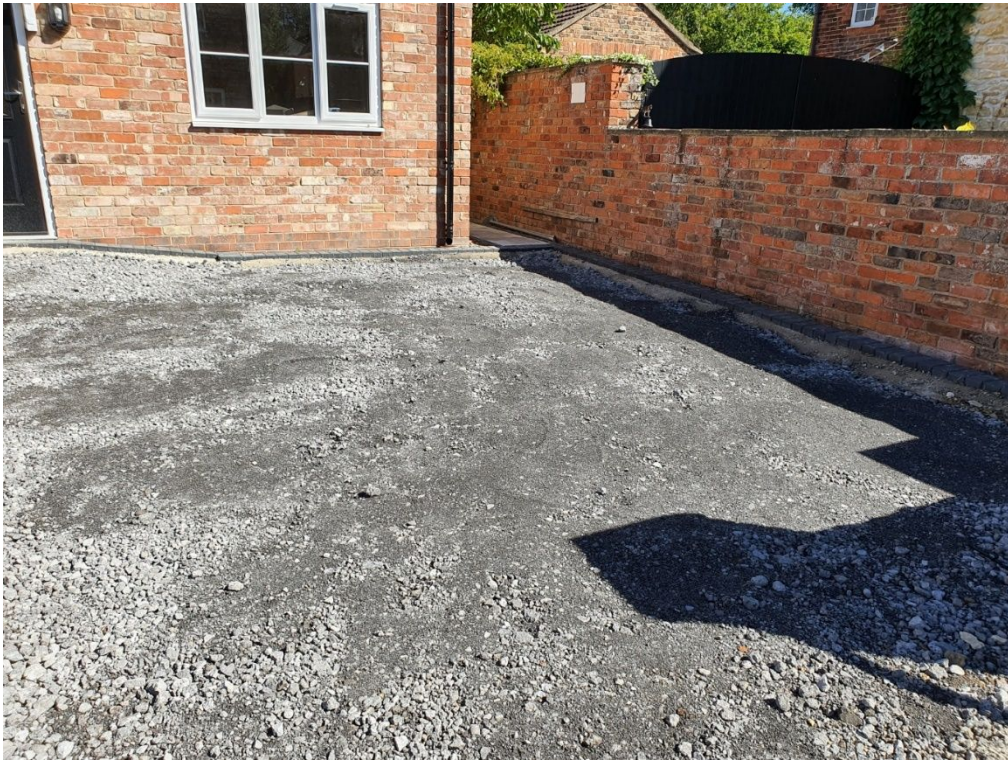
Plot 2 front parking area

Hardstanding to the front parking areas included 50mm down blast furnace slag granular fill supplied by ???? loaded from ???, this included two deliveries on 23rd October 2019 totalling 37tonnes with conveyance note no's 0 and 1. This area will also include bituminous surfacing which was still to be undertake after the final validation visit. Copies of the conveyance notes are included within appendix C.

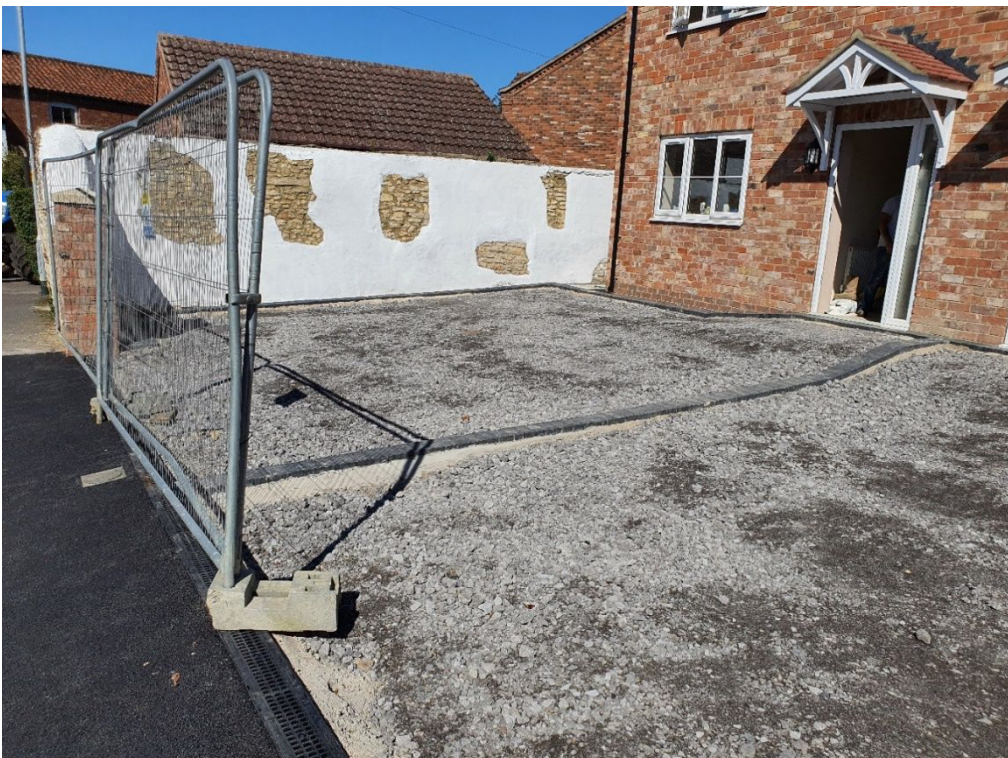
Plot 1 front parking area

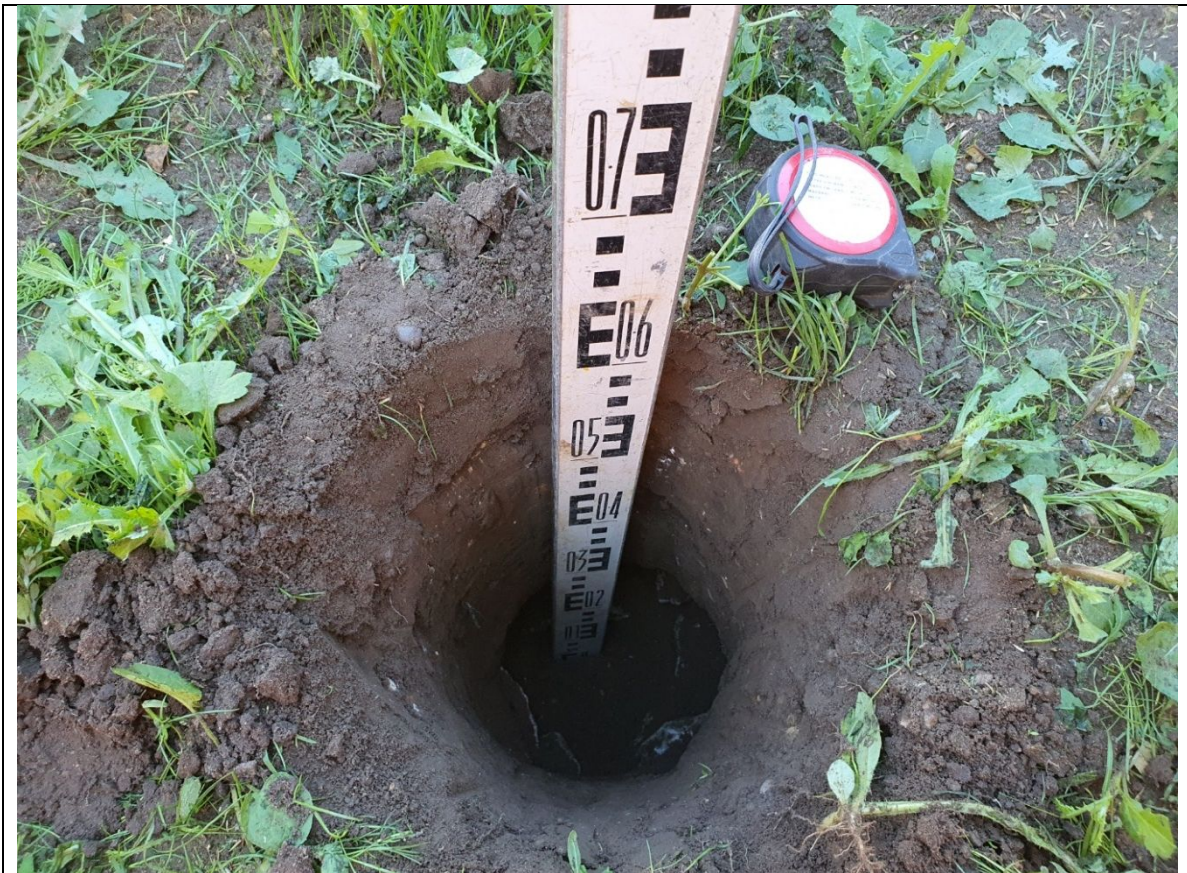
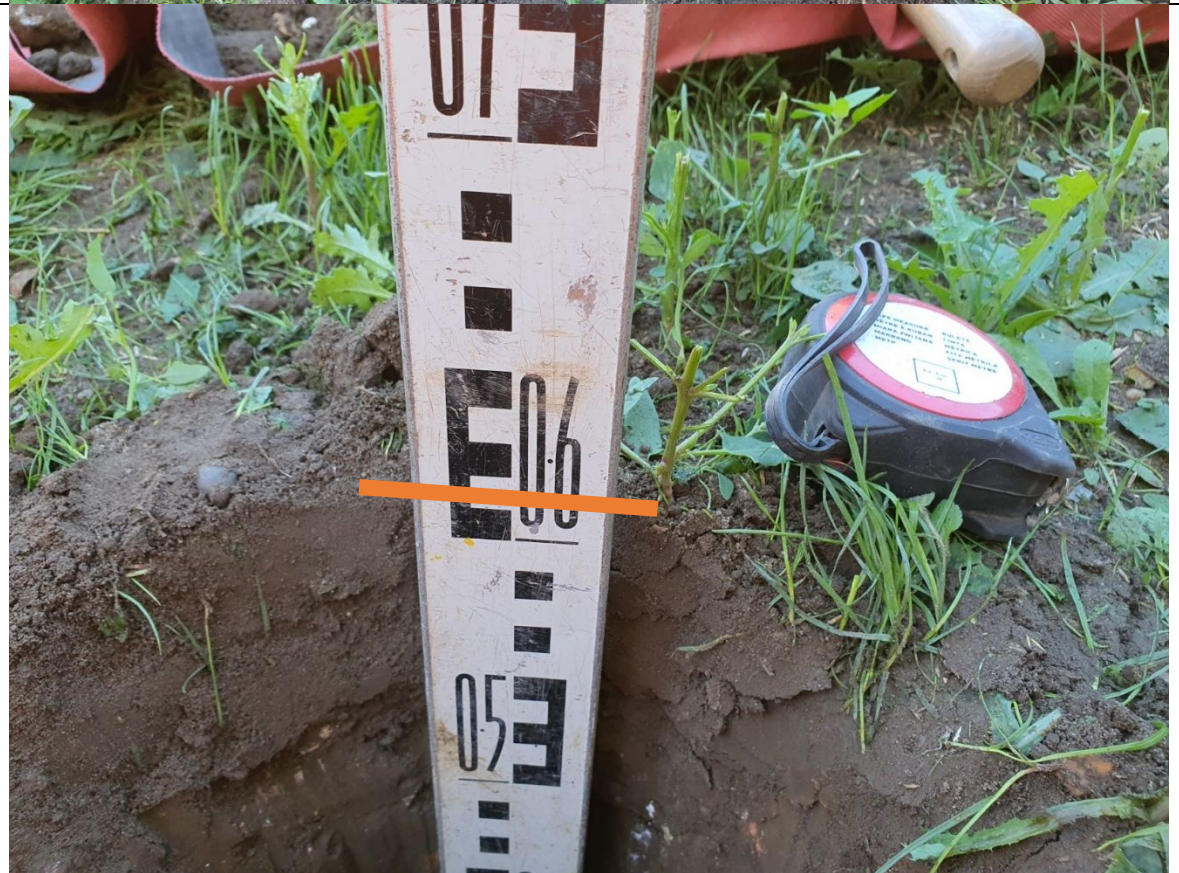
Trial pit	Topsoil depth (mm)	Depth to geotextile membrane (mm)	Capillary layer depth (mm)
1	490	611	121
2	435	614	179
3	480	605	125

Trial pit 1 – rear garden granular capillary layer

The trial pits show an average depth of 142mm for the rear gardens.

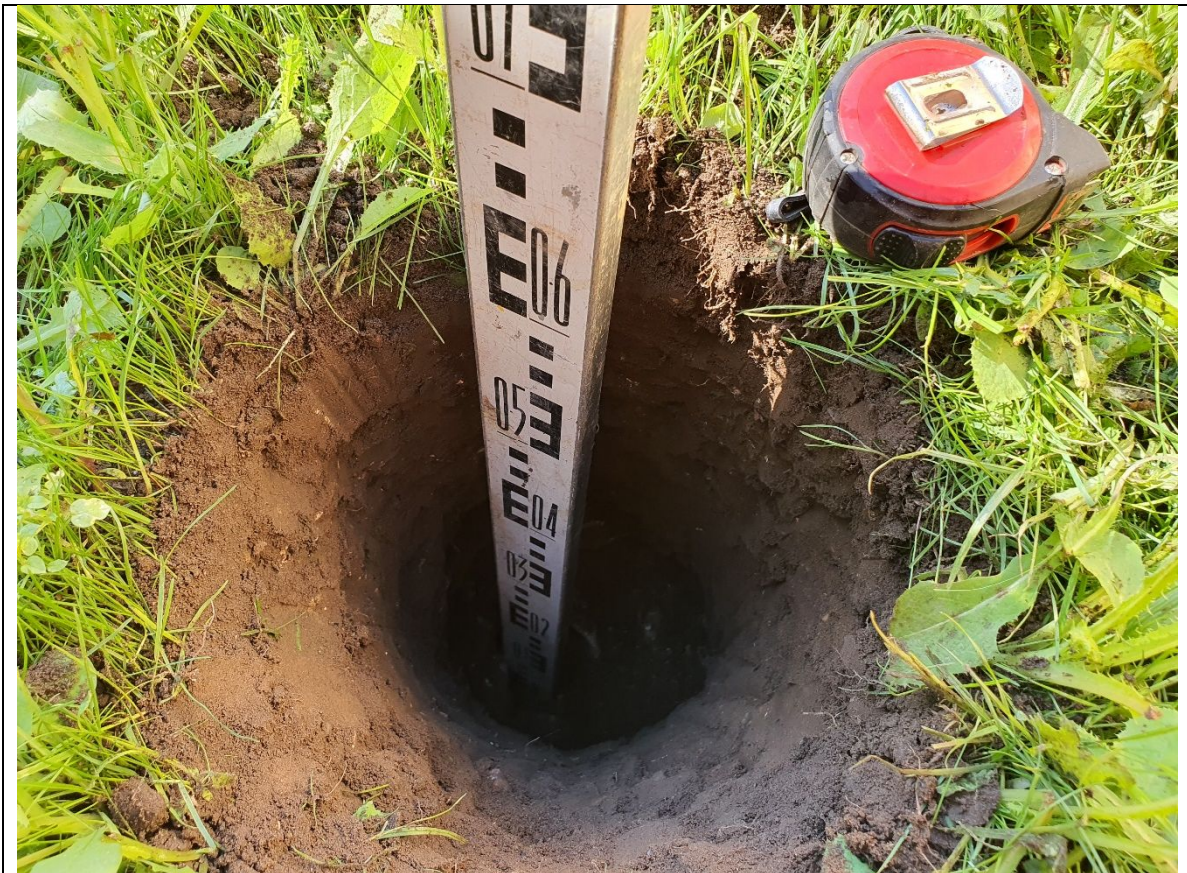
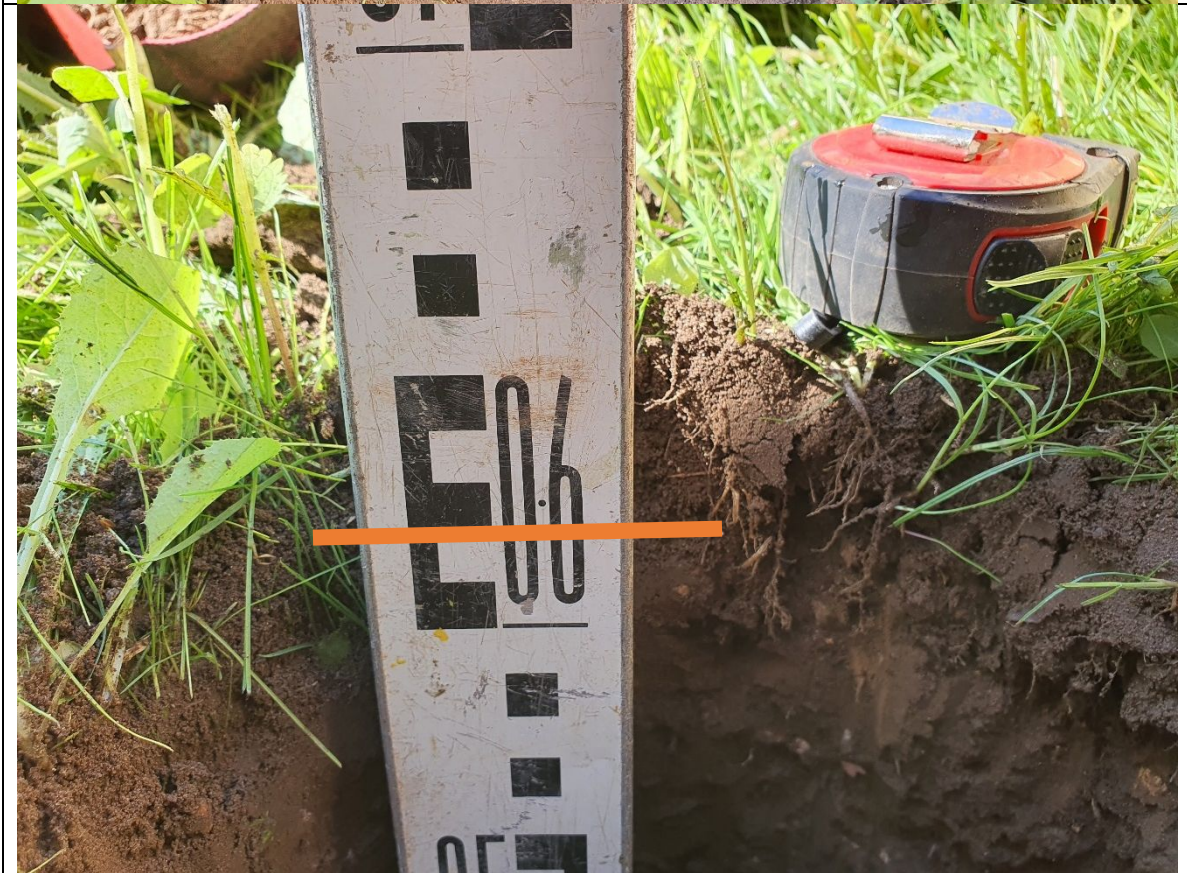
Trial pit 2 – rear garden granular capillary layer
