Validation report

9a Darwin Street, Kirton in Lindsey

Produced for C&K Builders (Mr K McCabe)

<i>Title:</i>	Phase 4: Validation report 9a Darwin Street, Kirton in Lindsey
<i>Client:</i>	C&K Builders (Mr Ken McCabe)
<i>Date:</i>	September 2020
<i>Report number:</i>	1166/4758/P/P4

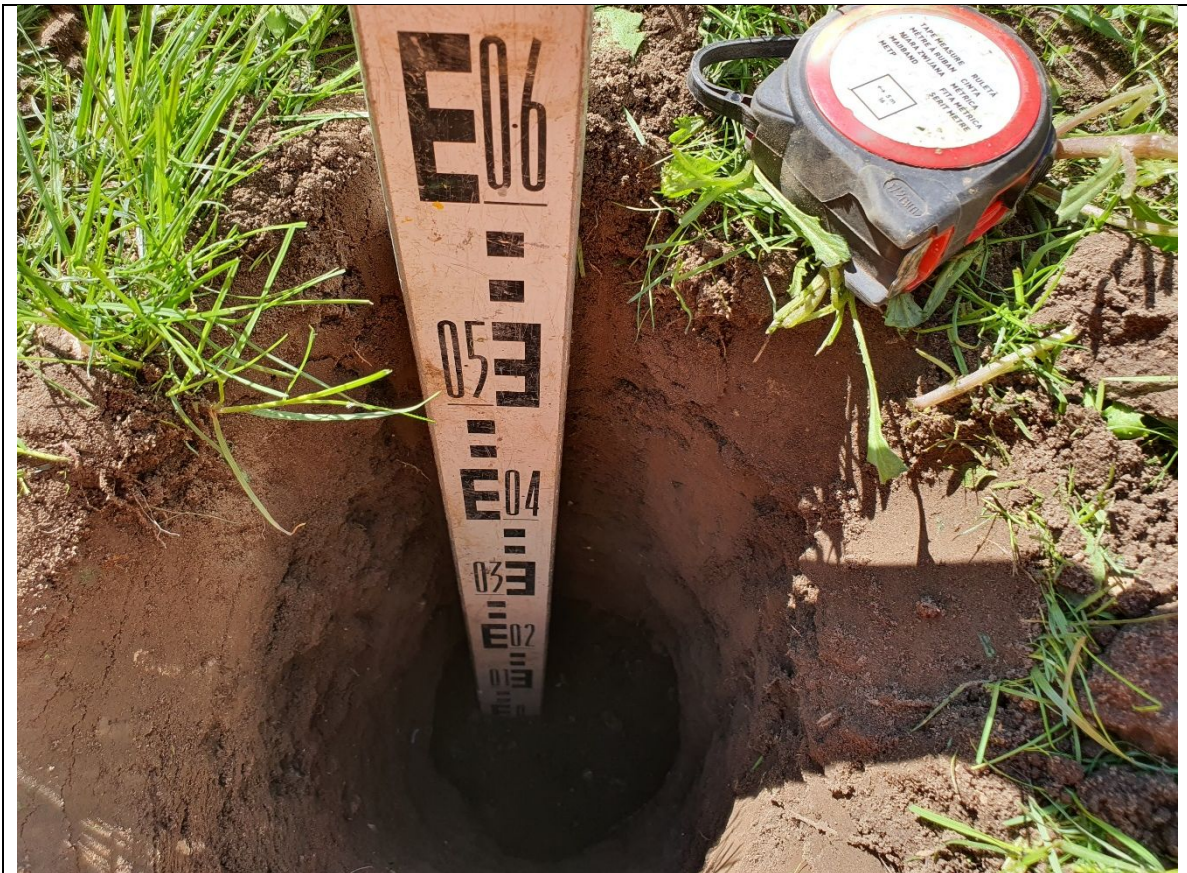
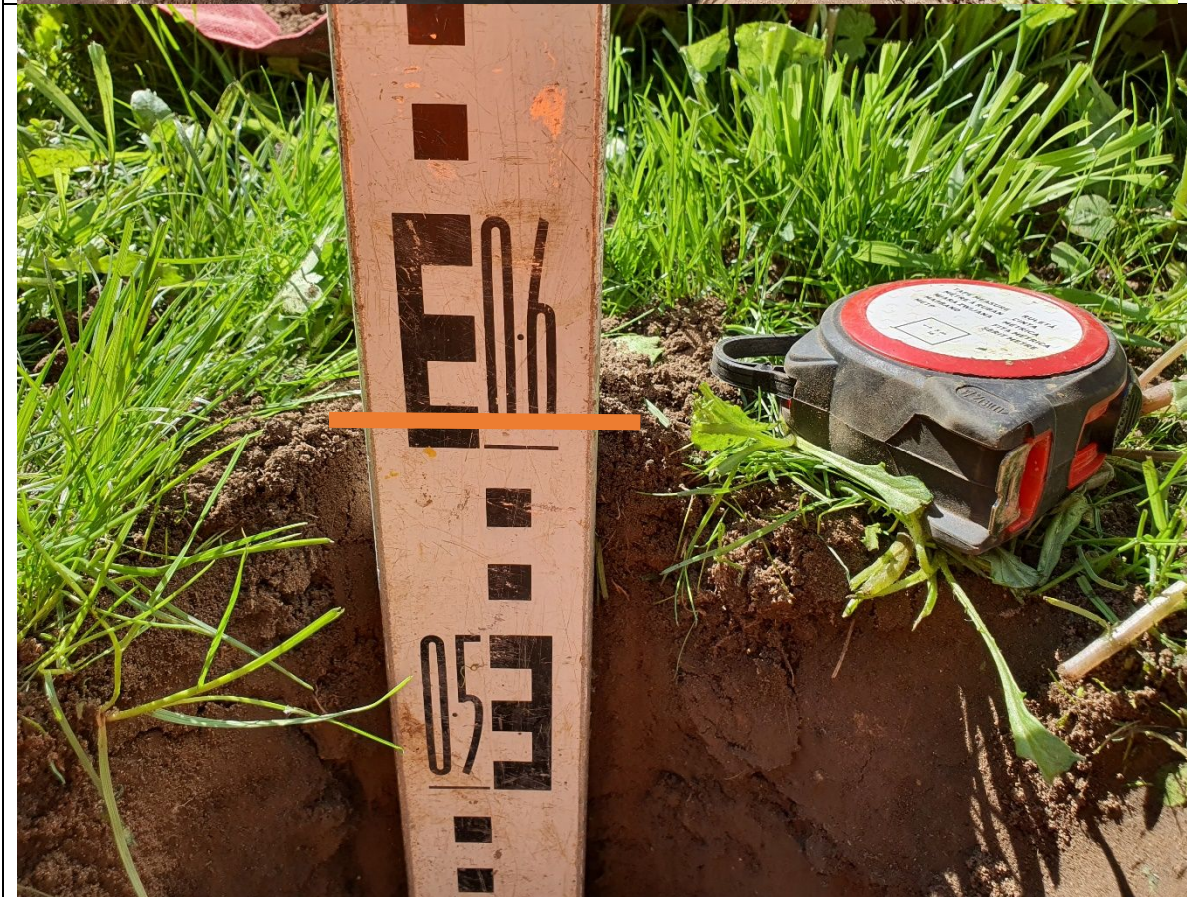
Trial pit	Topsoil depth (mm)	Depth to geotextile membrane (mm)	Capillary layer depth (mm)
1	490	611	121
2	435	614	179
3	480	605	125

Trial pit 3 – rear garden granular capillary layer

The trial pits show an average depth of 142mm for the rear gardens.

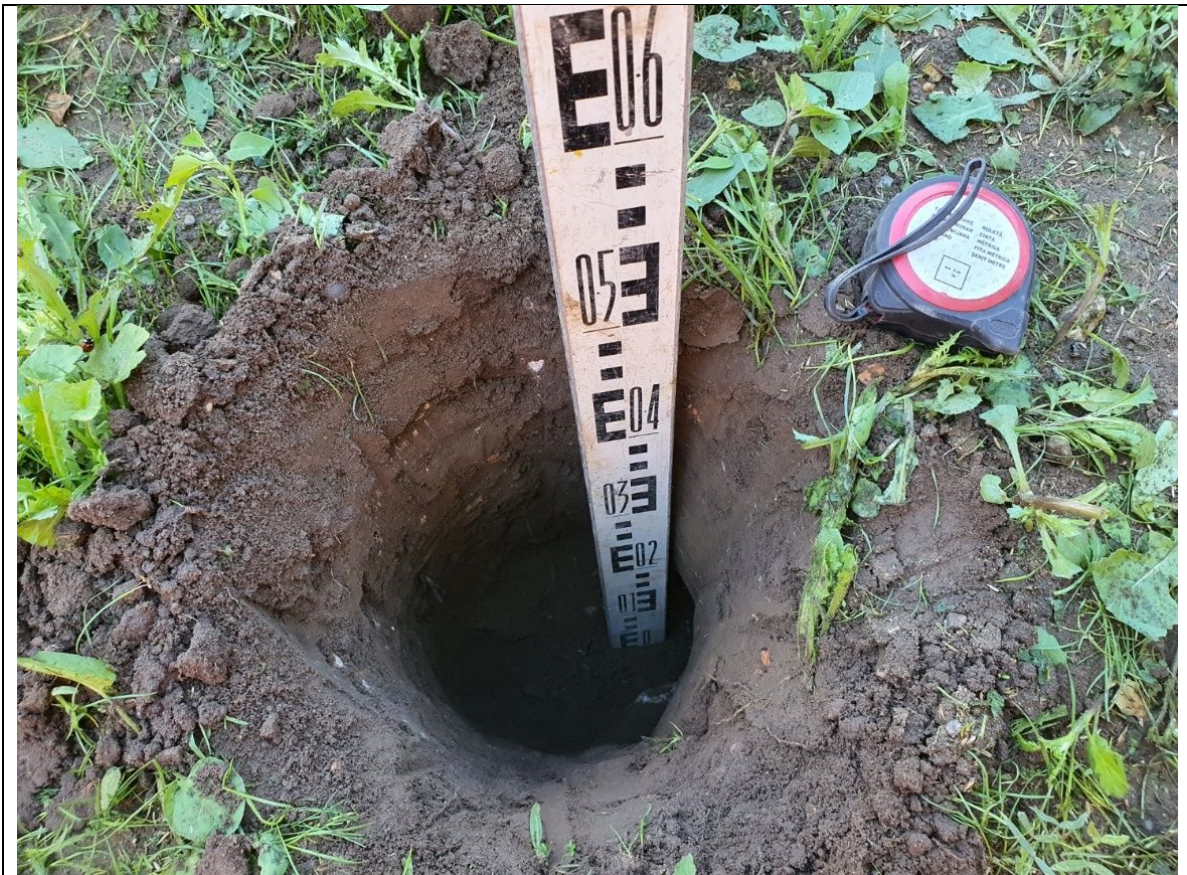
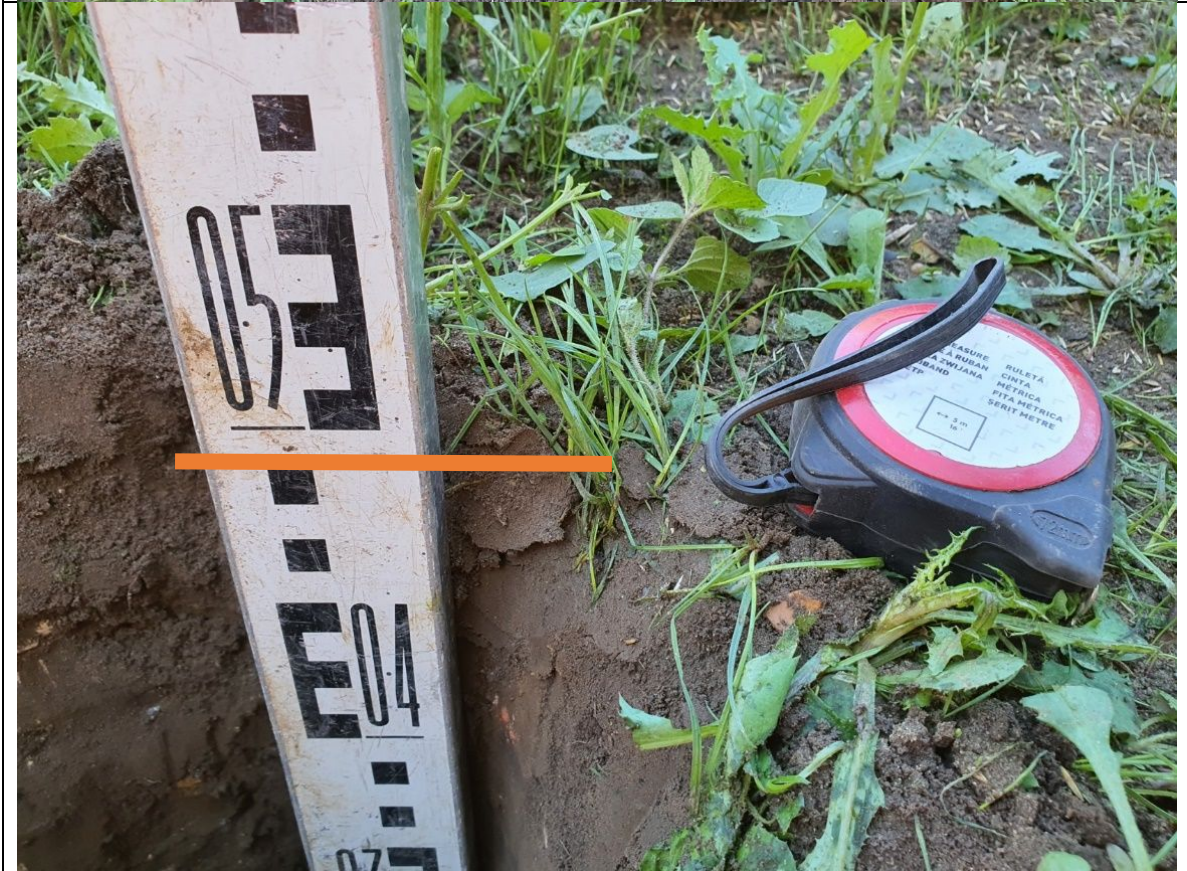
Trial pit	Topsoil depth (mm)	Depth to geotextile membrane (mm)	Capillary layer depth (mm)
1	490	611	121
2	435	614	179
3	480	605	125

Trial pit 1 – rear garden topsoil

The trial pits show an average depth of 468mm for the rear gardens.

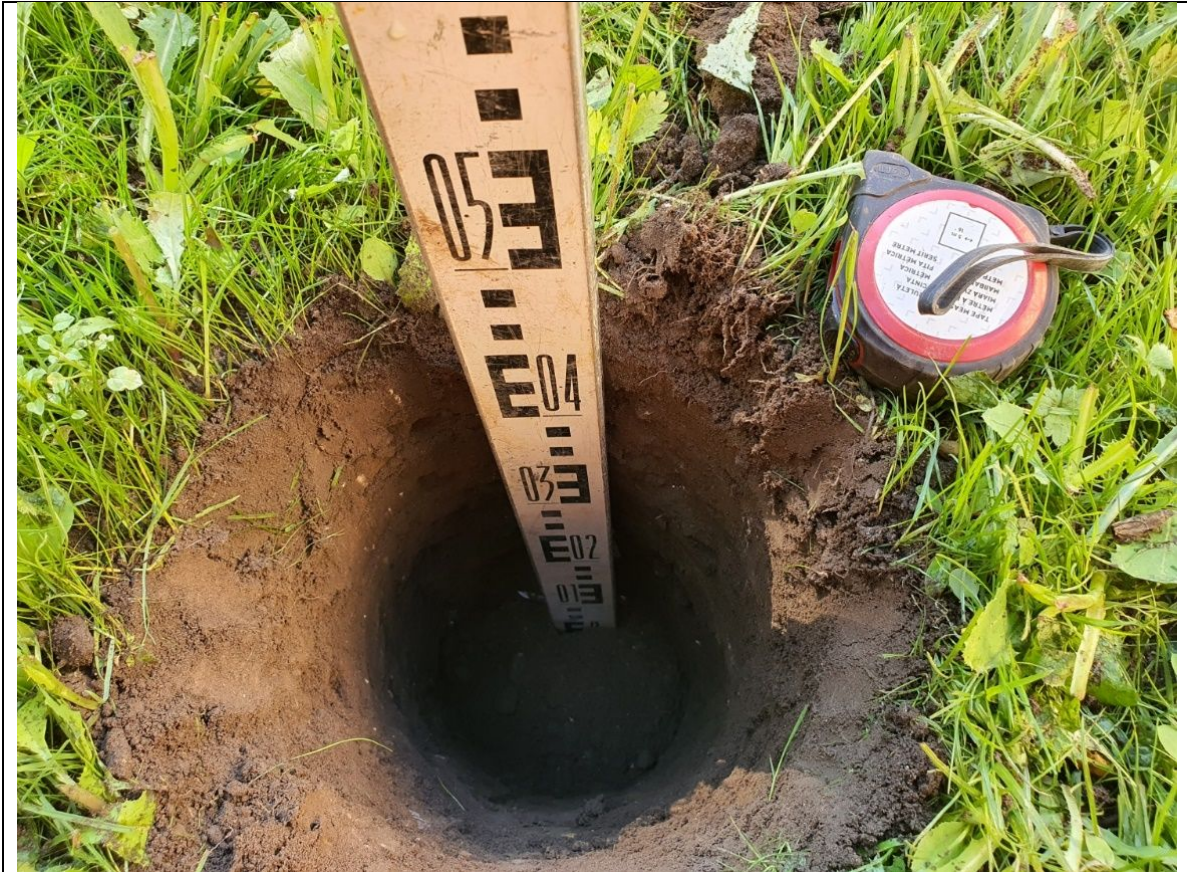
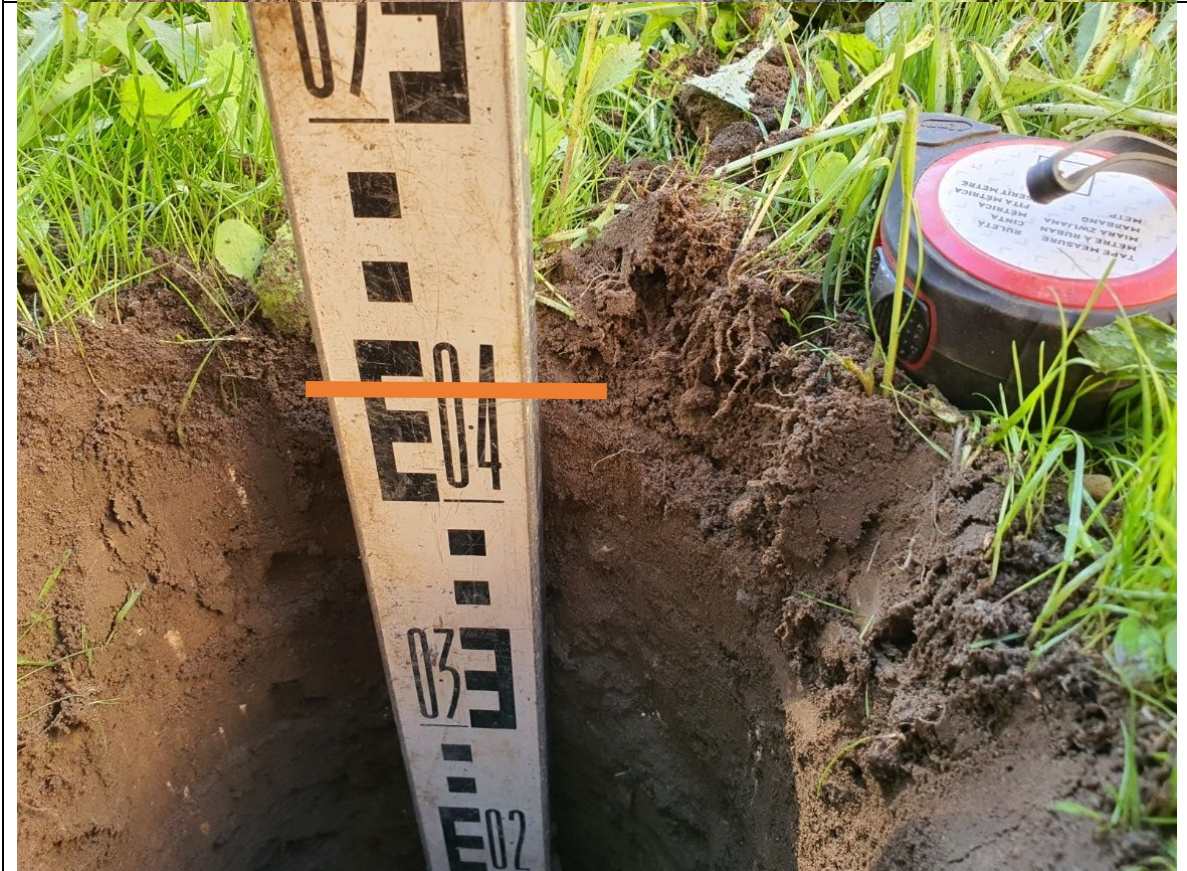
Trial pit 2 – rear garden topsoil

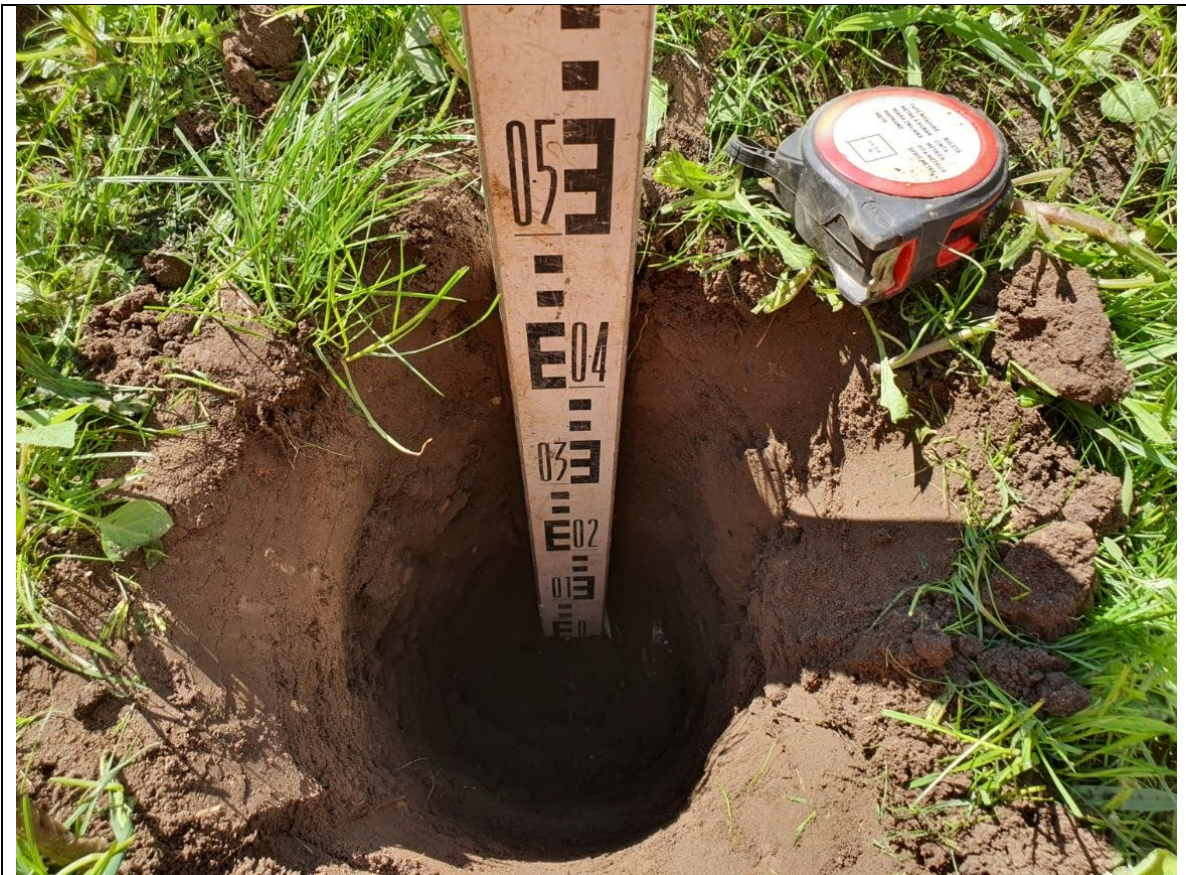
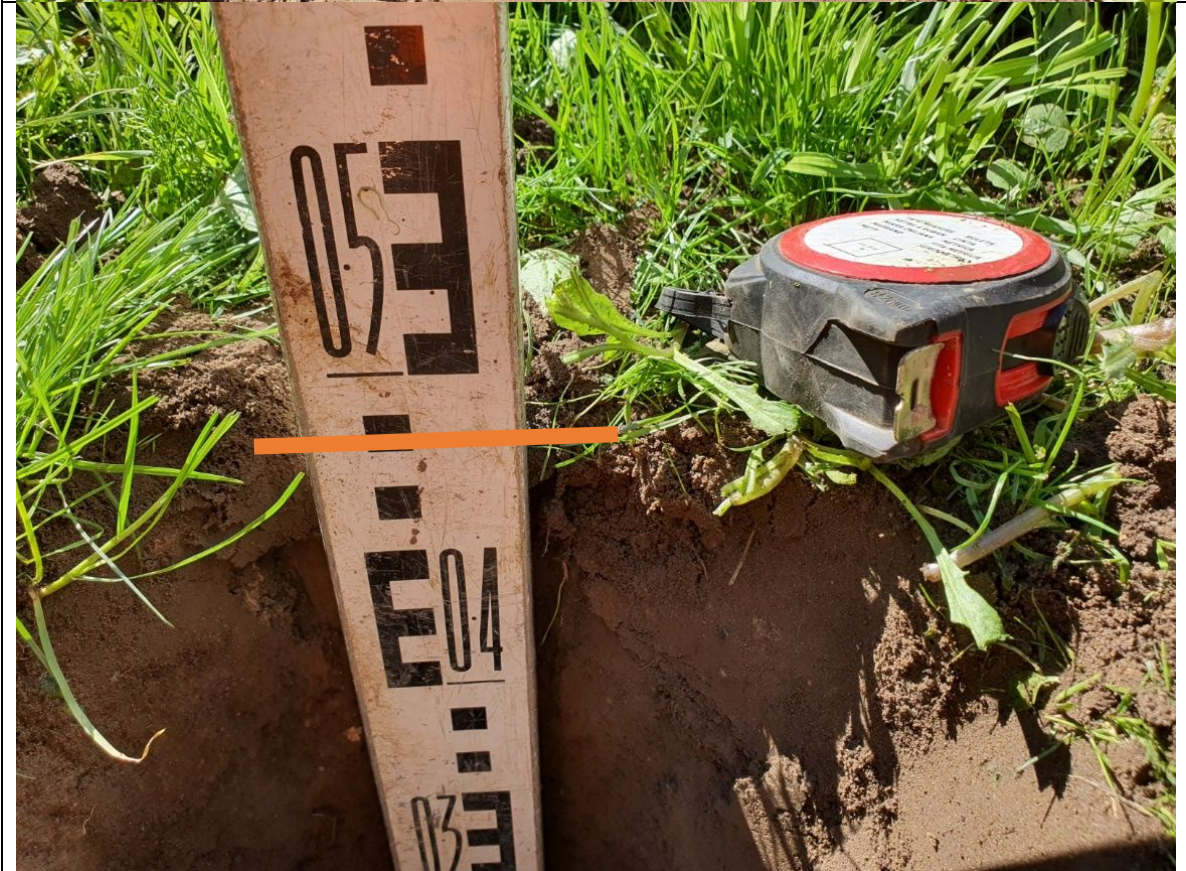
Trial pit 3 – rear garden topsoil
