**Validation report**

**9a Darwin Street, Kirton in Lindsey**

<b>Title:</b>	Phase 4: Validation report 9a Darwin Street, Kirton in Lindsey
<b>Client:</b>	C&K Builders (Mr Ken McCabe)
<b>Date:</b>	September 2020
<b>Report number:</b>	1166/4758/P/P4

# **Phase 4 (Validation) report**

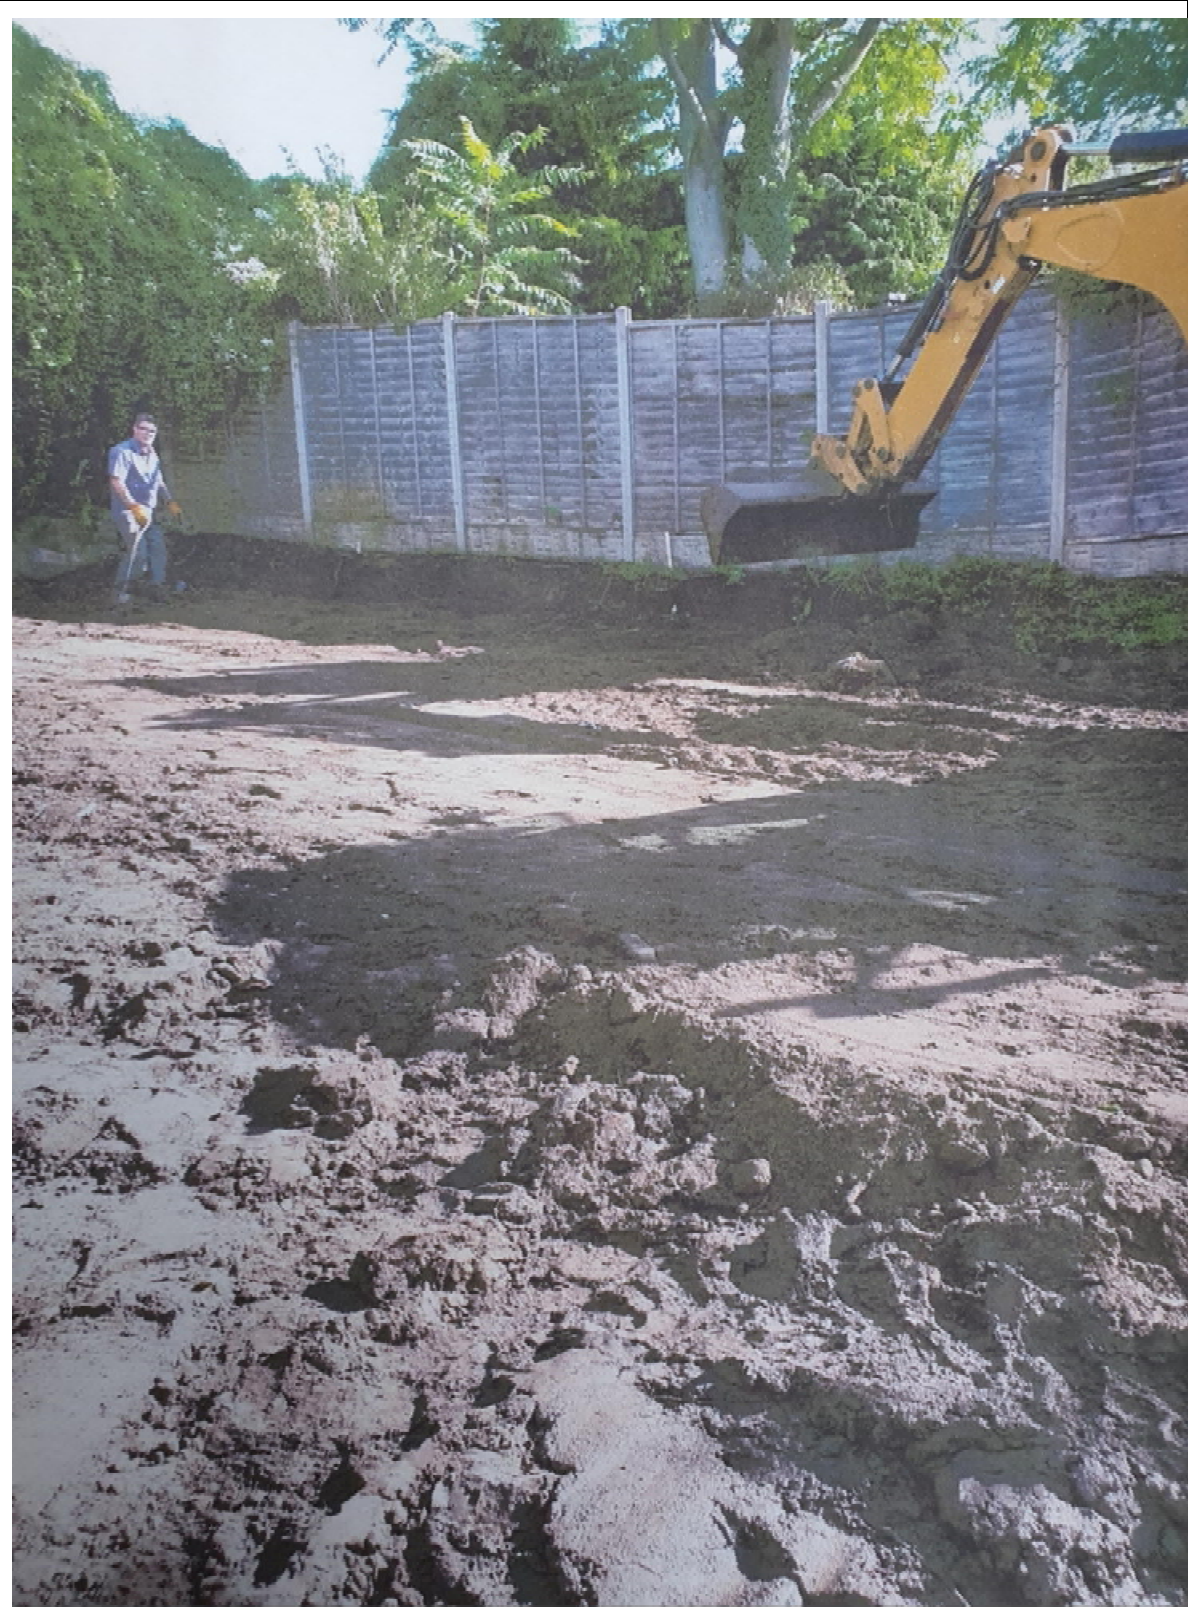
Made ground /soil removal from rear garden areas

The made ground and natural soils within the rear garden areas were excavated to 600mm below proposed final levels, as discussed within the phase 3. This would equate to approximately 100mm in depth as the rear garden areas are to be raised by 500mm. Level controls were monitored by the contractor during remediation, this included datum points from the adjoining block wall, brick wall and fence line. Initial spoil from the excavation were placed directly into a licensed waste skip and subsequently removed by the provider to an appropriate waste management facility (Ellgia, Scunthorpe). Further removal from site foundation digs was via spoil loaded directly into lorries and removed to an appropriate waste management facility (Sandstop Quarries Ltd, Drax golf course). Placement of the subsequent geotextile membrane, granular capillary layer and topsoil took place within the following days. Photographs below show the following,

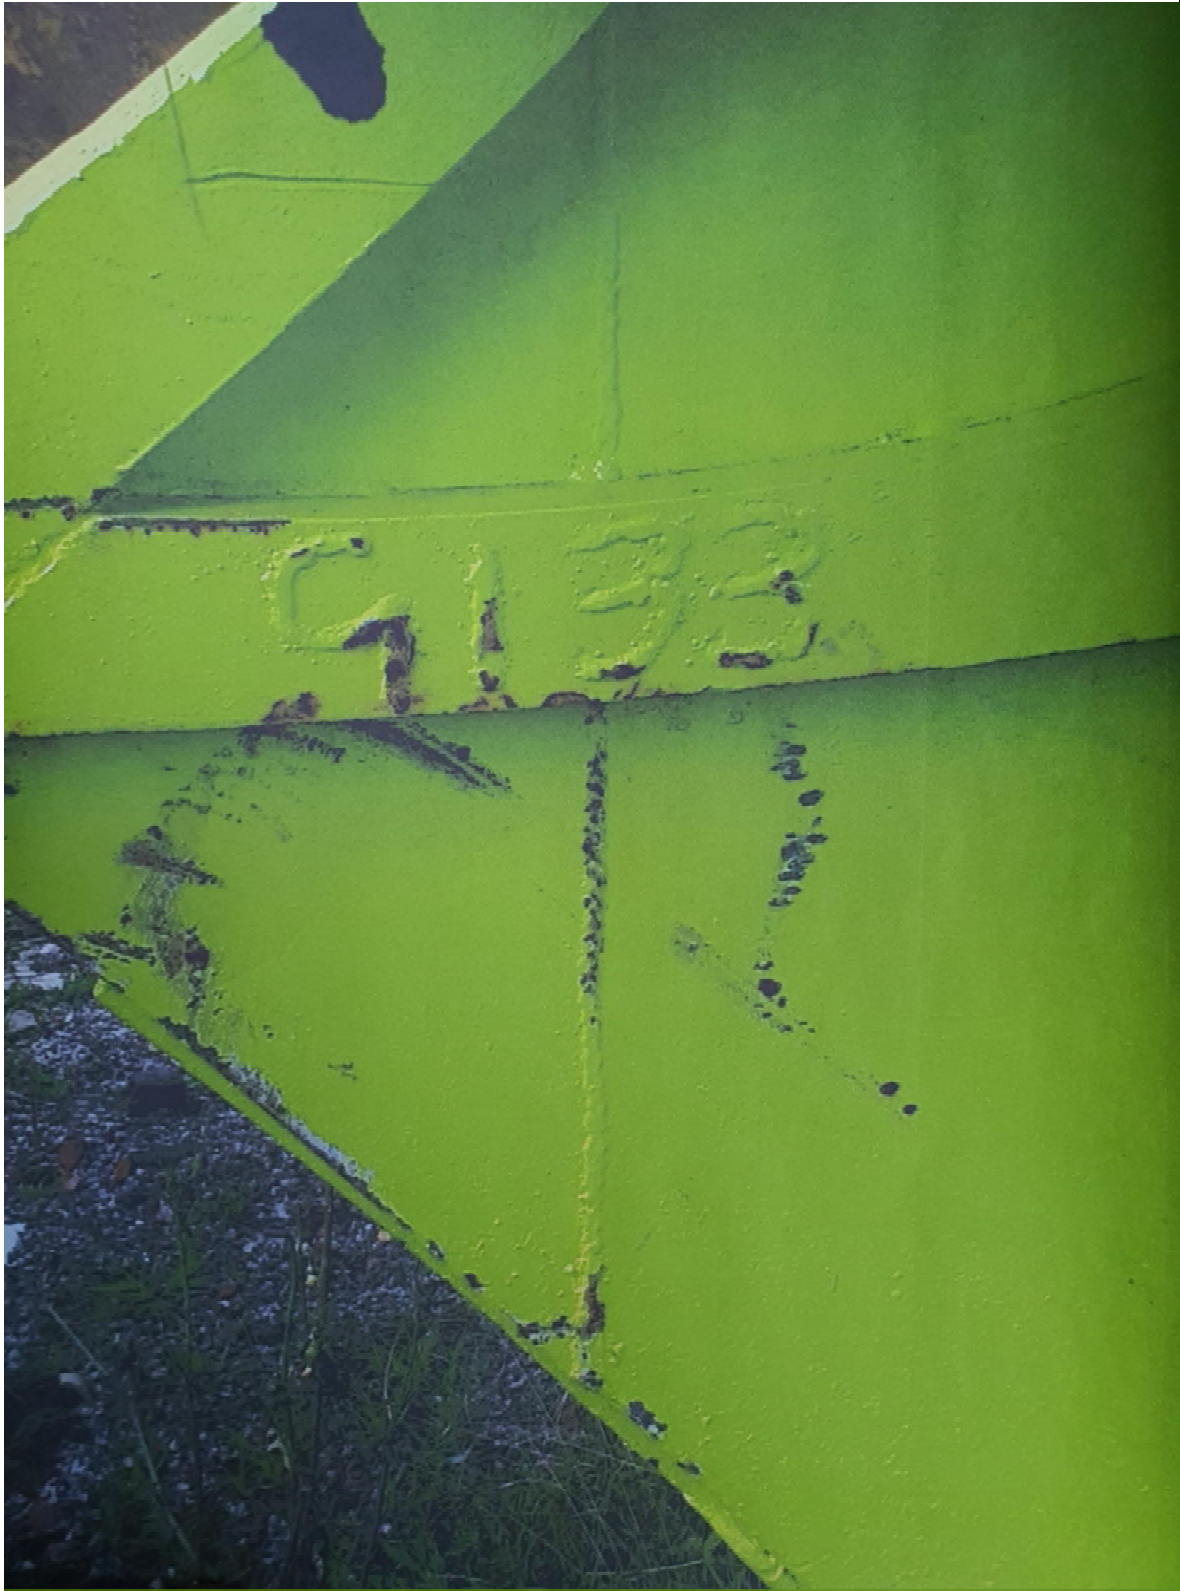
On-site waste skip serial number

Material identified within the phase 2 report as unsuitable to be retained within garden areas was excavated straight into an on-site waste management skip. This was then transported to a suitable waste management facility by a licensed haulage company at a later date. Ellgia were utilised for the skip and haulage with the waste being taken to FCC Winterton Landfill, Integrated Waste Management Winterton (DN15 9AP). This included one skip totalling 7 tonnes. Further soil from foundation excavations and general workings were loaded directly into lorries and transported to Drax Golf Course by Sandstop Quarries Ltd, this include two lorries totalling 39tonnes. Table 1 below summarises the removed waste removed with copies of the consignment notes included within appendix C.

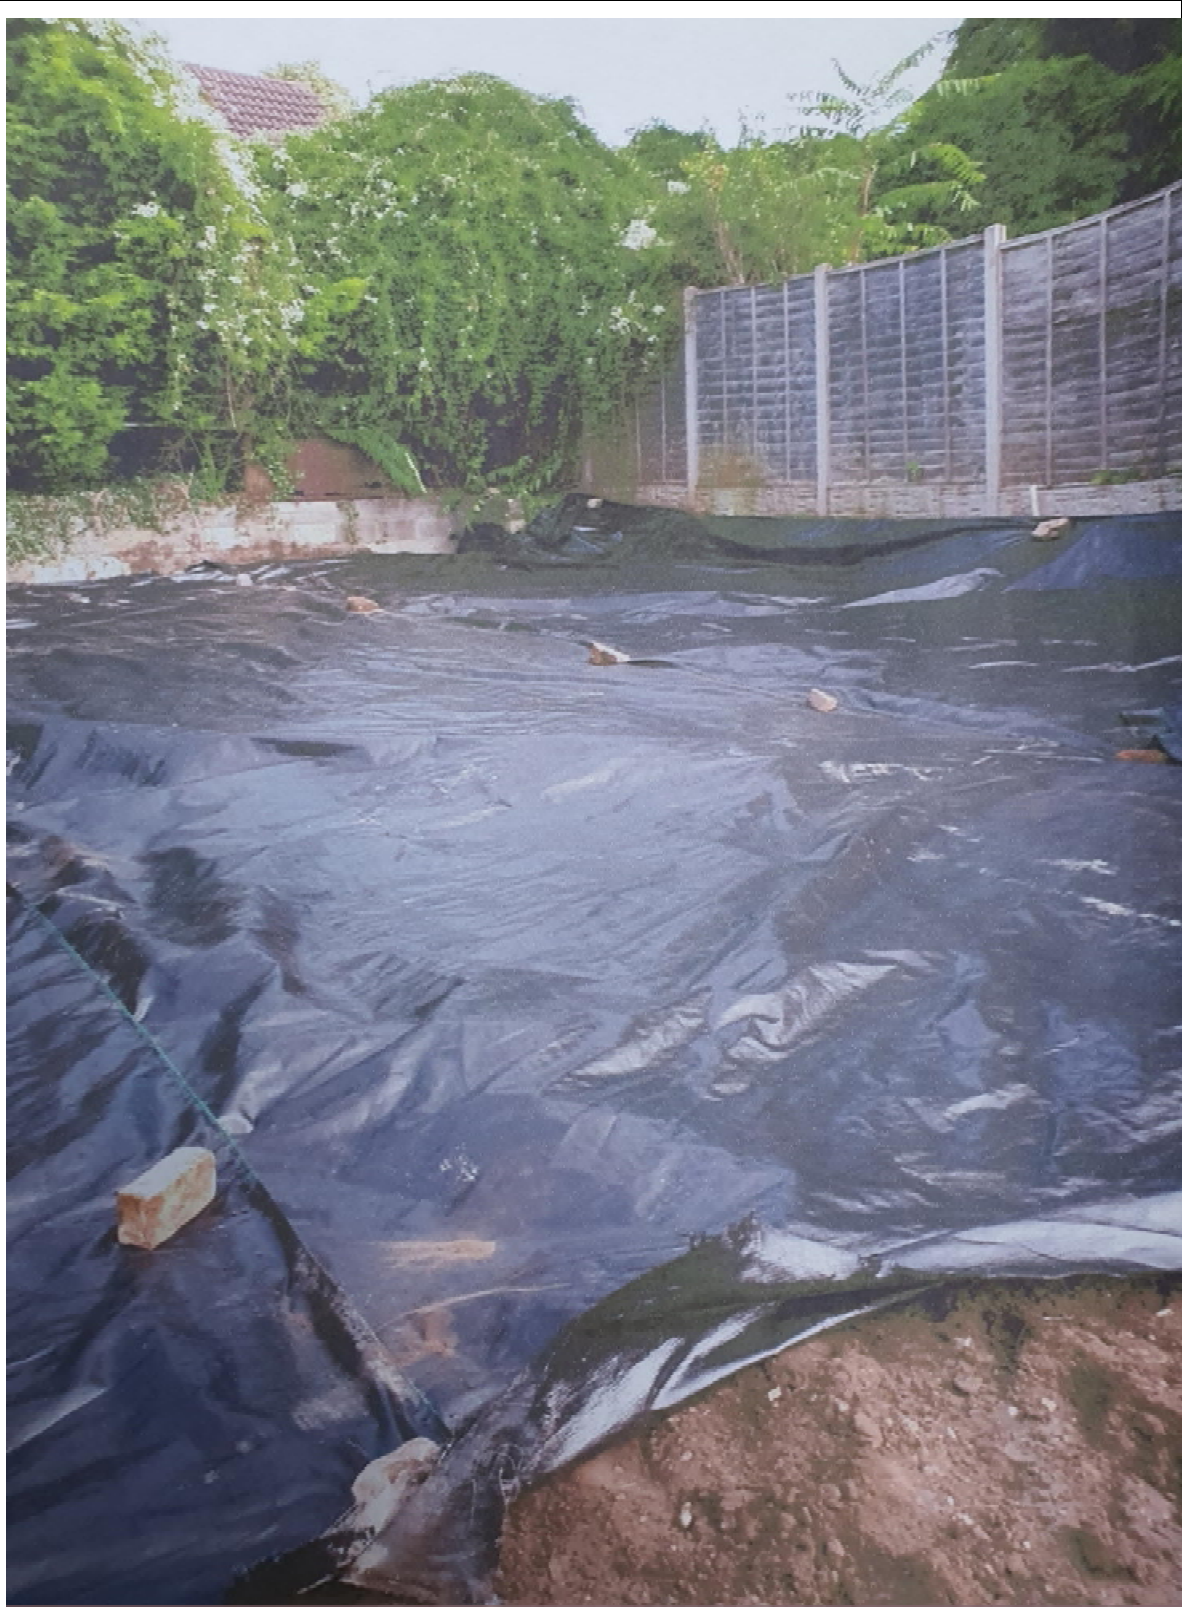
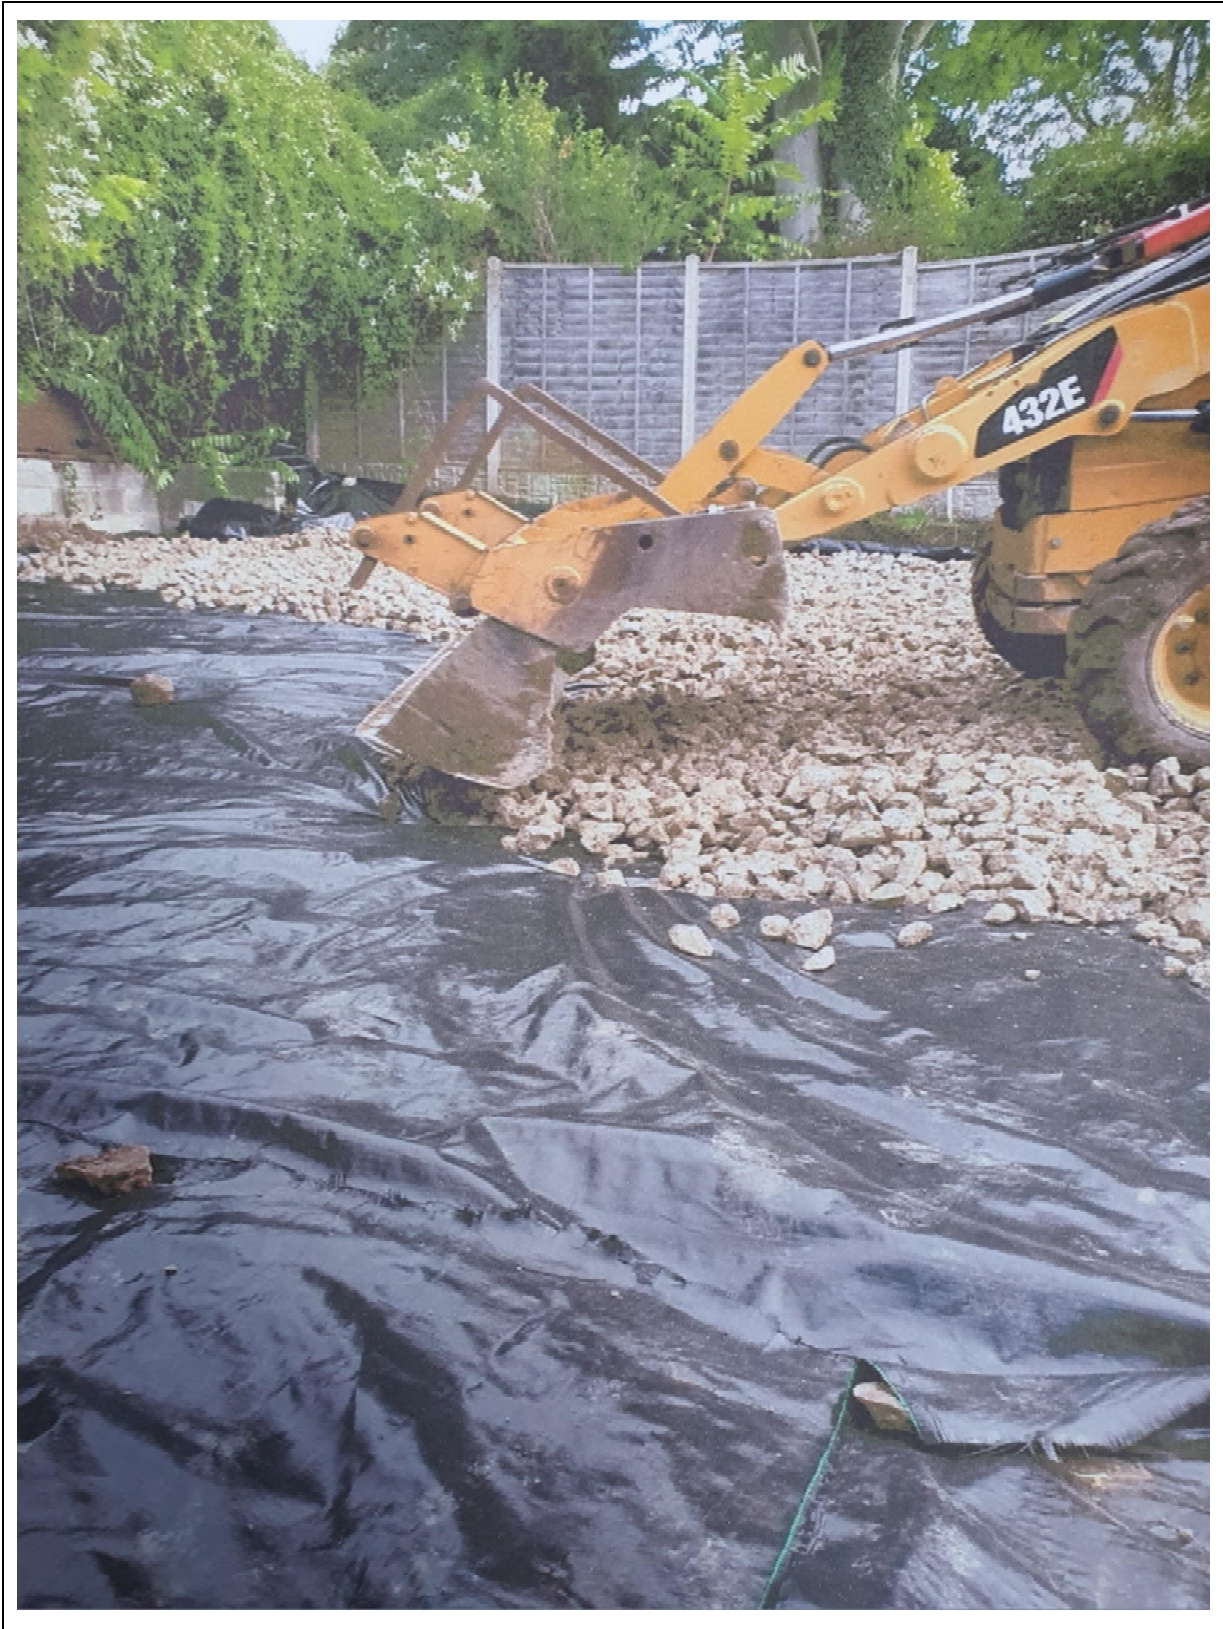
Placement of geotextile

A geotextile membrane was placed on the excavated areas within the gardens, photographic evidence of the membrane placement is included within section 4. The geotextile was sourced from Travis Perkins as a Wrekin woven geotextile Fastrack membrane, a delivery note is included within appendix C with Travis Perkins reference 09B82840.

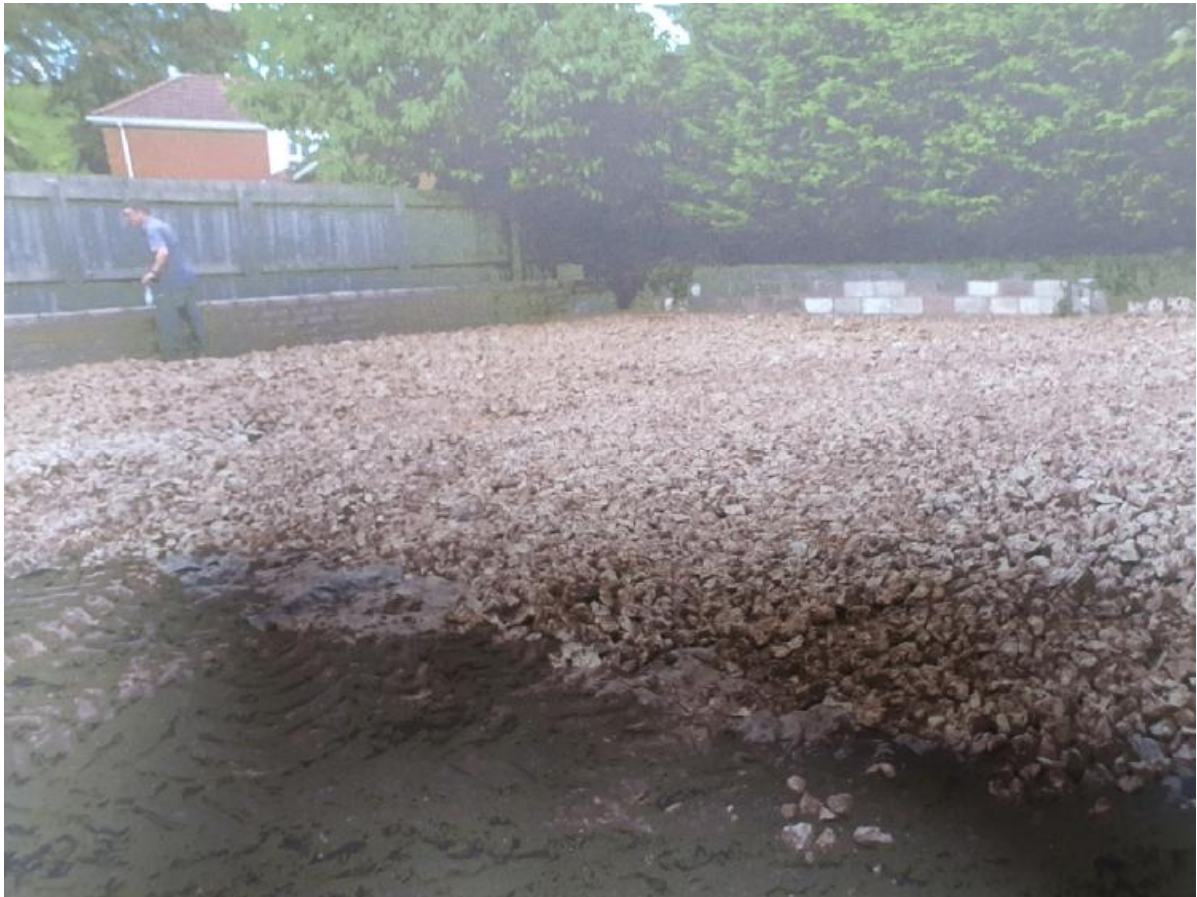
Placement of granular capillary break layer

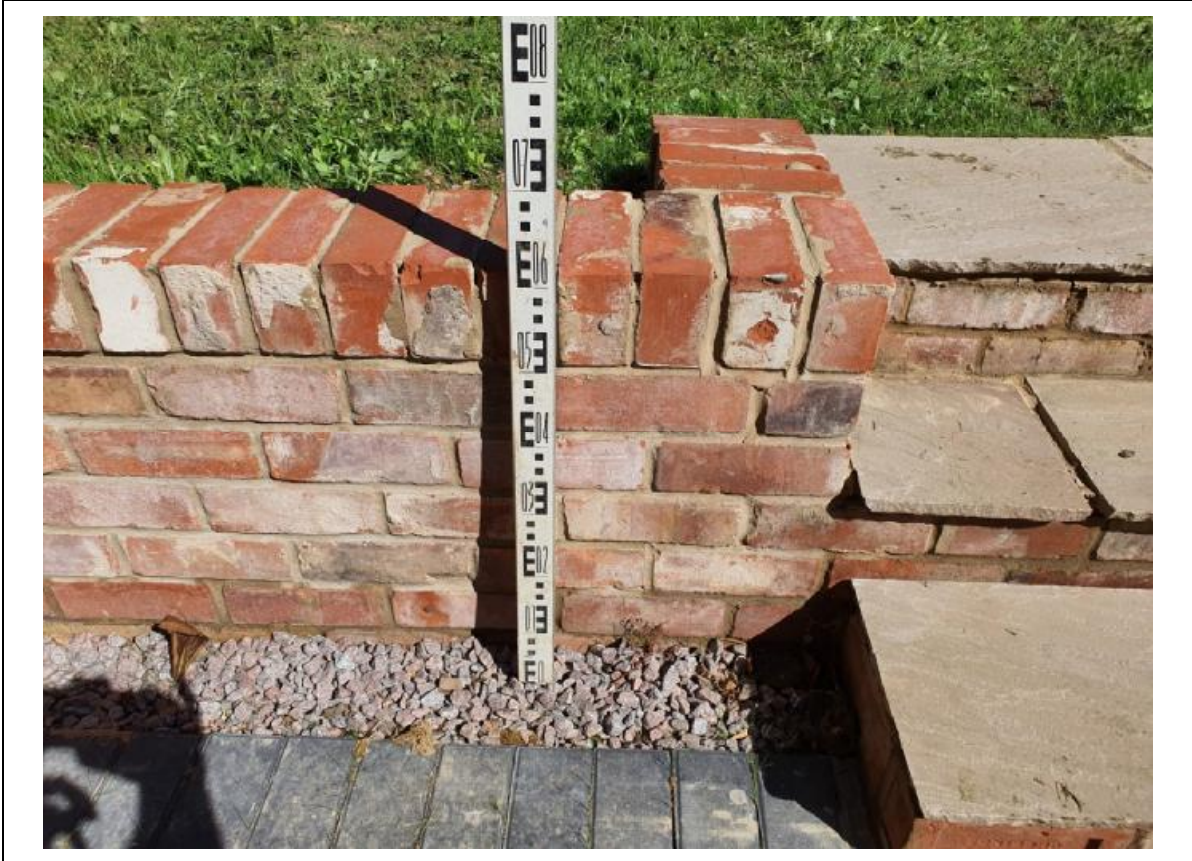
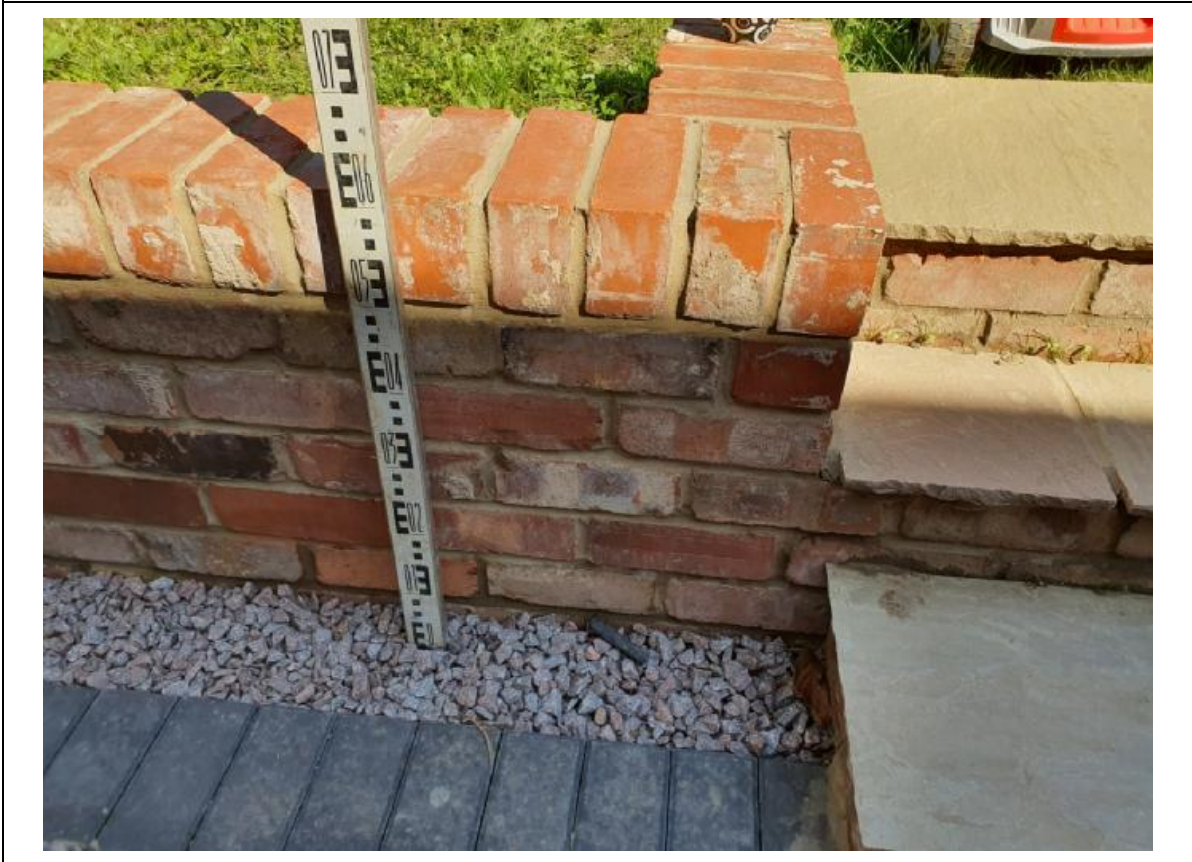
Construction of retaining wall

The rear gardens will consist of patio areas adjacent to the houses with soft landscaping to the rear. The patio areas will extend about 3.7m (i.e. 12ft) beyond the rear walls of the proposed dwellings. At this stage, it is understood that the finished floor levels in the soft landscaped area could be elevated by about 0.5m above average existing ground levels with the aid of traditional short retaining walls (i.e. dwarf walls).

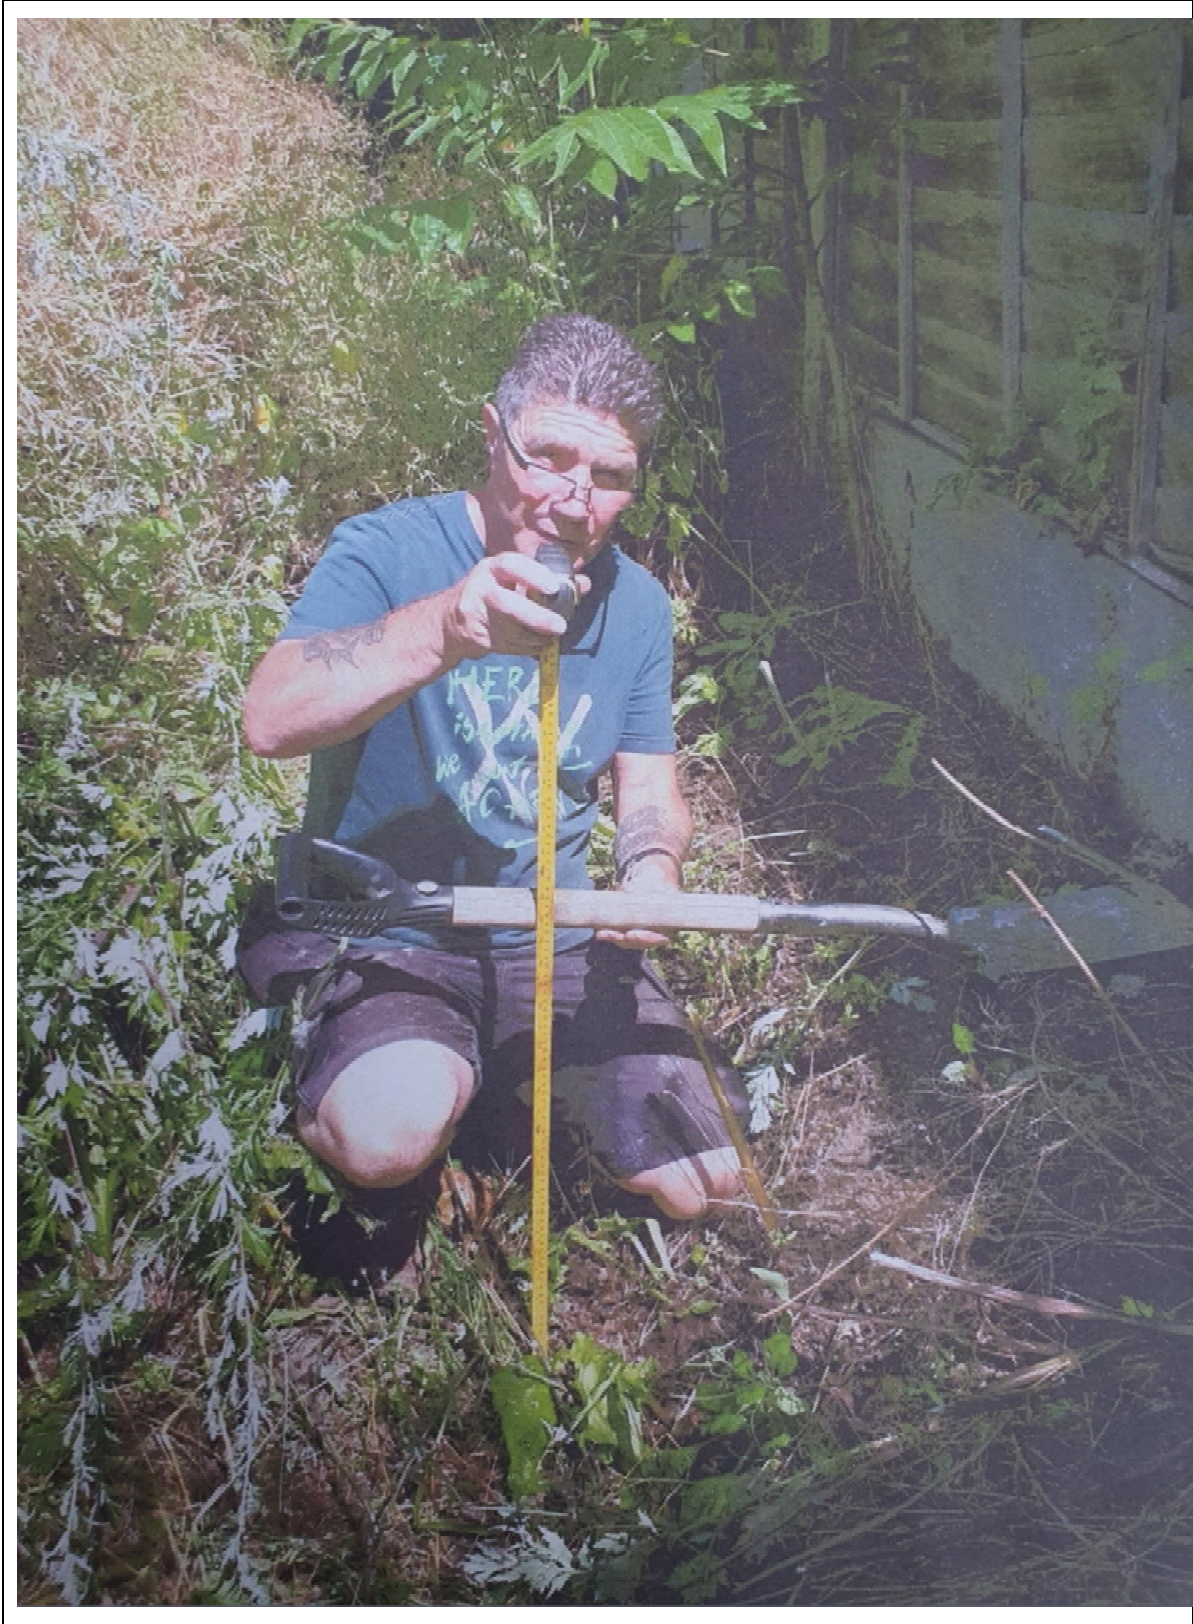
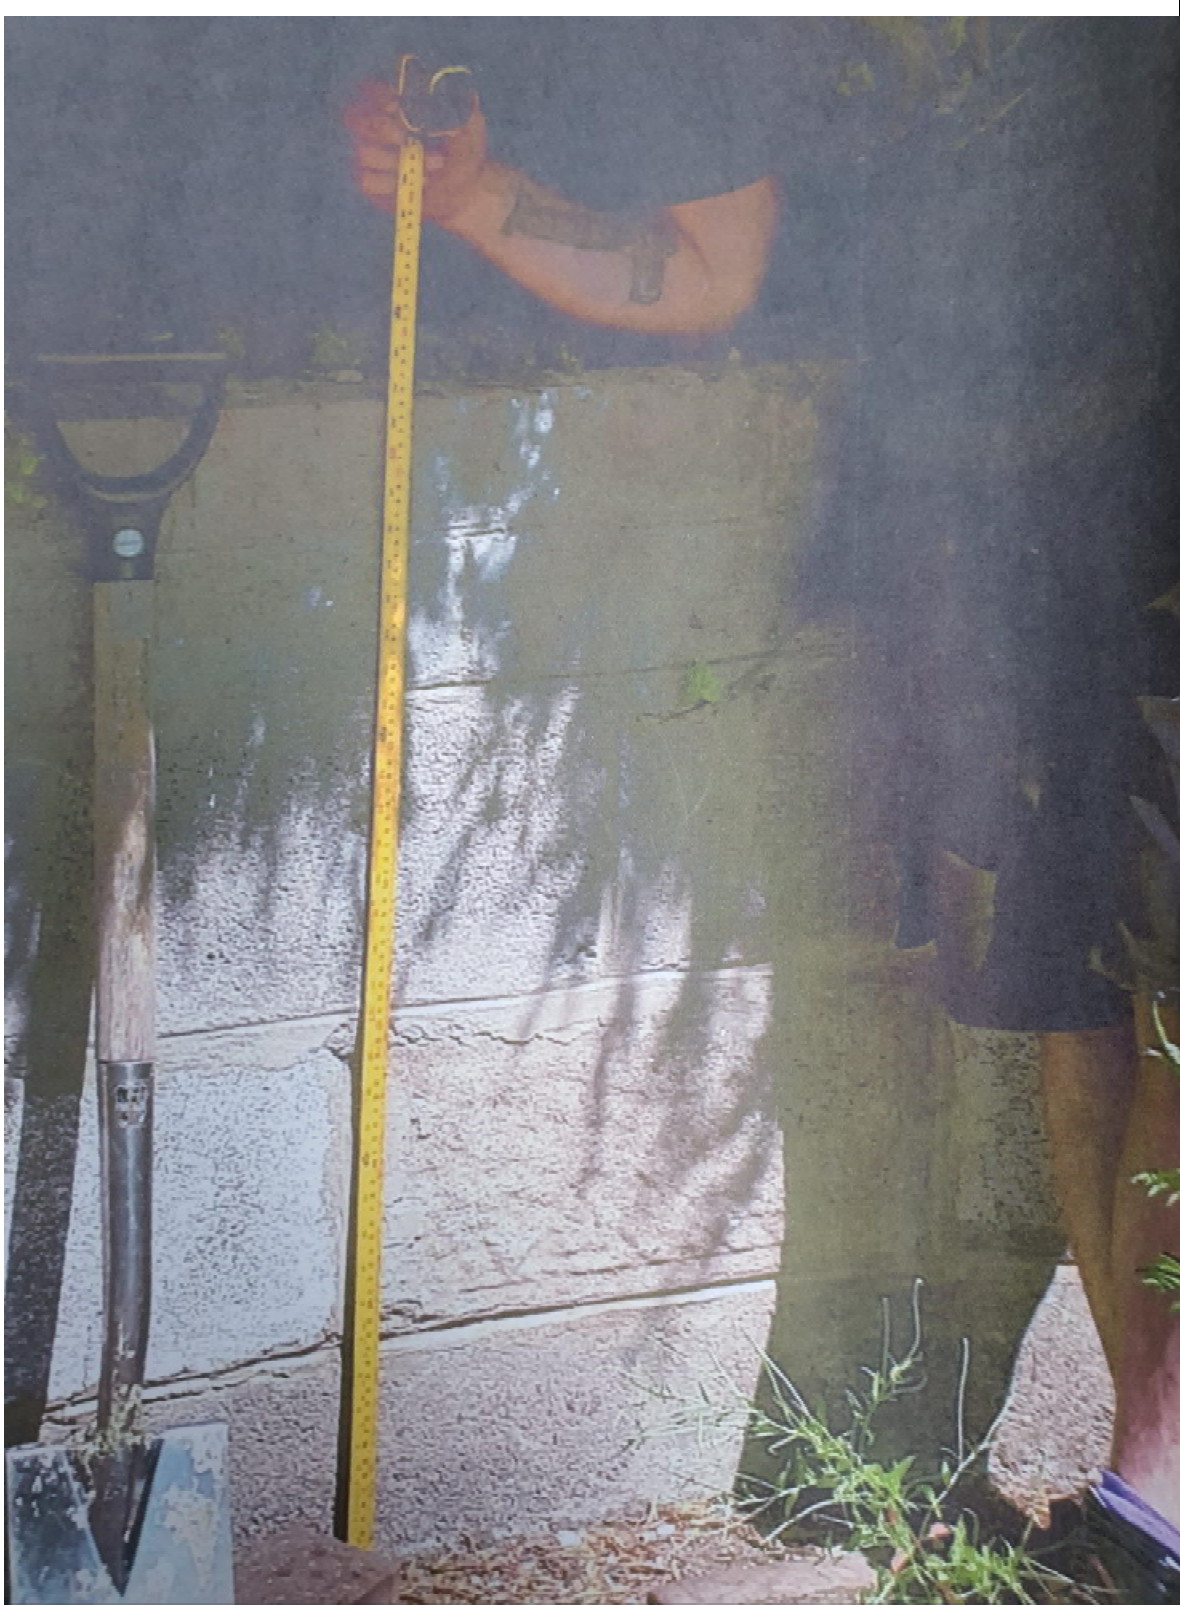
Evidence of level control

Photograph within section 4.2 show the capillary layer to appear level with no major undulations indicating good level control. Trial pits within both plots were hand excavated on completion of the rear gardens to prove depths achieved, these were undertaken after seeding with some grass growth visible. In total three trial pits were excavated; these were evenly spaced throughout the garden areas. Locations of the trial pits are marked on the site plan within appendix A. The topsoil was excavated and placed to one side for sampling, this exposed the chalk granular capillary layer. The depth of the granular capillary layer was proven by further excavation to the geotextile layer. Table 3 below shows the depths encounter followed by photographic evidence.

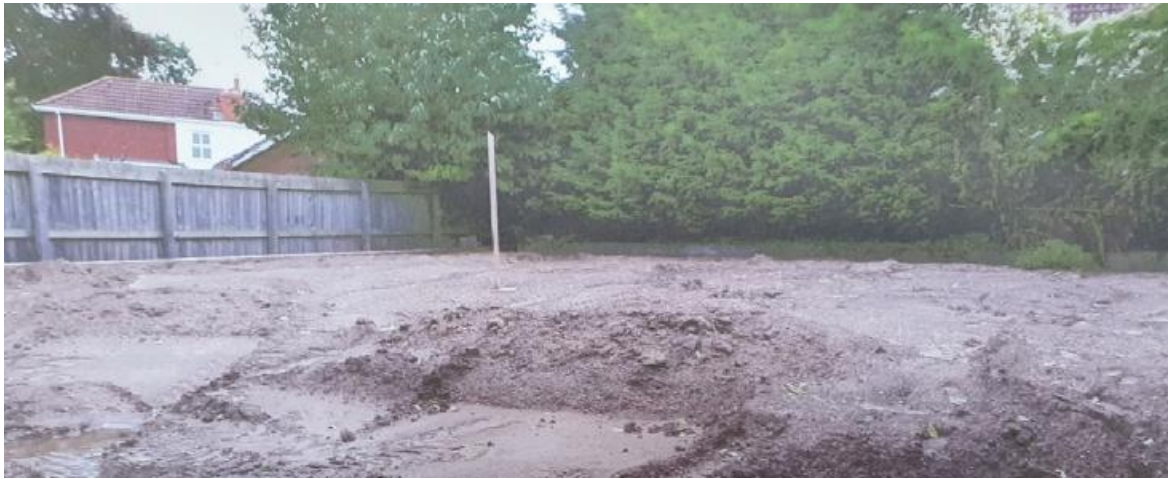
Placement of topsoil

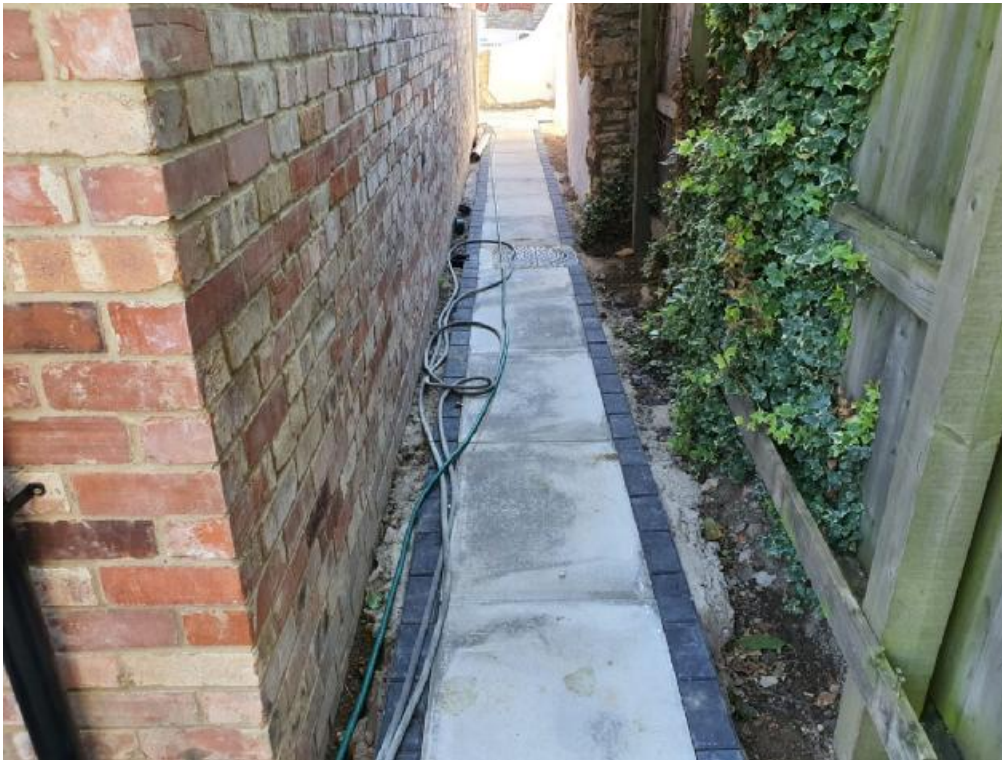
Plot 1 side walkway

Hardstanding to the rear gardens and side walkways included limestone and concrete cast slabs on 50mm down chalk granular fill supplied by Brianplant loaded from Singleton Birch, this included two deliveries on 23<sup>rd</sup> October 2019 totalling 37tonnes with conveyance note no's 11760 and 11761, a copy of the conveyance notes are included within appendix C.

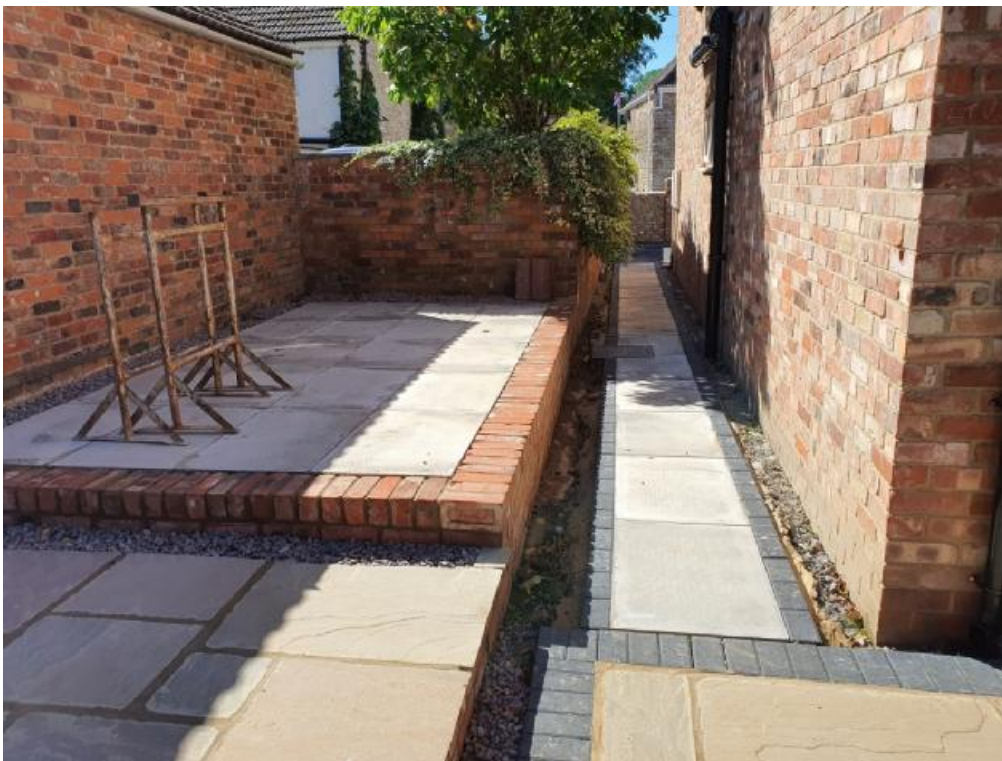
Plot 2 side garden area and walkway

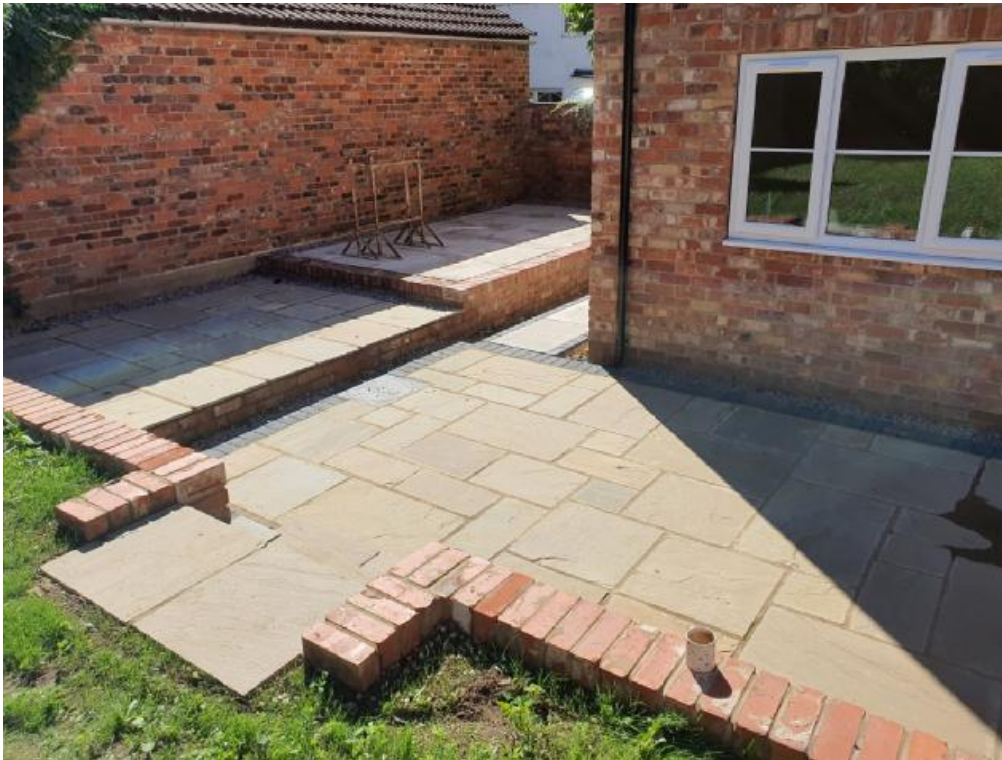
Plot 2 rear garden

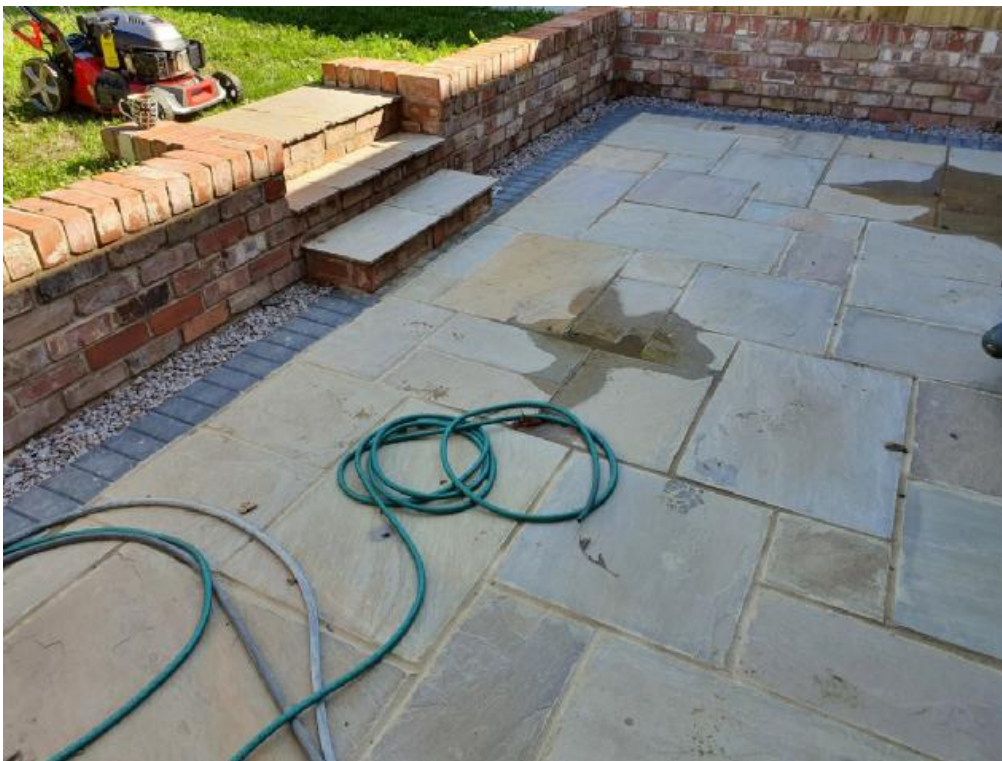
Plot 1 rear garden

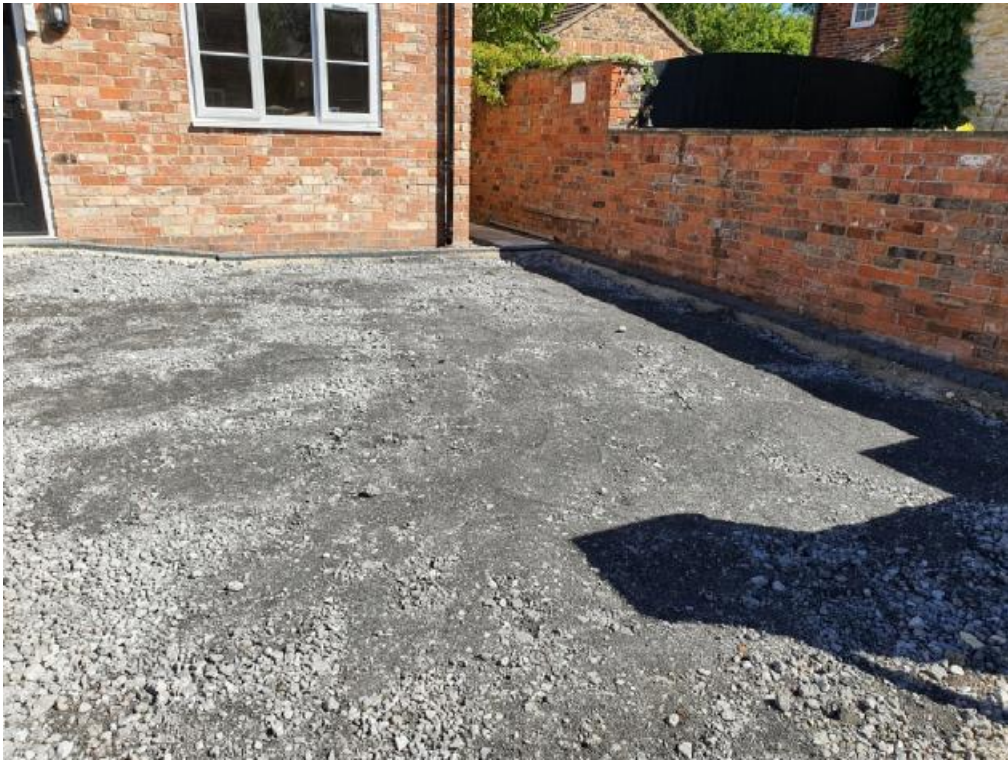
Plot 2 front parking area

Hardstanding to the front parking areas included 50mm down blast furnace slag granular fill supplied by Overhall Aggregates, test certificates for the material are provided within appendix C. Post the final validation visit the front parking area was surfaced with bituminous layers, this work was undertaken by Matte Black Surfacing Ltd, appendix C includes an invoice for the surfacing.

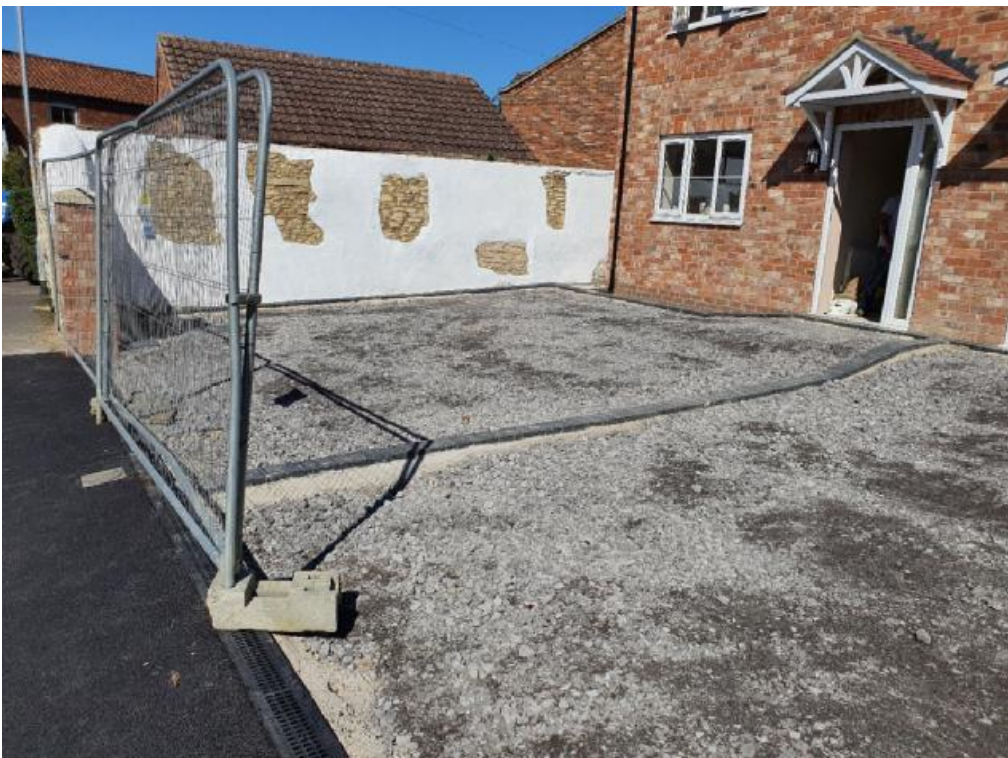
Plot 1 front parking area

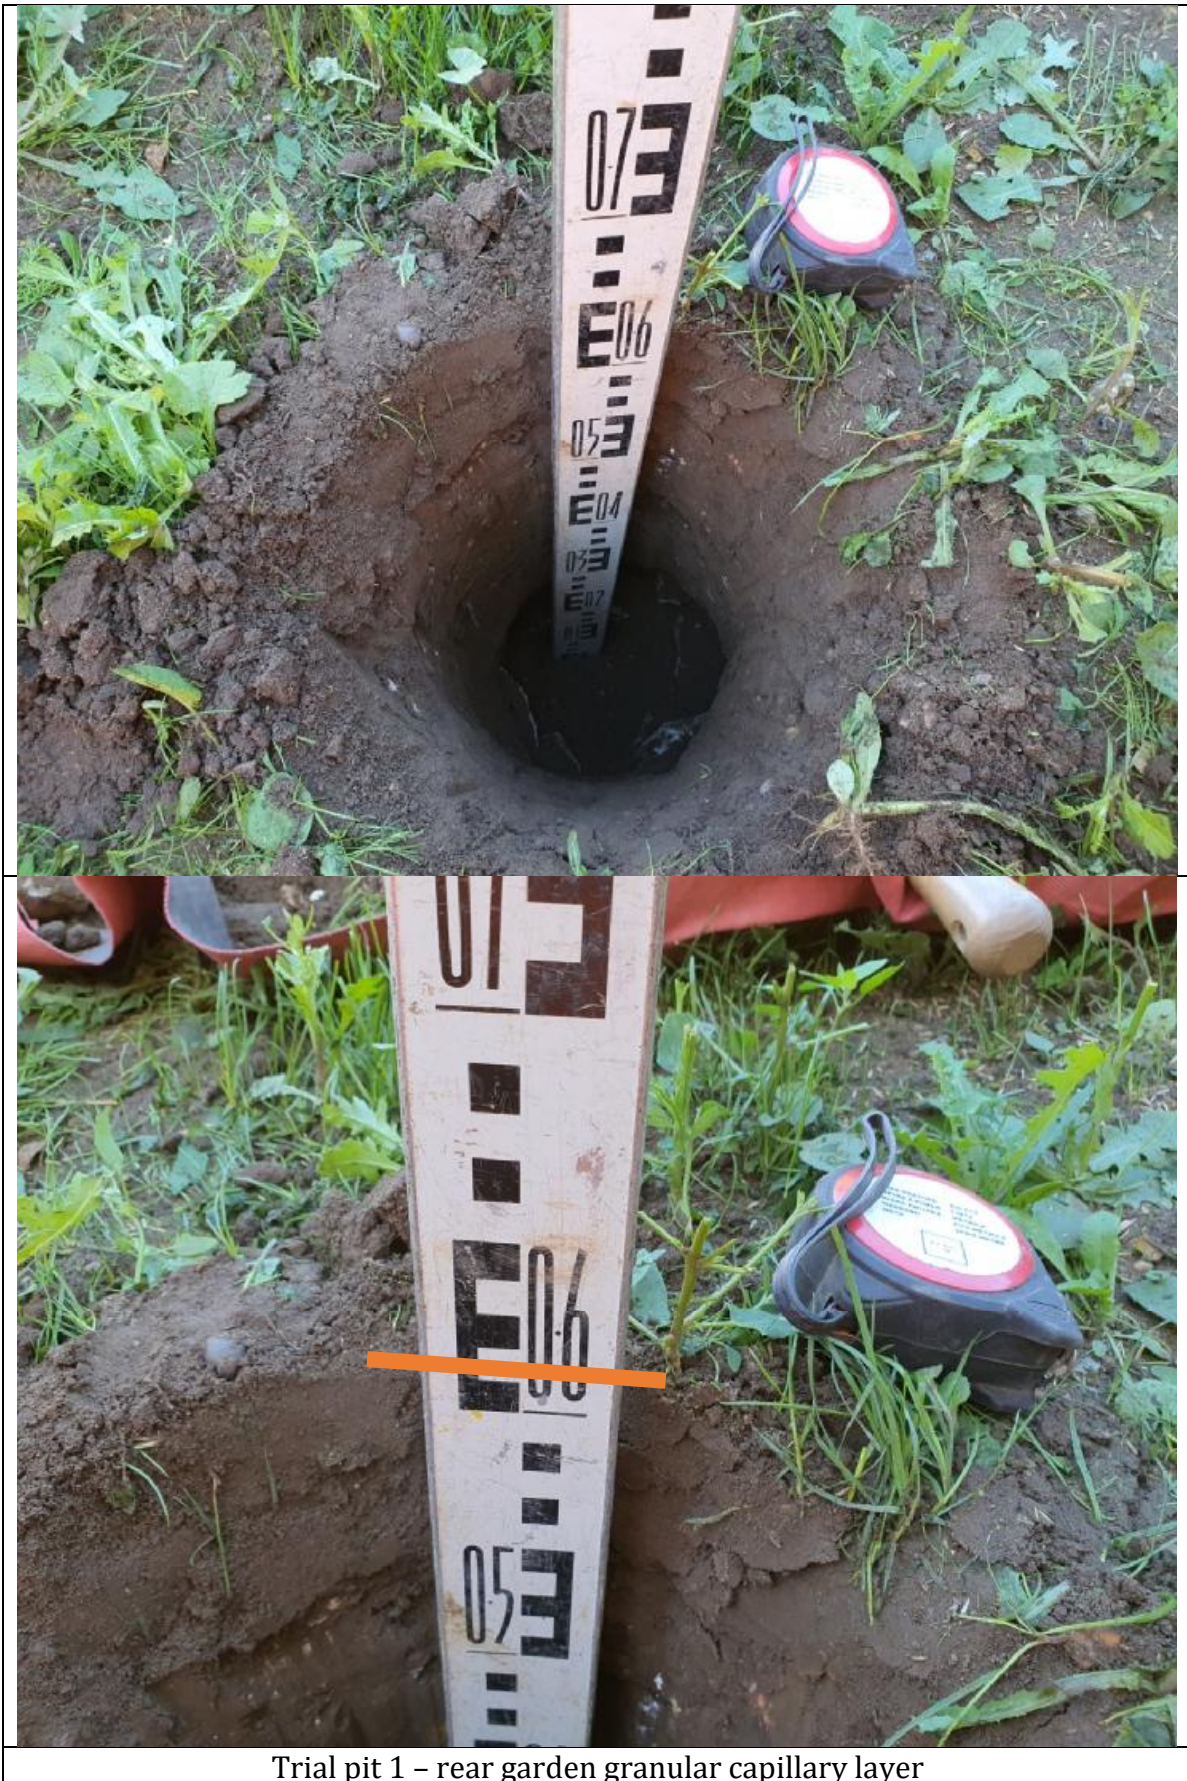
Table 3 – depth of rear garden capillary layer			
Trial pit	Topsoil depth (mm)	Depth to geotextile membrane (mm)	Capillary layer depth (mm)
1	490	611	121
2	435	614	179
3	480	605	125

Trial pit 1 - rear garden granular capillary layer

The trial pits show an average depth of 142mm for the rear gardens.
