**Validation report**

**9a Darwin Street, Kirton in Lindsey**

<b>Title:</b>	Phase 4: Validation report 9a Darwin Street, Kirton in Lindsey
<b>Client:</b>	C&K Builders (Mr Ken McCabe)
<b>Date:</b>	September 2020
<b>Report number:</b>	1166/4758/P/P4

# **Phase 4 (Validation) report**

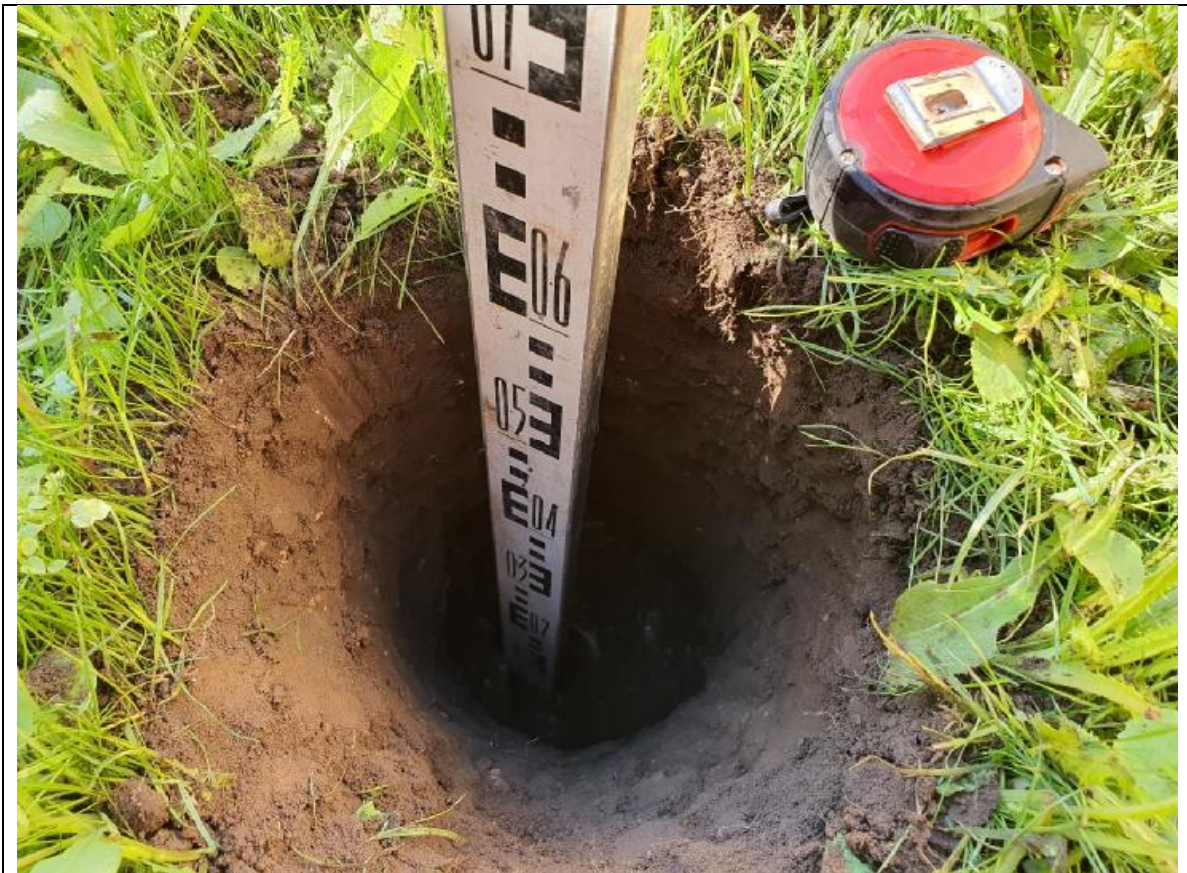
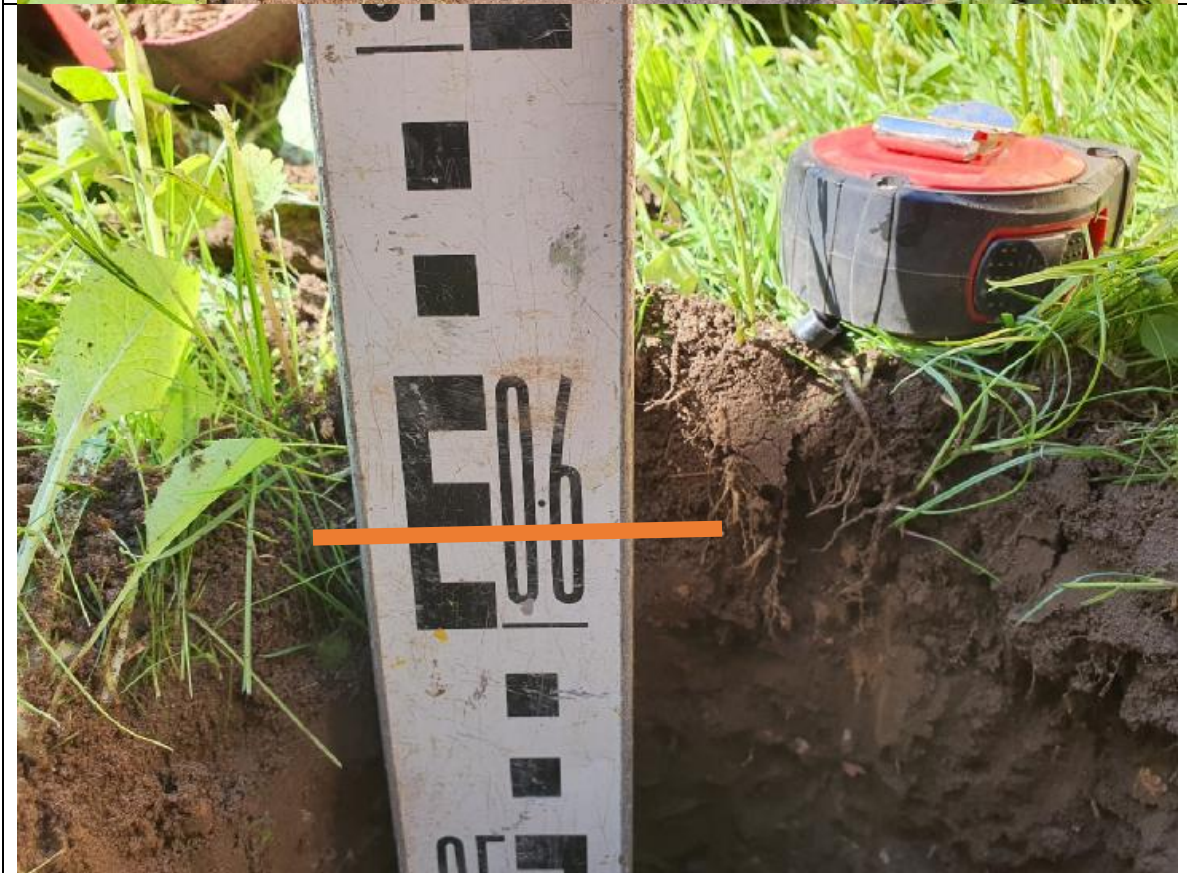
Table 3 – depth of rear garden capillary layer			
Trial pit	Topsoil depth (mm)	Depth to geotextile membrane (mm)	Capillary layer depth (mm)
1	490	611	121
2	435	614	179
3	480	605	125

Trial pit 2 - rear garden granular capillary layer

The trial pits show an average depth of 142mm for the rear gardens.

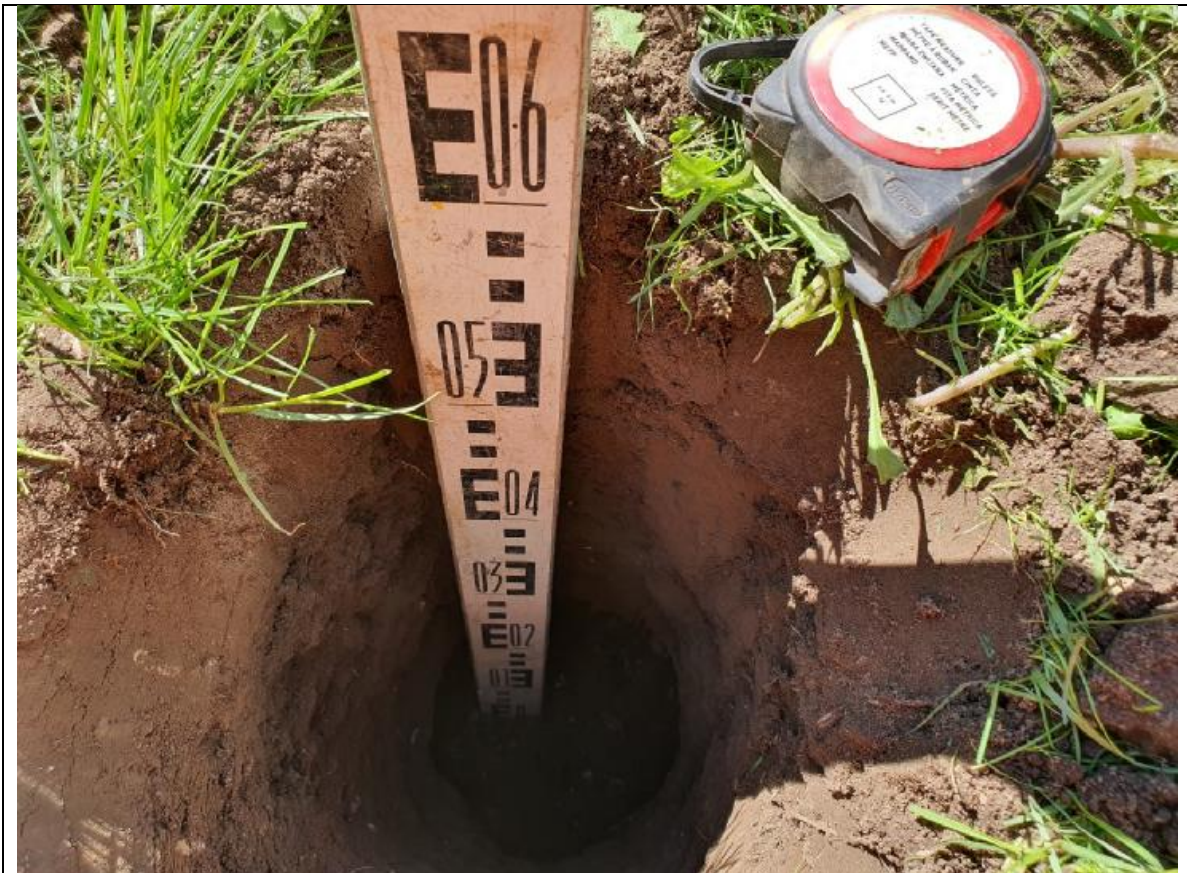
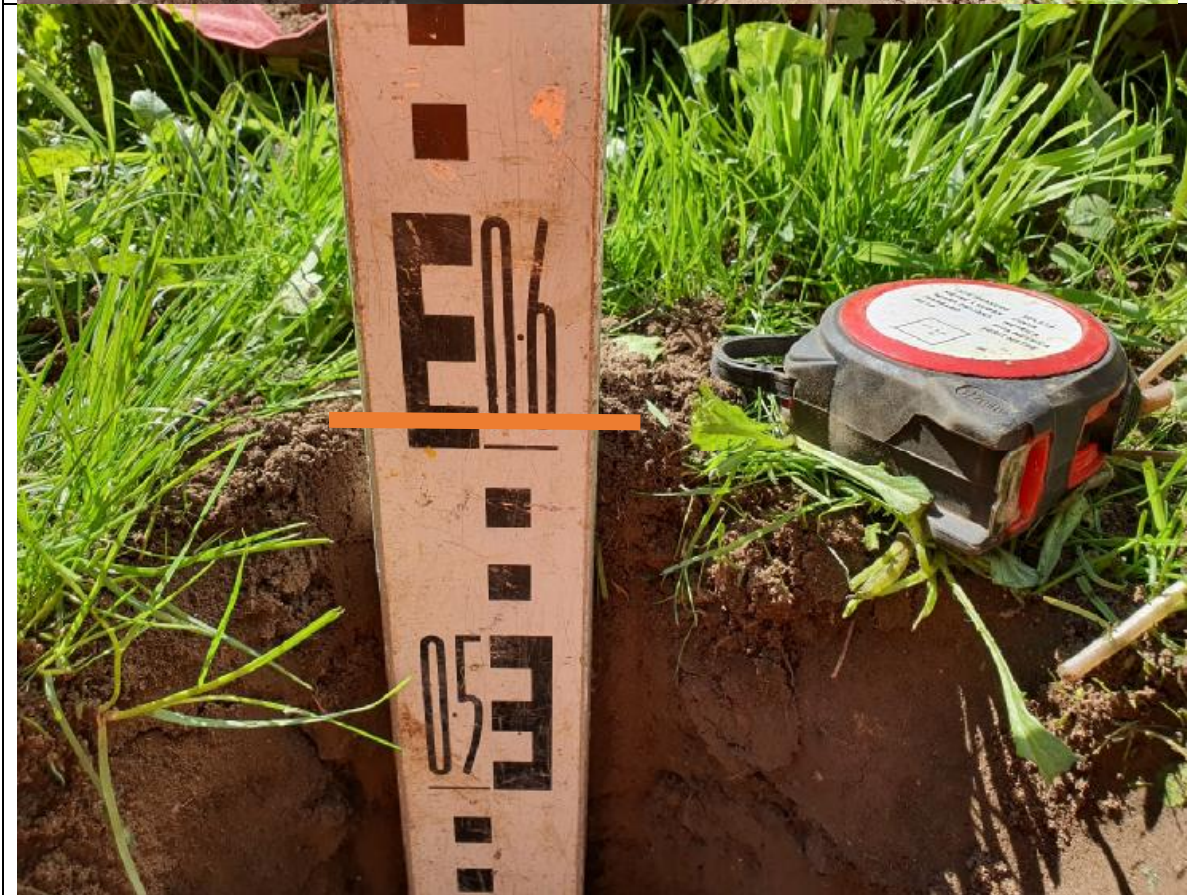
Trial pit 3 – rear garden granular capillary layer

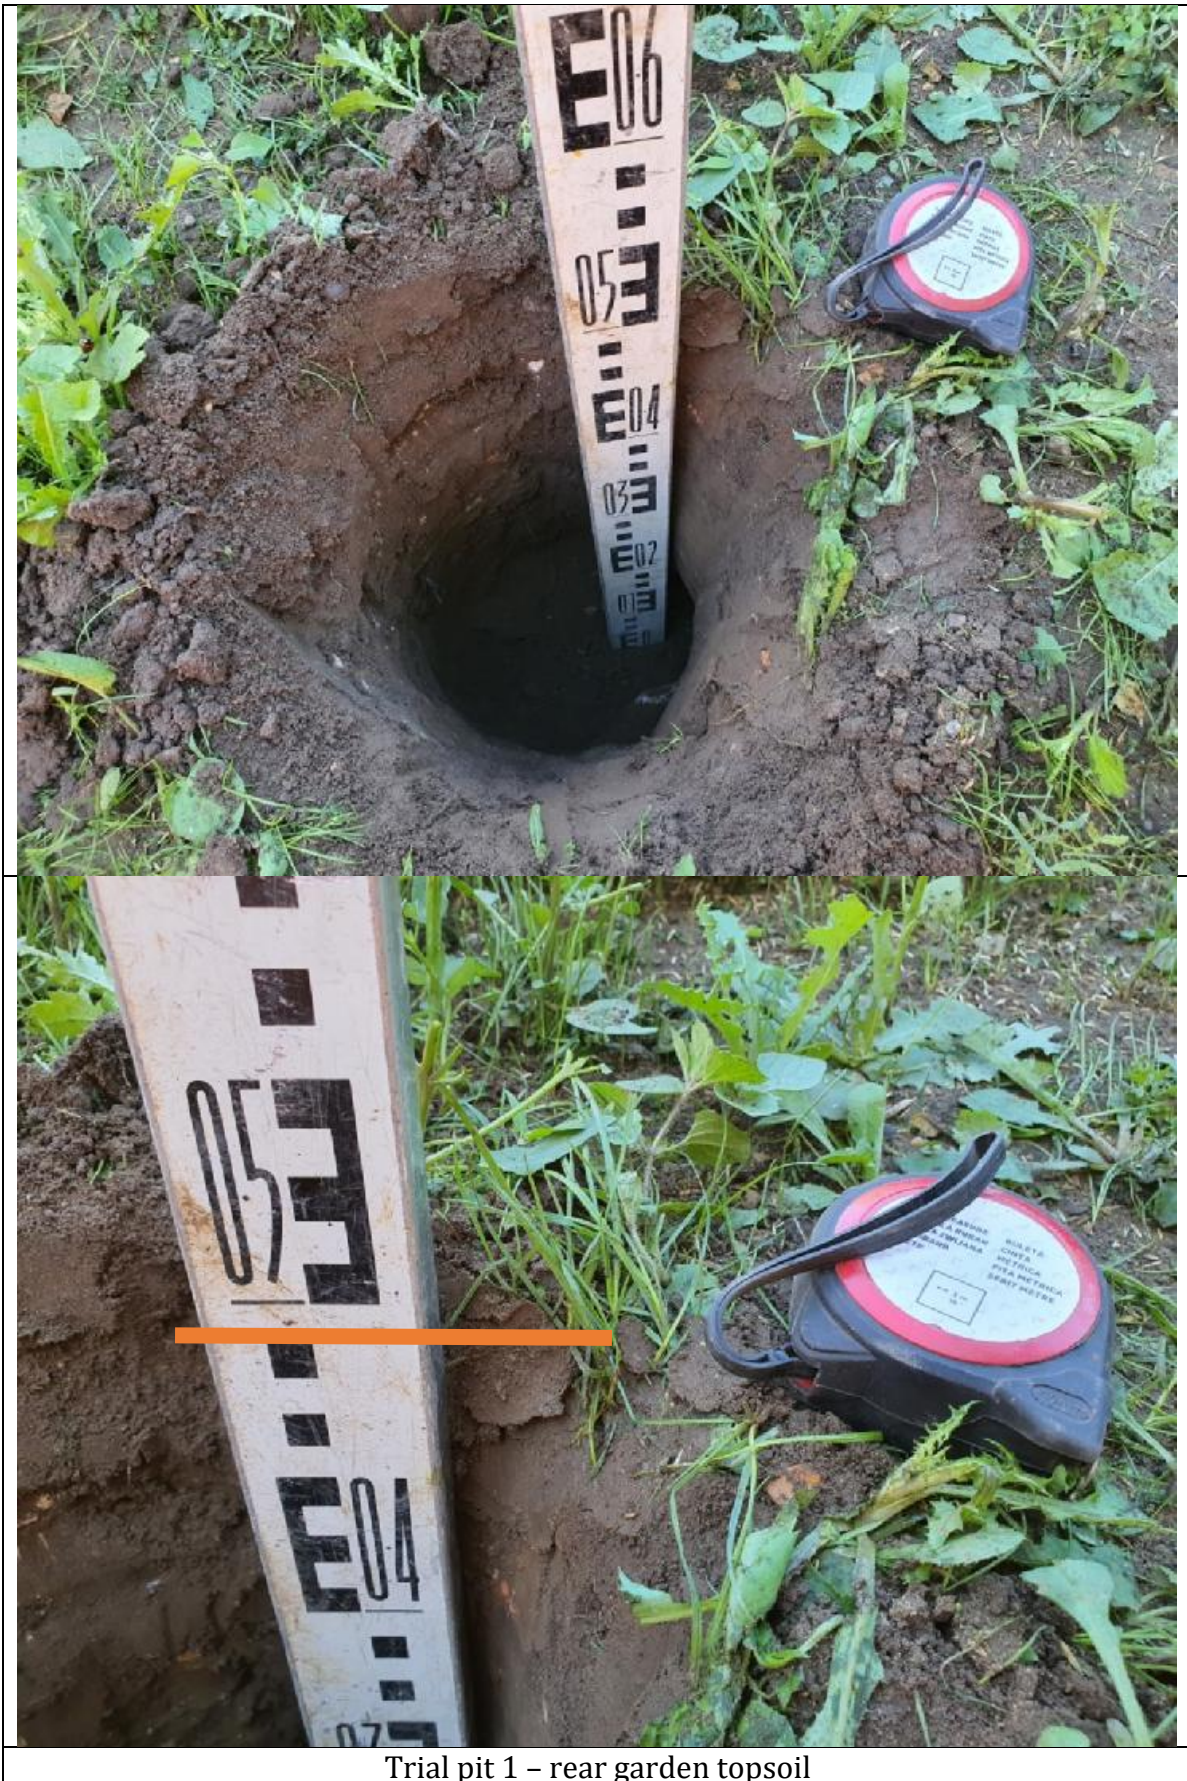
Trial pit	Topsoil depth (mm)	Depth to geotextile membrane (mm)	Capillary layer depth (mm)
1	490	611	121
2	435	614	179
3	480	605	125

Trial pit 1 – rear garden topsoil

The trial pits show an average depth of 468mm for the rear gardens.

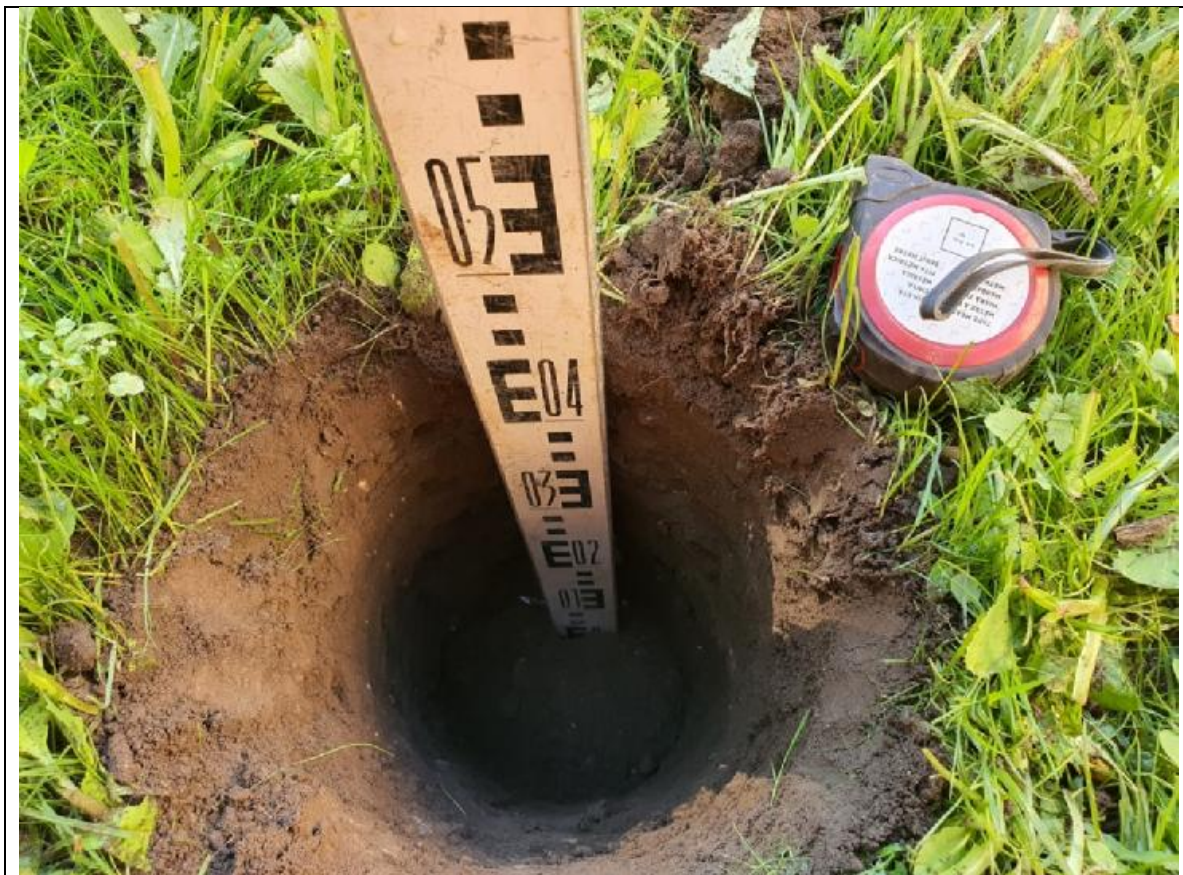
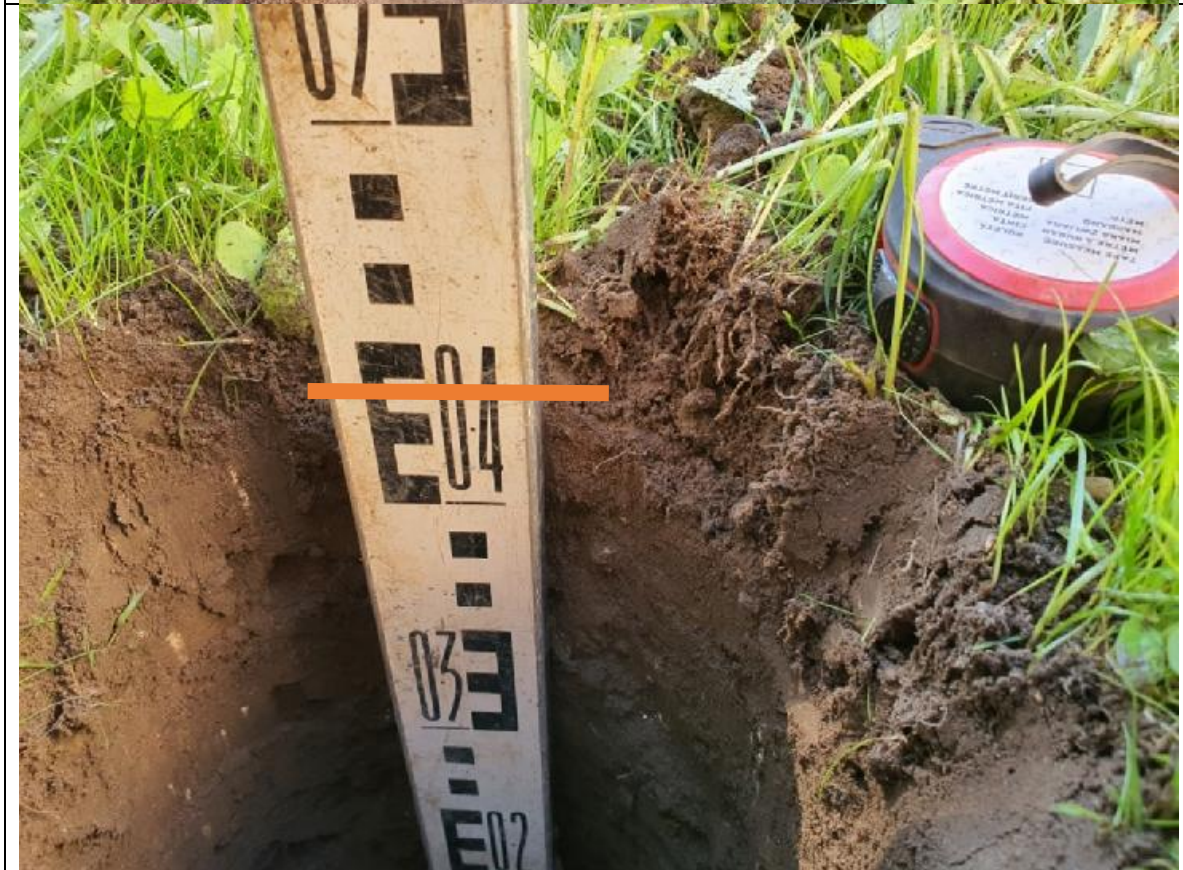
Trial pit 2 - rear garden topsoil

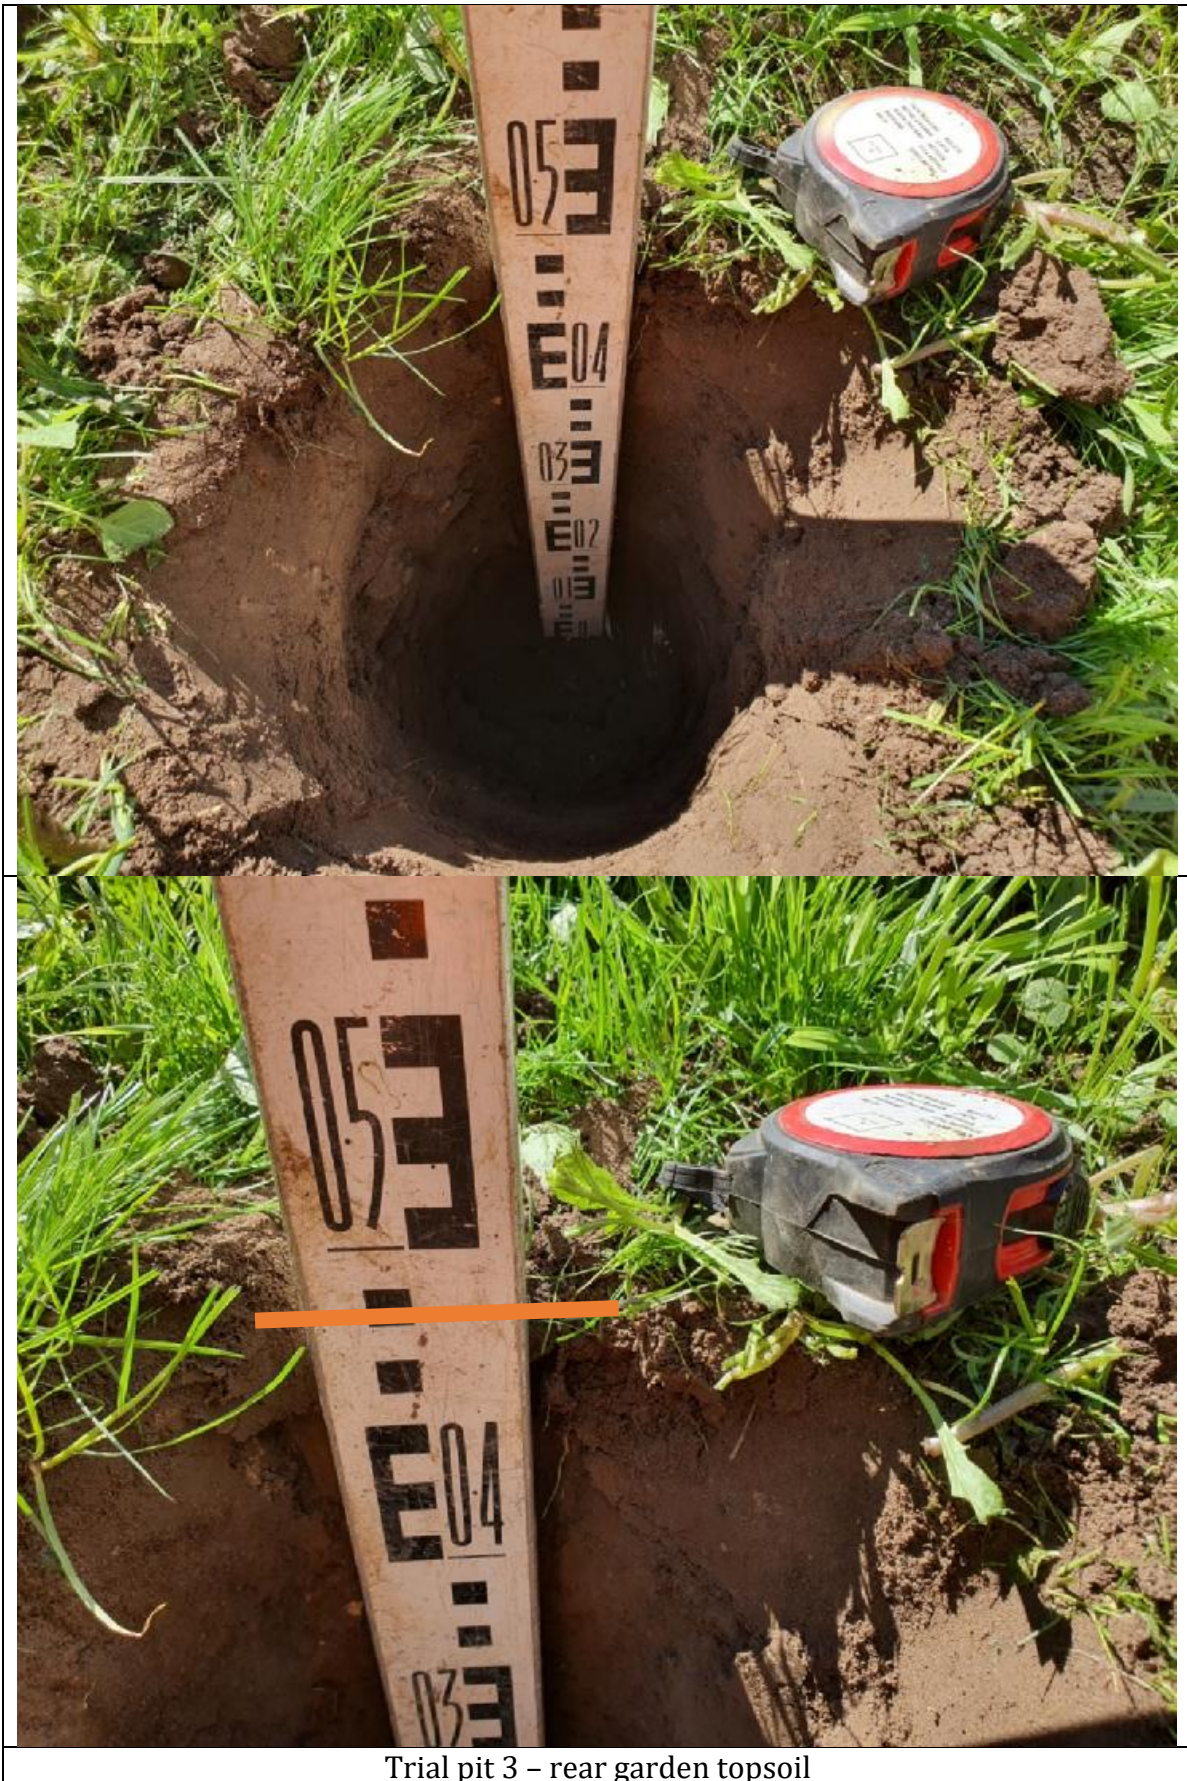
Trial pit 3 – rear garden topsoil

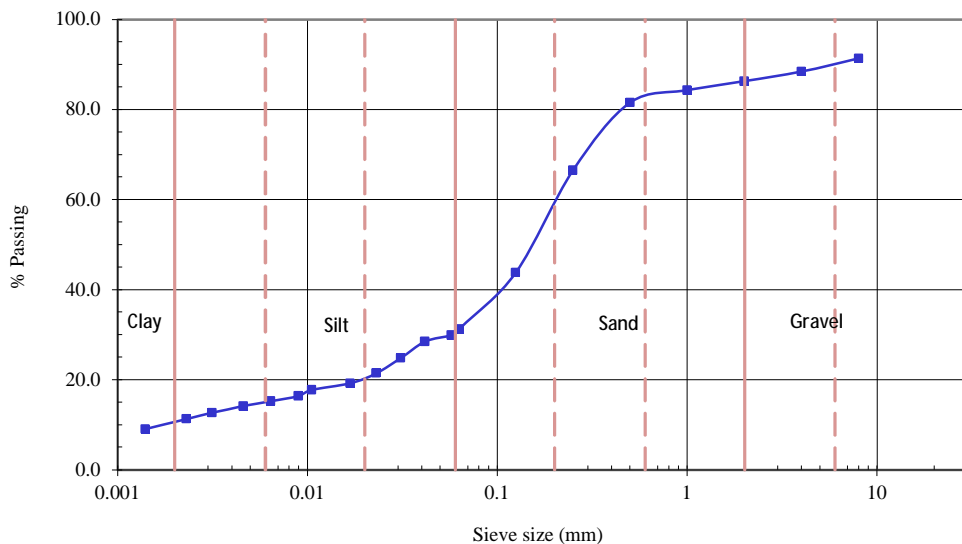
### Determination of Particle size distribution - Sedimentation method

%
Clay	11
Silt	20
Sand	55
Gravel	14

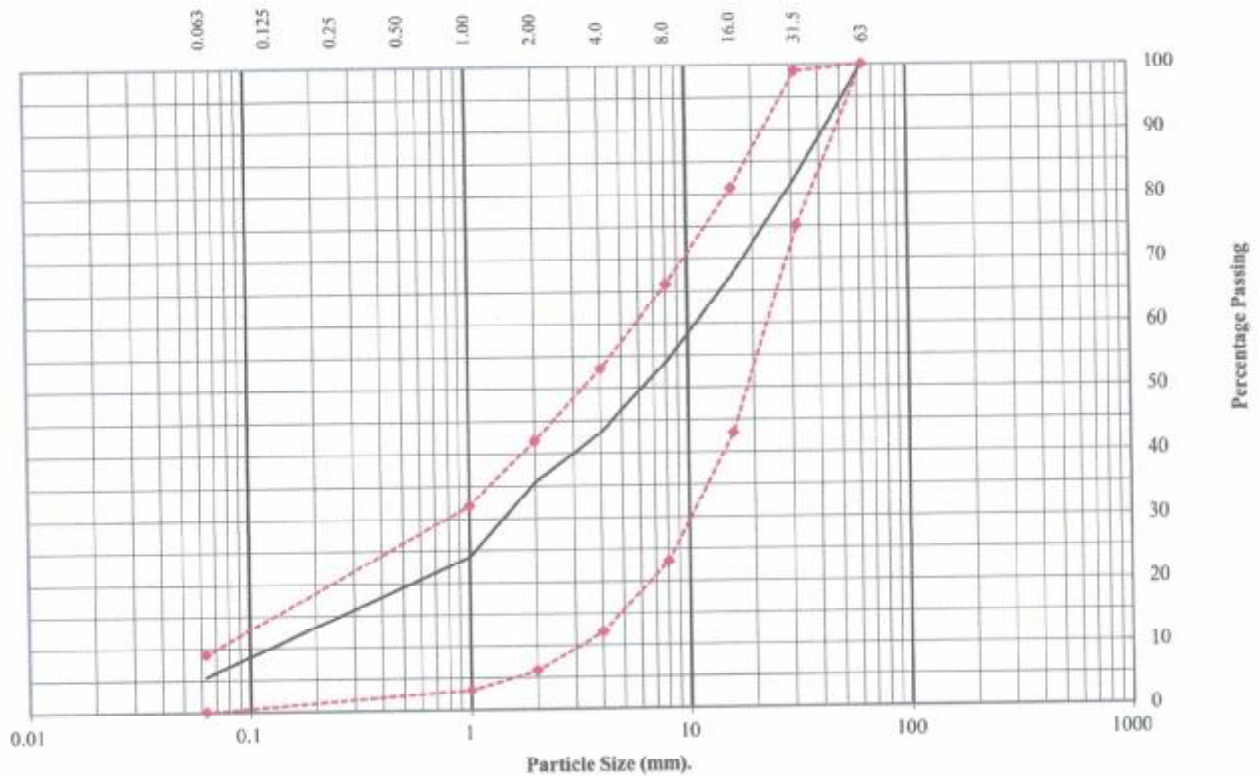
BS Test Sieve mm	Percentage Passing %	Vol.1 Spec. for Highways Works Table 8/5 Requirement for Type 1 Subbase	
		Lower	Upper
63	100	100	100
31.5	83	75	99
16	67	43	81
8	54	23	66
4	43	12	53
2	36	6	42
1	24	3	32
0.5	16		
0.25	10		
0.125	7		
0.063	5	0	9

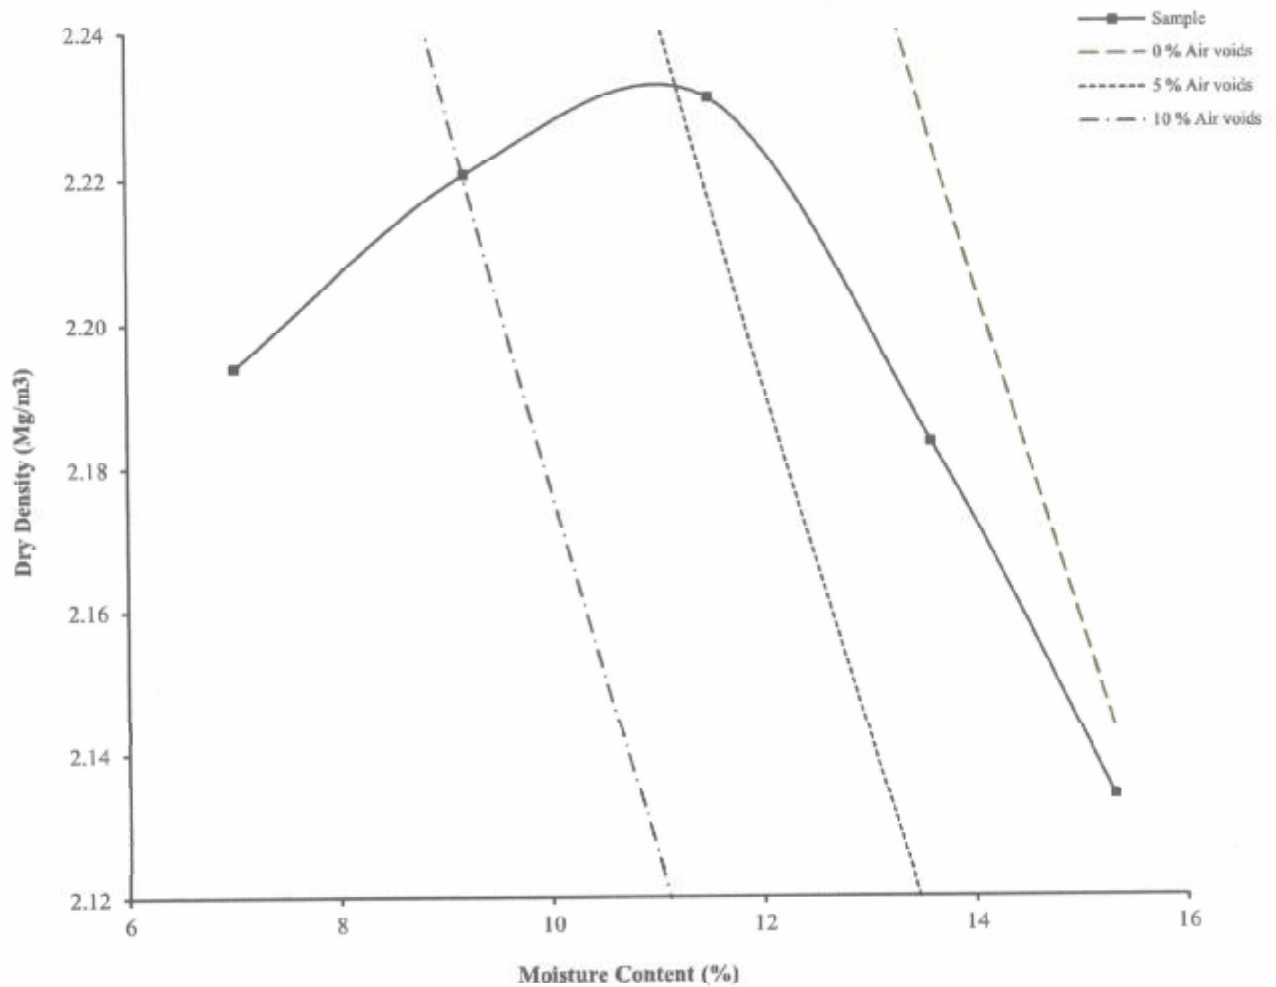
# DRY DENSITY / MOISTURE CONTENT RELATIONSHIP

Initial Moisture Content:	7.0	Method of Compaction:	Vibro	Separate Samples
Particle Density (Mg/m <sup>3</sup> ):	3.19	Measured	Material Retained on 37.5 mm Test Sieve (%):	5
Maximum Dry Density (Mg/m <sup>3</sup> ):	2.23	Material Retained on 20.0 mm Test Sieve (%):	30	
Optimum Moisture Content (%):	12			
Remarks See summary of soil descriptions.

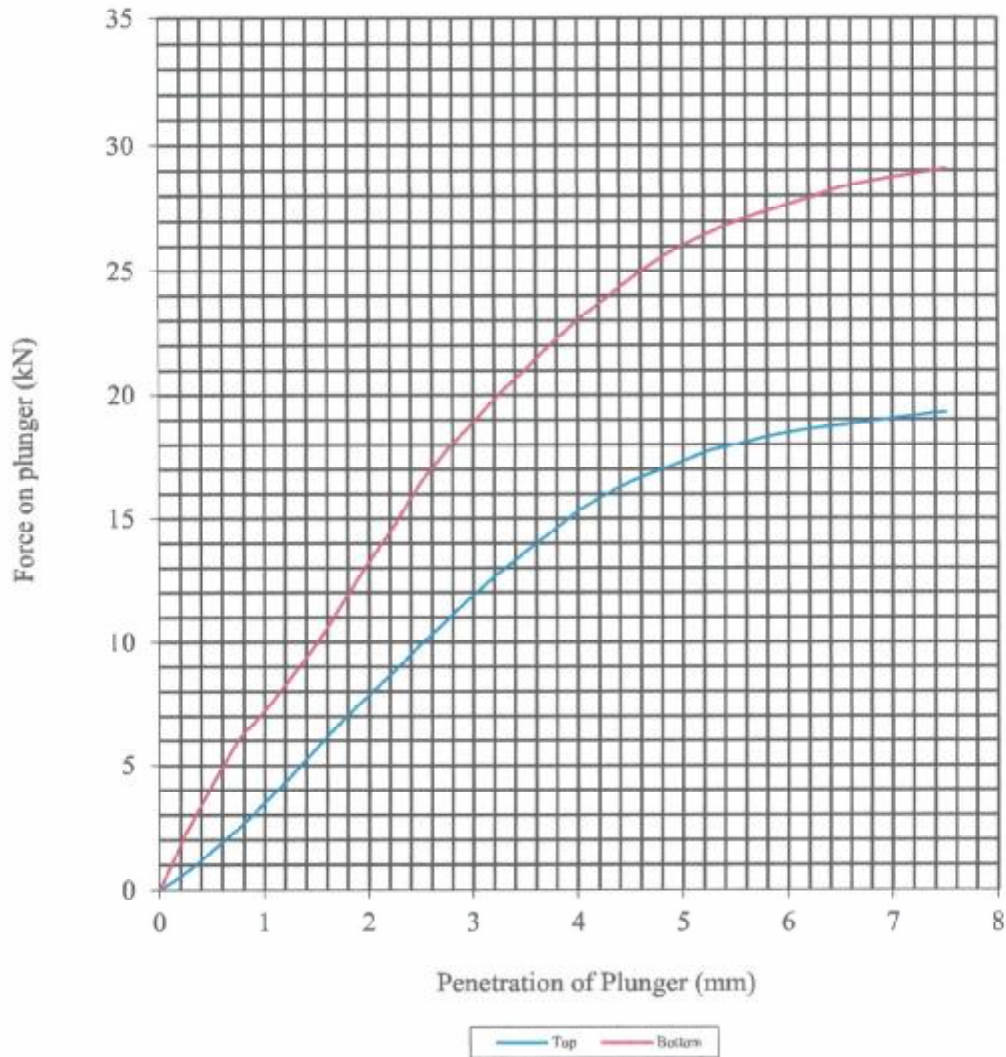
Initial Sample Conditions		Sample Preparation		Final Moisture Content %		C.B.R. Value %	
Moisture Content:	7.0	Surcharge Kg:	4.20	Sample Top	7.0	Sample Top	86.7
Bulk Density Mg/m <sup>3</sup> :	2.35	Soaking Time hrs	0	Sample Bottom	7.0	Sample Bottom	130.2
Dry Density Mg/m <sup>3</sup> :	2.19	Swelling mm:	0.00	Remarks : See Summary of Soil Descriptions.			
Percentage retained on 20mm BS test sieve:			35				
Compaction Conditions		Vibro
