**Phase 3: Remediation Strategy**

**Frodingham Road, Scunthorpe**

Produced for Moore Facilities Management

<b><i>Title:</i></b>	Phase 3: Remediation Strategy Frodingham Road, Scunthorpe
<b><i>Client:</i></b>	Moore Facilities Management
<b><i>Report number:</i></b>	0135/5363/P/P3

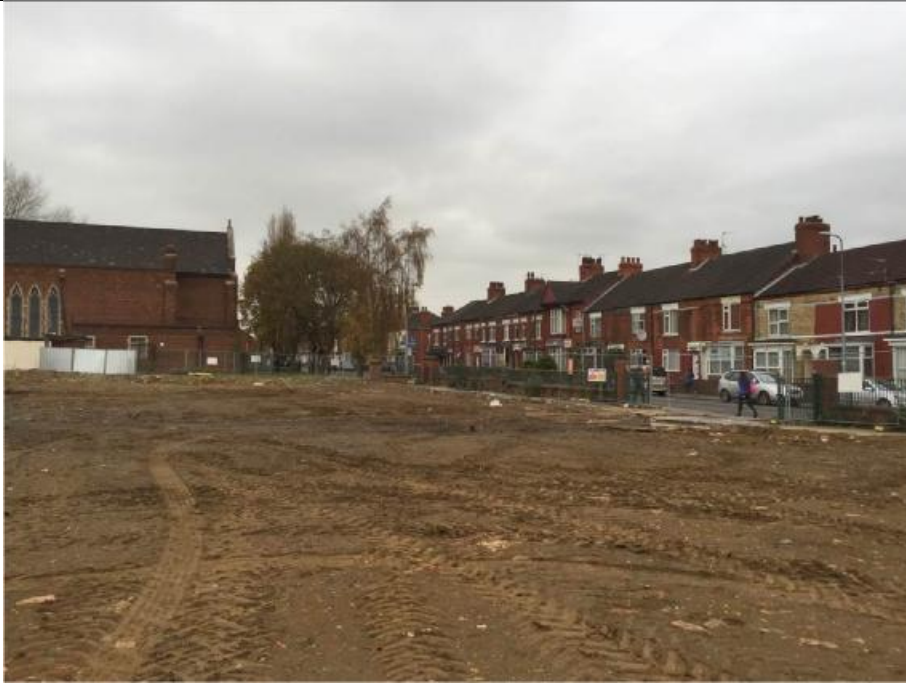
**Photo: 1**      **Date:** February 2018  
**Photo direction:** North  
**Description:** General site after demolition

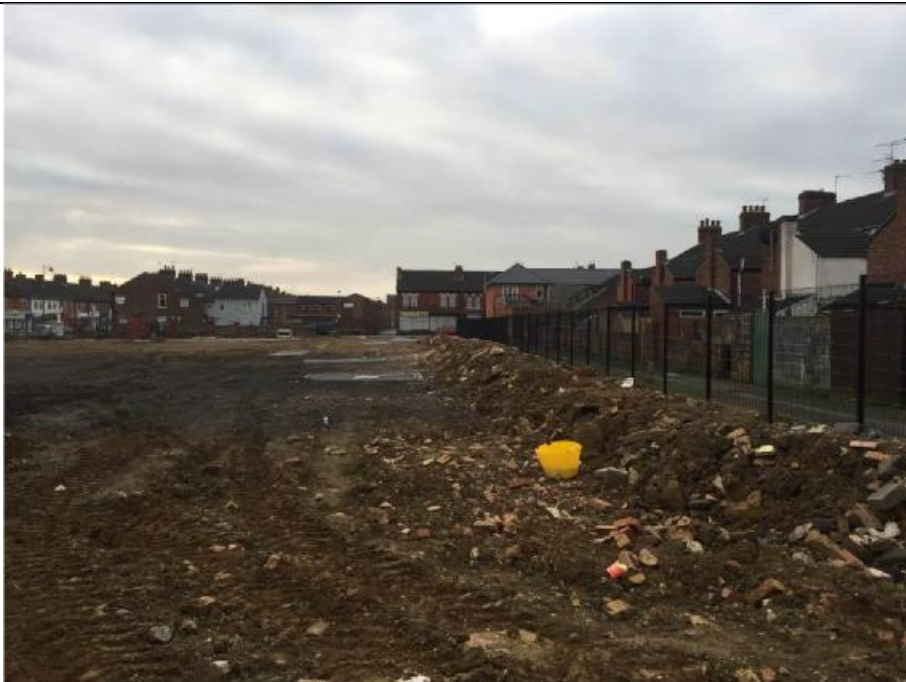
**Photo: 2**      **Date:** February 2018  
**Photo direction:** South  
**Description:** General site after demolition

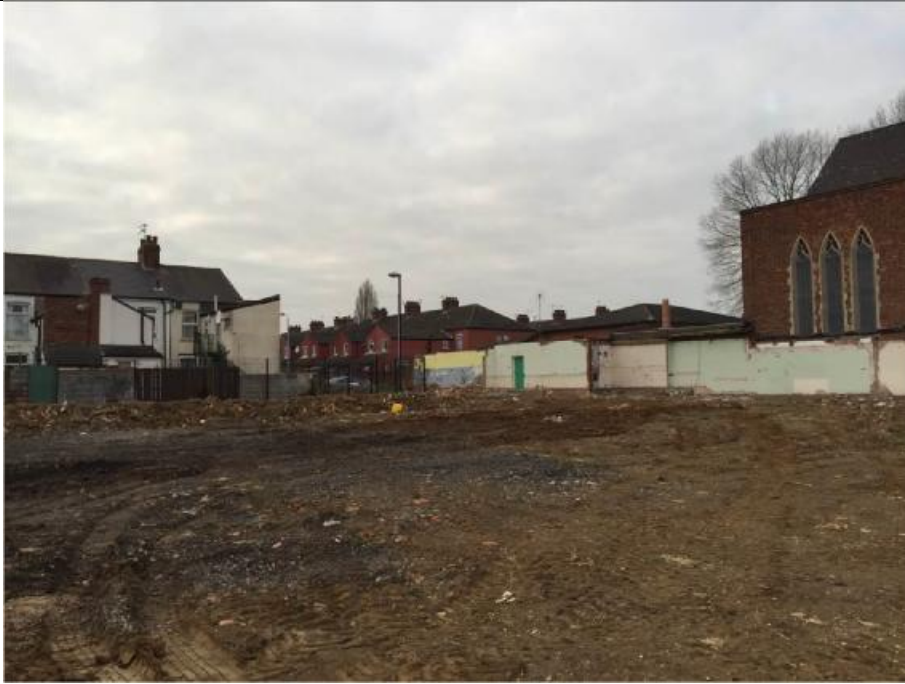
**Photo: 3**      **Date:** February 2018  
**Photo direction:** Northwest  
**Description:** General site after demolition

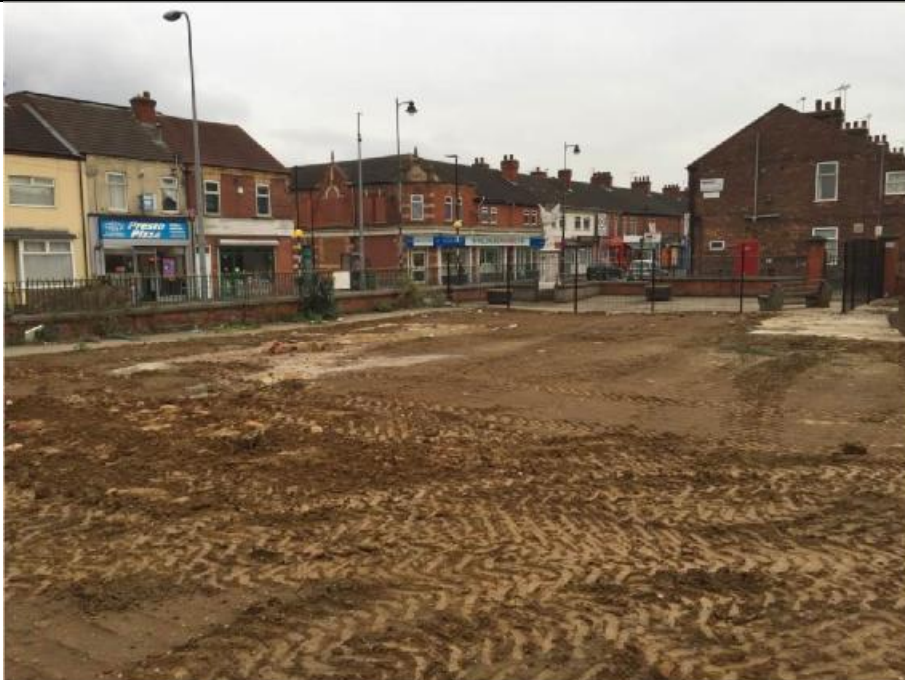
**Photo: 4**      **Date:** February 2018  
**Photo direction:** Southeast  
**Description:** General site after demolition

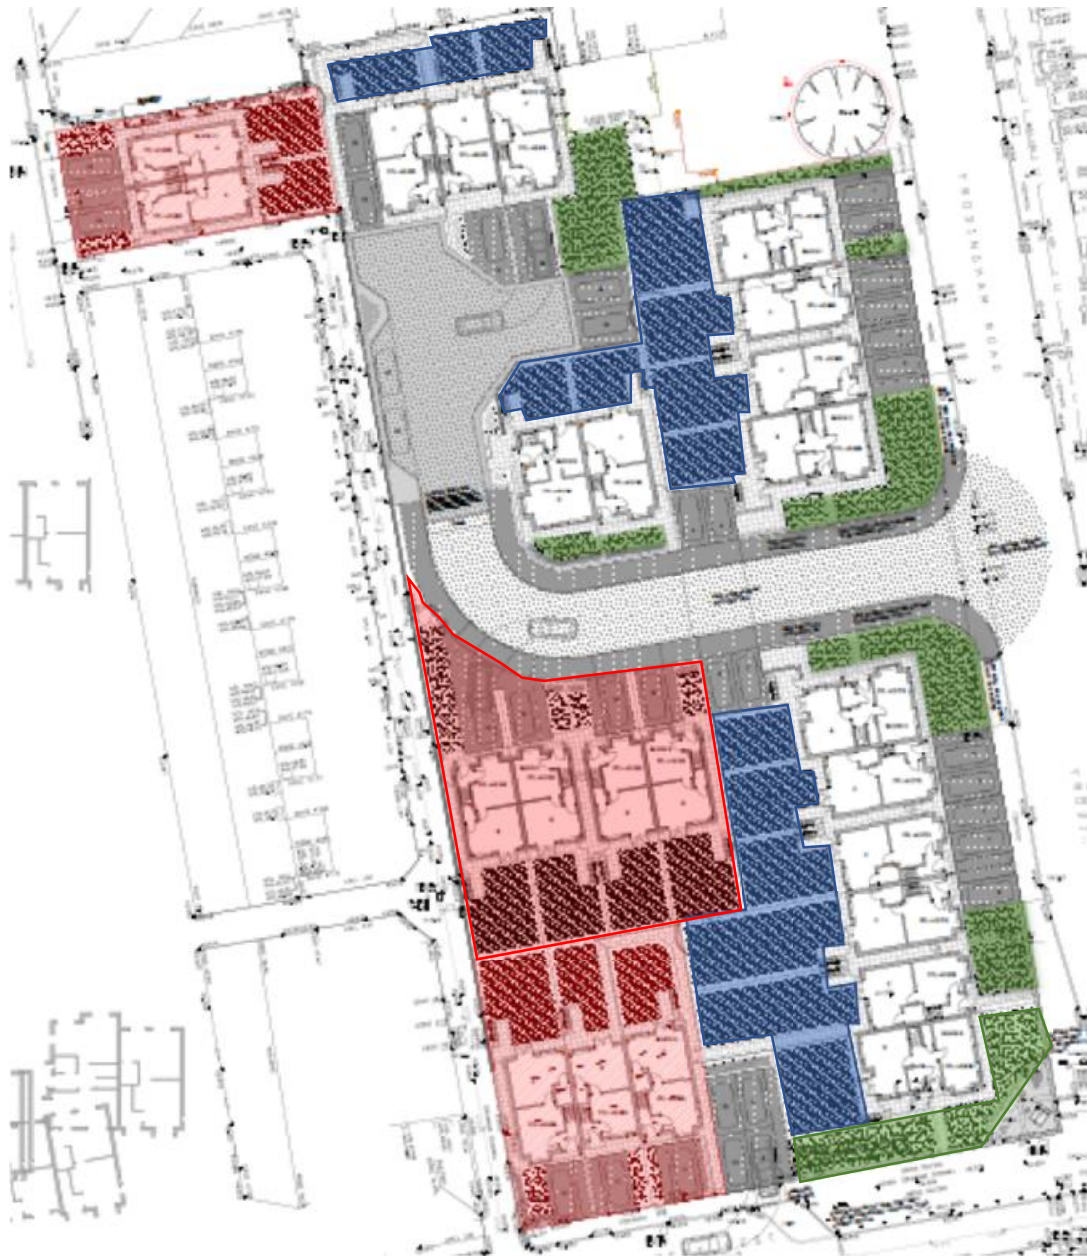
Rear garden remediation areas

10. Geotextile shall be a suitable separator layer (Fastrack 1800 or similar)
11. Granular capillary break layer shall be 100mm thick or 3 times nominal diameter of particles

12. Allowance shall be made for increasing the cover system thickness below new trees to accommodate the root ball

Approximately 600mm of in-situ below ground material will be removed in soft landscaped rear garden areas to accommodate a 600mm deep cover system. However, should final ground levels be altered, the depth required for removal will be reduced/increased commensurately. A 0.45m deep cover system should be adequate for front gardens immediately adjacent to parking areas and for public soft landscaped areas. The cover system will need to be locally increased for tree planting to accommodate any new tree root balls.

Following successful completion of the structural works, the cover system can be installed in the soft garden areas (e.g. below lawns or plant beds). This shall be placed to a thickness of 0.60m below final ground levels in rear gardens (and 0.45m in front gardens and public soft landscaped areas), which is recommended by BRE Report 465 (Tedd et al., 2004).
