Arboricultural Assessment Report (ver 1)

Ash Tree Close
Belton
North Lincolnshire

March 2021

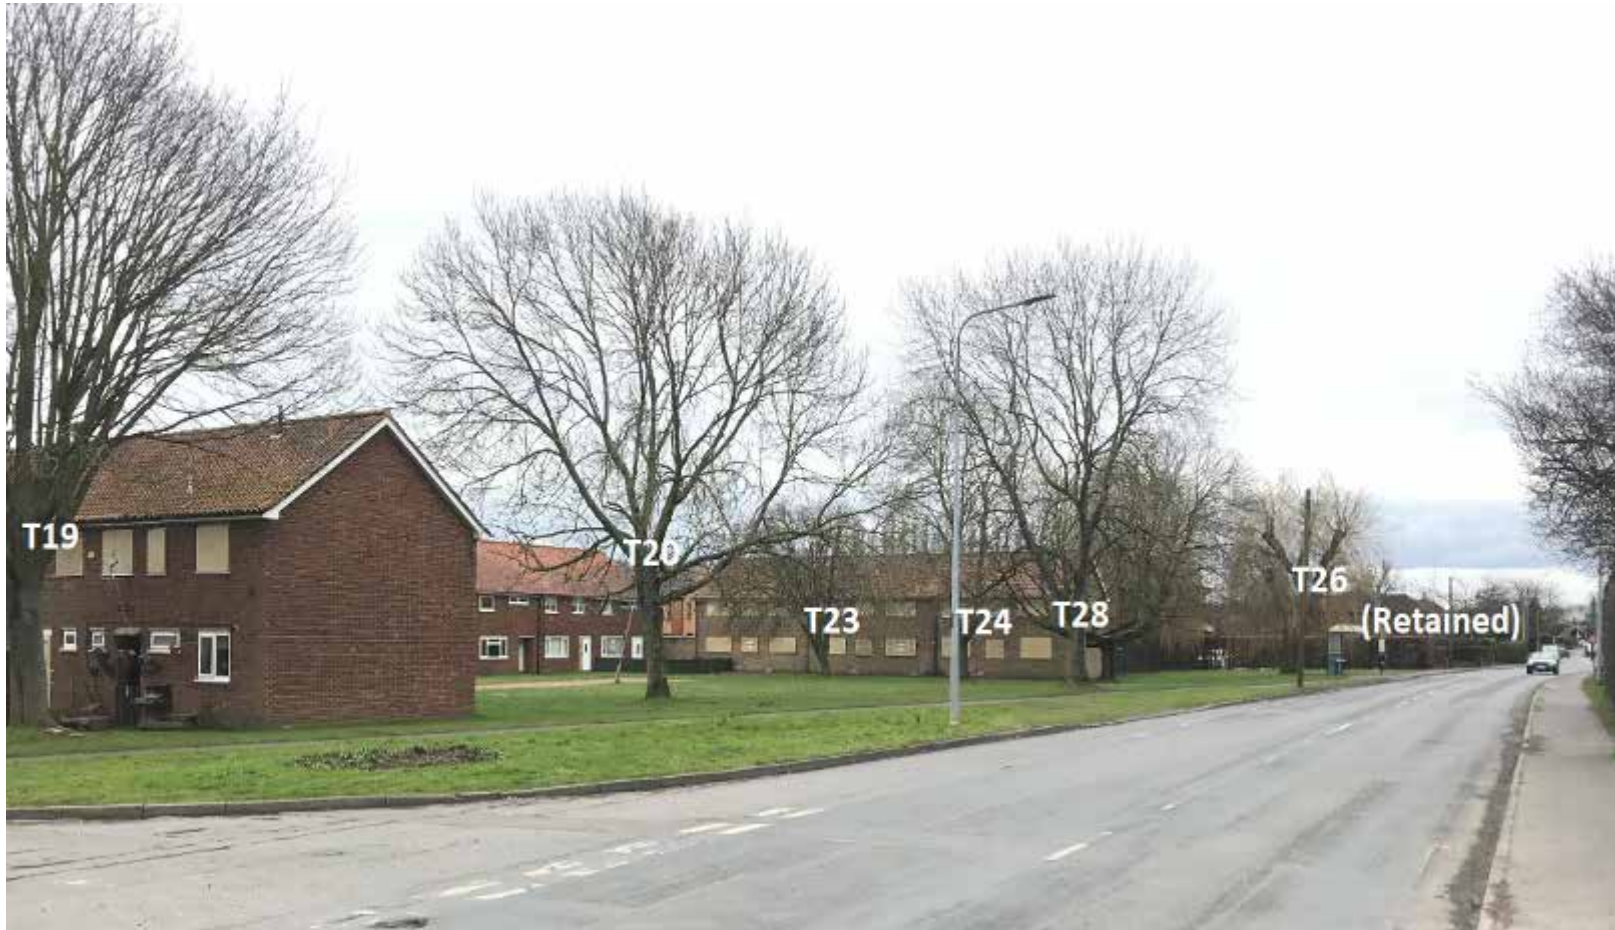
Photograph 1 (Southern Area)

4.2.1 The development proposal requires the removal of the mature trees within the two main open space areas alongside the main road (A161). Some of the trees are attractive large mature specimens and have therefore been given the category B2. However, some of these trees have outgrown their situation in relation to the existing properties. The following photograph identifies the trees to be removed.

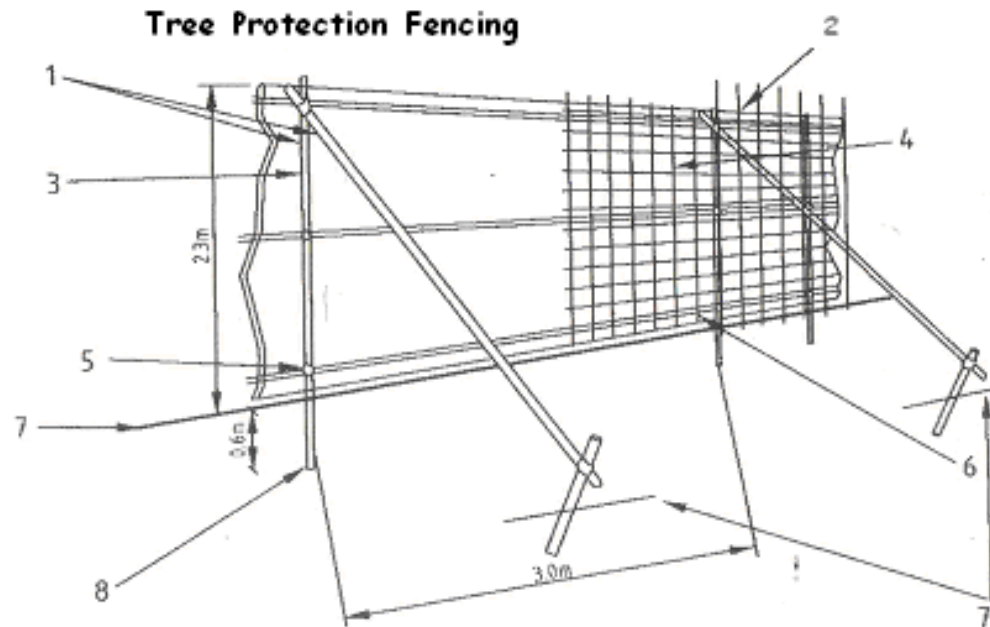
Extract from BS5837

- 1) Standard Scaffold Poles
- 2) Uprights to be driven into the ground
- 3) Panels secured to uprights with wire ties
- 4) Weldmesh
- 5) Standard clamps
- 6) Wire twisted and secured on inside of fence
- 7) Ground level
- 8) Approx 0.6m into the ground

- Tree Protection Fencing to be erected as indicated on the Tree Protection Plan 3A and as detailed in Appendix A
- Tree protection fencing to be marked with signs at 4m intervals 'TREE PROTECTION FENCING – DO NOT REMOVE'.
- No storage of materials or equipment within the tree protection fencing.
