Our Ref: 0088/4925/P/RL  
Your Ref: Victoria Road, Barnetby

Date: 23 Dec. 21

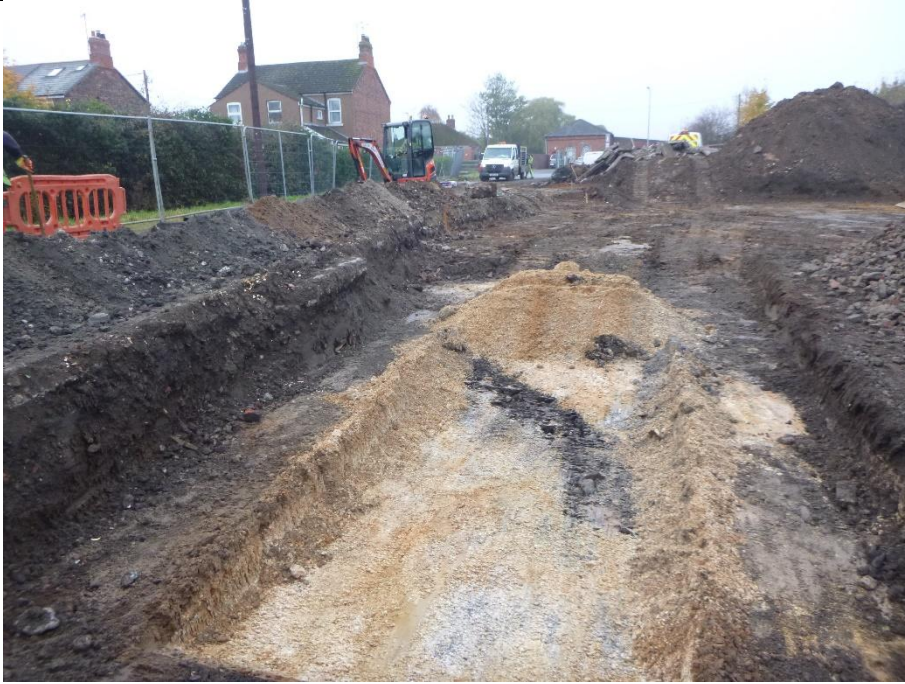
**Site photo: 1**    **Date:** 16 November 2021  
**Photo direction:** Southwest  
**Description:** Partly completed remediation excavation showing staining at the base

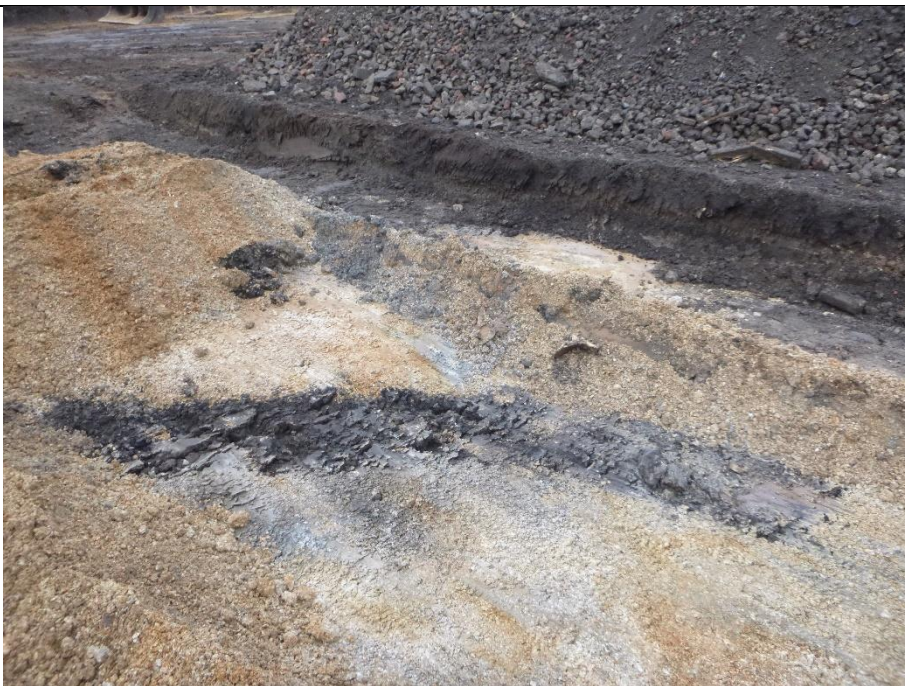
**Site photo: 2**    **Date:** 16 November 2021  
**Photo direction:** Northwest  
**Description:** Partly completed remediation excavation showing staining at the base
