Victa Property Ltd

123 Westgate Road, Belton

POTENTIAL ROOST ASSESSMENT

AND NESTING BIRD SURVEY

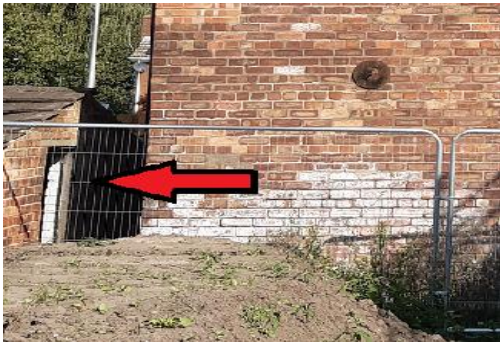
Photograph 1: B2 exterior

- 4.4 A small brick outbuilding was also present adjacent to the south eastern corner of B1 but unconnected to the larger building. It featured a pitched roof covered with slate tiles although some of the tiles had slipped or were missing leaving a hole in the roof.
- 4.5 B2 did not contain a roof void and the interior was open to the elements due to the damaged roof and open access door on the eastern side.
- 4.6 Potential access points included the open doorway and slipped/missing roof tiles. However, given the size, nature and poor condition of this structure it was considered unsuitable for use by roosting bats. No evidence of bats was found associated with B2 externally or internally.

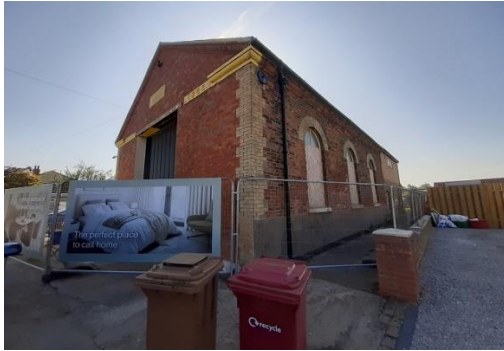
Photo: B1 northern and western aspects

- 4.7 This large brick building was currently being used to store building materials to supply the housing development works on adjacent land.
- 4.8 B1 featured a gable roof covered with slate roof and ridge tiles. A large industrial access door was located on the northern aspect adjacent to Westgate Road. A smaller access door was located on the small single storey lean-to section attached to the eastern aspect.

- 4.9 Windows were present along both eastern and western aspects with a single window also on the southern gable. All had wooden frames, and some were covered with wooden security boards where panes of glass had been broken. Wooden soffit boxes were present at the eaves level on part of the two-storey section, but these appeared to be in good condition and tightly fitted. No barge boards or soffits were present on either of the gable ends of the building. A small wooden shutter/hatch door was present on the southern gable end.

- 4.10 Most of the brickwork and mortar was in good condition. However, there were some localised areas of brickwork on the southern gable where the mortar between bricks had degraded although the resulting crevices appeared to be superficial and too shallow to support roosting bats.

- 4.11 Externally, potential access points on B1 included an occasional gap created by a lifted roof tile. There were also gaps above the metal door on the northern aspect and between the wooden lintel and a warped cladding board also above this door. Two large gaps were also noted in the brickwork above this doorway which may lead to cavities above, but this could not be confirmed during the building assessment. A small gap was noted around the wooden hatch on the upper storey of the southern gable wall.

- 4.12 No evidence of use by bats was found associated with any of these potential access points/roosting features or anywhere else on the exterior of the building.

- 4.20 In general, the buildings contained limited opportunities for use by breeding birds. However, there were holes in the brickwork above the large access door on the northern aspect which may offer a potential location for nest building. No evidence of historical use such as abandoned nests, nesting material or bird droppings were noted within the buildings on site during the surveys.

- 5.5 No historic evidence of nesting birds was recorded during the building survey. However, localised areas that could be used by nesting birds were identified and as all birds are protected whilst on the nest under the Wildlife and Countryside Act 1981 (as amended) the demolition of the buildings should take place outside of the bird breeding season (considered to be March – September inclusive). If this is not possible then they should be checked by a qualified ecologist prior to removal. Active bird's nests are nests which are in the process of being built, or contain eggs, chicks or fledglings. If any active bird's nests are found, they should be left in place with an appropriate buffer (minimum 5m) until fledglings have left the nest.

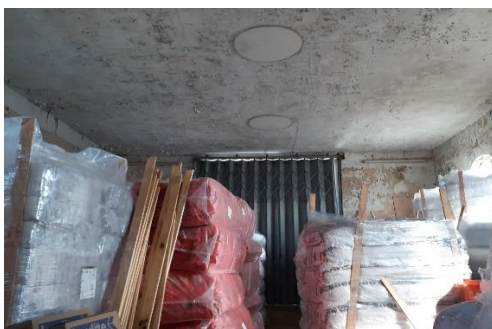
Photo: B1 interior

- 4.13 Internally, the building was divided into a small office area and a larger main section used for storage. The interior walls and ceiling were plastered and decorated with only superficial cracks in the plaster.

- 4.14 No potential roosting features or evidence of use by bats was found within the building. A roof void was present between the ceiling and roof although no internal access hatch was present so this void could not be inspected for evidence of roosting bats.
