Report No: C531
Date: October 2022

GEOENVIRONMENTAL APPRAISAL
Of land at
7 BELTON ROAD, EPWORTH,
SOUTH YORKSHIRE

REPORT NUMBER:	C531	REPORT STATUS:	Final
REPORT TYPE:	Geoenvironmental Appraisal (Phase 2)		
REPORT DATE:	October 2022		
SITE:	7 Belton Road, Epworth, Yorkshire		
PREPARED FOR:	Cherry Lane Homes Ltd		
PREPARED BY:	A Swinbourne BSc. (Hons) FGS, MIEEnvSc, ACIEH.		
REVIEWED BY:	G Swinbourne BSc. (Hons) MSc. DIC, FGS.

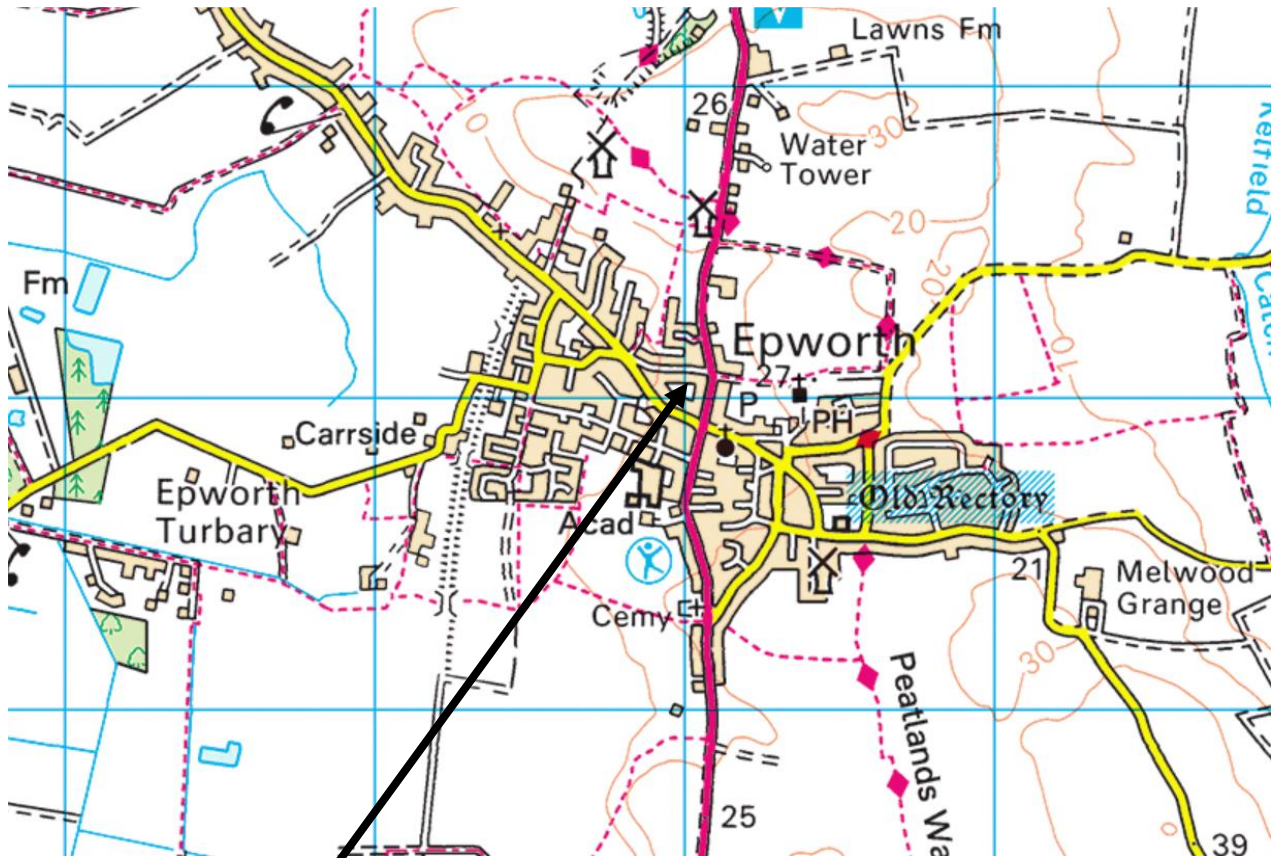
Site Location Plan Drawing No C531/1

The Site

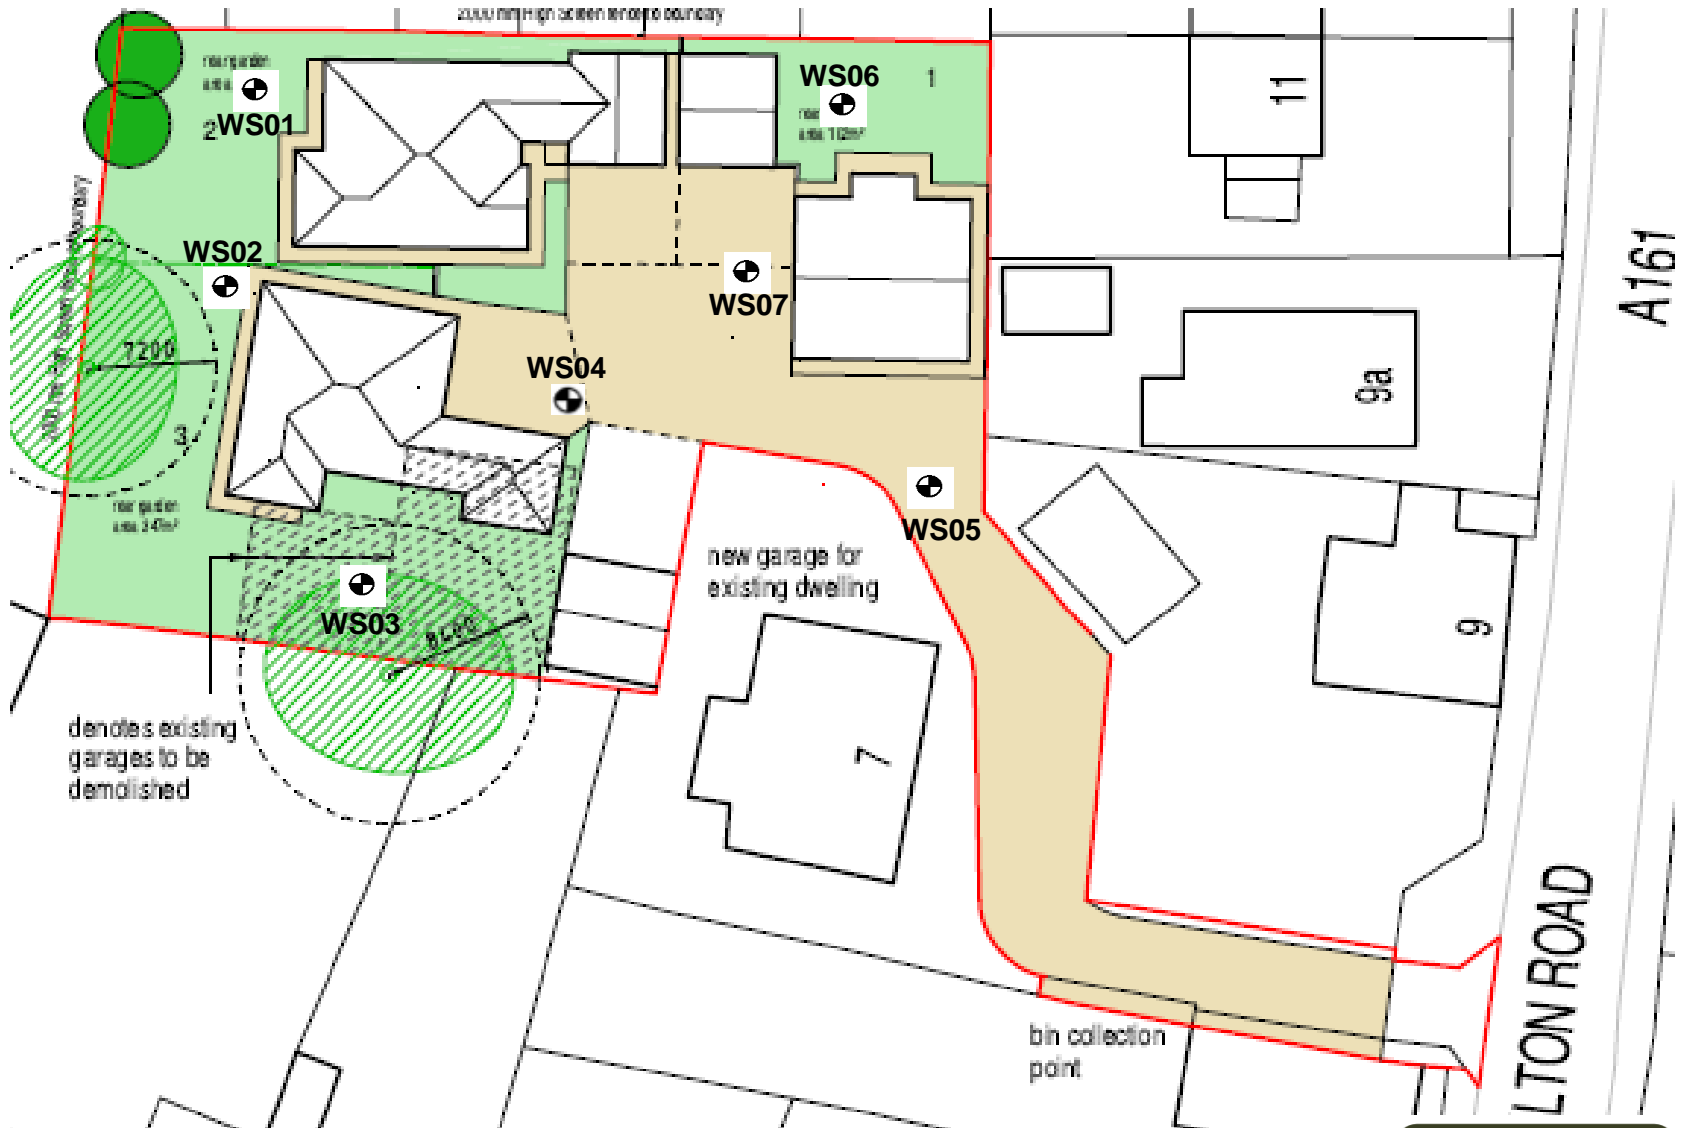
Drawing No: C531/2	Scale NTS	
Contract C531 – Belton Road, Epworth	Drawn AS	Approved GS
	Drawing Name – Exploratory Hole Location Plan	
Client – Cherry Lane Homes Ltd

The exploratory hole positions were set out and the fieldwork supervised by a G&M engineering geologist. The locations of the holes are shown on Drawing No C531/2, presented in Appendix A of this report.

- Drilling of seven window sample boreholes, referenced WS1 to WS7 inclusive, to depths of between 2.0m and 3.0m below ground level (bgl).

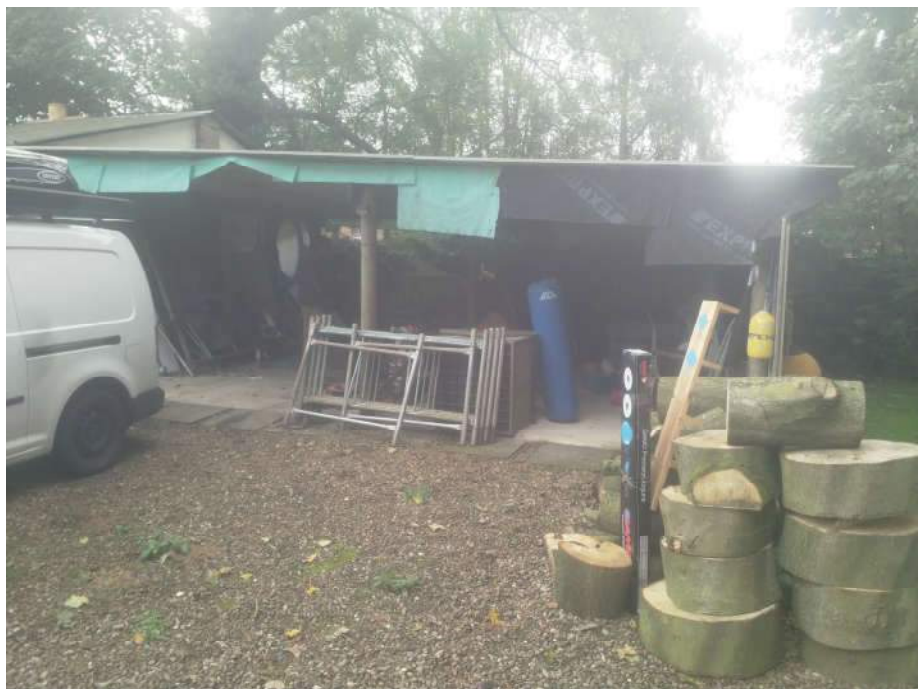
- 2.1 The site covers an area of approximately 0.2 hectares. It is located within the grounds of 7 Belton Road in Epworth, approximately 20km East of the centre of Doncaster. The Ordnance National Survey Grid Reference is 478110, 404300 and it lies at approximately 12 mAOD. Figure 1 shows the general site location, whilst figure 2 shows the site in more detail.
- 2.2 The site was inspected on 9th October 2020. It comprises the garden area to the rear of 7 Belton Road. Access is from Belton Road, along a tarmac driveway. The garden area is largely lawned with a number of semi-mature trees. There is a small garage building on the Southwestern corner of the site which is used for domestic storage purposes. It is proposed to demolish this building. The surrounding area comprises residential properties.

Garage Area
