Phase One Planning

Desktop Preliminary Environmental Risk Assessment

Land at Park Farm Road,
Scunthorpe

Report Reference
AEL-4491-PP1-935062_draft

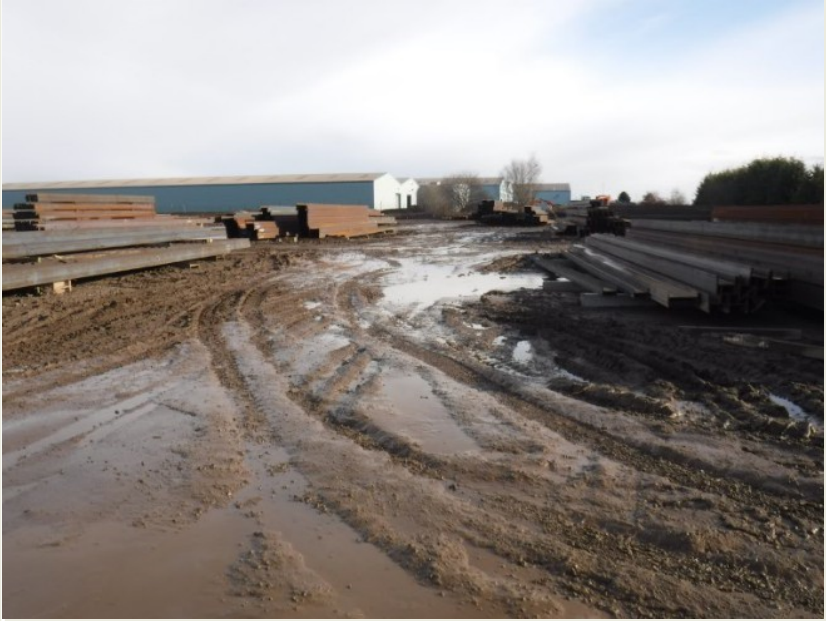
Site Description	
General description	<p>The Site is currently undeveloped land used for the open air storage of steel beams. Numerous rows of steel beams are located across the Site, with vehicle tracks located between each row.</p> <p>A number of forklift trucks were observed during the walkover which are used for the transportation of steel beams onto articulated lorries which park in a waiting area prior to loading. The main access point onto the Site is for vehicles, including articulated lorries, and is located in the south east.</p>

Buildings and infrastructure	<p>No permanent buildings are located on the Site, with only a small metal portacabin located in the south west. A generator is located adjacent to this, with two 208l steel drums assumed to contain diesel fuel for the generator.</p> <p>No permanent infrastructure routes are located on Site, however there are established vehicle routes caused by the continuous transportation of steel beams across the land.</p>

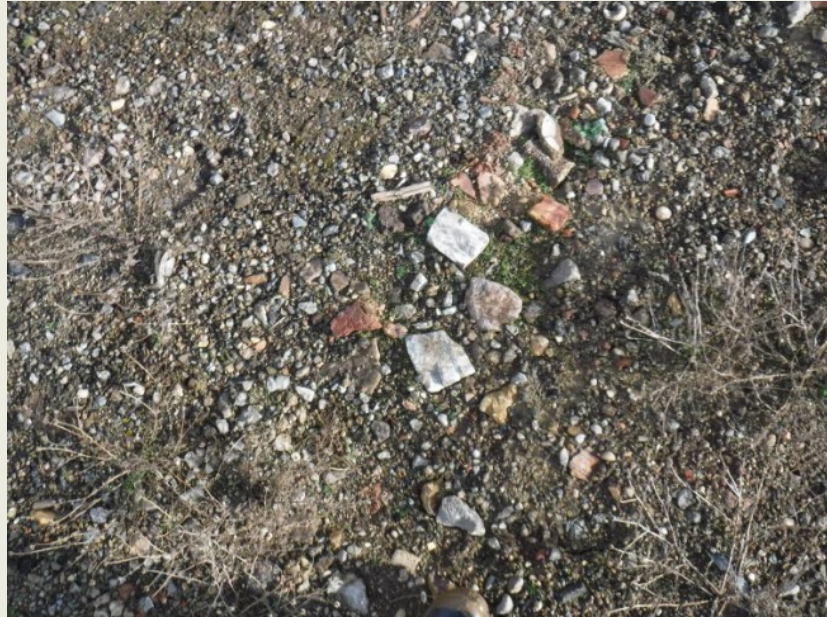
Surface conditions across the Site largely consist of a mix of soil, brick, clinker, rope, and metal type materials, as shown below. Part of the Site appears to have been capped with a mixture of said materials, as well as crushed hardcore, however the coverage of this material is inconsistent across the entirety of the property, and is largely restricted to the north west. The centre and eastern areas of the Site predominantly consist of soil and bare ground. The area where articulated lorries await loading consists of an area of hard standing, assumed to be concrete in order to support the weight of the loaded lorries.

The vehicle access routes on soft landscaping across the Site should be surfaced appropriately to break any existing pathway of potentially contaminated soils and dust which could cause an existing and future risk to site users and third parties.

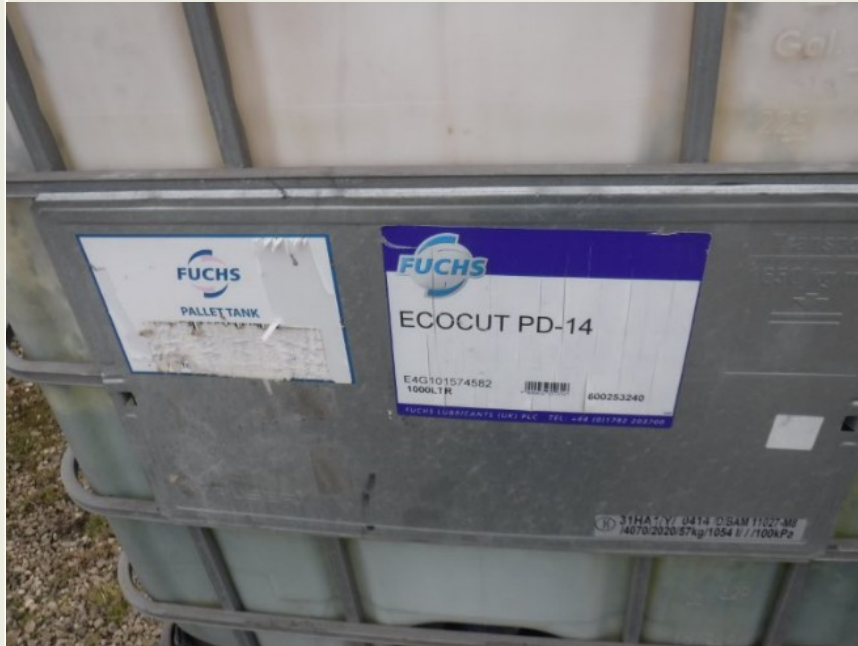
A 1,000litre Intermediate Bulk Container (IBC) containing ECOCUT PD-14 cutting oil is located in the south west of the Site, next to a route frequently used by forklift trucks.

It is assumed that this is used for cutting steel stored on the Site. The container was not stored on a spill tray, and no secondary containment was apparent.

An IBC containing cutting ECOCUT PD-14 cutting oil is located on the Site, with evidence of spraying on the Site apparent. No secondary containment was noted, therefore it is plausible that excess oil is able to come into contact with the soft landscaping surrounding this storage container. In addition, it is plausible that droplets may become airborne during the application/spraying process.

Given the processes in which this material is used, it is unlikely to present a significant risk to ground contamination. If future site users and ground workers are wearing the correct PPE, this will prevent dermal contact, ingestion and inhalation.

With regards to the proposed development to offices and warehousing, any minor ground contamination arising from the application of cutting oil would be removed during the development if found through a discovery strategy, and the resurfacing of the Site with tarmac would prevent any future ground contamination, ingestion/dermal contact of contaminated soil.
