PHASE 2 SITE INVESTIGATION

**1 STATION ROAD
GUNNESS
SCUNTHORPE
NORTH LINCOLNSHIRE
DN15 8SU**

**DOCUMENT REFERENCE: 42332R2
DRAFT REV A1
APRIL 2024**

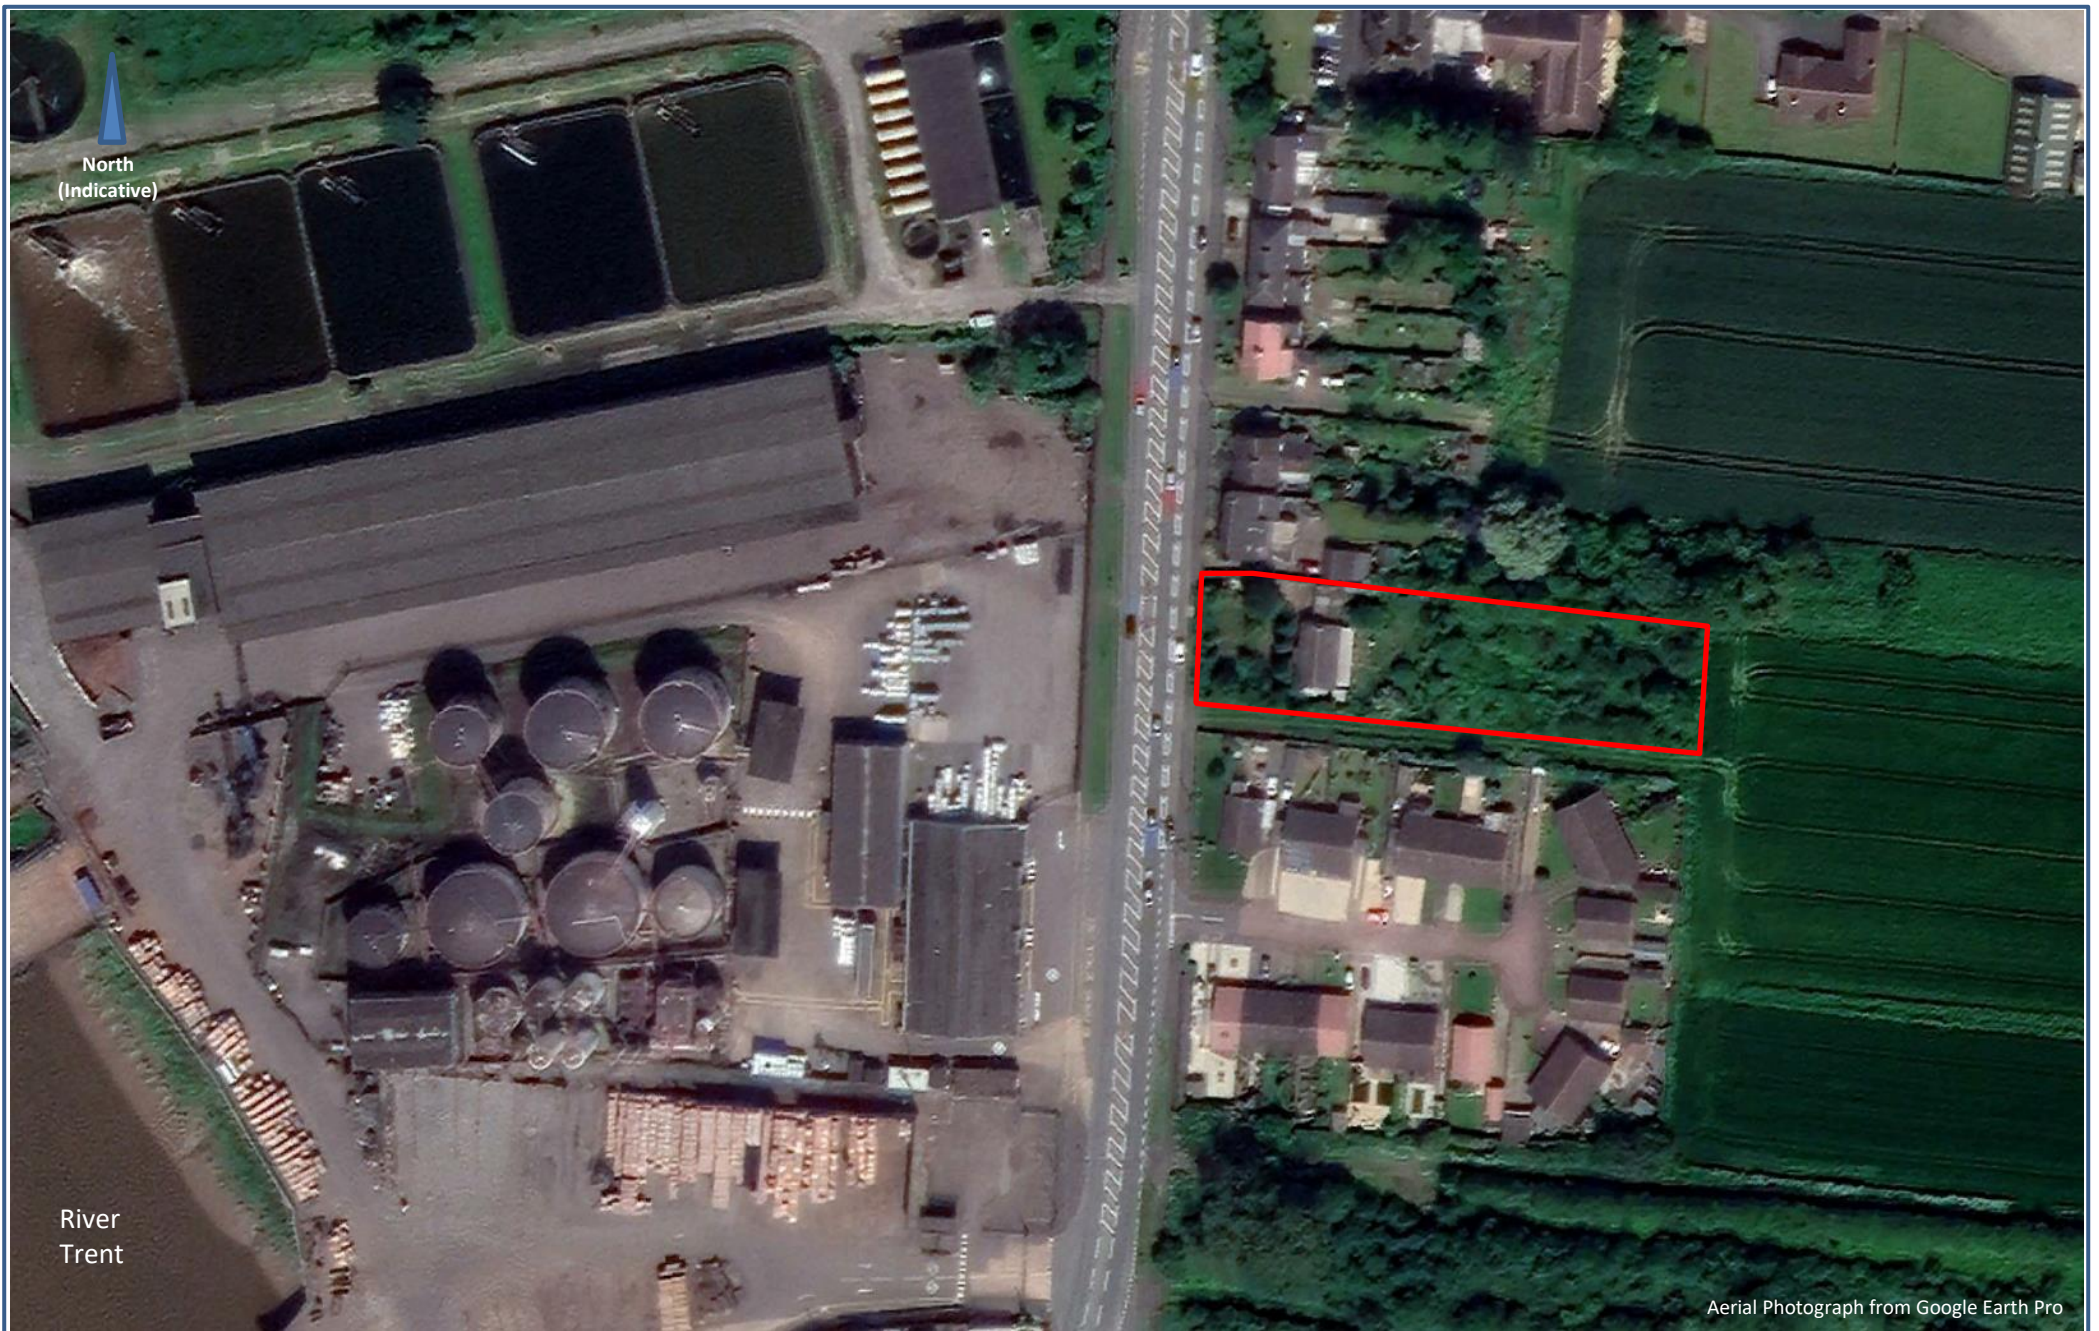
Figure 2

Aerial Photograph from June 2019

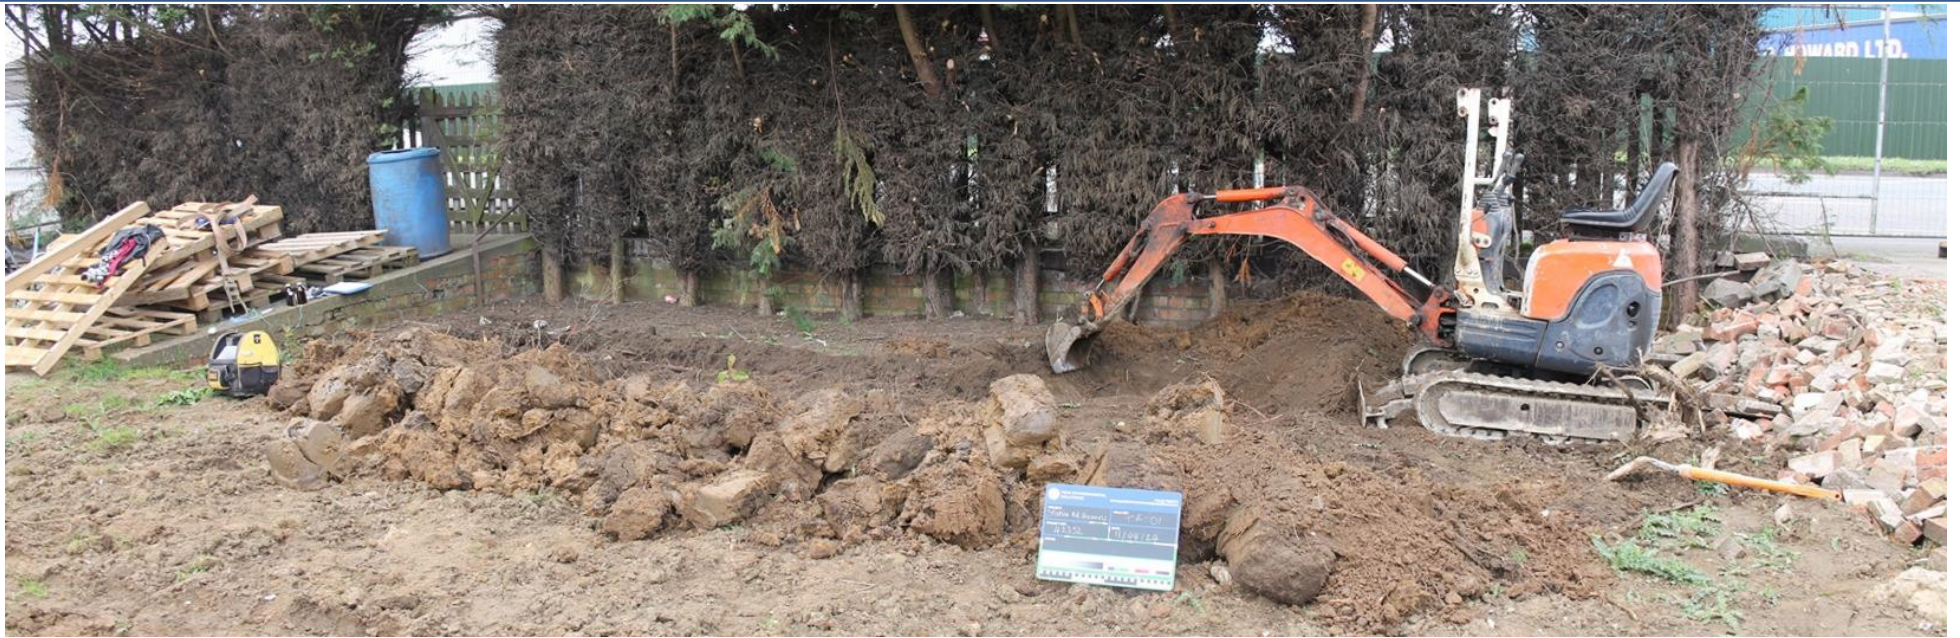
Photo 1: TR-01 in the west of the site with Station Road in the background and Guinness Wharf beyond

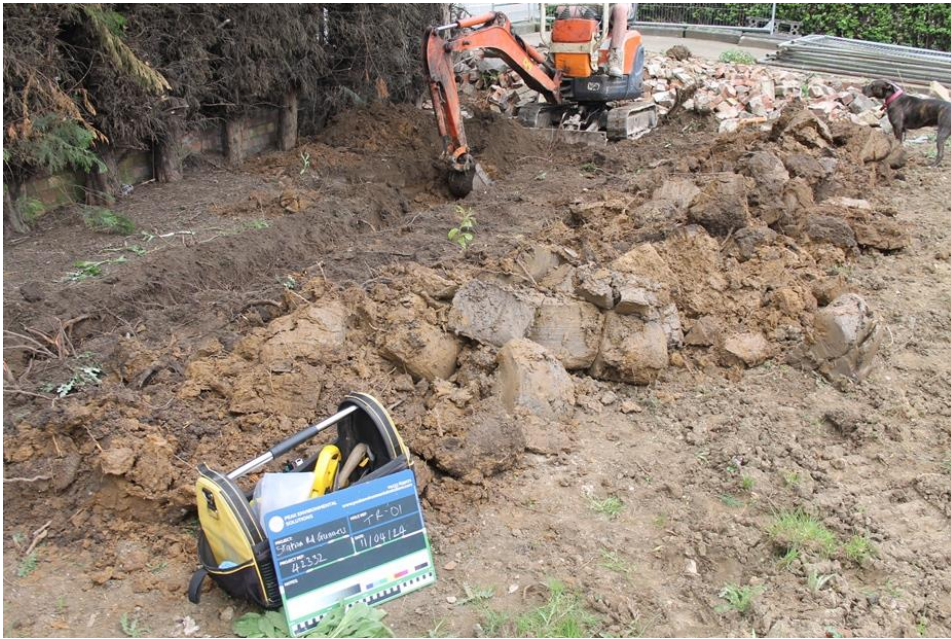
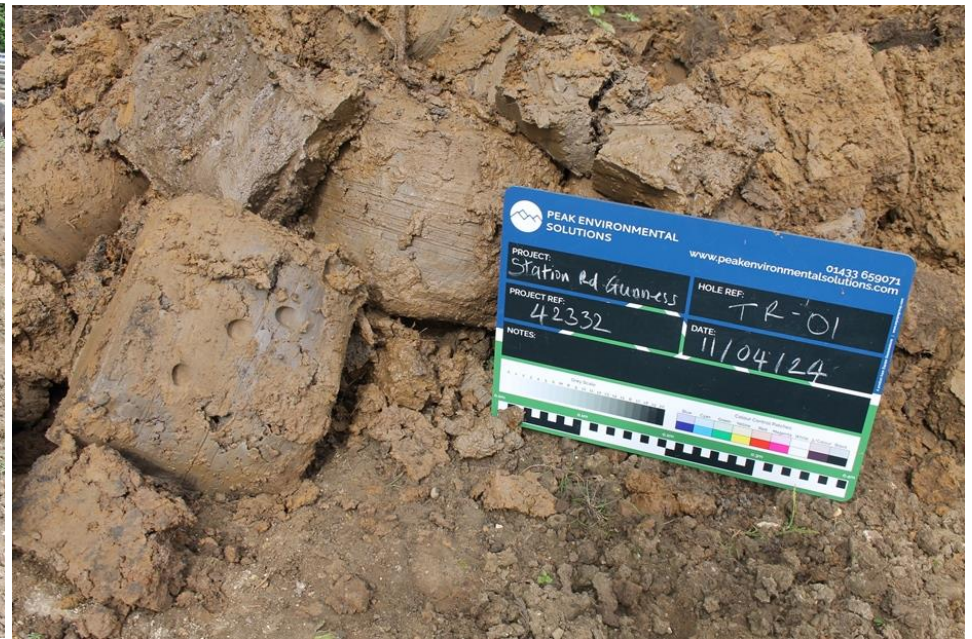
Consistent ground conditions were identified along the whole length of the trench and comprised:

0.0 – 0.3m bgl: Dark to mid brown topsoil with roots and rootlets.

0.3 – 1.2m bgl: Very soft to soft orange brown slightly silty CLAY.

Photos 3&4: TR-01 Ground conditions

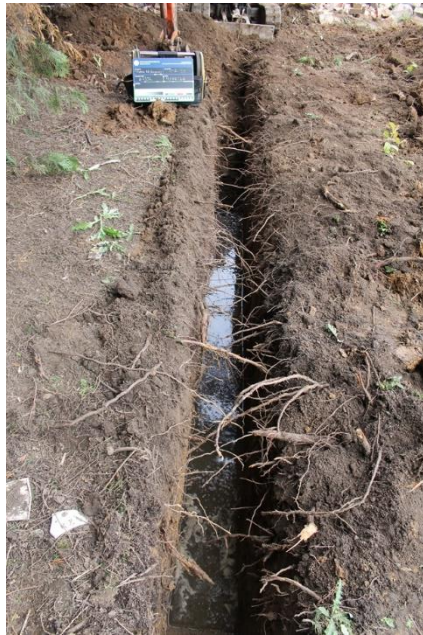
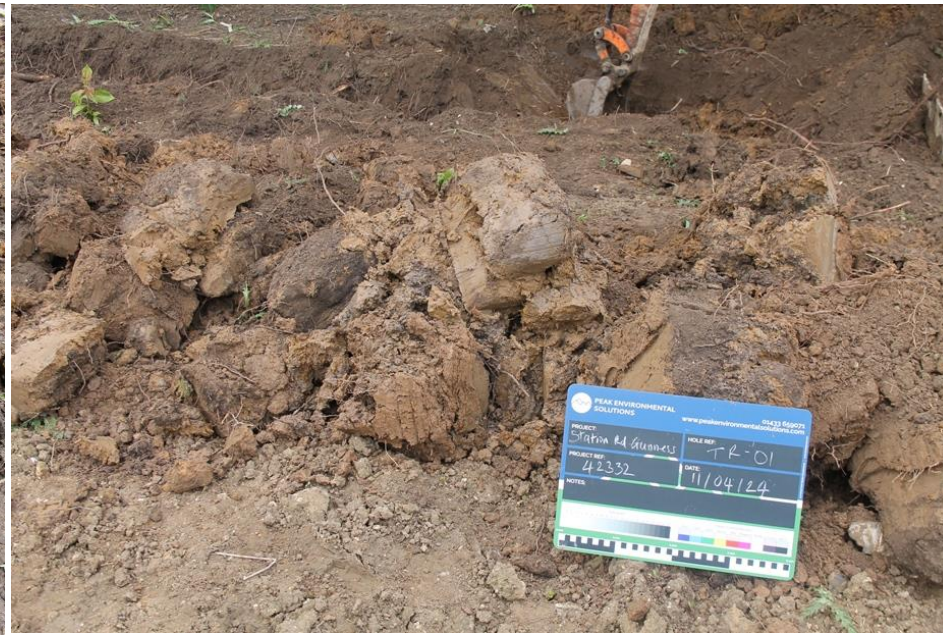
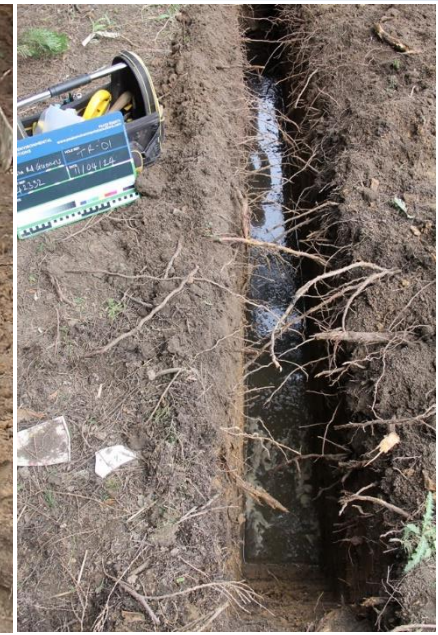
Groundwater ingress into the trench consistently occurred at a depth of 0.9m bgl. Inflow was generally slow to moderate and water levels within the trench quickly stabilised during the ~1 hour period the trench was left open at 0.9m bgl. Groundwater sampling using a bailer was undertaken from the deepest part of the trench.

No significant visual or olfactory evidence to suggest the presence of ground contamination was identified during the trial trenching. No odours were identified and no oily sheens were observed on the surface of the groundwater.

Photo 5-7: TR-01 Groundwater and ground conditions
