Bat Emergence and Re-Entry Surveys (BERS)

11 Akeferry Road, Westwoodside, Doncaster, North Lincolnshire DN9 2DX

21st August 2024

This report is prepared to inform a planning application with North Lincolnshire Council. The proposal is described as:
Erection of the first-floor extension to the front, rear and sides of the dwelling, including demolition of existing conservatory.

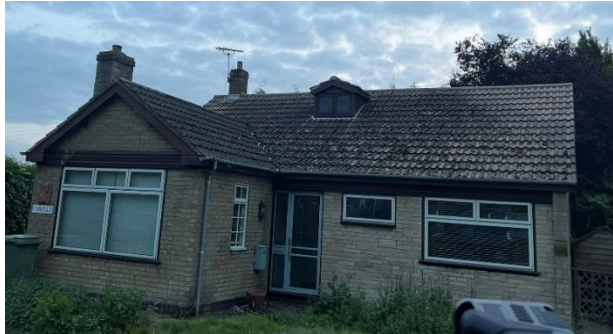
<p><i>IR position 1</i></p>	<p>The footage reflected the view of surveyor 1. No bat roosting behaviour was recorded. No emergencies or re-entries were observed.</p>

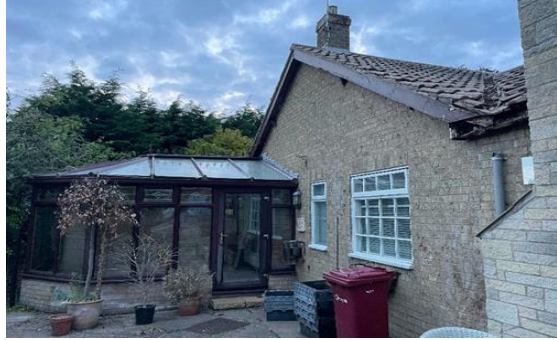
<p><i>IR position 2</i></p>	<p>No emergencies recorded. Sporadic pass of one CPIP corresponding with surveyor observations.</p>
