**Arboricultural Report (Ver 1)**

Humber Bridge Garden Centre

Far Ings Road

Barton on Humber

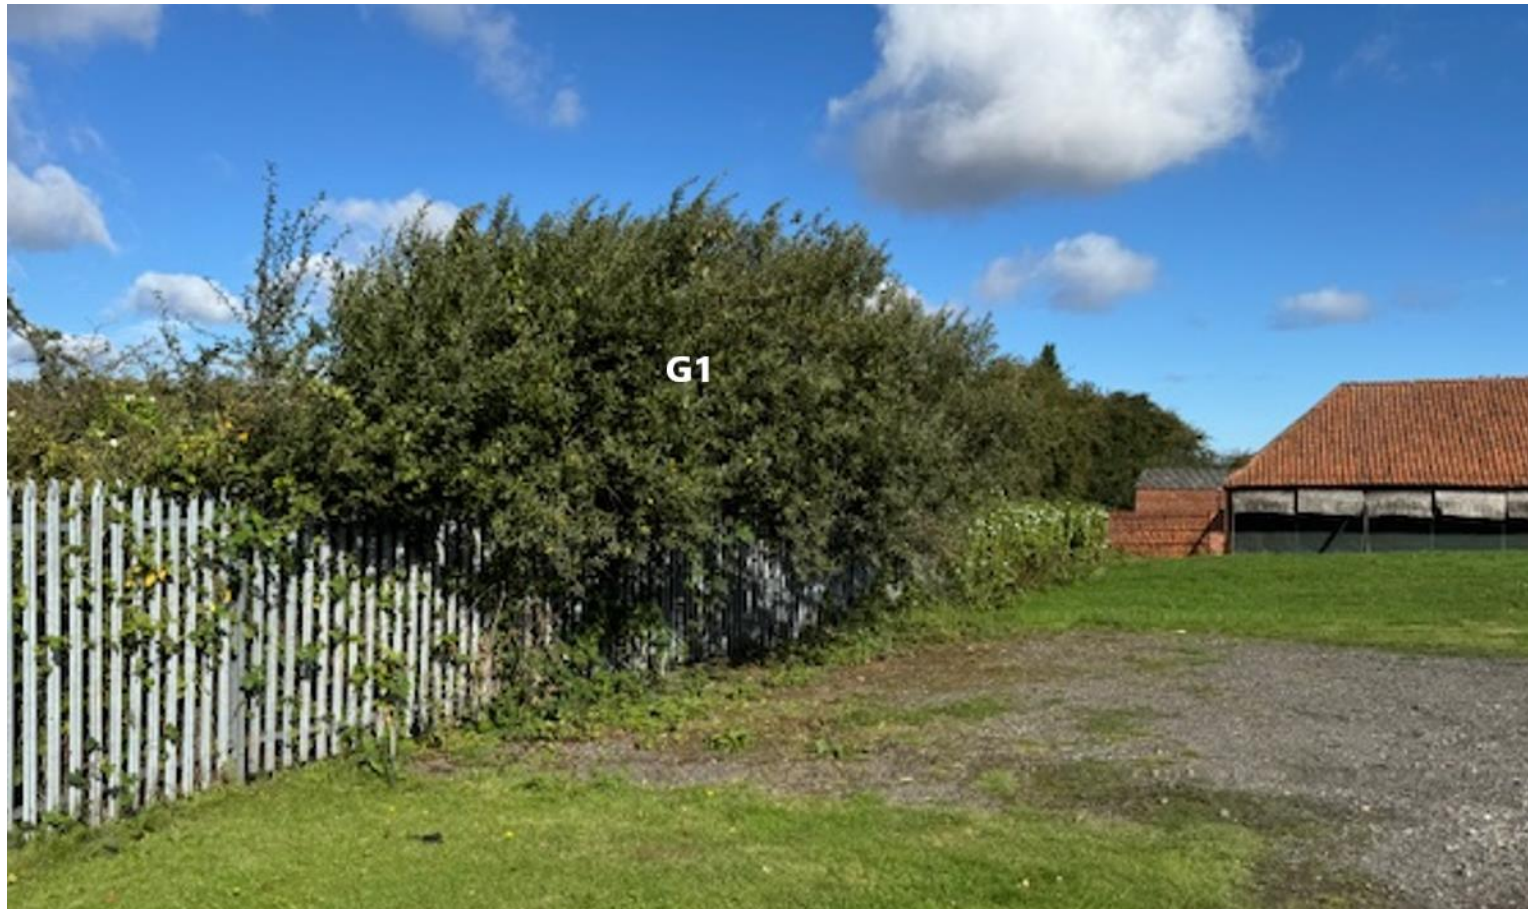
The trunk of the goat willow G2, is located approximately 3m from the fence line within the adjacent land. The tree appears to have fallen over and branches extend through the boundary fence of this scrubby tree. Only minor pruning work is required to trim back to the boundary and clear the boundary security fence.

- No trees to be removed. – Minor trimming of goat willow (G1).

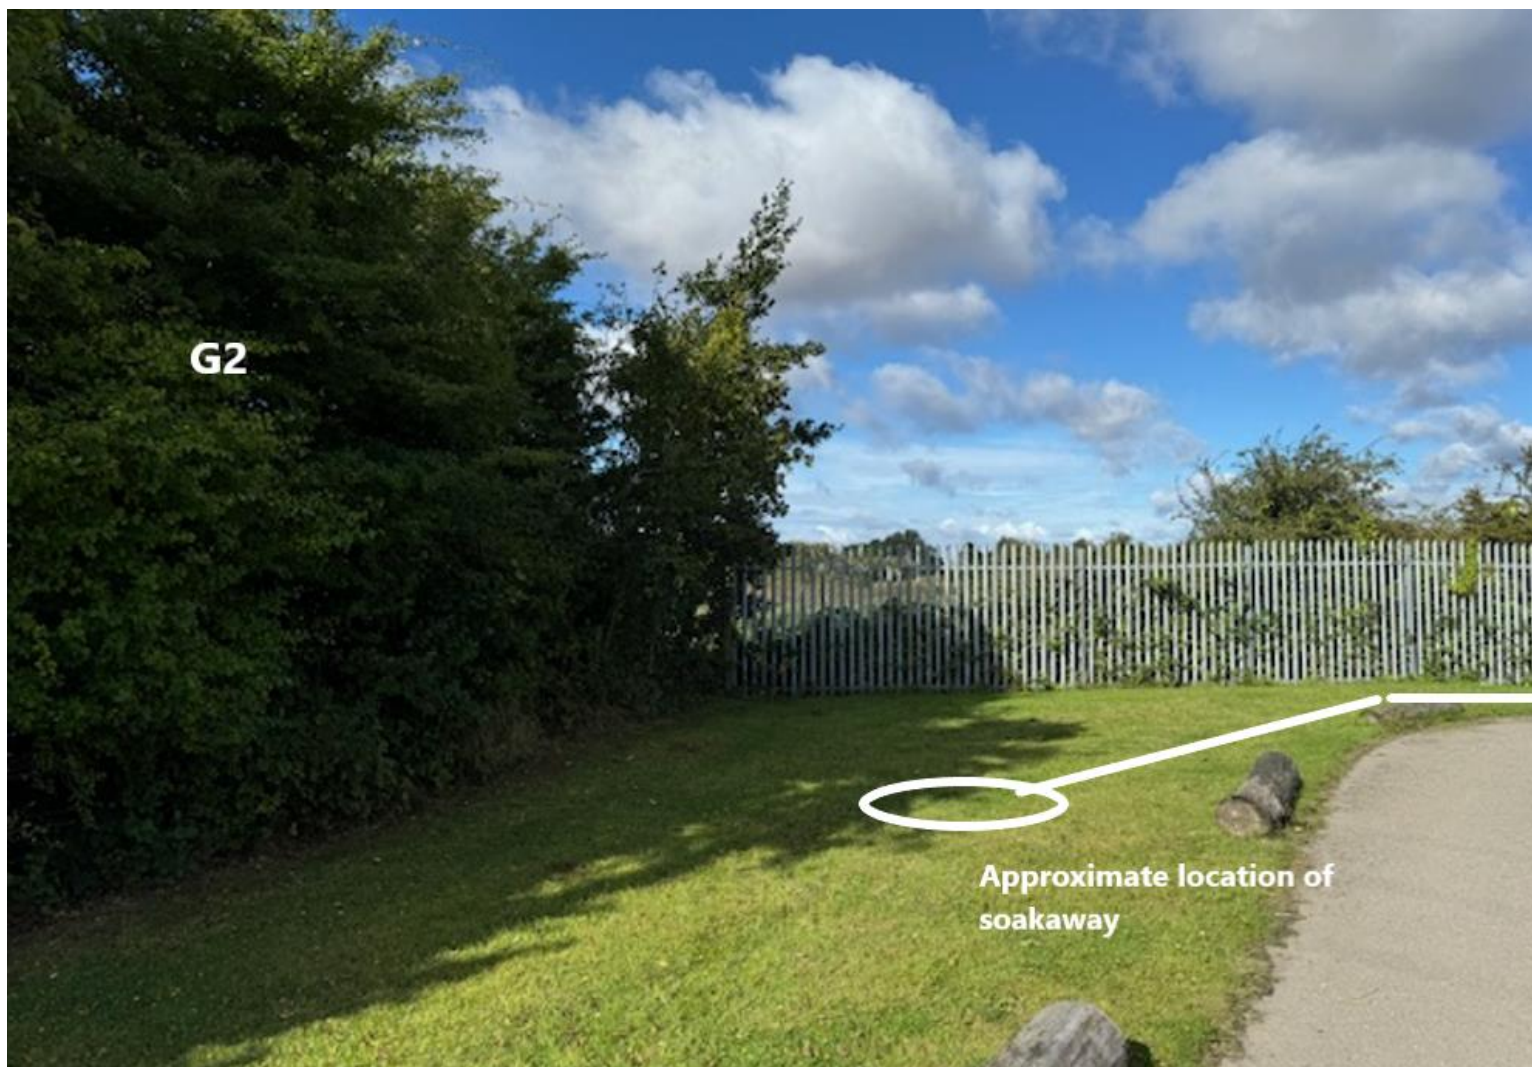
Adjacent to the proposed soakaway are some young trees and shrubs (G2) as illustrated in the photograph below. These would be unaffected by the excavation works as well outside the root protection areas for these plants.

- The existing security fencing will act a suitable protection for G1. Given only a simple trench and hole are required for the soakaway in a wide verge area it is considered that the existing boundary fence will also be sufficient for the protection of G2 in this instance. See fencing plan in appendix A for further details.
