Phase 2 (Supplementary) Report

Mendle Farm, Holme

Title:	Phase 2 (Supplementary report) Mendle Farm, Holme
Client:	Flynn Architecture c/o Mr J W Richardson
Report number:	1260/5063/P/P2

Ground investigation report

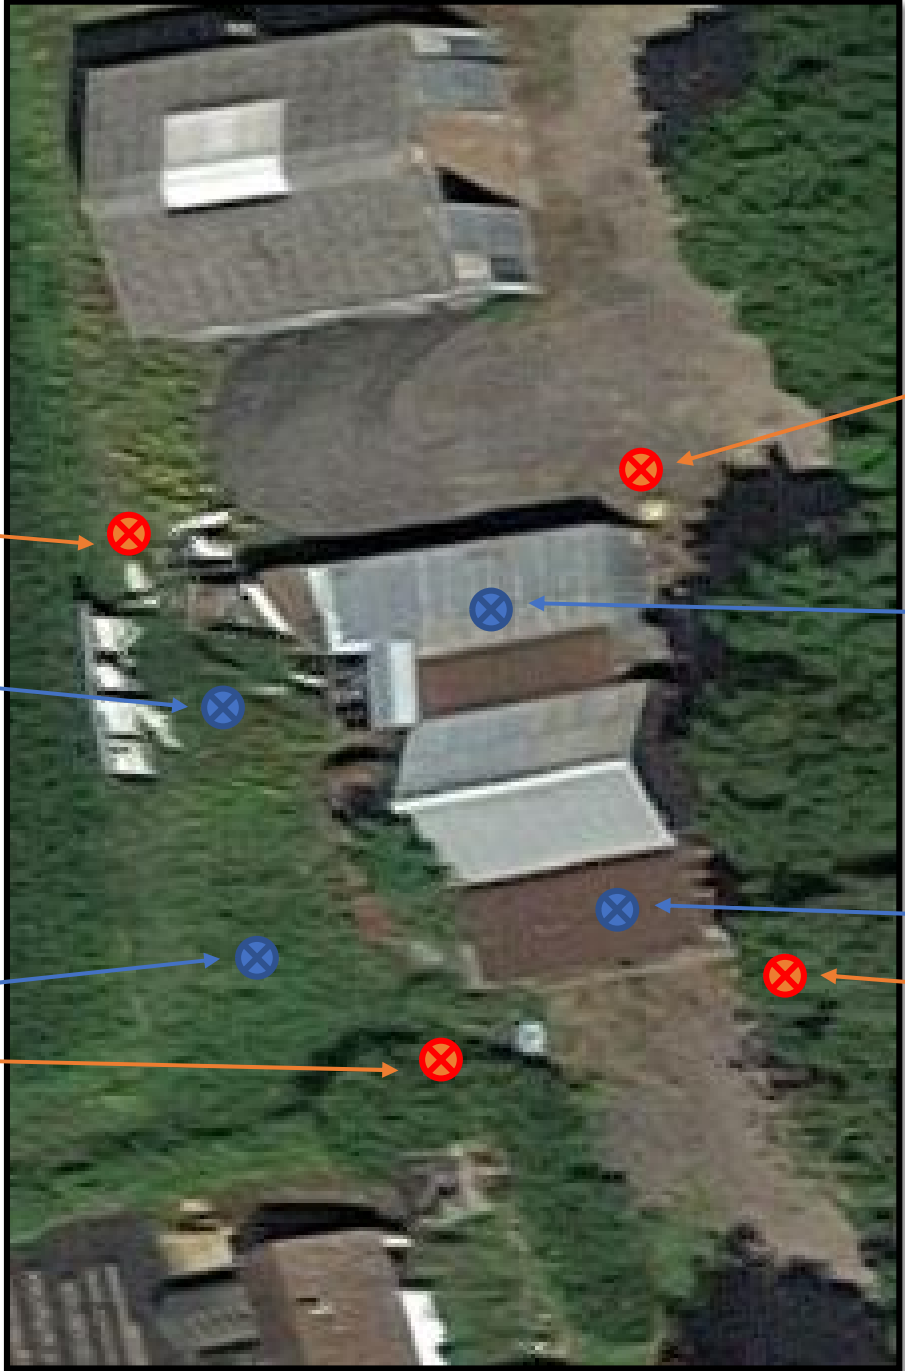
Mendle Farm, Holme – WS/HP location plan		
<p>WS1</p> <p>HP2</p> <p>HP1</p> <p>WS3</p>

<p>WS2</p> <p>HP4</p> <p>HP3</p> <p>WS4</p>	
<p>March 2020</p>

Approximate locations of the site works are shown in the exploratory hole location plan which is presented later (in Appendix A).

The hand pits and previous windowless sampler holes have been located in the most onerous positions in relation to the proposed development. WS1 to WS3 and HP1 to HP2 have been located within proposed soft landscaped areas. HP2 and HP4 were located below existing structures and WS4 is located within the proposed drive/garden path area. An approximate plan within appendix A shows the proposed plot and sample locations.

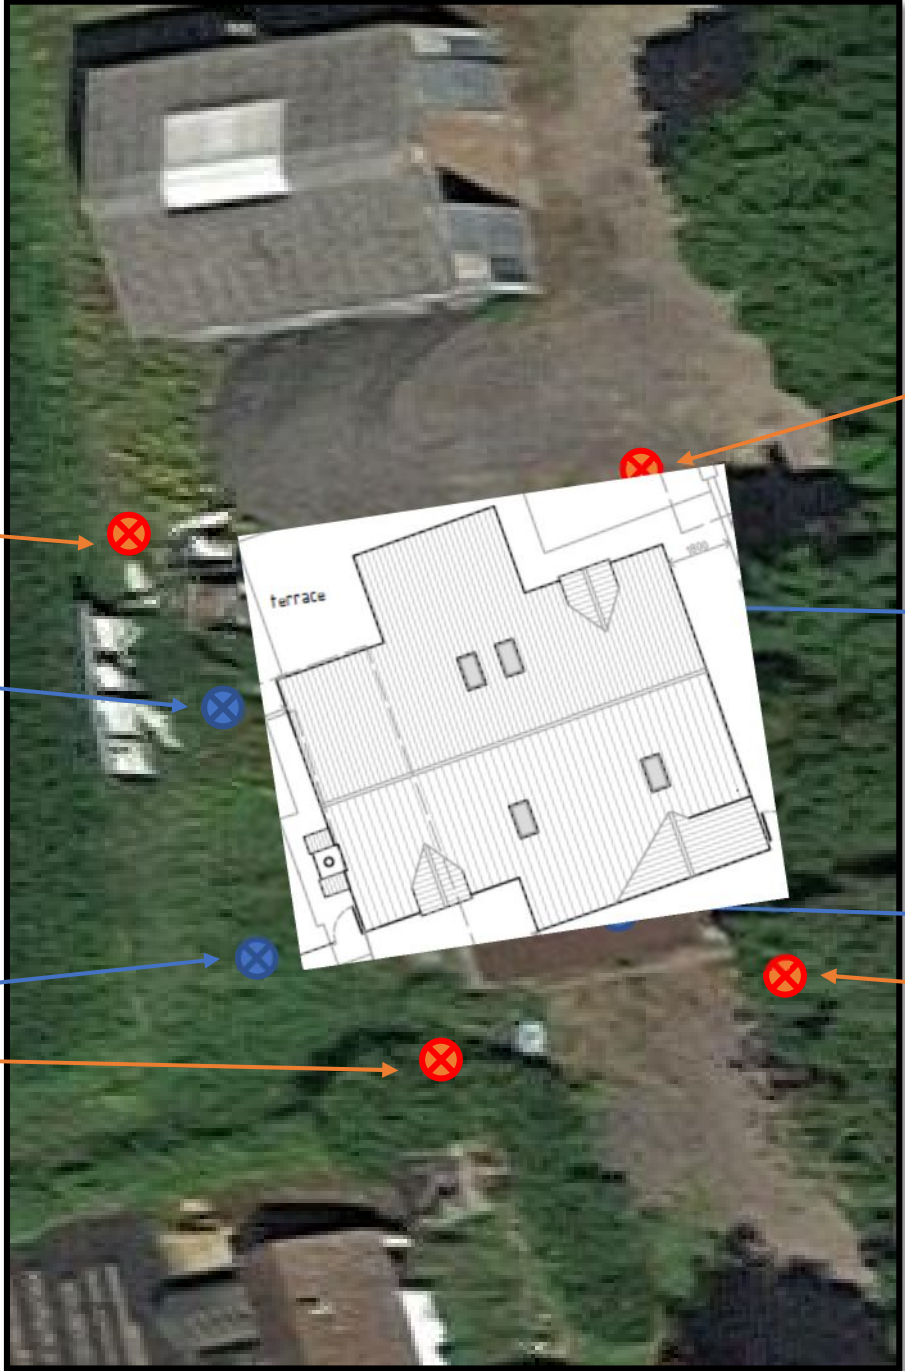
Mendle Farm, Holme – Estimated location

<p>WS1</p> <p>HP2</p> <p>HP1</p> <p>WS3</p> <p>terrace</p> <p>WS2</p> <p>HP4</p> <p>HP3</p> <p>WS4</p>
March 2020

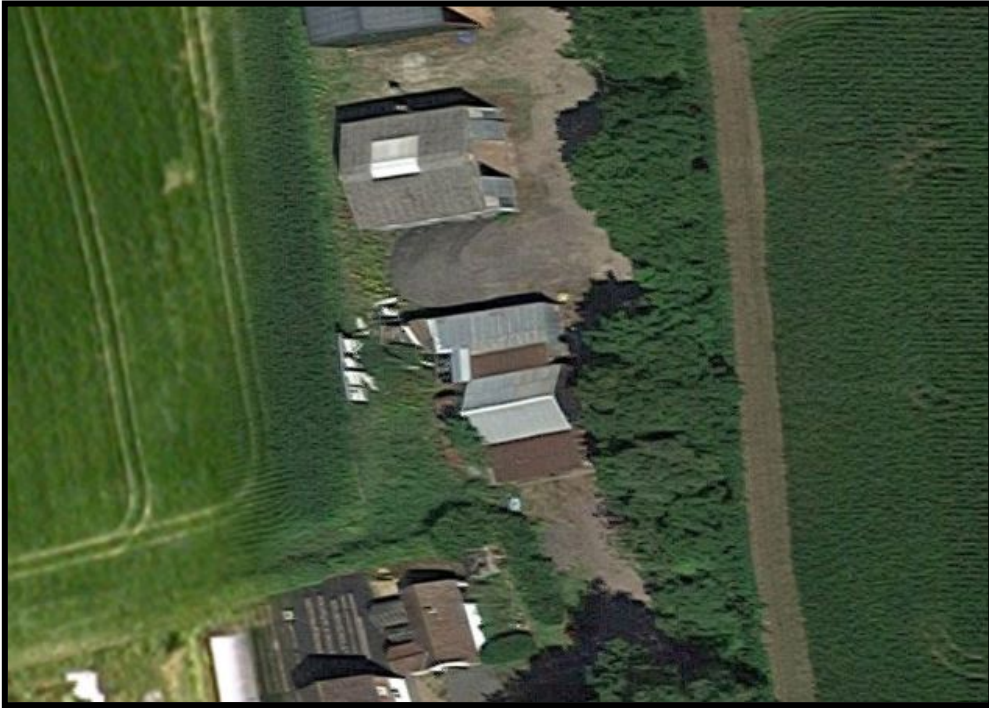
Aerial view of site
(Screenshot from Google maps)

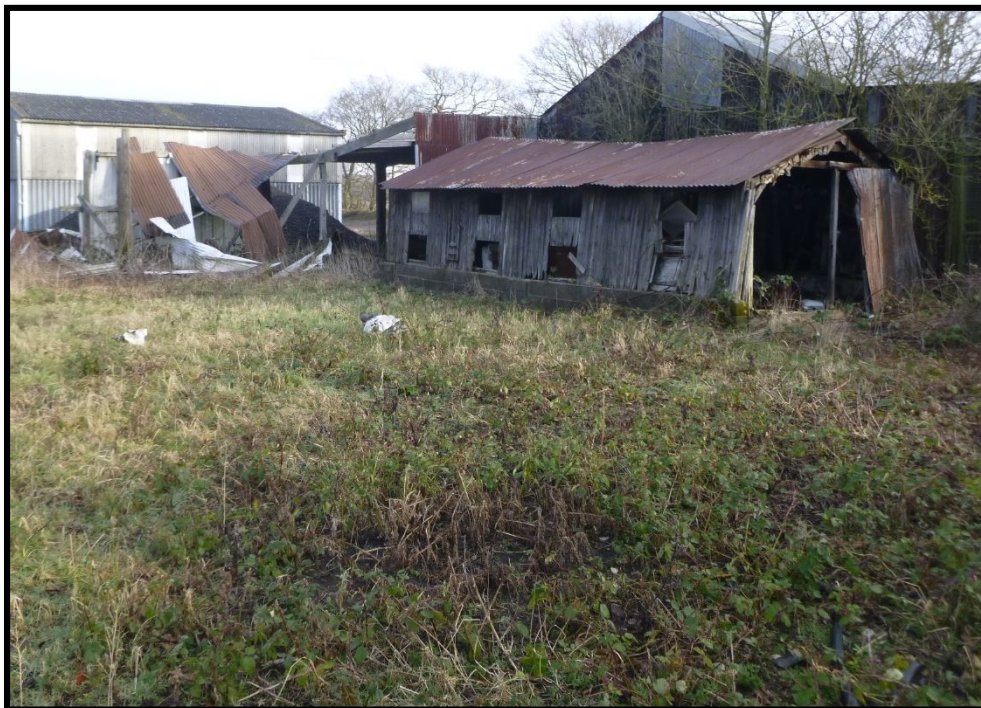
Green area to the west of existing structure

HP1 and HP2 within the green section to the west of the existing structures noted 0.3m to 0.4m thick layer of topsoil. None of the remaining hand pits or window sampler holes reveal any topsoil as anticipated.

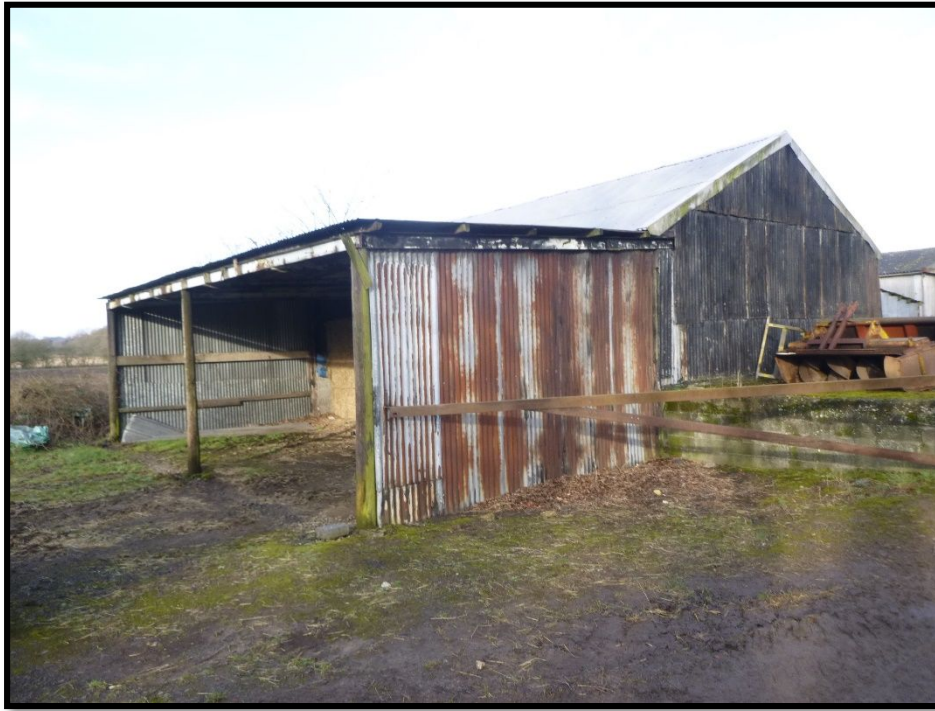
Existing structure (South east)

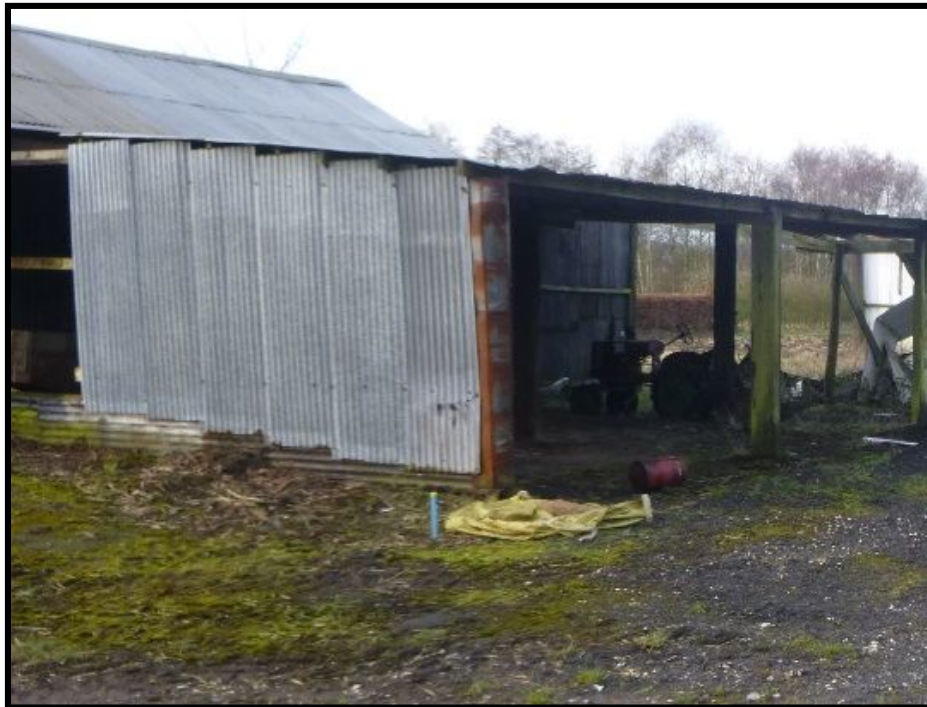
Existing structure (north)
