Phase 3- Method Statement

Mendle Farm, Holme

Title:	Method Statement Mendle Farm, Holme
Client:	Flynn Architecture c/o Mr J W Richardson
Date:	August 2020
Report number:	1260/5063/P/P3

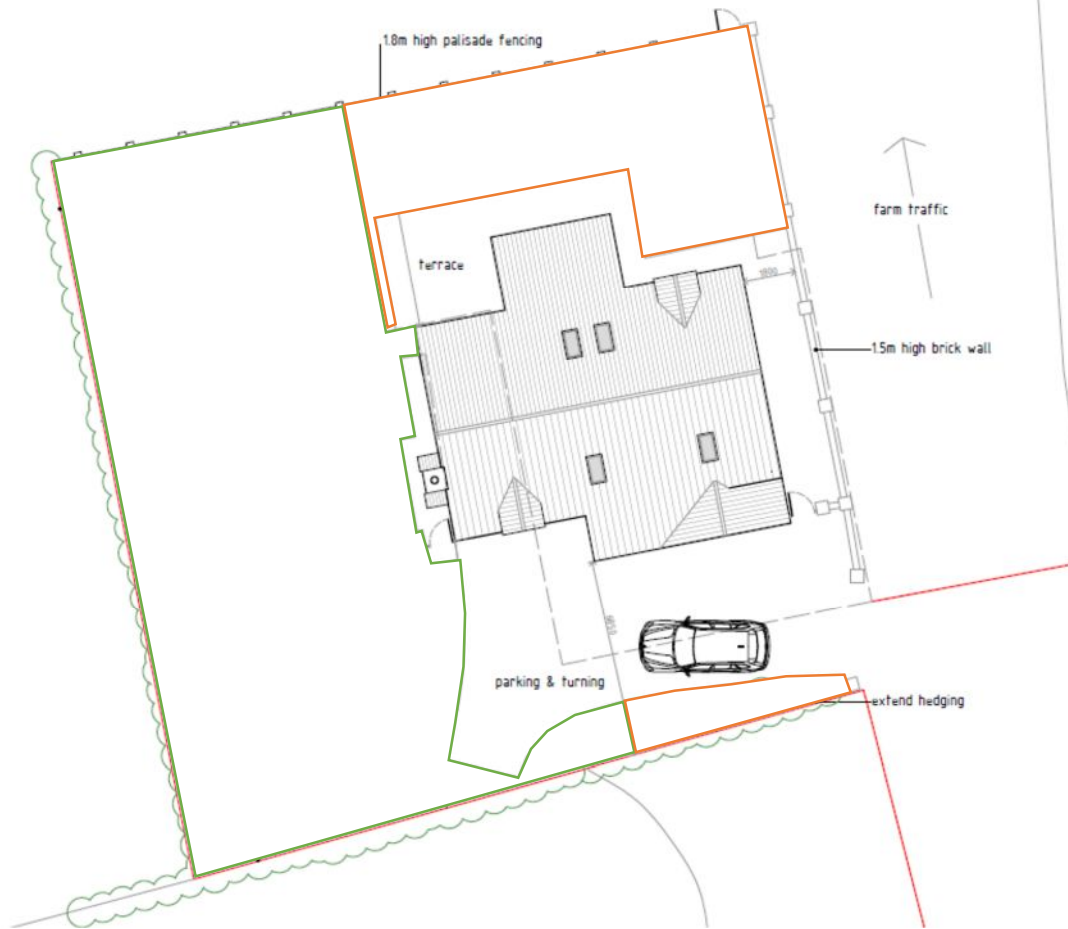
Plan 3

A site plan below shows proposed areas for remediation (orange outlined) and proposed areas of existing grassland to be retained (green outlined).

Mendle Farm, Holme – proposed development plan

Area of existing grassland

Area of granular fill / hardstanding proposed to be gardens or soft landscaping (remediation area)

5) Undertake remediation to garden areas identified (orange outlined) within plan 3 in Appendix A.

All granular fill will be removed from garden areas down to existing natural strata (silty sands) to the satisfaction of the validating engineer. Trial pits and window sampler holes show the made ground to be approximately 0.30m to 0.32m in thickness. The area of existing grassland will not require remediation (outlined in green within the below plan).

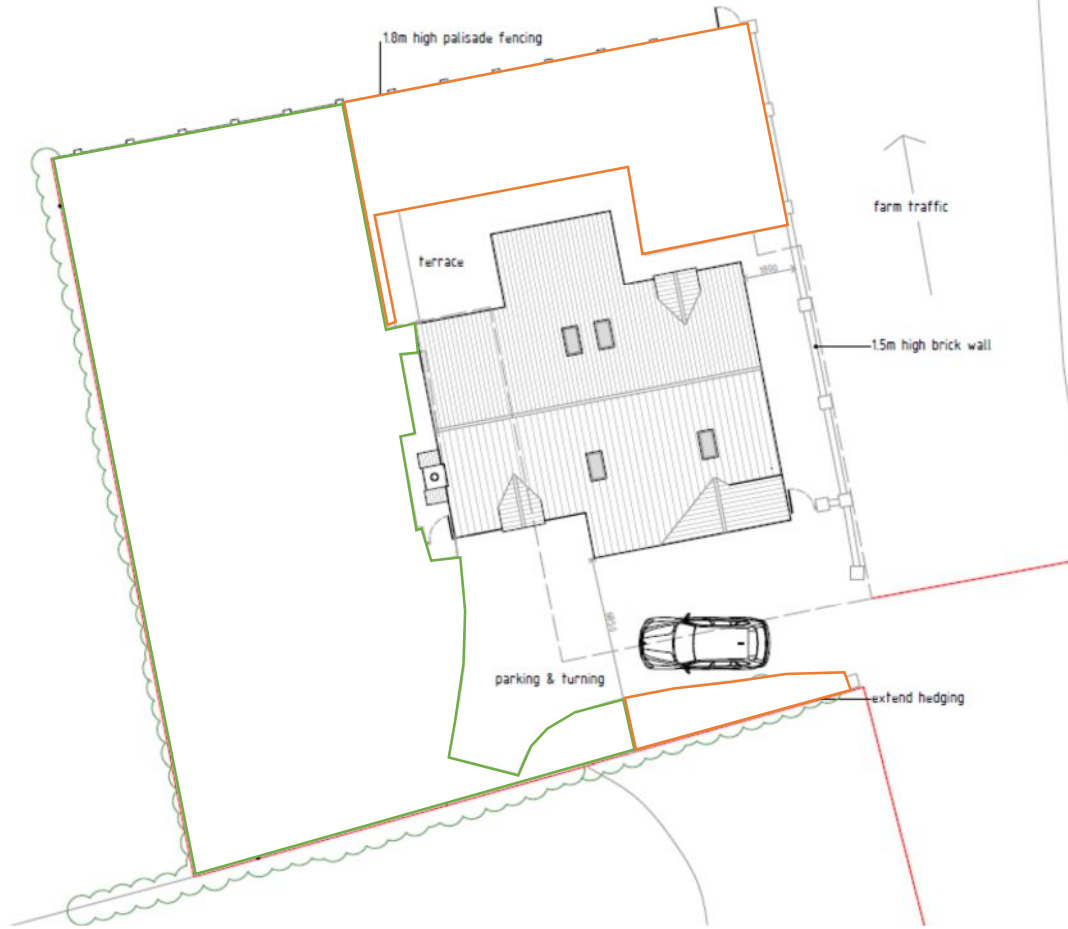
Plan 3

Mendle Farm, Holme – proposed development plan

Area of existing grassland

Area of granular fill / hardstanding proposed to be gardens or soft landscaping (remediation area)
