Our Ref: 1260/5063/P/DD01  
Date: 17 June 2025

**RE: Mendle Farm, Holme – phase 3 discussion**

This letter report provides an addendum to the above phase 3 report.

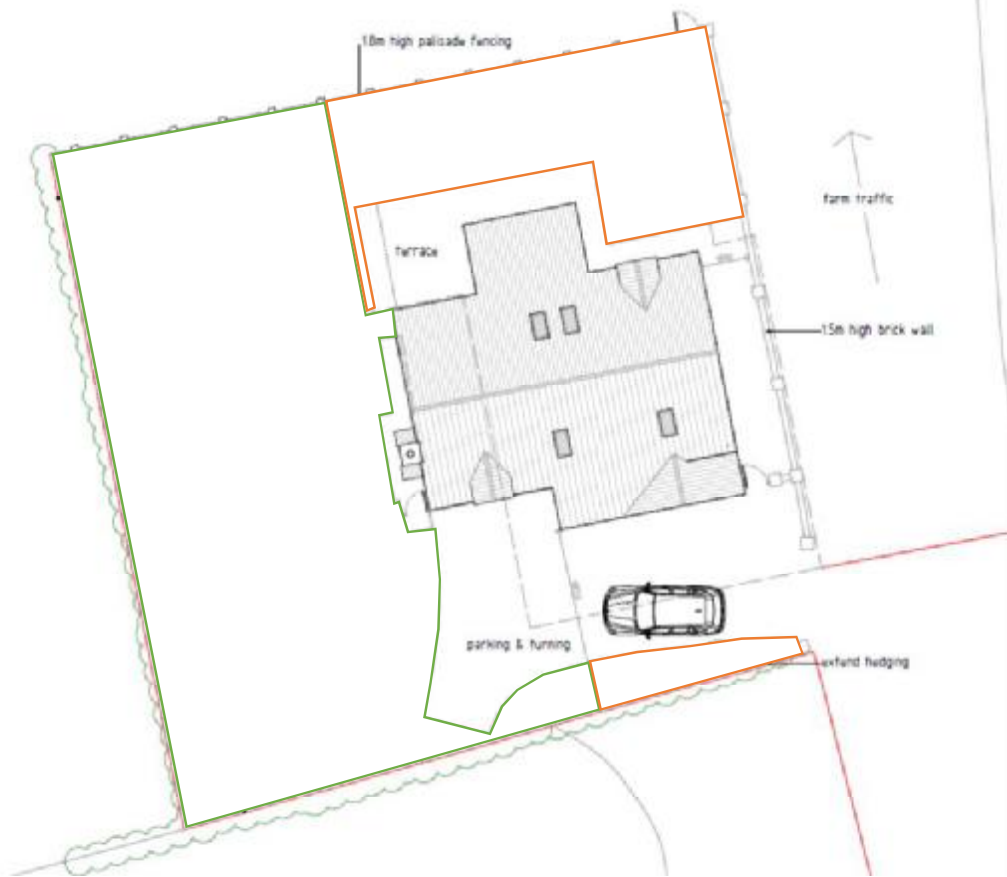
Plan 3

### Mendle Farm, Holme – proposed development plan

- Area of existing grassland
- Area of granular fill / hardstanding proposed to be gardens or soft landscaping (remediation area)

- The area identified for remediation within HML phase 3 report has not been completed with grass growth noted on the surface, a proposed remediation plan included within the phase 3 report is enclosed

The previous HML phase 3 method statement report identified a very small area on the site's southern boundary and a small area north of the proposed structure (between the proposed structure and an existing farm building). Both areas had proposed to remove existing made ground to natural soils with associated testing to mitigate migration concerns or to implement a 600mm deep cover system if natural soils showed migration of contaminants. With the site's current state and proposed new application for office structure and associated parking the proposed remediation is no longer suitable for the site.

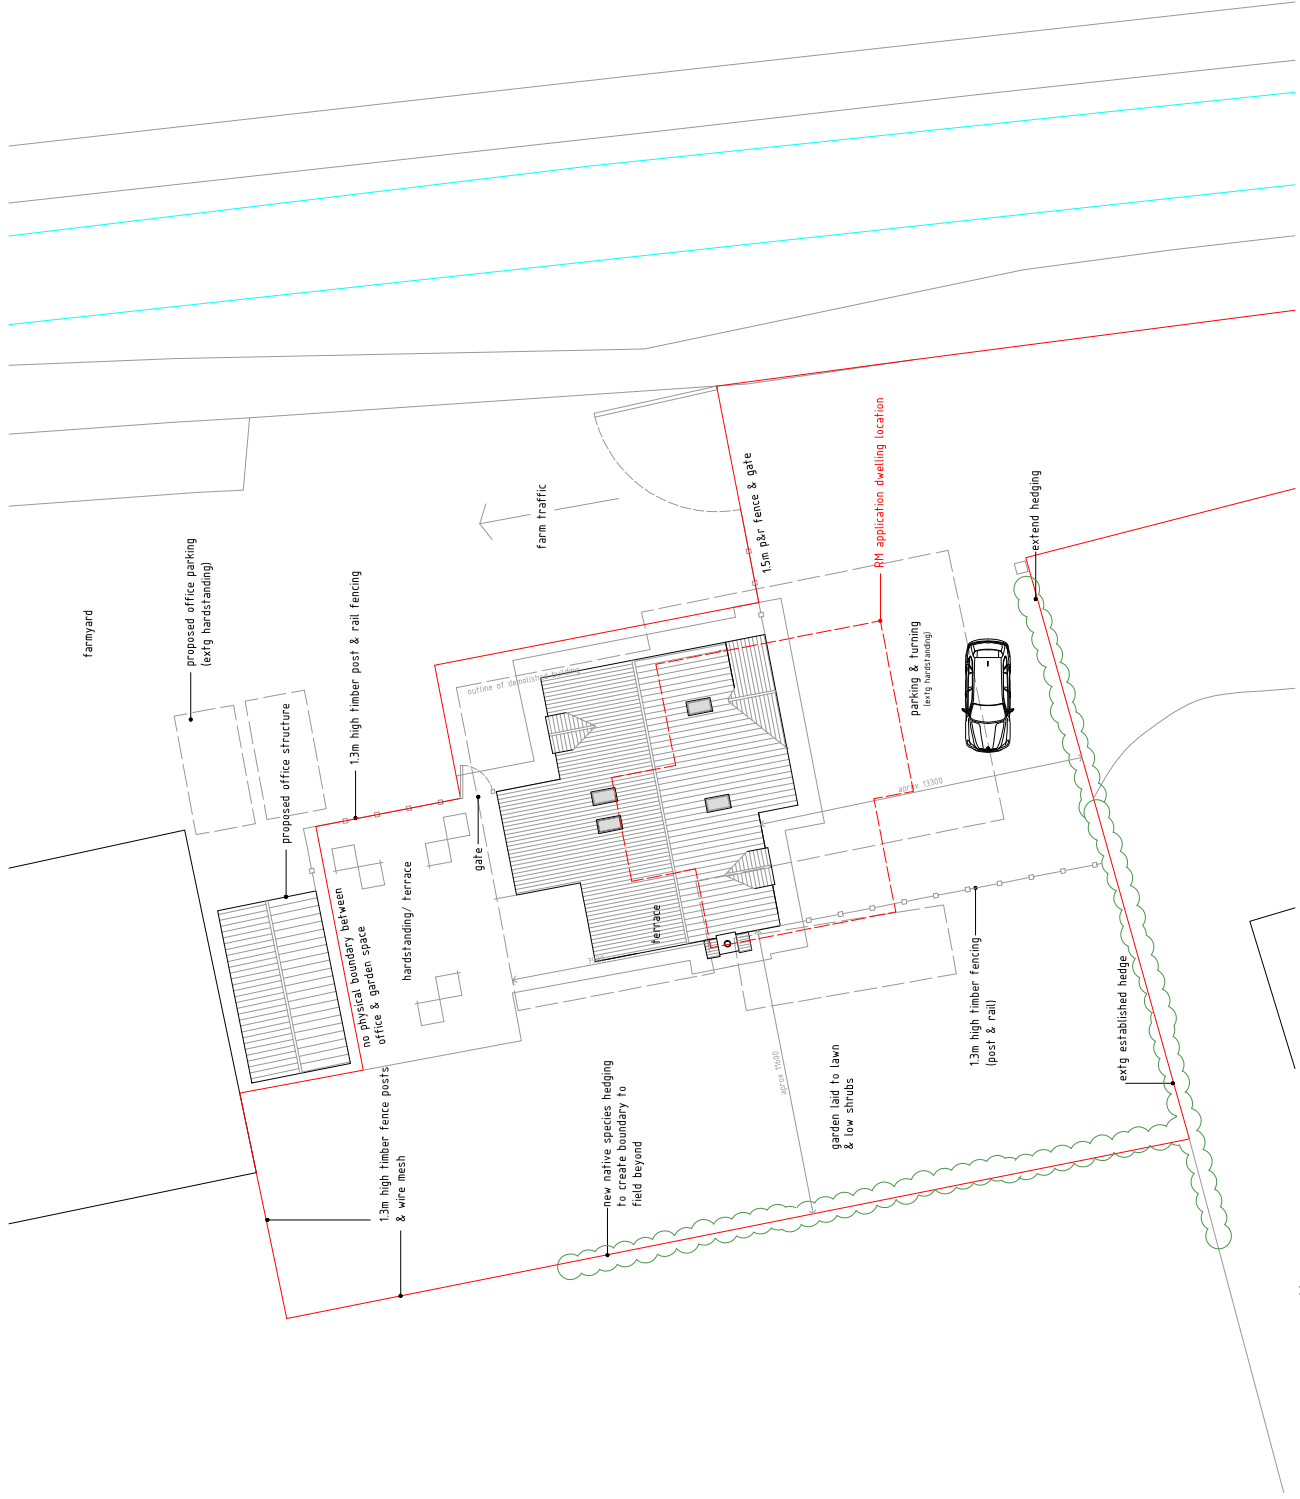
existing site layout  
 scale 1:100

Title  
 Existing site layout

- The proposed house was sited slightly north of shown location within original planning application as shown within enclosed plan (ref. HO/RI/MF/12 dated 16/05/2025)
- Hard standing to the south of the property was retained including additional area to previously planned due to the house's actual position
- Soft landscaping to the houses west and northwest has been retained as agreed within HML phase 3 report

The area on the sites southern boundary previously marked as a very small area of soft landscaping has not been implemented and is now shown as parking and turning (existing hard standing) within Flynn Architectures most recent plan (HO/RI/MF/12).

The area to the north of the proposed structure (between the proposed structure and an existing farm building) has reduced in size due to the house being located slightly north of the original planning application and a new proposed office structure with associated parking being sited adjacent the existing farm building. With this reduction of size there is no requirement to retain this area as soft landscaping especially with the sites vast soft landscaped area to the west of the property. Flynn Architectures most recent plan (HO/RI/MF/12) now shows the previously identified remediation area to be hard standing / terrace which has been suggested to consist of compacted granular fill and paving slabs.
