Archer Ecology Ltd
Office 1
Engine House
Marshalls Yard
Gainsborough
Lincolnshire
DN21 2NA

**Preliminary Roost Assessment:
Swallows Nest, Riverhead House, Redbourne**

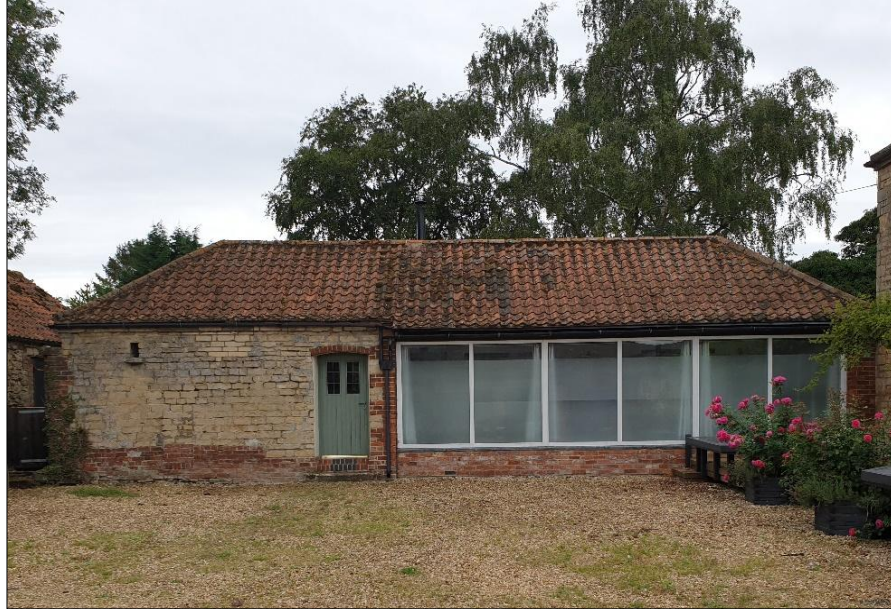
The building comprises a combined red brick and stone brick-built property with a single-pitched and hipped roof overlain with pantiles. A wooden door and large wooden framed windows are located on the eastern-facing elevation, while four Velux style windows are present within the roof (Appendix I, see Photographs 1 and 2).

Photograph 1: The property at Swallows Nest, eastern elevation

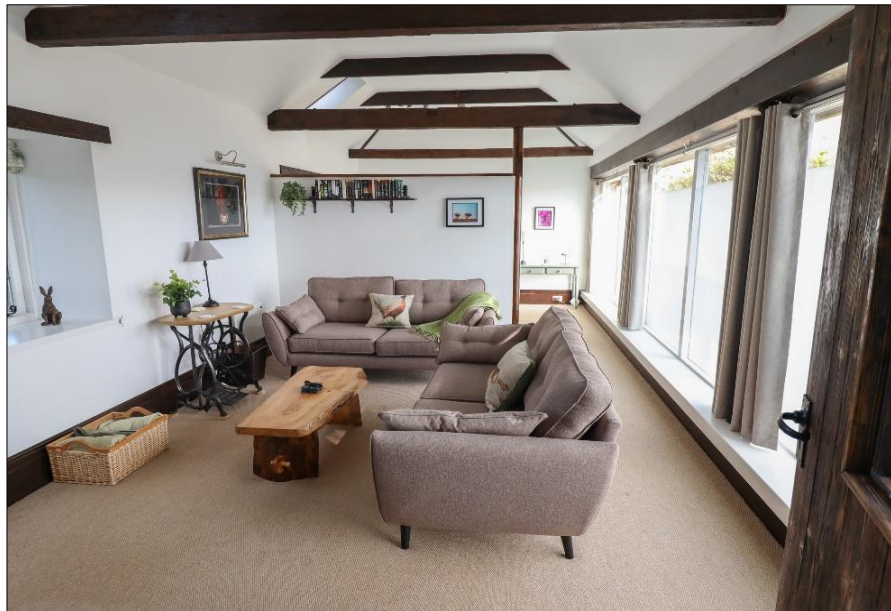
Internally, the majority of the roof space has been converted and there no longer exists a roof void. Only three very small roof voids remain although these are entirely enclosed and were appraised to be of insufficient dimension to sustain loft-dwelling species of bats. No features were found during the external assessment that could allow any of the small roof spaces to be accessed by individual bats from the outside of the property. The roof structure along the outside of these loft spaces was also observed to be consistently intact throughout. Furthermore, due to the high level of exposure to artificial lighting inside the holiday let, and natural light ingress through windows (particularly from the large windows along the eastern elevation), bat activity inside the property is expected to be deterred.

Photograph 2: View of the lounge inside the property

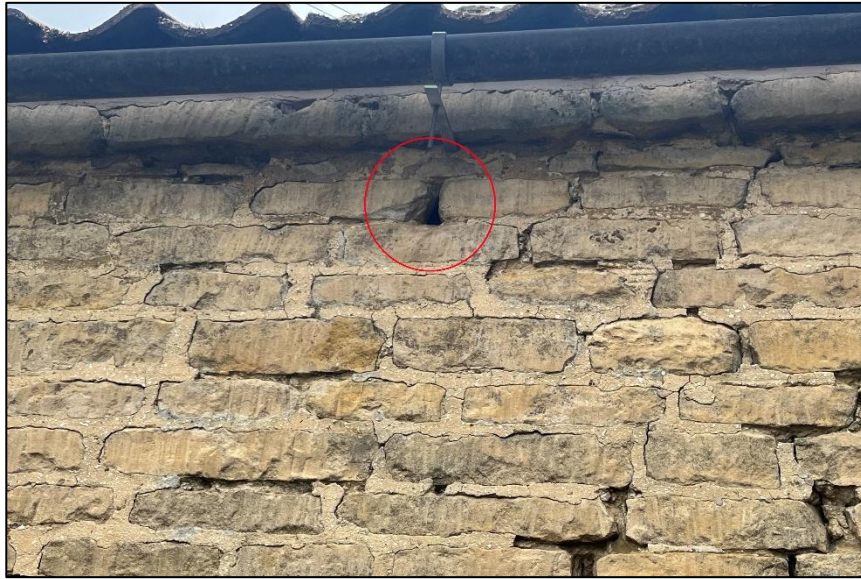
Potential roost features were identified during the external assessment, with gaps recorded between the stone bricks and mortar (Appendix I, see Photographs 3 and 4). Therefore, the property is appraised as having 'low potential to support bat roosts in line with current BCT guidelines. However, no evidence of roosting activity, such as droppings or urine staining was found to be associated with these features.

Photograph 3: A potential roost feature within the stonework on the northern elevation of the property (circled in red)

It is understood that no subsequent works are proposed to be undertaken at the property. Subsequently, the PRFs identified during the PRA will not be affected and potential impacts to bats are considered to be negligible; Therefore, there are no further constraints pertaining to roosting bats.

However, as an optional enhancement, it is recommended that a single bat box is installed on the exterior of the property to enhance the site for local populations of bat by providing an additional roosting feature. The Schwegler 2F bat box is recommended as an industry standard. This should be installed underneath the eaves of the southern elevation, at a minimum height of 3–4 metres, where there is a clear horizontal approach provided for bats to easily access and exit the box.

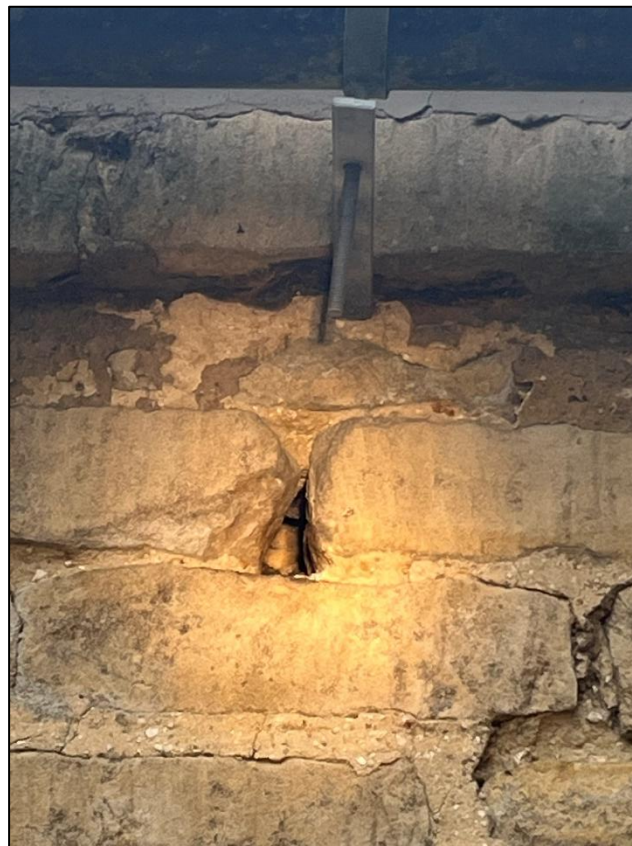
Photograph 4: A potential roost feature within the stonework on the northern elevation of the property (close up)
