# Phase 3 Remediation Options Appraisal

27 September 2025

## **Stephan North**

Land between Nasza Chata and Fairlawns, Jericho Lane, East Halton, DN40 3PZ

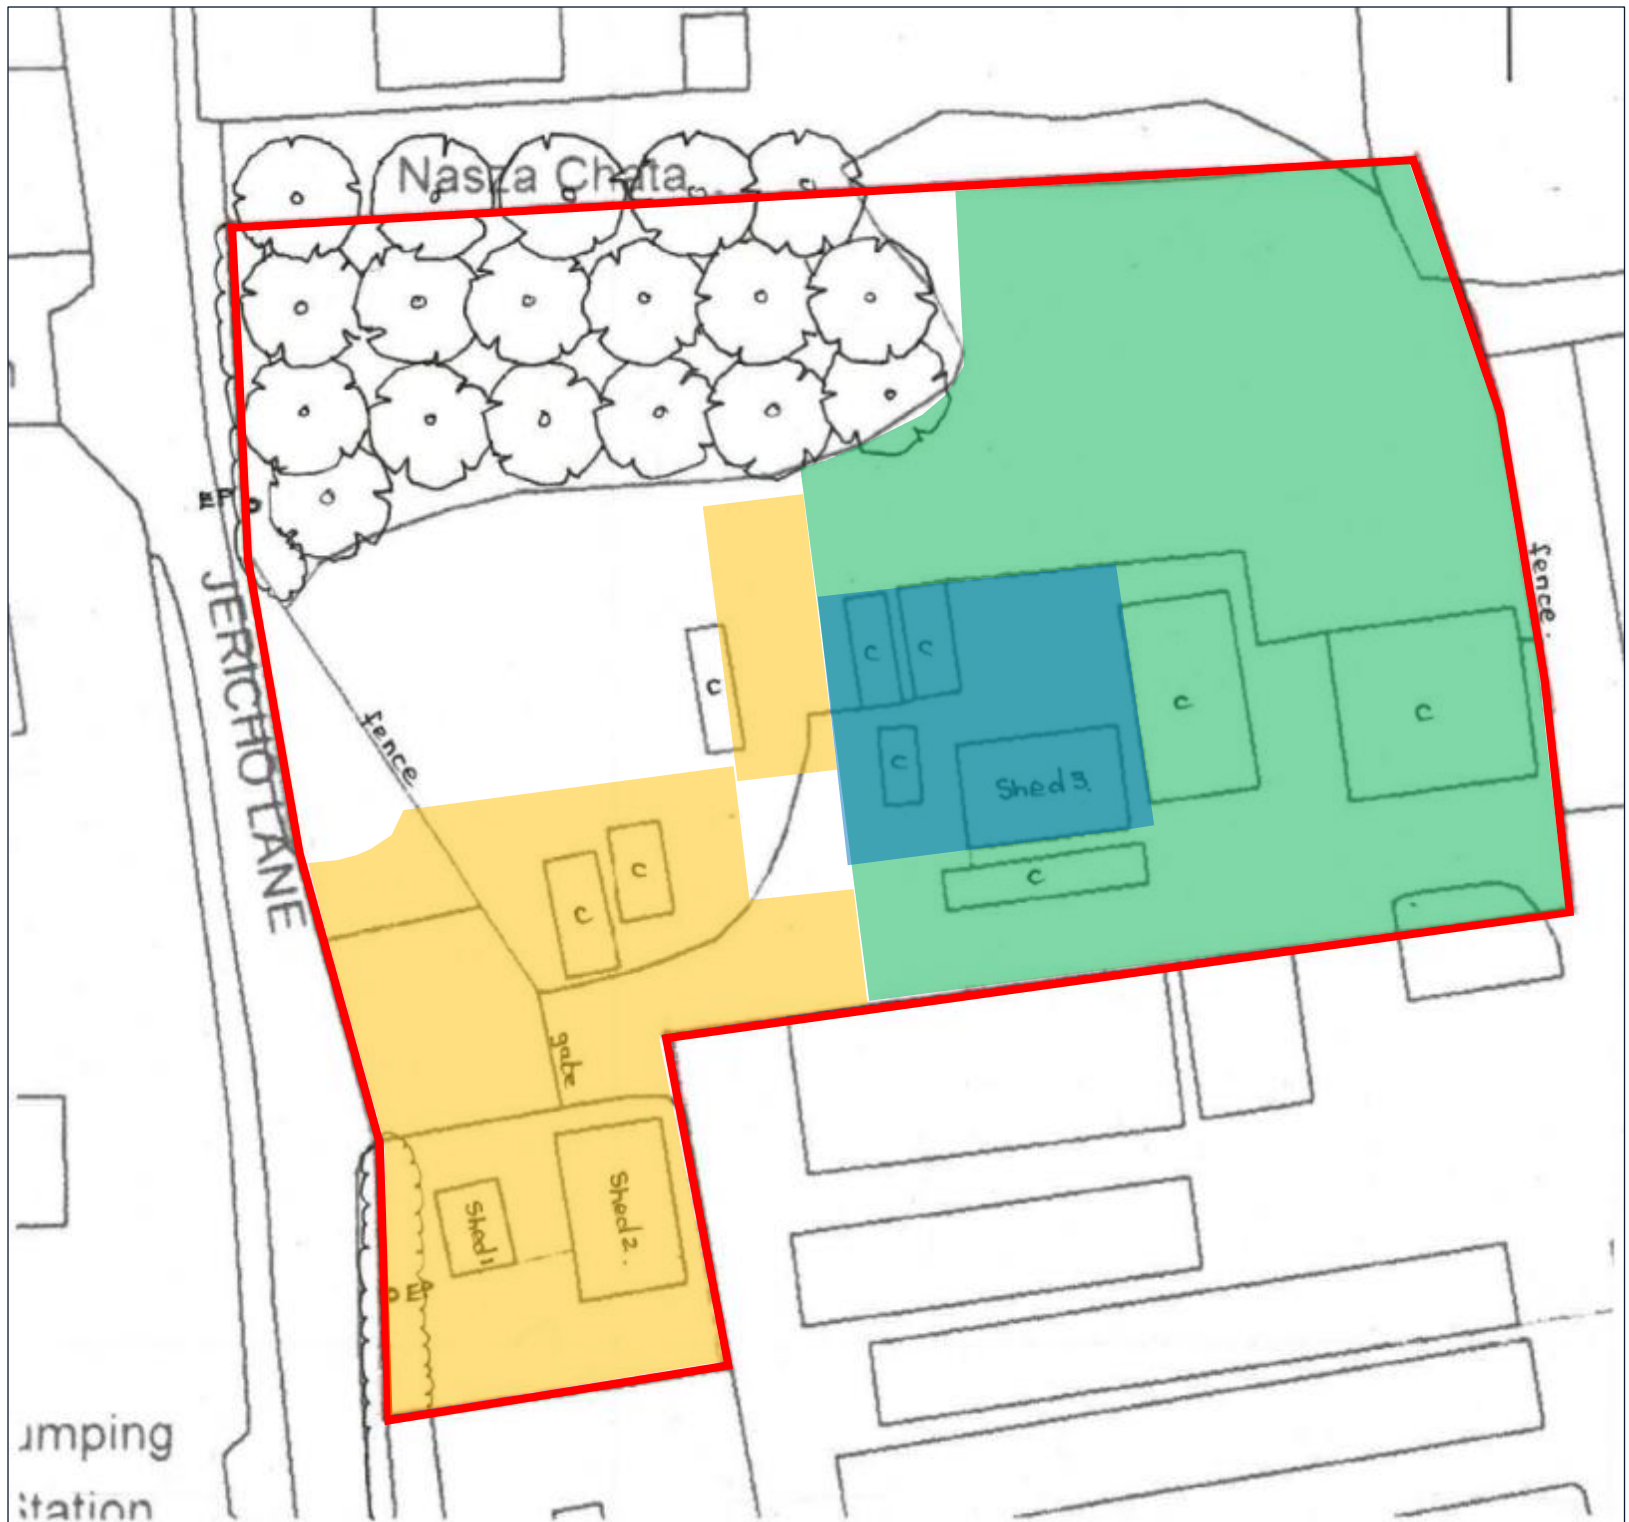
Appendix - Site Maps & Plans	
Description	
Proposed site plan showing required excavation, clean cover and additional hardstanding areas	
Sources	
Tony Vessey	
Key	
 	Site boundary
 	Extent of required 600mm clean cover

Extent of required made ground excavation (in areas of proposed soft landscaping only)
 	Extent of required hardstanding

Excavation should be carried out to ensure all made ground in proposed soft landscaping is removed. There is no minimum requirement for the depth of clean cover provided that it allows for an adequate depth for growth of plants, however, a minimum depth of 600mm clean cover is required where a localised area of hydrocarbon contamination was identified (around TP08), as shown on plans in the Appendix.

Considering site access, parking and building areas are located at the south west of the site, it is recommended to install hardstanding instead of soft landscaping in this area, as shown on plans in the Appendix.

Excavation and off-site disposal of contaminated made ground in all areas of proposed soft landscaping should be carried out, as shown on plans in the Appendix, following this, containment should be carried out, through placement of imported clean material. The Phase 2 Intrusive Site Investigation found the depth of made ground to be approximately 300mm across the contaminated areas at the site. Following the removal of made ground, there is no minimum requirement for the depth of clean cover provided that it allows for an adequate depth for growth of plants, however, a minimum depth of 600mm clean cover is required where a localised area of hydrocarbon contamination was identified (around TP08), as shown on plans in the Appendix.

Considering site access, parking and building areas are located at the south west of the site, it is recommended to install hardstanding instead of soft landscaping in this area, as shown on plans in the Appendix, in addition, a hi-vis non-woven geotextile membrane should be installed below the hardstanding layer to warn future developers and site users.

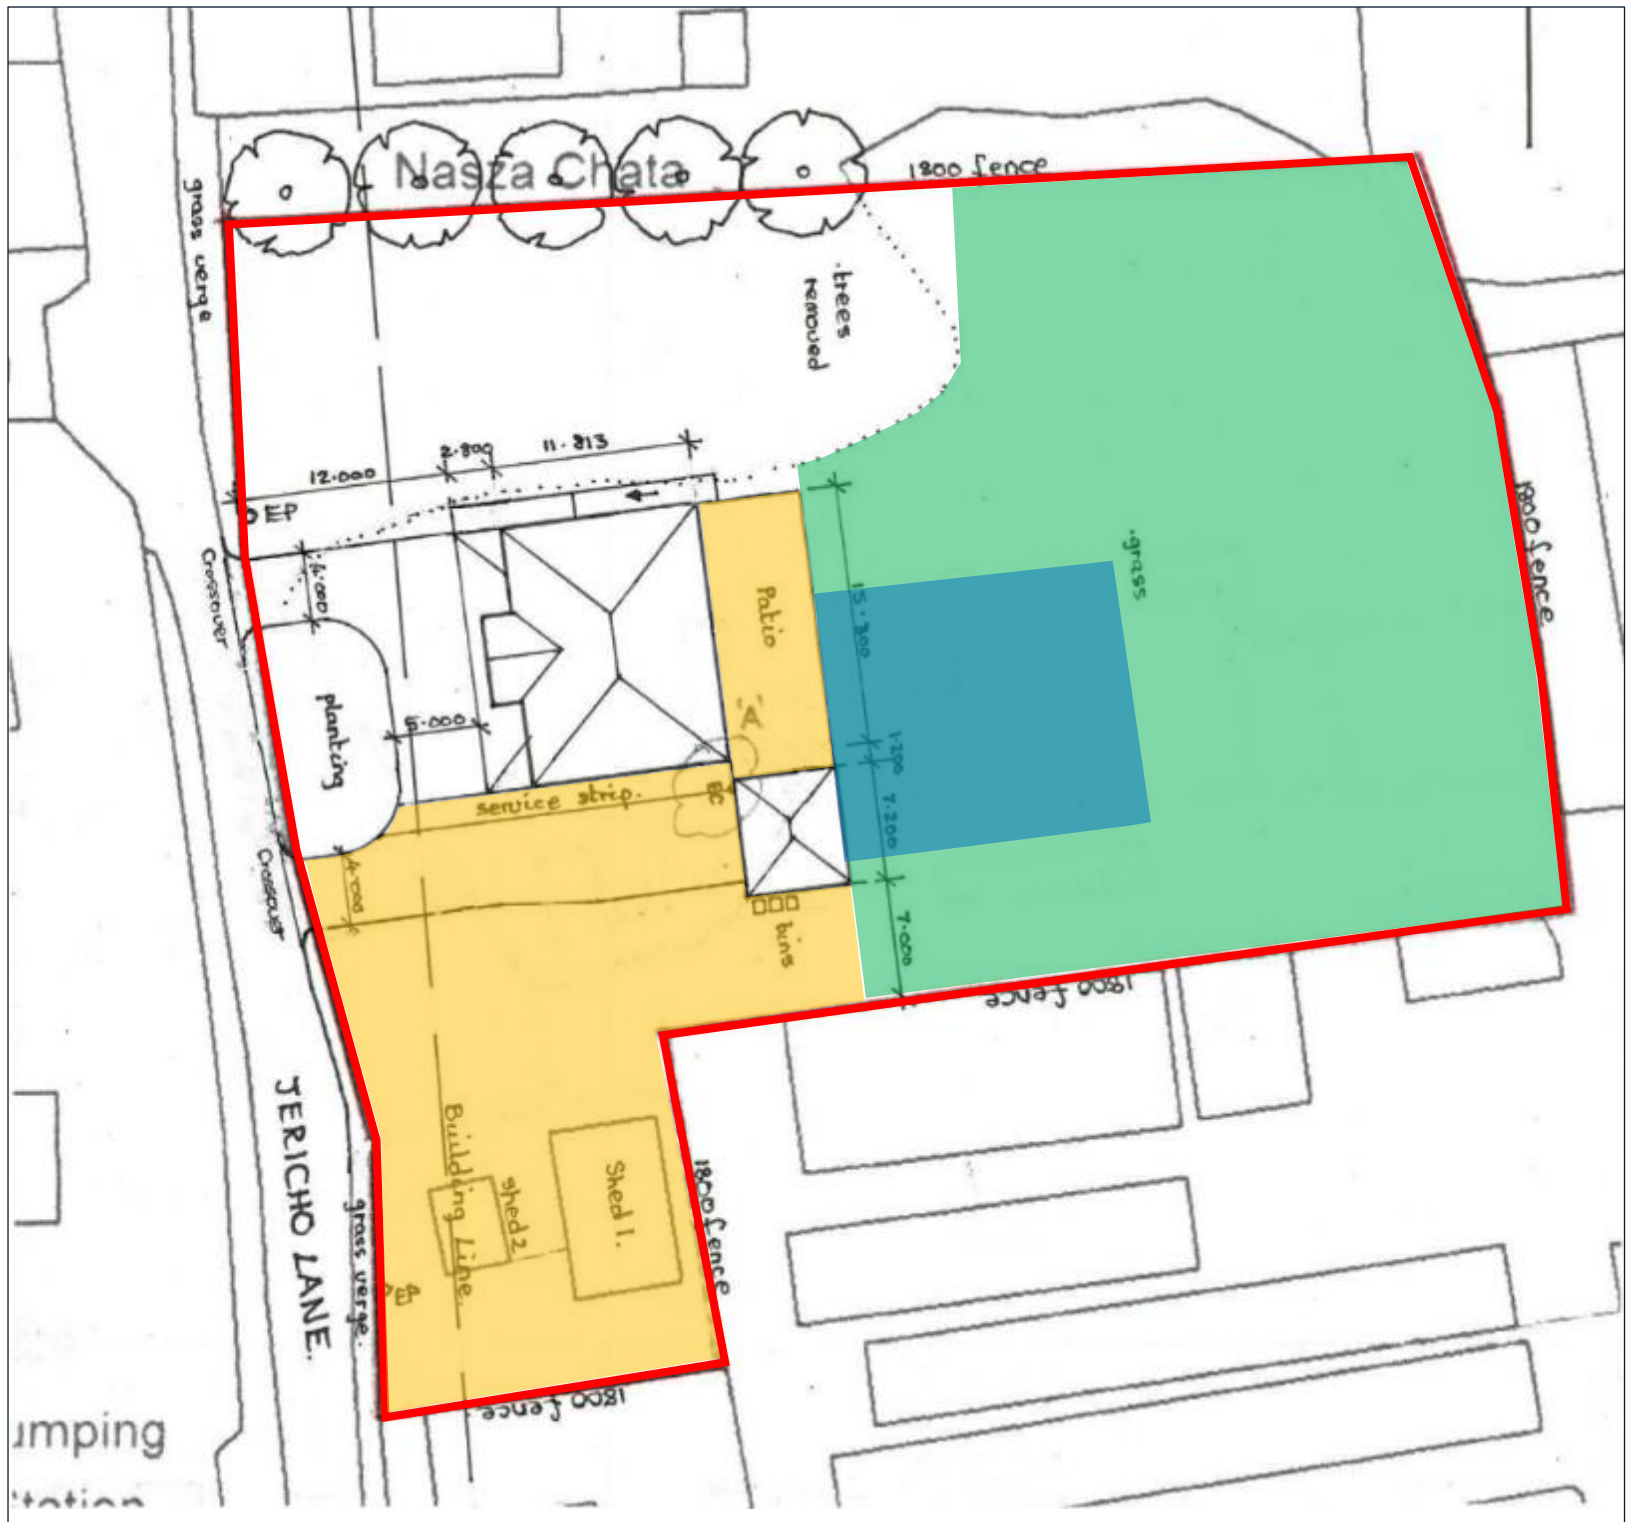
Appendix - Site Maps & Plans	
Description	
Proposed site plan showing required excavation, clean cover and additional hardstanding areas	
Sources	
Tony Vessey	
Key	
 	Site boundary
 	Extent of required 600mm clean cover

Extent of required made ground excavation (in areas of proposed soft landscaping only)

Extent of required hardstanding
 	North
