**Geotechnical & geoenvironmental (ground investigation)
assessment report**

Land off Applefields, Wrawby (Second Phase)

Produced for Keigar Homes

August 2025

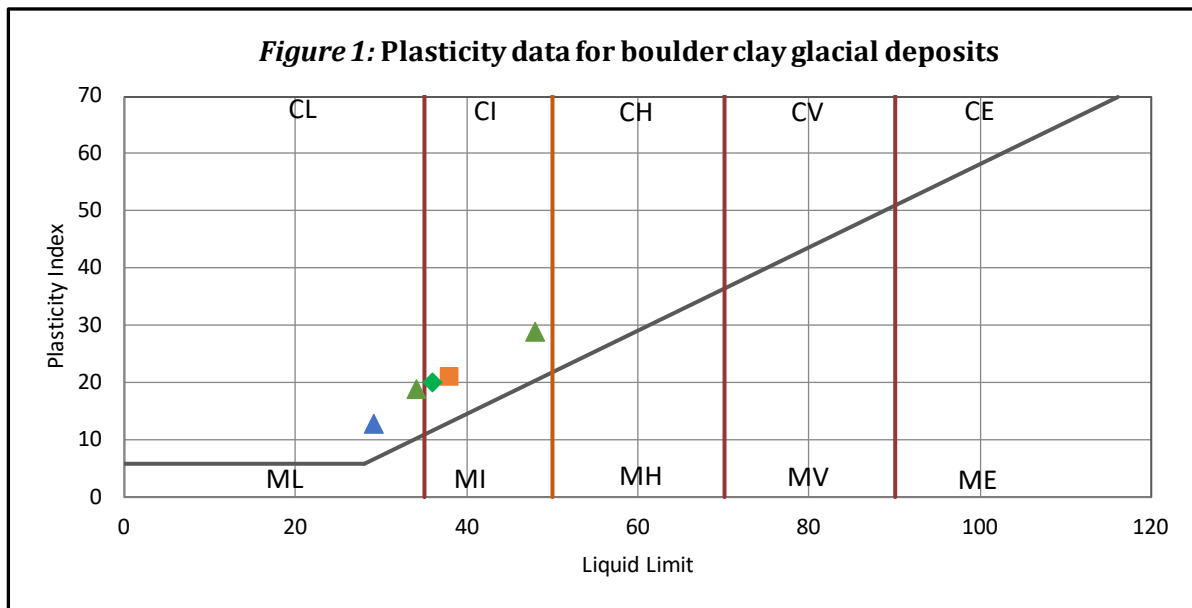
The plasticity data for the boulder clay, as shown below (in Figure 1), suggests the soil material could be a low to intermediate plasticity clay. The location of the sample data points on the chart (just above the A-line) is indicative of a clay or a silty clay.

The calculated modified plasticity index (i.e. the plasticity index multiplied by the fraction of sample passing a 425µm sieve) of the boulder clay is between 9.5% and 21% as shown above (in Table 7). The mean average is 17%.

Previous HML sampling and testing on similar glacial clay material in 2022 adjacent to the site yielded modified plasticity indexes of between 6% and 10%. Therefore, while the glacial deposits material is shrinkable, it could be safely categorised as being of **low volume change potential** (for example, as defined by NHBC Standards) – which seems

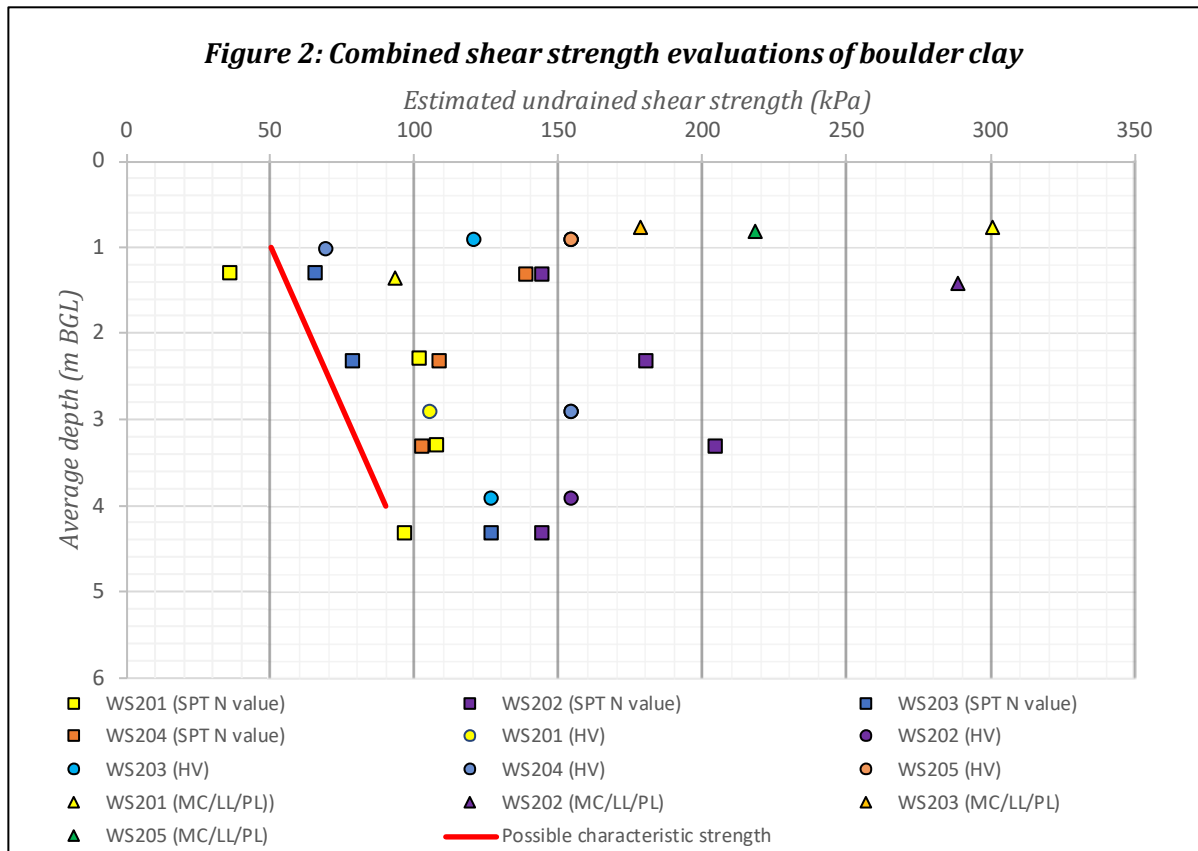
Table 11: Boulder clay – estimated undrained shear strength from SPTs				
Borehole	SPT start depth (m BEGL)	Average N value test depth (m BEGL)	SPT N value (blows/300mm)	Estimated undrained shear strength (kPa)
WS201	1.00	1.30	6	36
	2.00	2.30	17	102
	3.00	3.30	18	108
	4.00	4.30	16	96
WS202	1.00	1.30	24	144
	2.00	2.30	30	180
	3.00	3.30	34	204
	4.00	4.30	24	144
WS203	1.00	1.30	11	66
	2.00	2.30	13	78
	4.00	4.30	21	126
WS204	1.00	1.30	23	138
	2.00	2.30	18	108
	3.00	3.30	17	102
	4.00	4.30	21+	-
WS205	1.00	1.30	11+	-
	2.00	2.30	12+	-
	3.00	3.30	16+	-
	4.00	4.30	22+	-

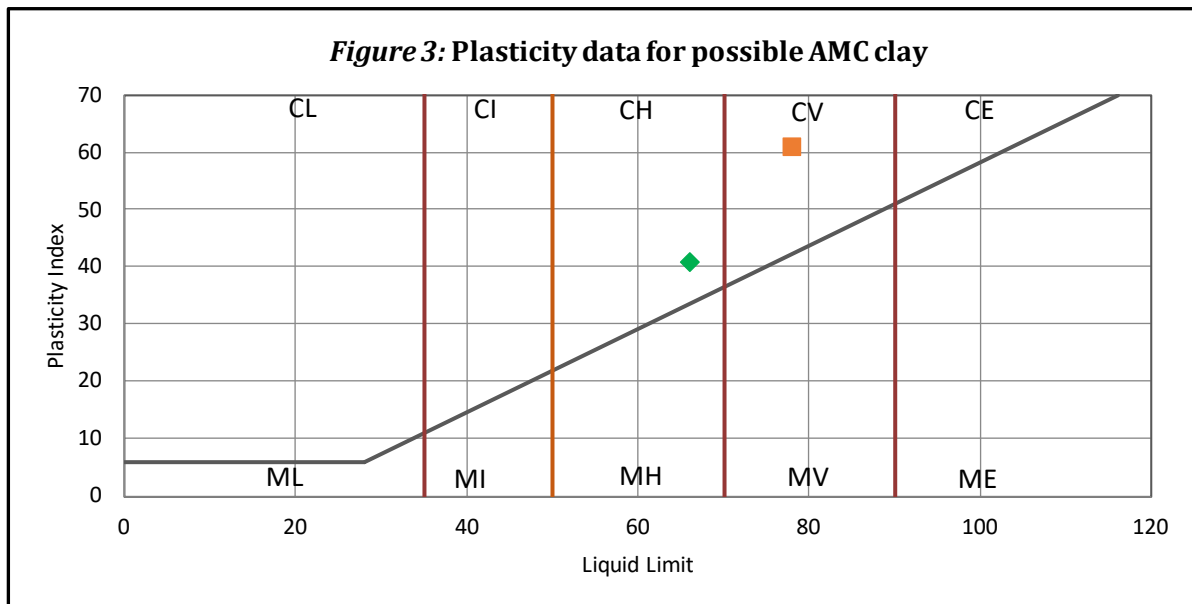
The plasticity data for the possible AMC clay, as shown below (in Figure 3), suggests the soil material could be a high to very high plasticity clay. The location of the sample data points on the chart (just above or far above the A-line) is indicative of a clay or a silty clay.

The calculated modified plasticity index (i.e. the plasticity index multiplied by the fraction of sample passing a 425µm sieve) of the possible AMC clay is between 41% and 60% as shown above (in Table 12). Therefore, the material is shrinkable and – using the

available data – and could be conservatively categorised as being of **high volume change potential** (for example, as defined by NHBC Standards).

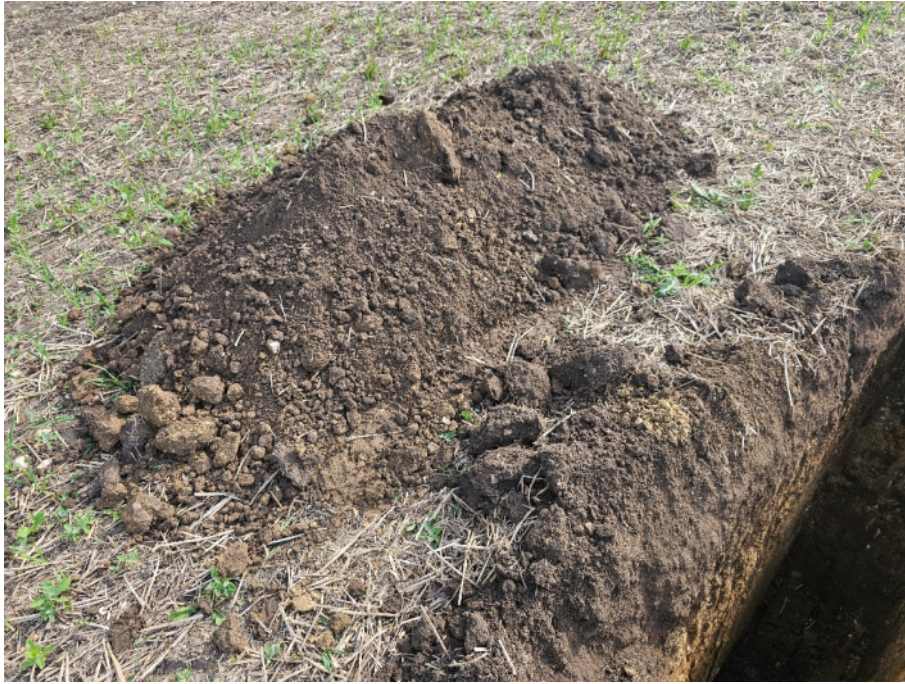
Site investigation photo: 3 *Date: 27 Jun 2025*
Photo direction: -
Description: Topsoil/subsoil from TP201

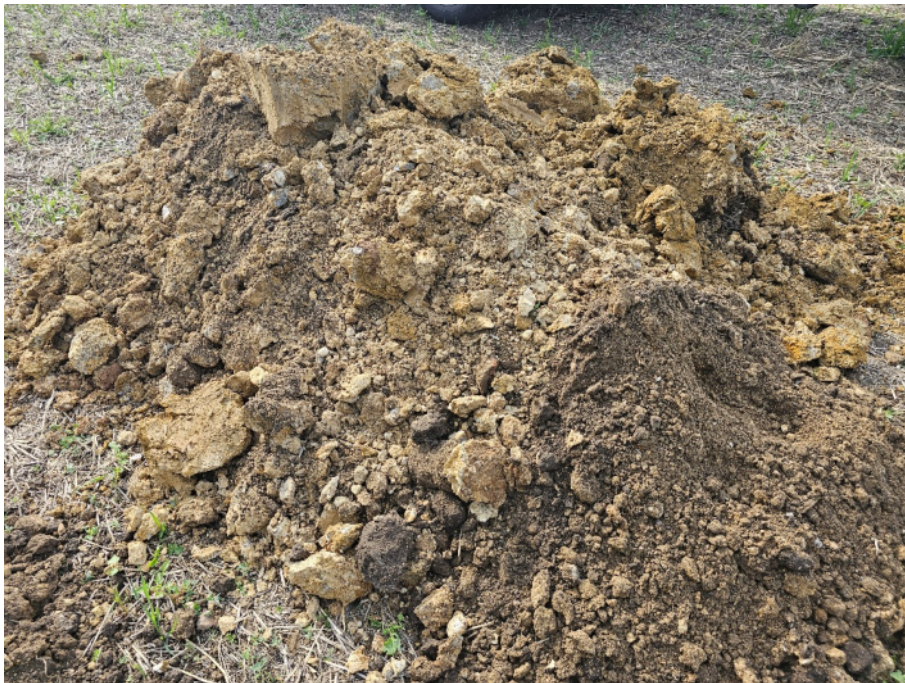
Site investigation photo: 4 *Date: 27 Jun 2025*
Photo direction: -
Description: Glacial deposits from TP201

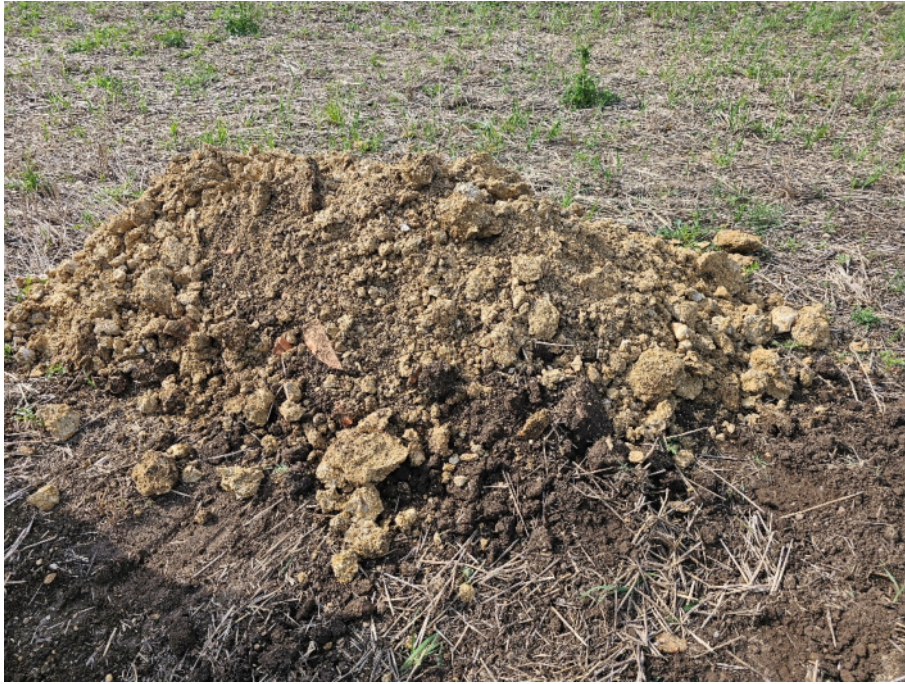
Site investigation photo: 11 *Date: 27 Jun 2025*
Photo direction: -
Description: Light brown sandy gravelly silt and clay glacial deposits from TP203

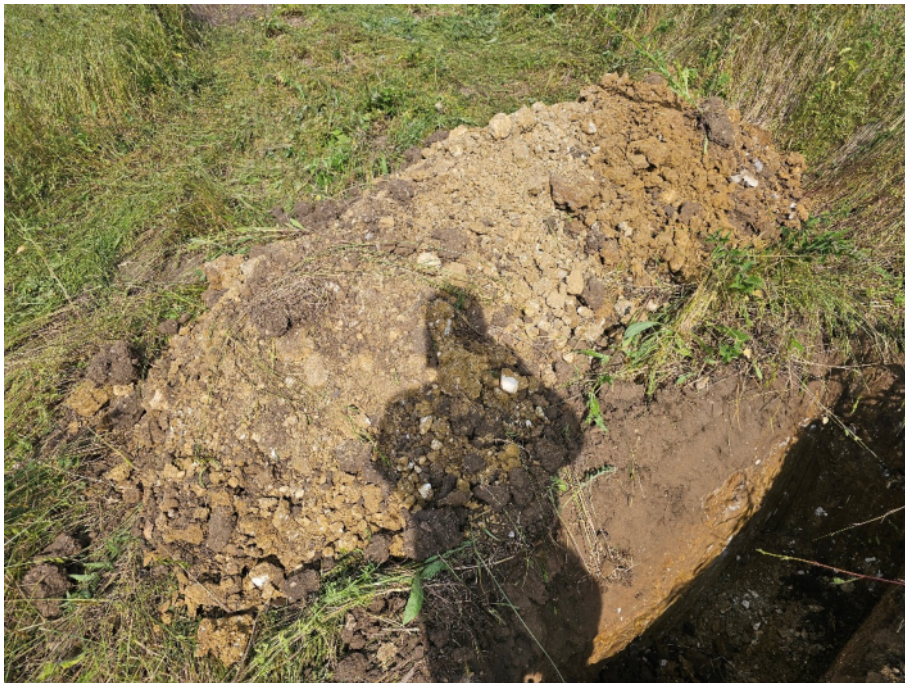
Site investigation photo: 14
Photo direction: -
Description: spoil from TP204

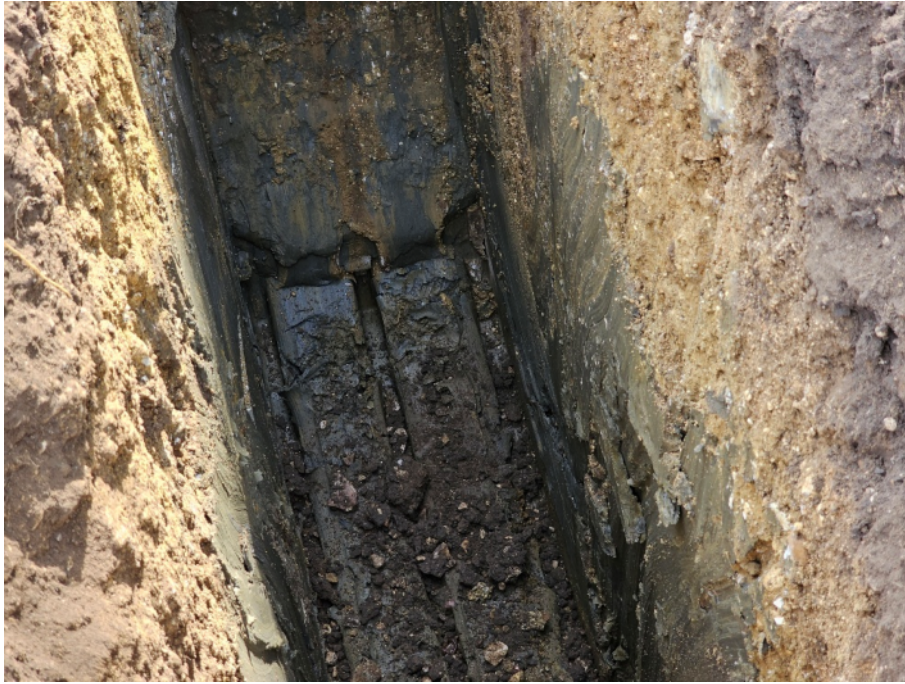
Site investigation photo: 17 *Date: 27 Jun 2025*
Photo direction: -
Description: TP205 – close up of possible weathered mudstone / stiff clay

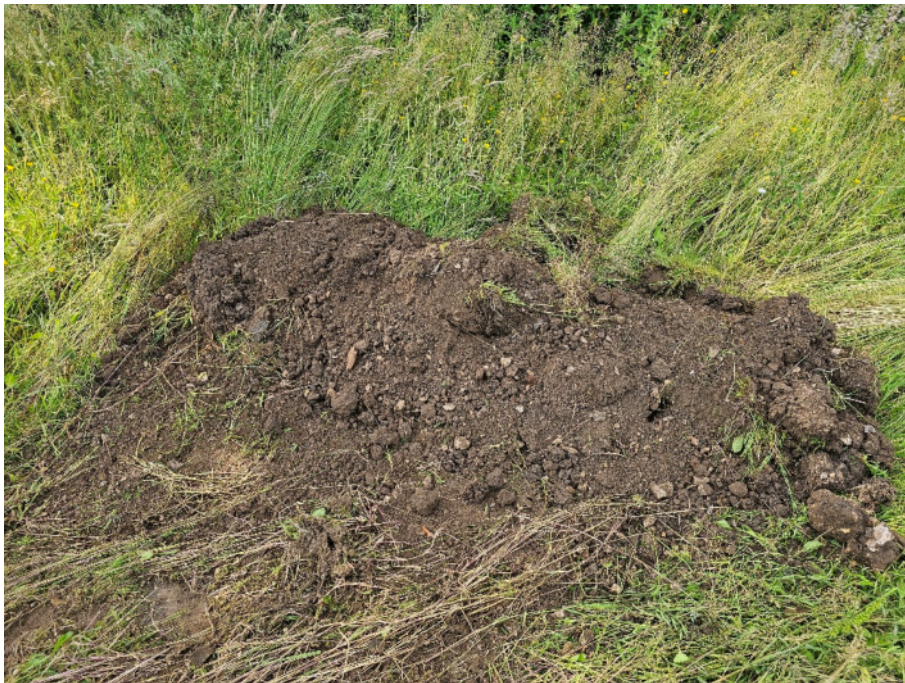
Site investigation photo: 18 *Date: 27 Jun 2025*
Photo direction: -
Description: Topsoil/subsoil from TP205

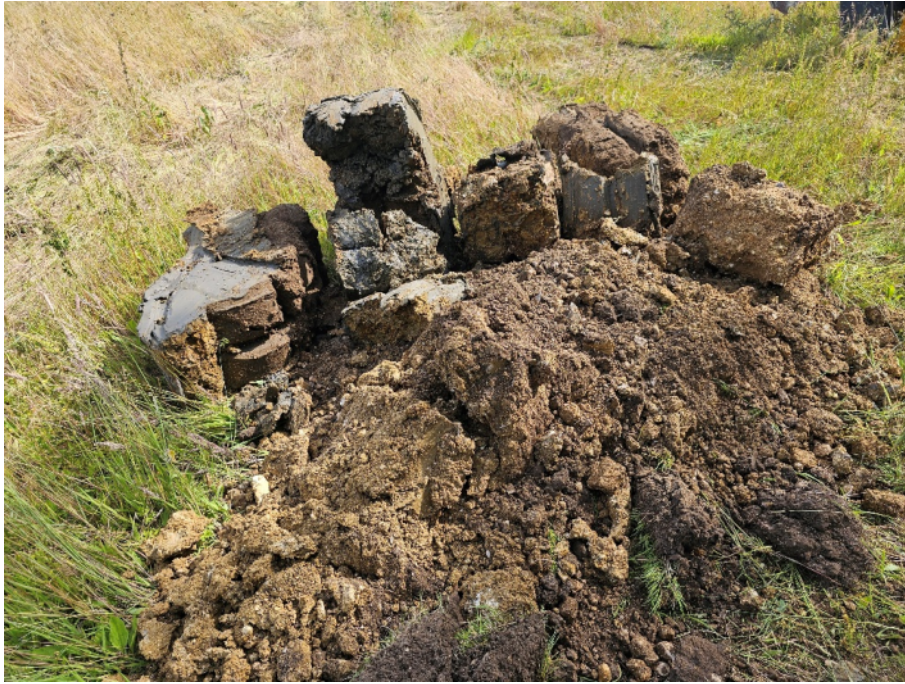
Site investigation photo: 19 *Date: 27 Jun 2025*
Photo direction: -
Description: Light brown glacial deposits and deeper grey possible weathered mudstone clay from TP205

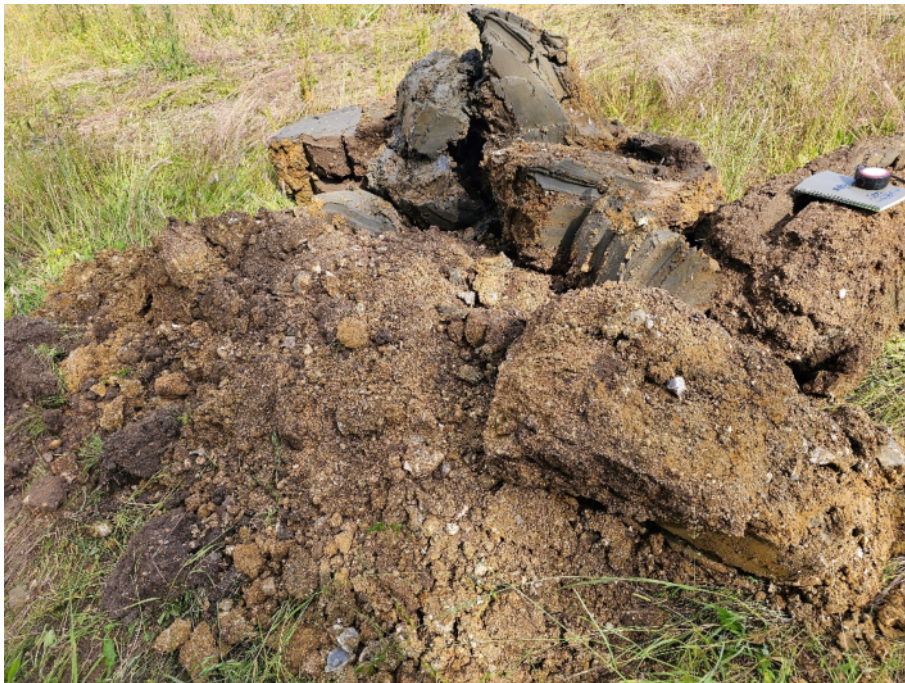
Site investigation photo: 20 *Date: 27 Jun 2025*
Photo direction: -
Description: Light brown glacial deposits and deeper grey possible weathered mudstone clay from TP205

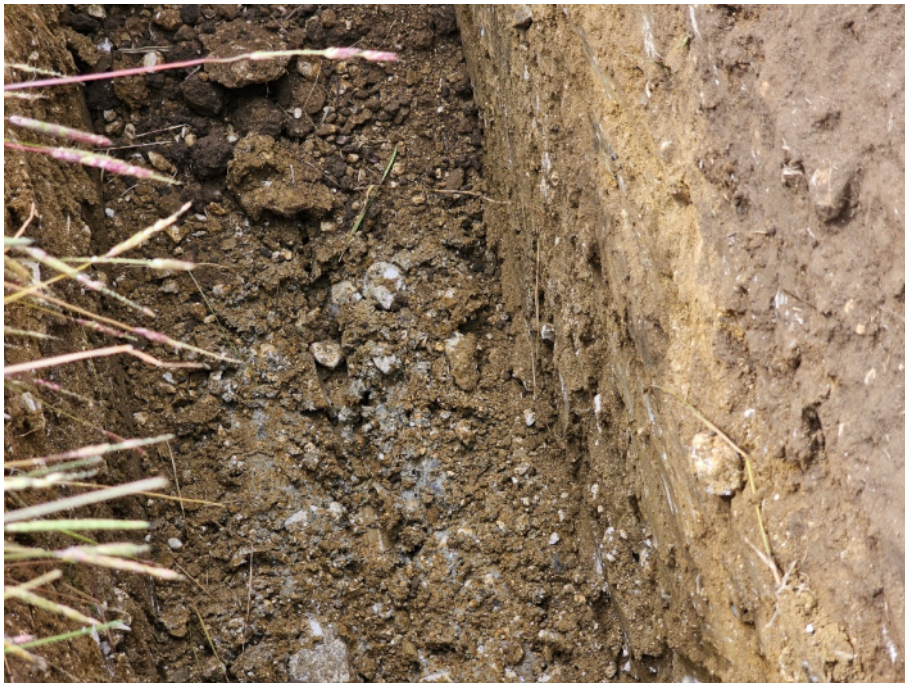
Site investigation photo: 22
Photo direction: -
*Description: TP206 – close-up of light brown sandy
gravelly boulder clay*

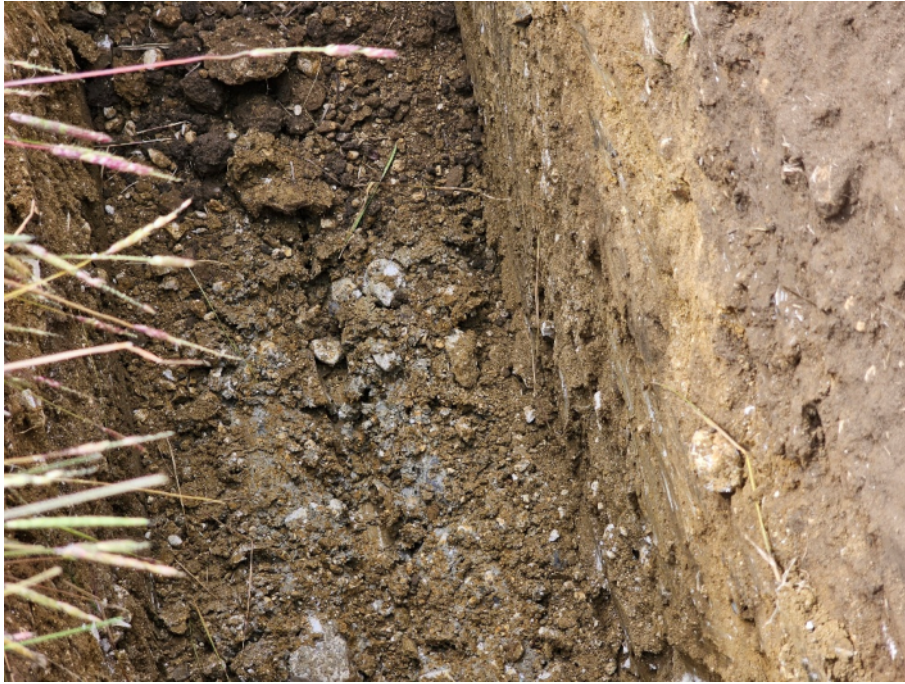
Site investigation photo: 23 *Date: 27 Jun 2025*
Photo direction: -
Description: TP206 – close-up of light brown sandy gravelly boulder clay

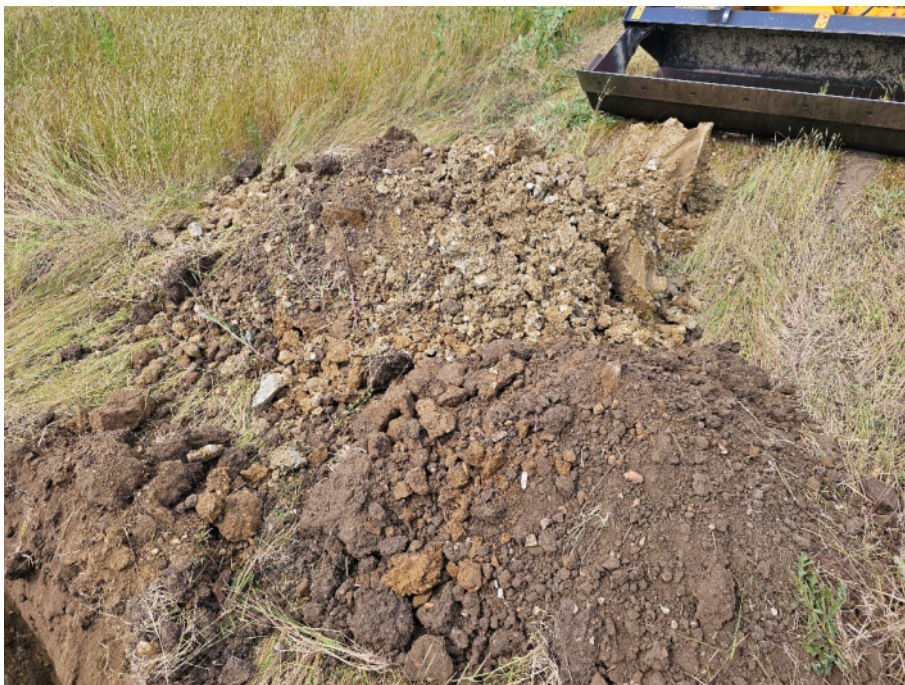
Site investigation photo: 24 *Date: 27 Jun 2025*
Photo direction: -
Description: TP206 – spoil
