**Whitcher Wildlife Ltd.
Ecological Consultants.**

10 GATEHOUSE, BYSTABLE LANE.

**BAT SURVEY REPORT AND MITIGATION
STRATEGY.**

Ref No: 230574/MIT.

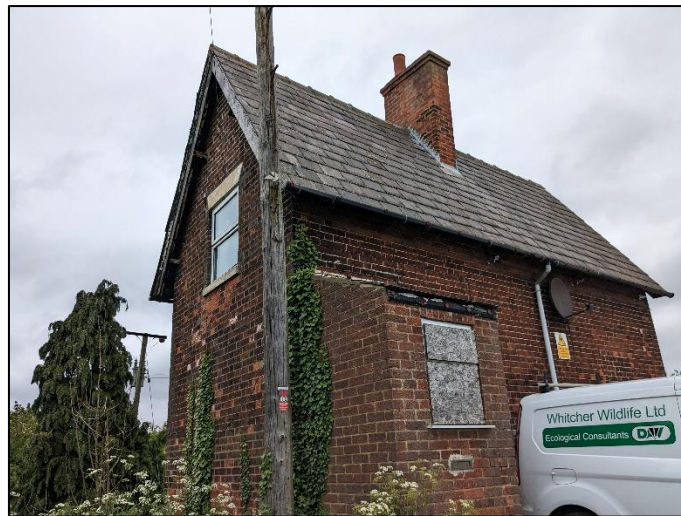
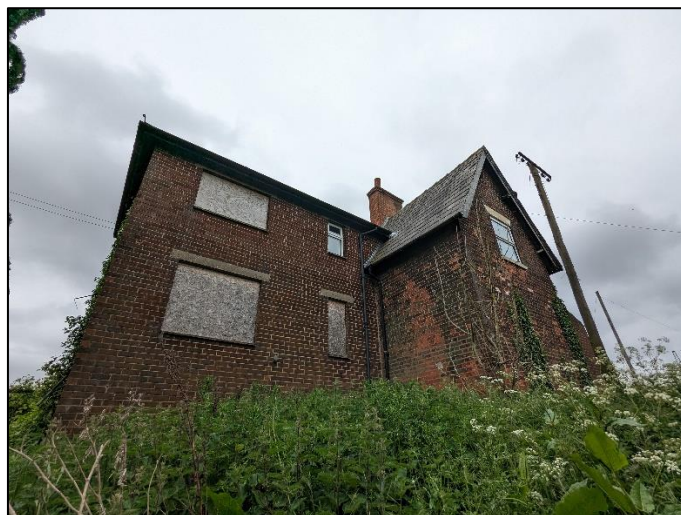
3.2.3. The survey area is a detached two-storey house built with cavity brick walls. The property has a pitched roof with slate tiles and it is shown in the photographs below from both the front and the rear. A single-storey, pitched roof porch is also

present to the front of the property, and a two-storey extension is present on the rear of the property.

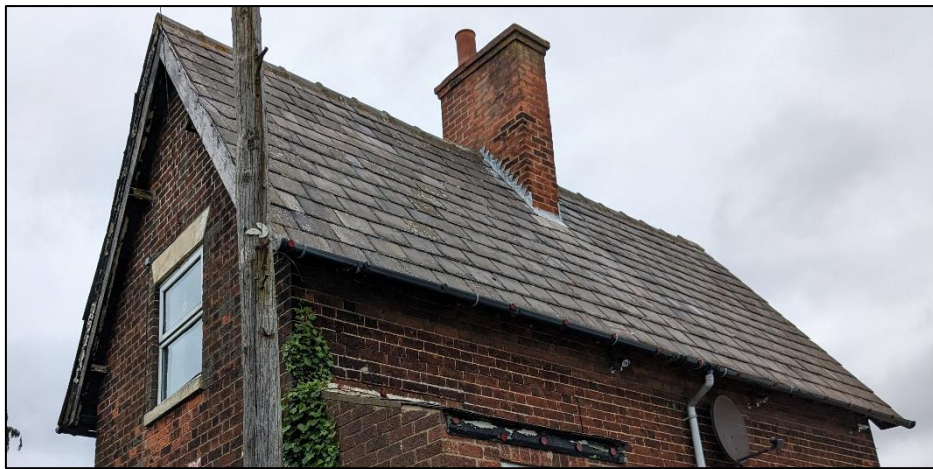
3.3.2. The roof of the building is also in a very good condition with no defects. All roof tiles and ridge tiles are firmly in place and none appear to offer suitable opportunities for bats to access beneath.

3.3.3 The flashing around the chimneys is also flush to the roof offering no access for bats. Both the roof tiles and chimneys can be seen in the photograph below.

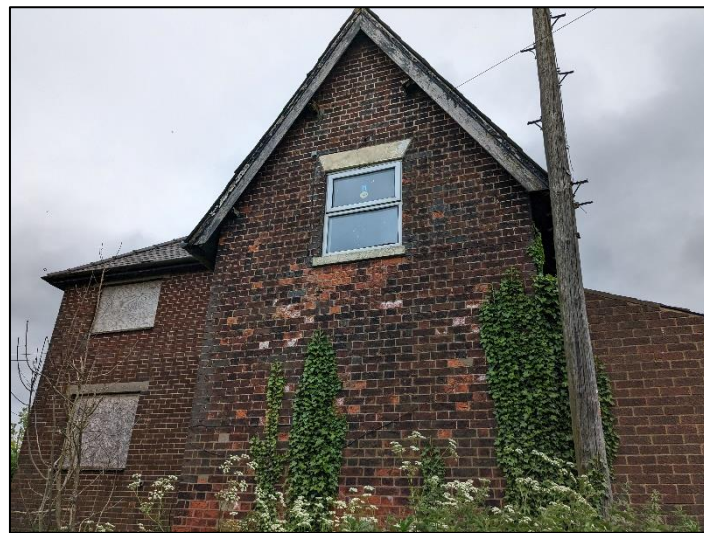
3.3.4. The mortar along the gables is in excellent condition, with none seen to be missing from ground level, to allow bats access into the building or below the tiles.

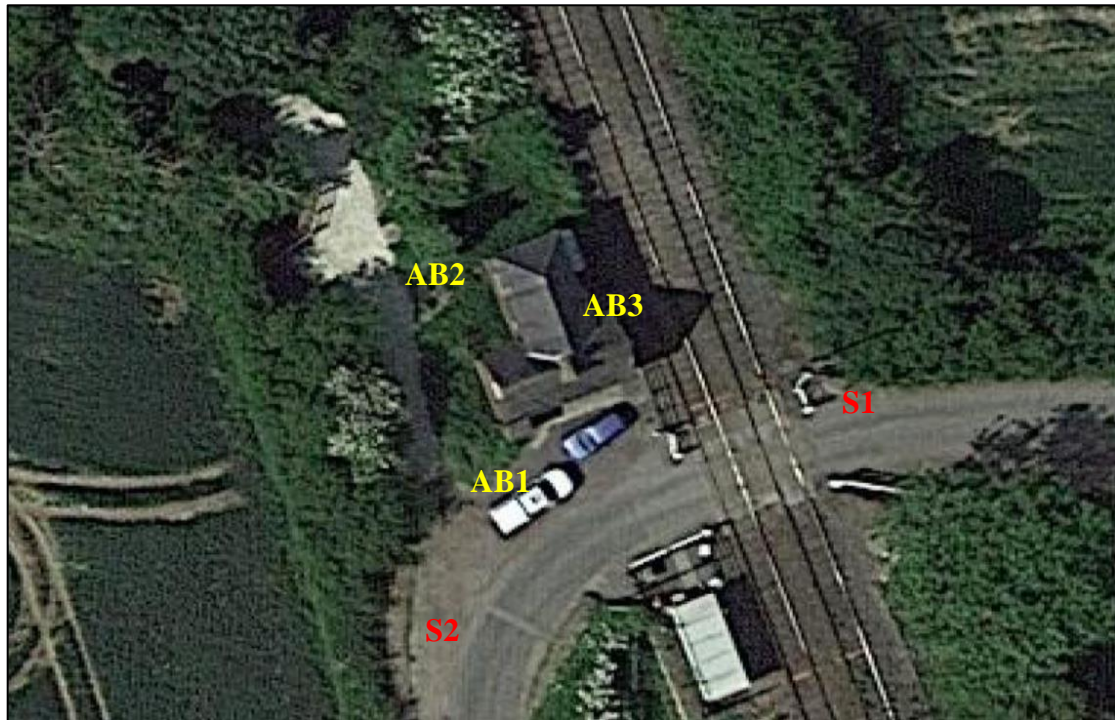
3.4.5. The aerial photograph below shows where the Surveyors (S) and Anabats (AB) were located throughout the survey.

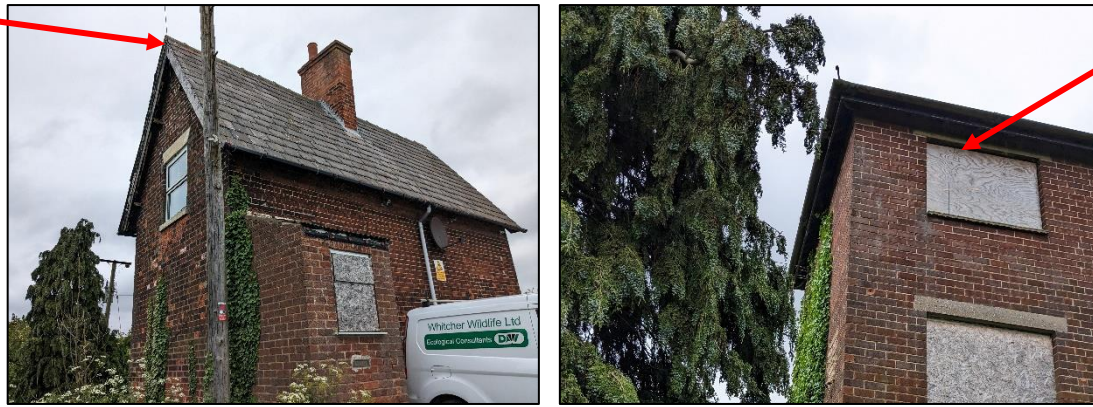
3.4.8. Activity during the survey was moderate with both common pipistrelle and *Myotis* sp. sporadically being recorded foraging up and down the footpath to the west of the building, along with within the hedgerows and tree lines at the opposite side of the level crossing. One common pipistrelle was seen to emerge from the apex of the western gable at 20:43, and a second common pipistrelle was seen to emerge from behind the plywood window boarding on the upper window on the western face.

3.4.9. The roost locations are shown in the images below, identified by the red arrows.

5.1. Three common pipistrelle day roosts have been identified in the building and therefore, there will be a requirement for a licence to be applied for from Natural England before this is demolished. Mitigation will need to be put in place for the loss of these roosts. Section 6 of this report includes a mitigation strategy that will be used as the basis for the Natural England licence application.

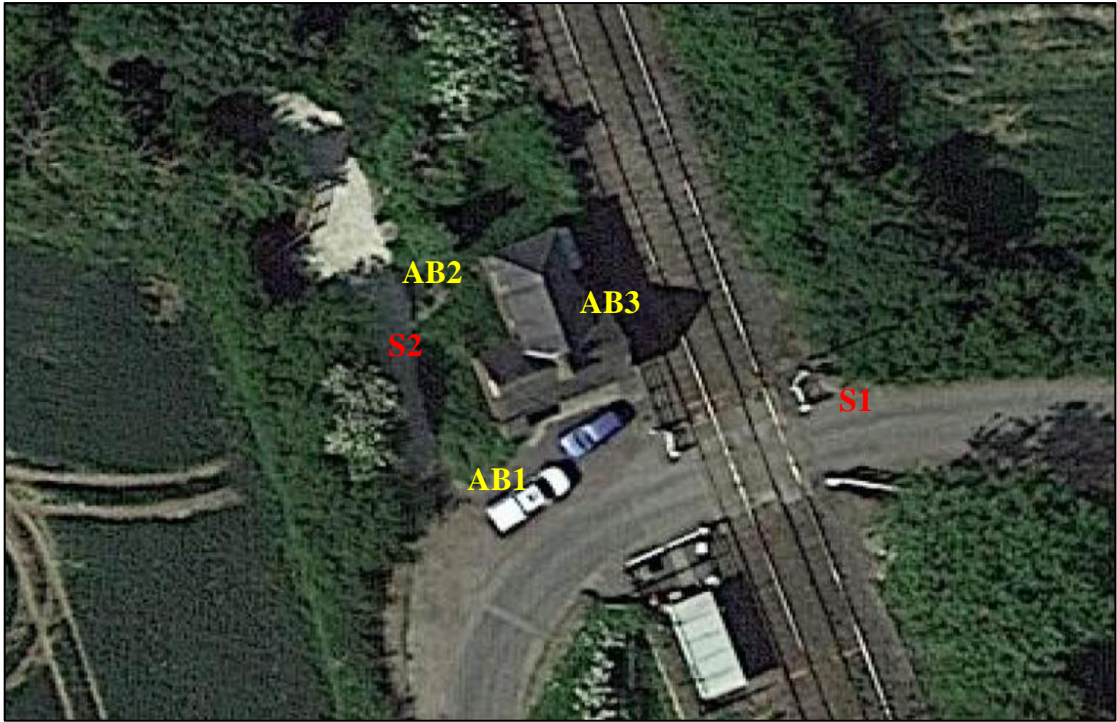
3.5.5. The aerial photograph below shows where the Surveyors (S) and Anabats (AB) were located throughout the survey.

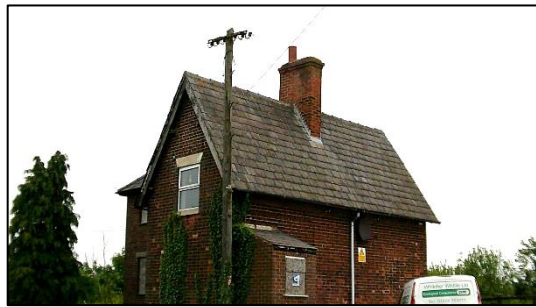
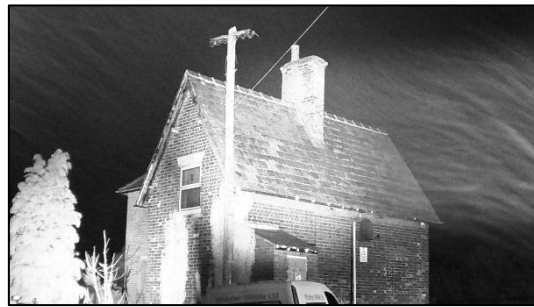
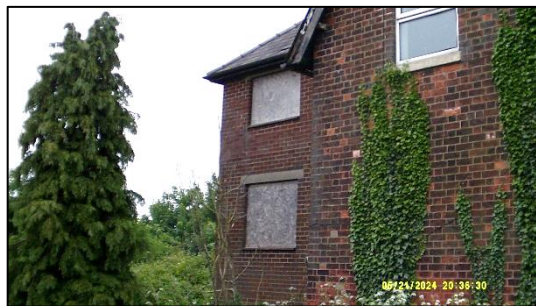
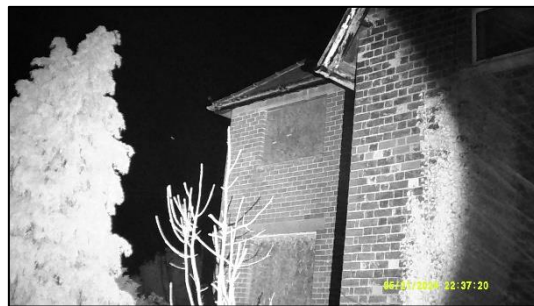
3.5.7. The below shows start and end still photographs which show the views of the cameras both at the beginning of the surveys as well as at the end of the surveys.

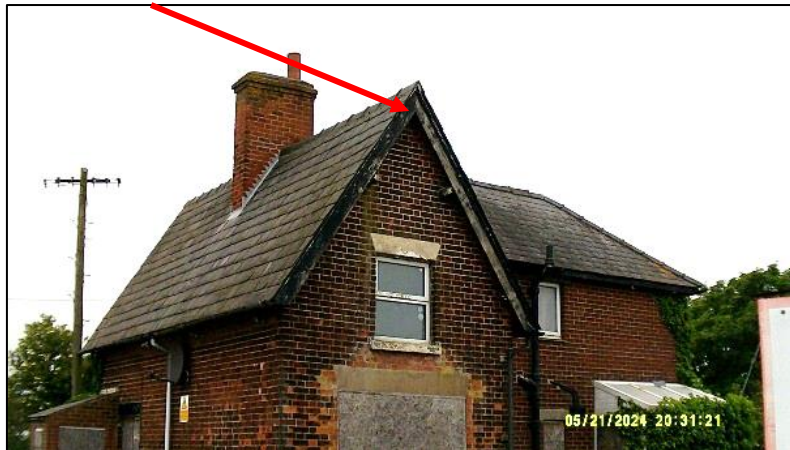
3.5.9. Activity during the survey was moderate, similar to the previous year, with both common pipistrelle and *Myotis* sp. foraging around the building and across the level crossing. A small amount of noctule activity was also observed early in the survey, with several passing north to south. One common pipistrelle was seen to emerge from the apex of the eastern gable at 21:35, and a second common pipistrelle was seen to emerge from apex of the western gable at 21:36. Subsequent analysis of the camera recordings also identified one bat touching up the plywood window sheeting in the same roost location as the previous year, at 22:26, and then entering the roost at 22:34.

3.5.10. The roost locations are the same as in the previous survey, in addition to the below location.

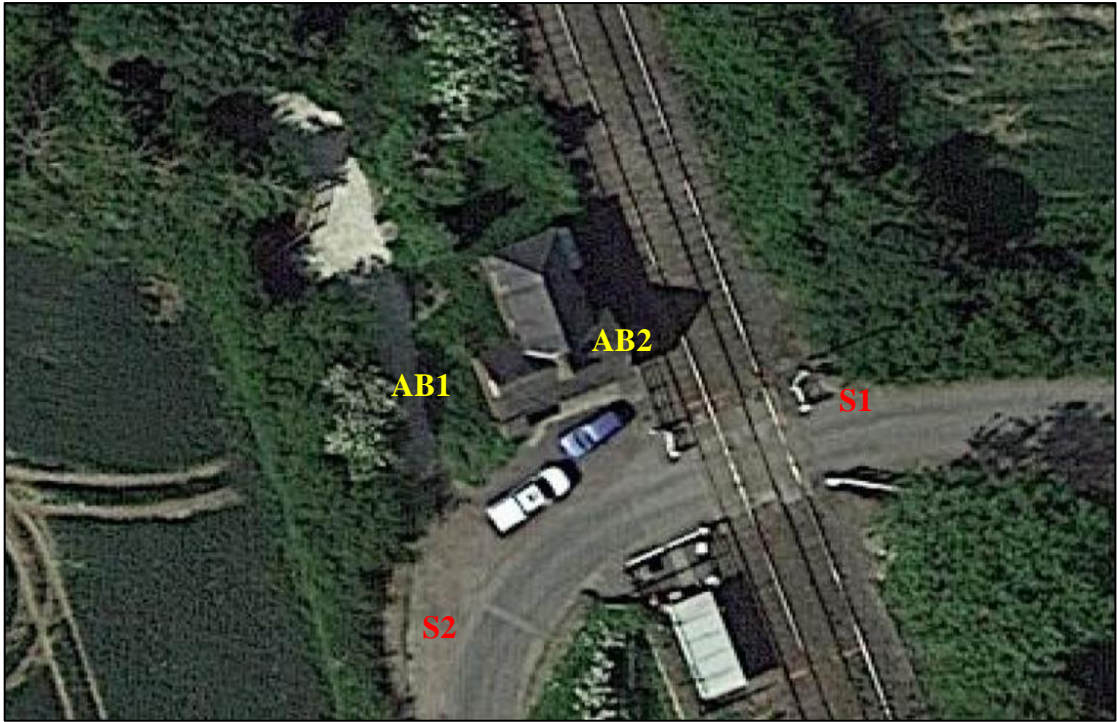
3.6.5. The aerial photograph below shows where the Surveyors (S) and Anabats (AB) were located throughout the survey.

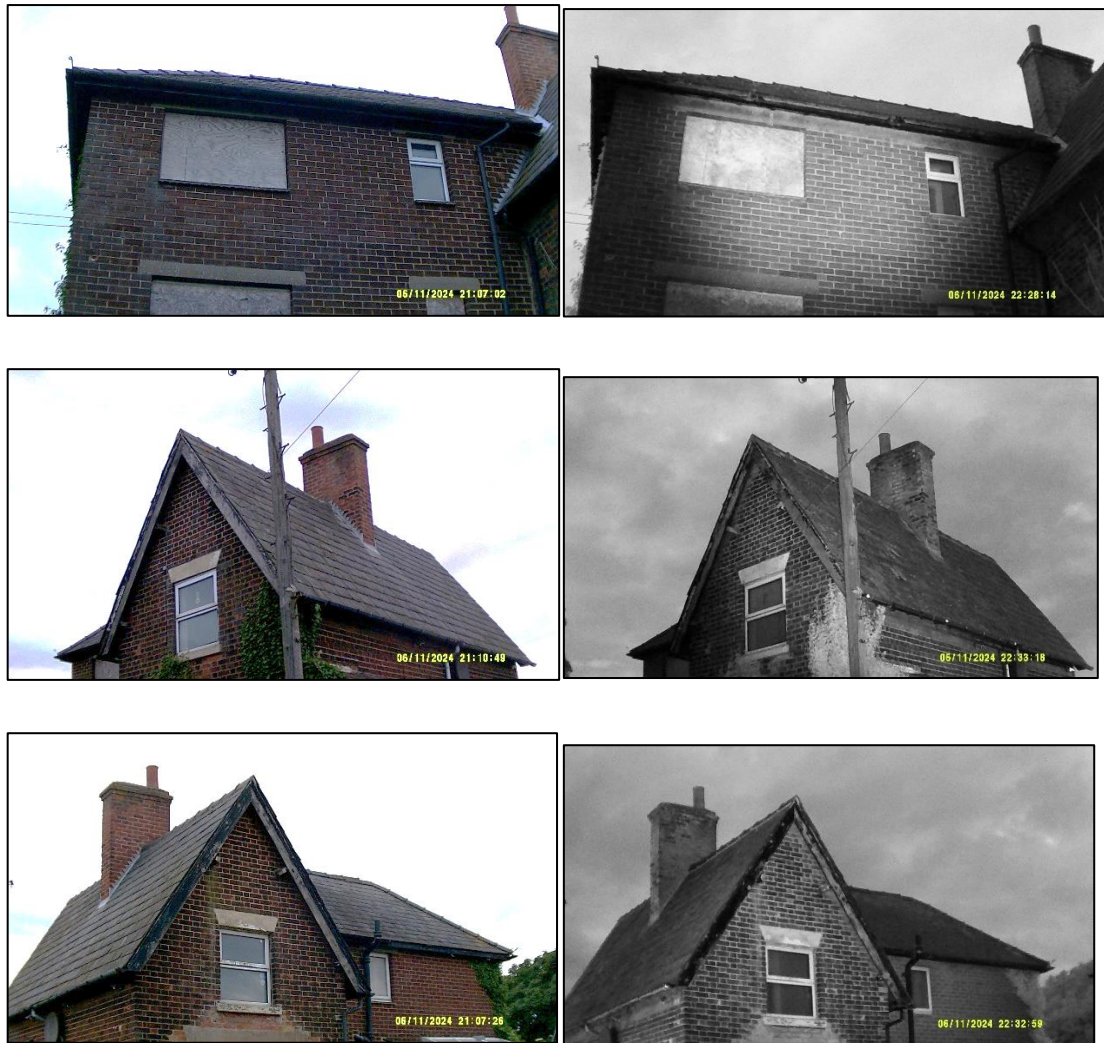
3.6.7. The below shows start and end still photographs which show the views of the cameras both at the beginning of the surveys as well as at the end of the surveys.

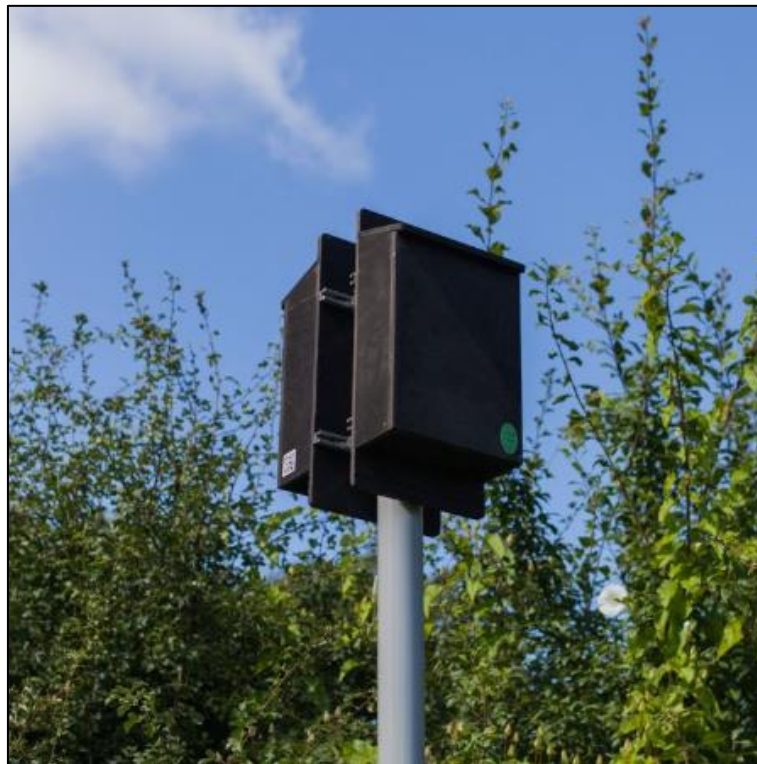
6.2. Prior to any demolition works, a double pole-mounted bat boxes such as the one shown below will be erected in a suitable area of the site where it will not be disturbed by demolition activities. A double bat box is required due to the loss of three roosts. This should be as close as possible to the site and within Network Rail land. It is possible that Natural England may request a third bat box due to the loss of three roosts. If this is the case, a third bat box will be included.

6.5. In the event that a bat is found during the soft demolition of the roost, the ecologist will remove it by hand and place it into one of the pole-mounted bat boxes.

6.7. The location of the pole-mounted bat box will be added to the hazard directory and clear signage will be in place to ensure its longevity.
