CUMBERWORTH LODGE, DONCASTER
PRELIMINARY ECOLOGICAL APPRAISAL
REPORT

DOCUMENT CONTROL	
CLIENT	GRACEMACHIN
PROJECT CODE	JME_2662
DOCUMENT REFERENCE	JME_2662_PEA_01_V1
AUTHOR	AM MSc BA (Hons) MCIEEM
REVIEWED	JM BSc (Hons) MCIEEM
VERIFIED BY	AM MSc BA (Hons) MCIEEM
DATE	FEB 2026
NOTICE	
<p>All results contained in this report, including any recommendations, are based on the information made available to JM Ecology during surveys and assessment. The conclusions drawn by JM Ecology could therefore differ if the information is found to be superseded, inaccurate or misleading. JM Ecology accepts no liability should this be the case, nor if additional information exists or becomes available with respect to this scheme.</p> <p>JM Ecology is not obliged to and disclaims any obligation to update this report for events taking place after the assessment is complete and when the final report is released. This is only likely permissible where such changes have been agreed between JM Ecology and the client directly.</p> <p>This document is for the sole use of the Client in accordance with the terms of the appointment. JM Ecology accepts no responsibility for reliance or use of the contents by a t

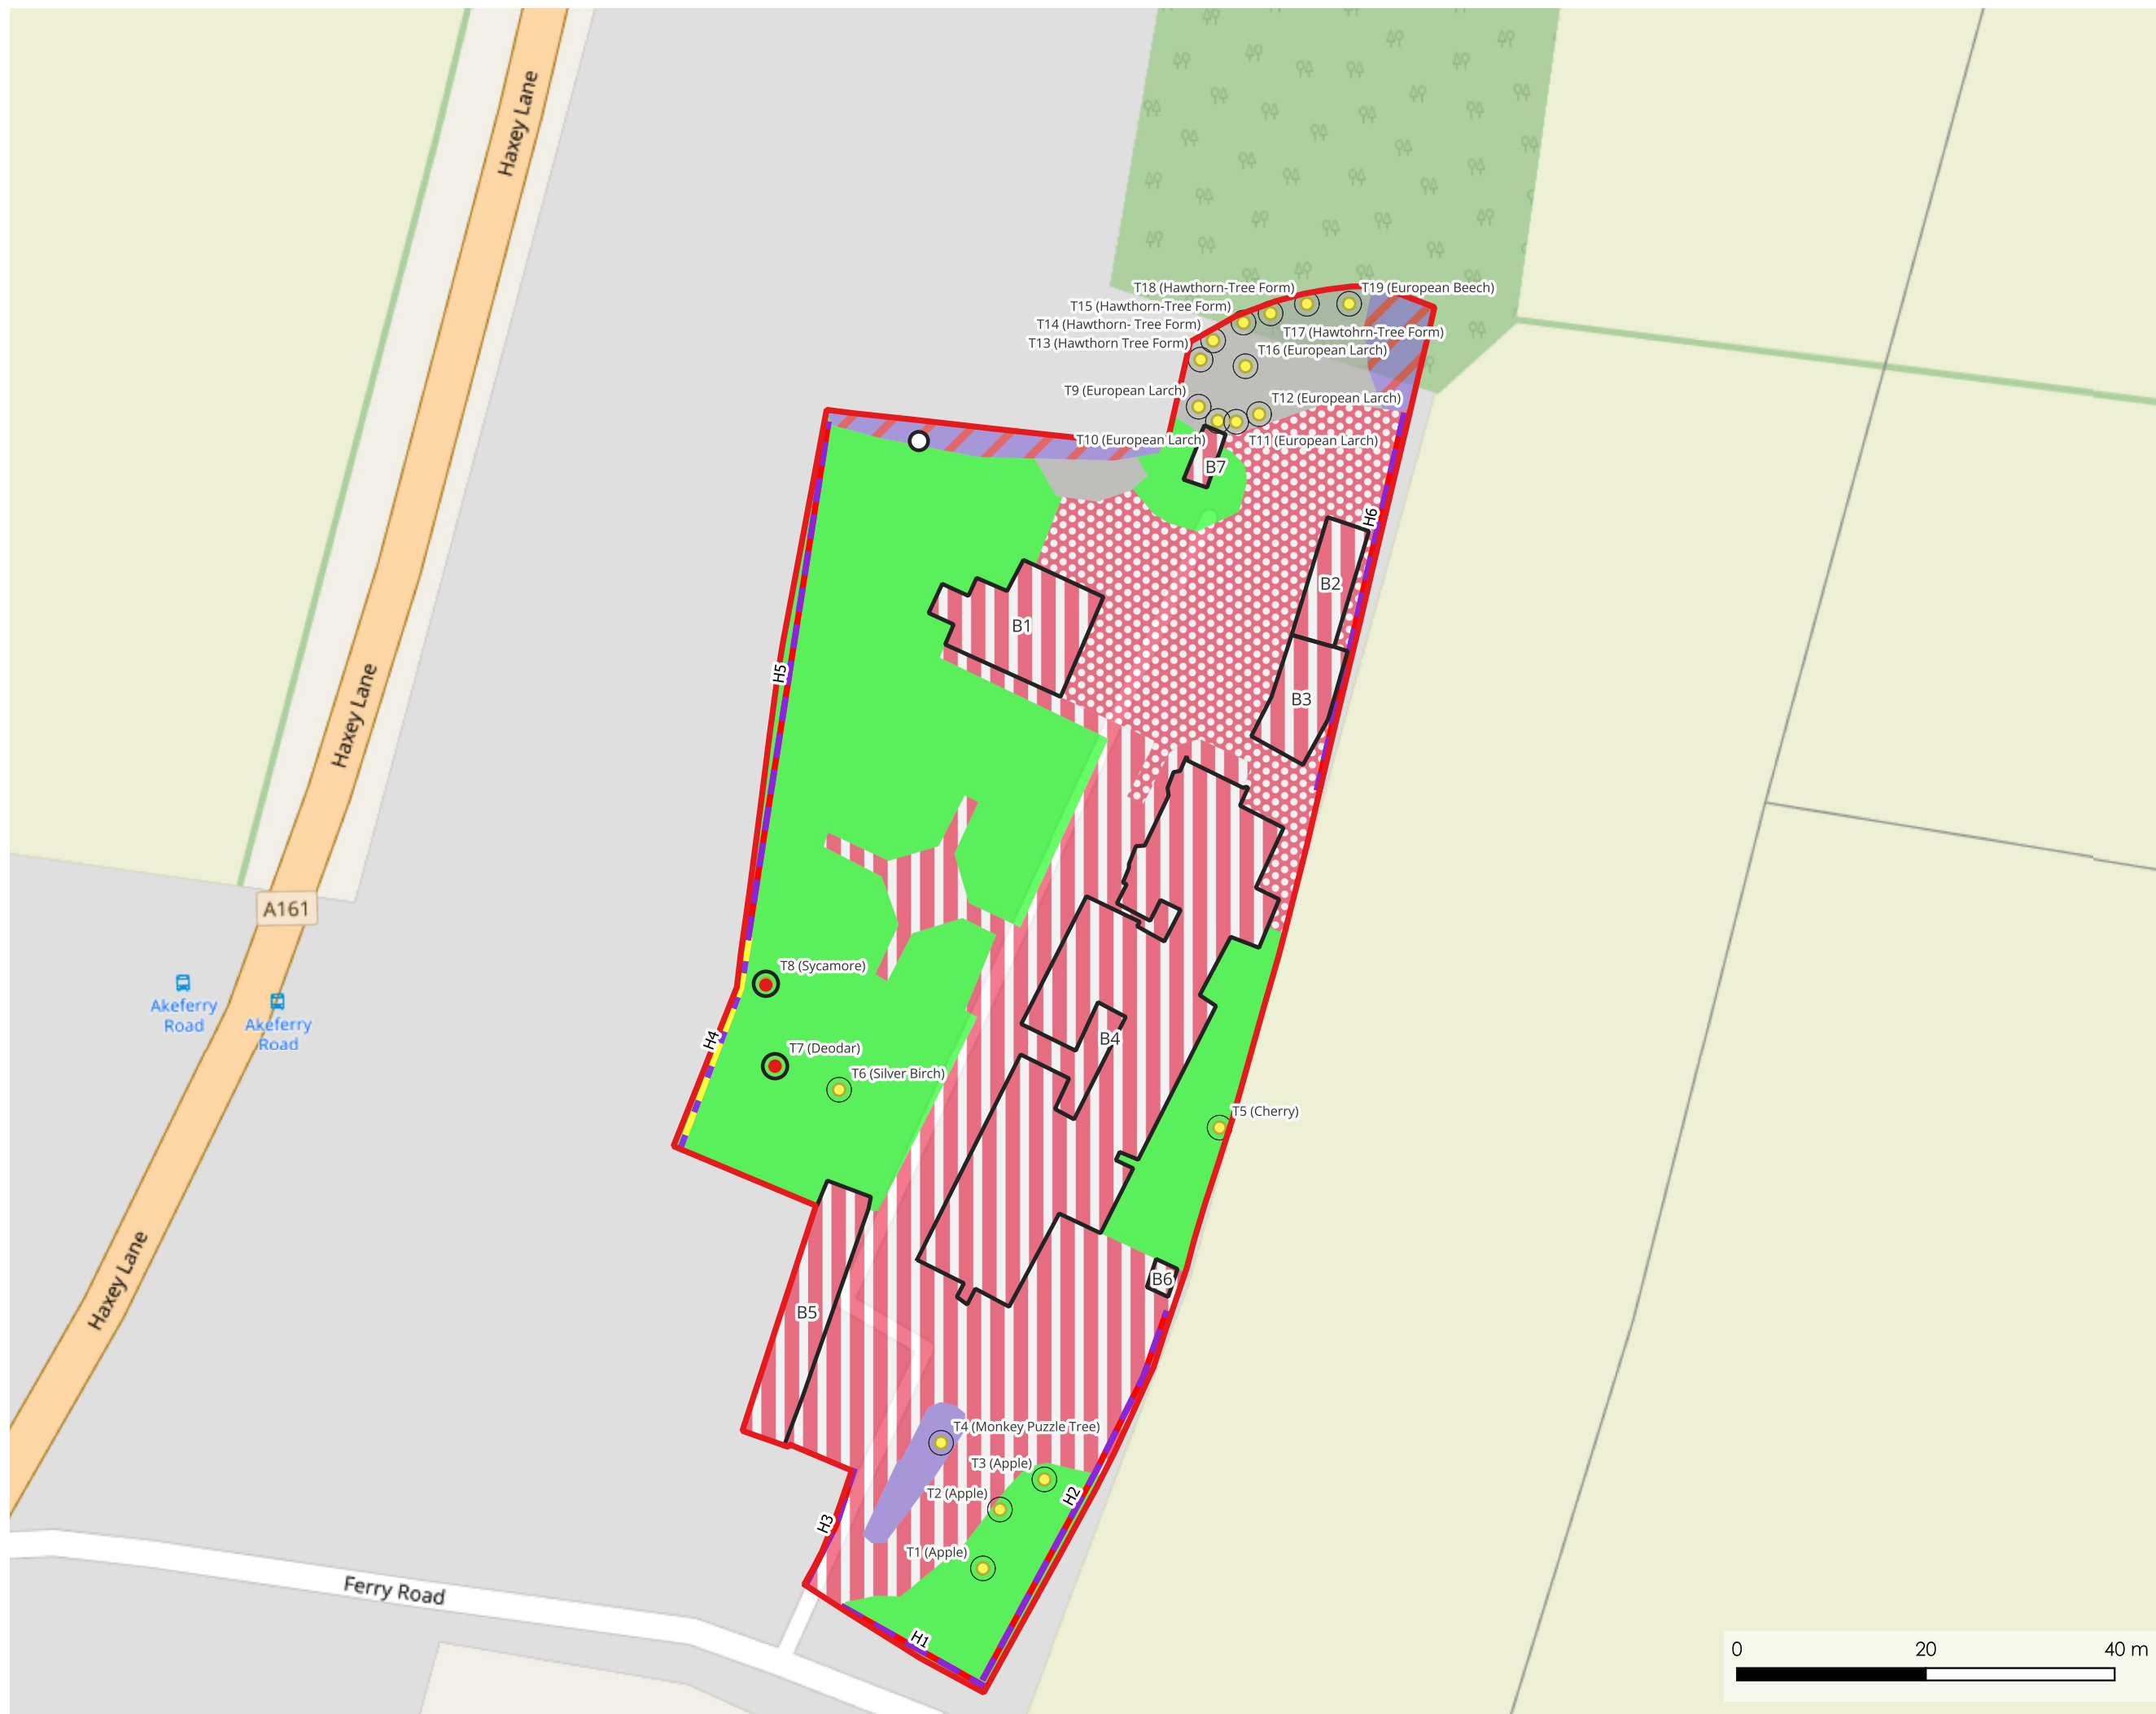
APPENDIX 1: Baseline Habitat Map

- 4.5 For baseline habitat map see Appendix 1 at the end of this report. A summary of the habitats identified on-Site are set out below in Table 4.1.

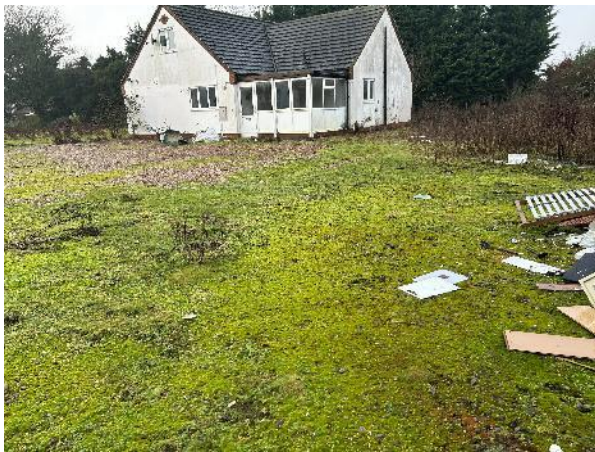
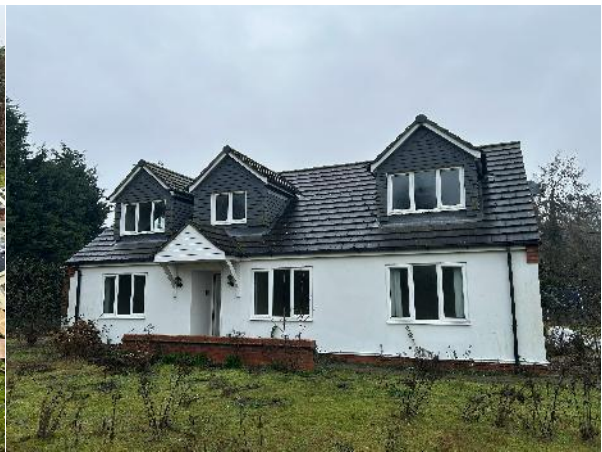
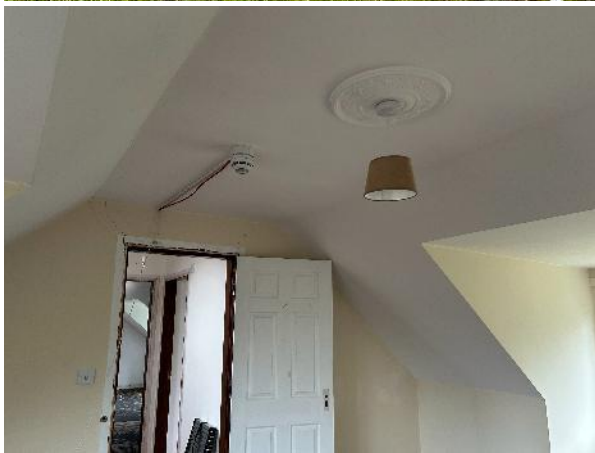
BUILDING	DESCRIPTION	BAT ROOSTING POTENTIAL
B1	<p>Building one is a two-story residential building, where the first floor is within the roof space. It is constructed from red brick in good condition, with white rendering across the brickwork. There is a small protruding wooden porch by the front door entrance. There are several sections to the roof including three protruding dormer windows with hanging tiles present.</p> <p>All of the roof tiles, including the hanging tiles, appear to be present and intact and no obvious roosting features for bats or access points noted, However lead flashing between the dormer windows and the roof is slightly lifted and gaps are present where bats could access roof voids.</p> <p>In the main structure was no accessible loft void as the area has been converted to living space. Based on the design of the roof, there is likely small voids at the eaves – however there was no access to these voids.</p> <p>There is one small loft space at the rear of the property (which appears to be an extension). It has a trust roof construction and is approximately 3m to the ridge board. It is lined with bitumastic felt, and there is a breeze block gable wall at the north. The loft is partially boarded out and loft insulation is present. No evidence of bats was present.</p>	Moderate

- 6.10 B1,4 and 5 have been assessed as having 'Moderate' bat roosting suitability. Similarly T7 was assessed as PRF-M and T8 was assessed as PRF-I for roosting bats. In accordance with best practice (Collins, 2023) the following further survey work is recommended if impacts are proposed to the afore referenced features:

- B1, B4 and B5 require two nocturnal surveys between May and August with both surveys at least three weeks apart.
 - T7 requires three nocturnal surveys between May and August with all three surveys at least three weeks apart. Climbed surveys (aerial assessment via rope access/ladders) are not considered appropriate owing to the perceived health and safety risk associated with the tree in poor vigour (heartwood deteriorated).

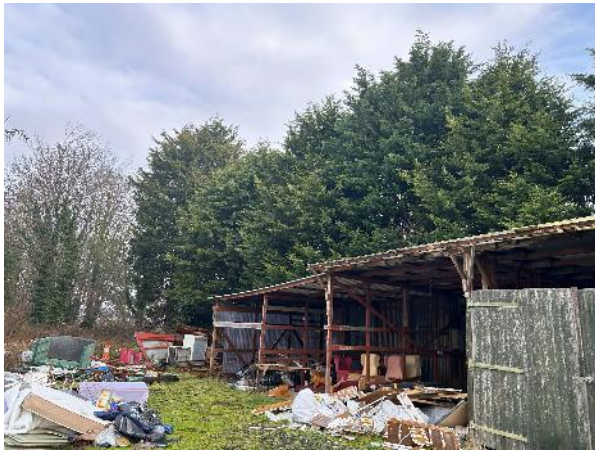
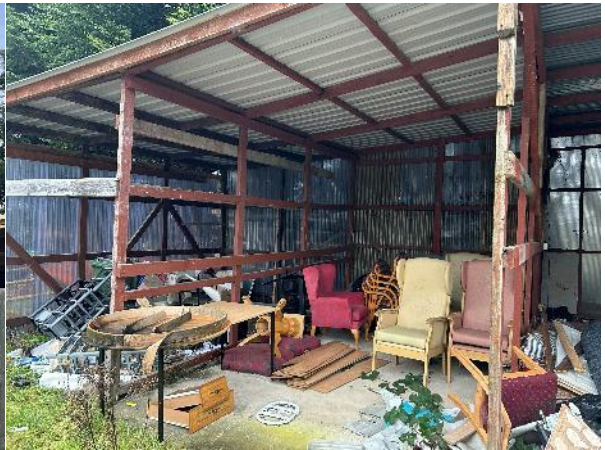
B2	<p>This is a derelict construction, made of wooden beams and corrugated plastic, and metal walls and roofing. There is no potential access for roosting bats and no roosting features noted. No evidence of bats was recorded.</p>	Negligible
B3	<p>This is two connected double garages with a walk-through between them. it's constructed from pebbledash, prefabricated walls with wooden facias present. It has a corrugated metal flat roof. There are several access routes for bats into the interior of the building, including from the partially open garage doors, open wooden door at the south side of the structure and no doorway being present on the walk-through between the garages - however internally no roosting features for bats were noted.</p>	Negligible

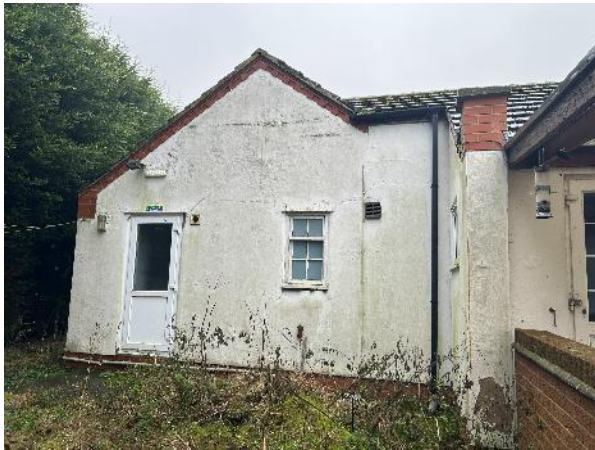
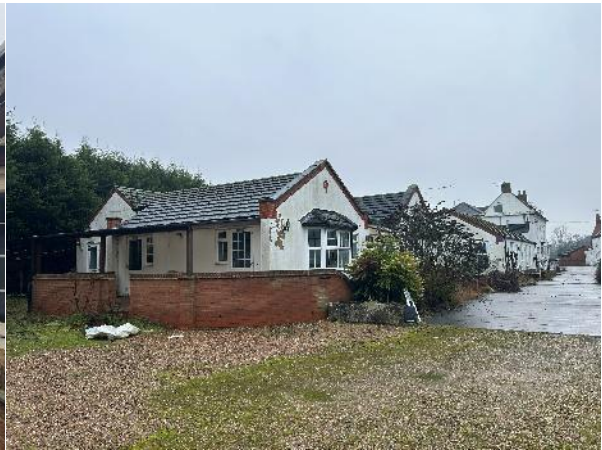
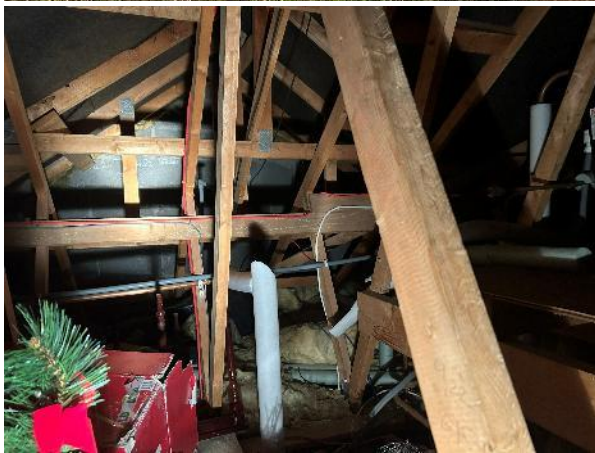
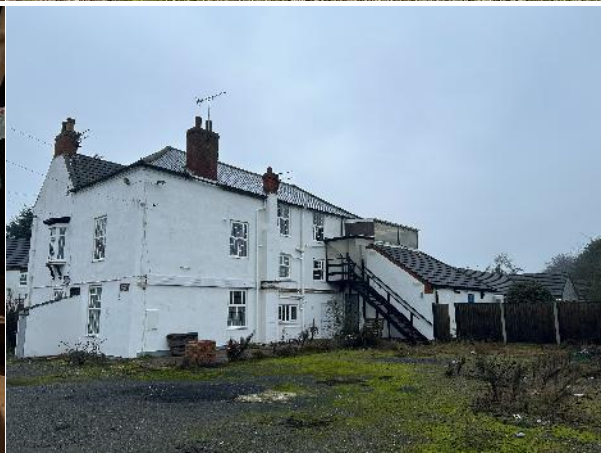
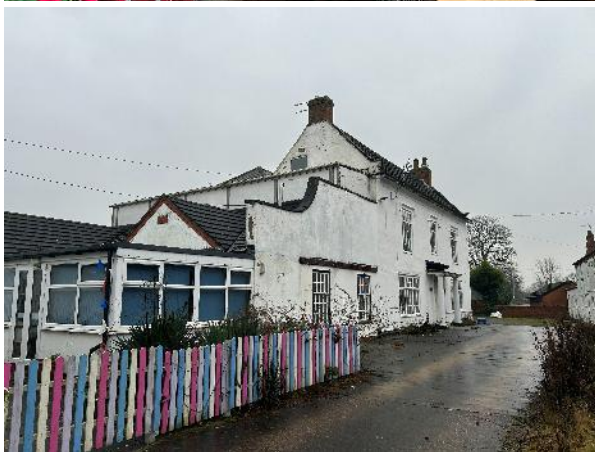
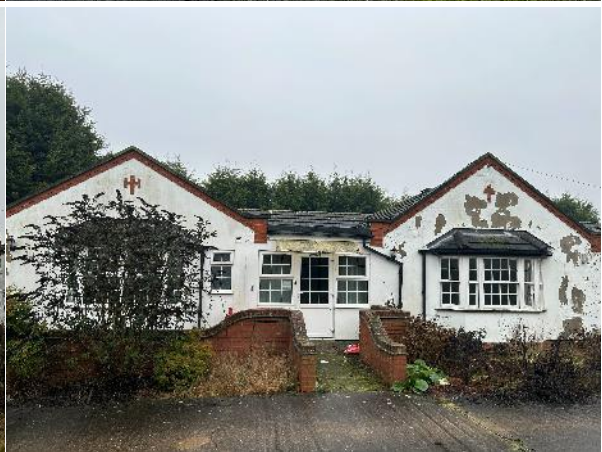
B4

<p>B4</p>	<p>Building four is a very long building that is connected with several walkways and has many different roof pitches. It is primarily brick built with white rendering, which although there is signs of weathering it is all still intact. Some of the gable walls have parapet walls, and some are without.</p> <p>The majority of the building is single storey, however at the south of the property there is a two- story section with one pitched roof and one hipped roof. The two-story roofs are in poor condition and at the gable you can see potential access for bats under the roof tiles. There are several chimneys present and on tiled section, the tiles are generally in good condition. However, there are small gaps under the hip tiles present, which provide access for bats into the roof void. Additionally, lead flashing around the chimney breast appears to have small gaps underneath potentially providing access for bats into the property.</p> <ul style="list-style-type: none">• Loft A (LA) was inaccessible as the hatch was locked shut.• LB was 'X' shaped loft space with a trussed roof construction lined with bitumastic felt. There are four breeze block walls and it is being used for storage and a water tank. It has loft insulation throughout. Mouse droppings recorded throughout the loft space.• LC was 2.5m to the ridge board with a trussed rafter construction. It was lined with loft insulation, and the roof was lined with breathable membrane. There is no evidence of bat droppings and no light gaps (providing potential access points for bats noted. This loft void is accessible via two different loft hatches.• LD follows on from a small section of LC, and is accessed via a very large loft hatch, approximately one meter squared. It has a trussed roof construction and loft insulation present, and is bitumastic felt lined. Evidence of mice, but no bat droppings noted.• LE has two main sections one is within the hipped roof. There very old loft insulation present. Access throughout the lost void was limited due to health and safety (no where to stand due to the joists being covered by loft insulation), however there were light gaps throughout showing potential access for bats from the eaves and ridges. The part of the roof that is within the pitched roof section was completely inaccessible due to health and safety (as above). However, it appears that there may be a window within the loft void (as what was visible was well lit). This part of the roof is lined with a bitumastic felt and light gaps were seen from where a safe standing position could be achieved. <p>Loft Plan Below:</p>

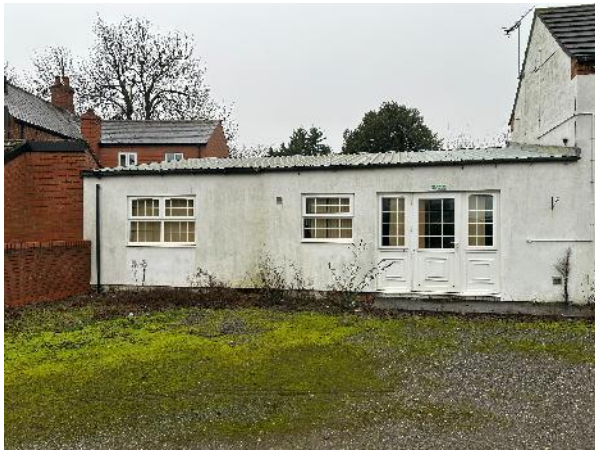
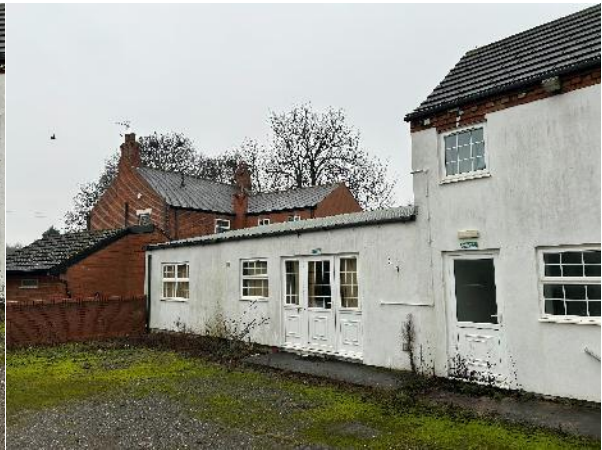
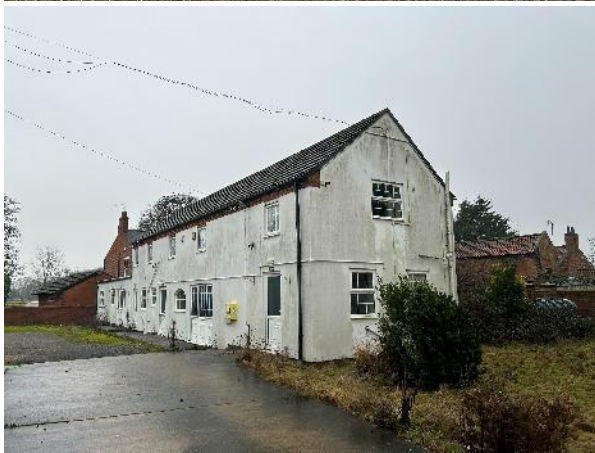
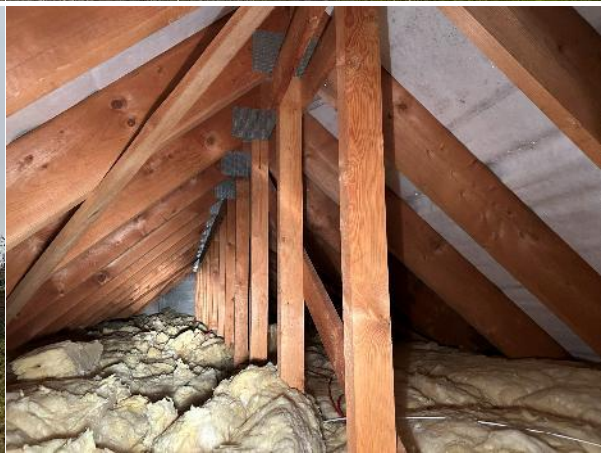
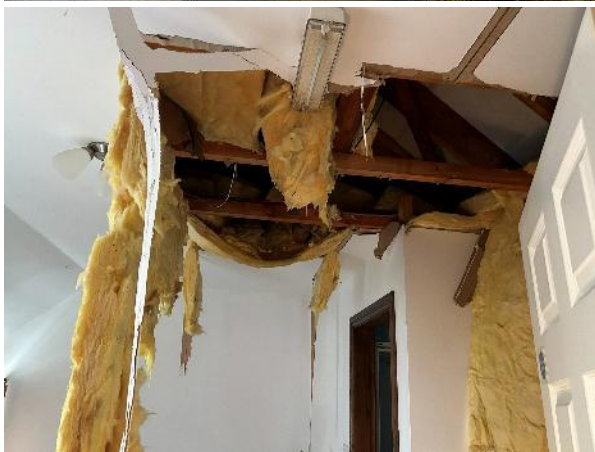
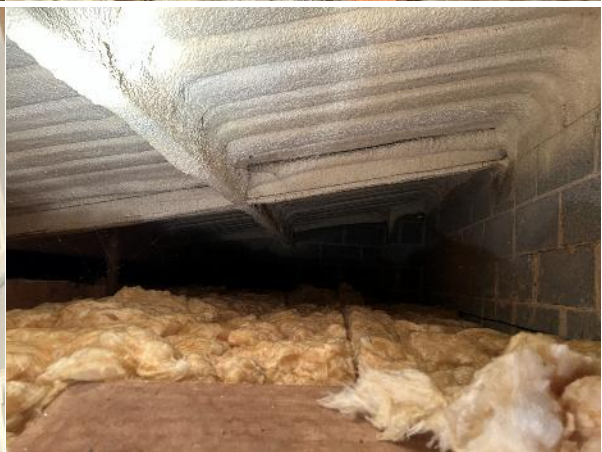
BUILDING	DESCRIPTION	BAT ROOSTING POTENTIAL
B5	<p>B5 is a two-story construction made from brick that has white rendering throughout, with double glazed windows. It has a tiled roof with ridge tiles present, all in good condition. At the gable all the mortar appears to be intact. At the south of the property is a single story section of property has a sloping corrugated roof.</p> <p>Internally the two-story section of the property, there is a loft hatch leading to a void that span the length of the two-story section of the property. It is approximately 1.5m to the ridge and it's been lined with breathable membrane, at the south of the loft. The ceiling has fallen through into the first floor of the property with extensive water damage throughout. It's not clear what is causing the water damage, as there are no obvious light gaps within the loft space. Evidence of mice was recorded.</p> <p>The loft space above the single-story section of the property is partially sloping and is constructed from corrugated metal that has been sprayed with expanding foam, so no light gaps are present. No access points for bats are noted.</p>	Moderate

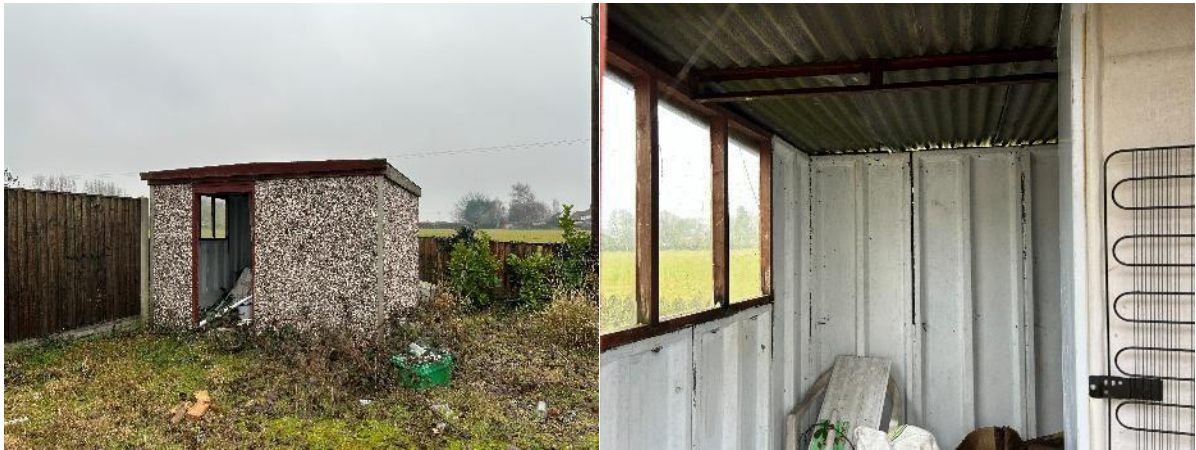
B6	Concrete shed, which is open fronted and had a flat roof. No loft space internally with wooden flat roof exposed. No evidence of bats internally.	Negligible
B7	Steel shipping container	Negligible

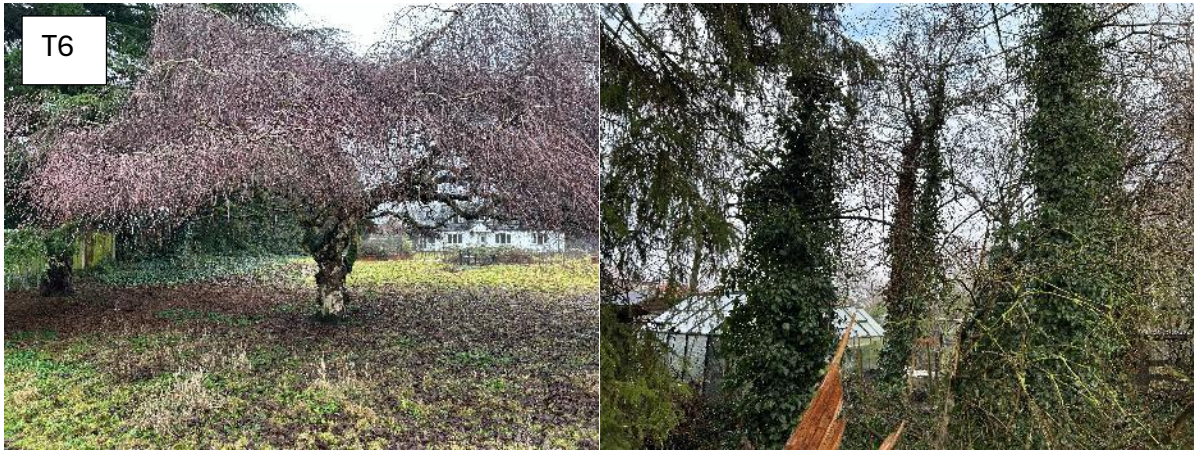
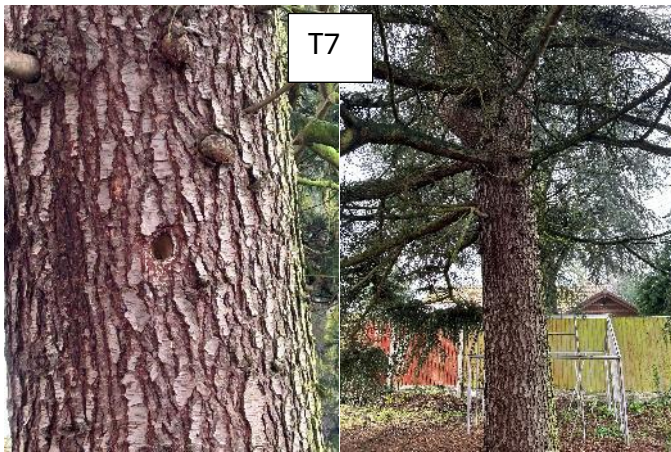
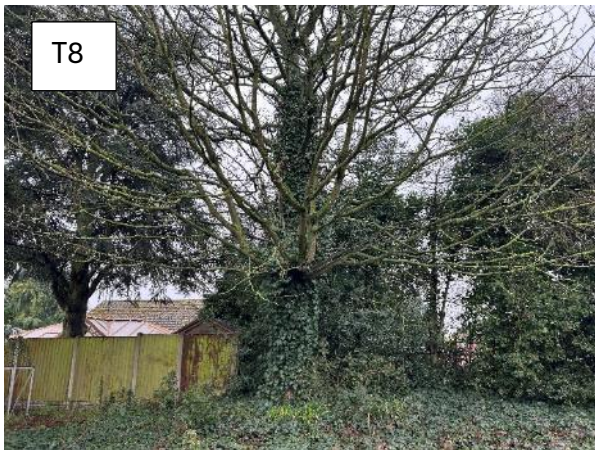
Trees

- T7- Deodar. This tree had numerous woodpecker holes on the tree trunk. As such was assessed as **PRF-M** for roosting bats; and,
- T8- Sycamore. This tree had some shallow cavities (inward ingress at <5cm for bats) in warped trunk with scope for individual transient bats only. As such this was assessed as **PRF-I**.

- T8 requires checks by a level 2 licensed bat worker immediately prior to any felling/pruning/reduction. If no bats or evidence found, tree can be felled using hand tools
