Ref: Proposed Development at 25 North Street, Owston Ferry – NLC Approval No PA/2022/756

Further to the recommendations of the Phase 2 report for the above site (Ref C603/01, dated August 2023), G&M Consulting (G&M) has carried out an inspection of the in-situ soils below the former barns and concrete slabs on the on the site, to ascertain whether any further localised contamination is noted within these areas. This inspection was undertaken following demolition and clearance of these buildings.

ATTACHMENT A – Inspection Photos

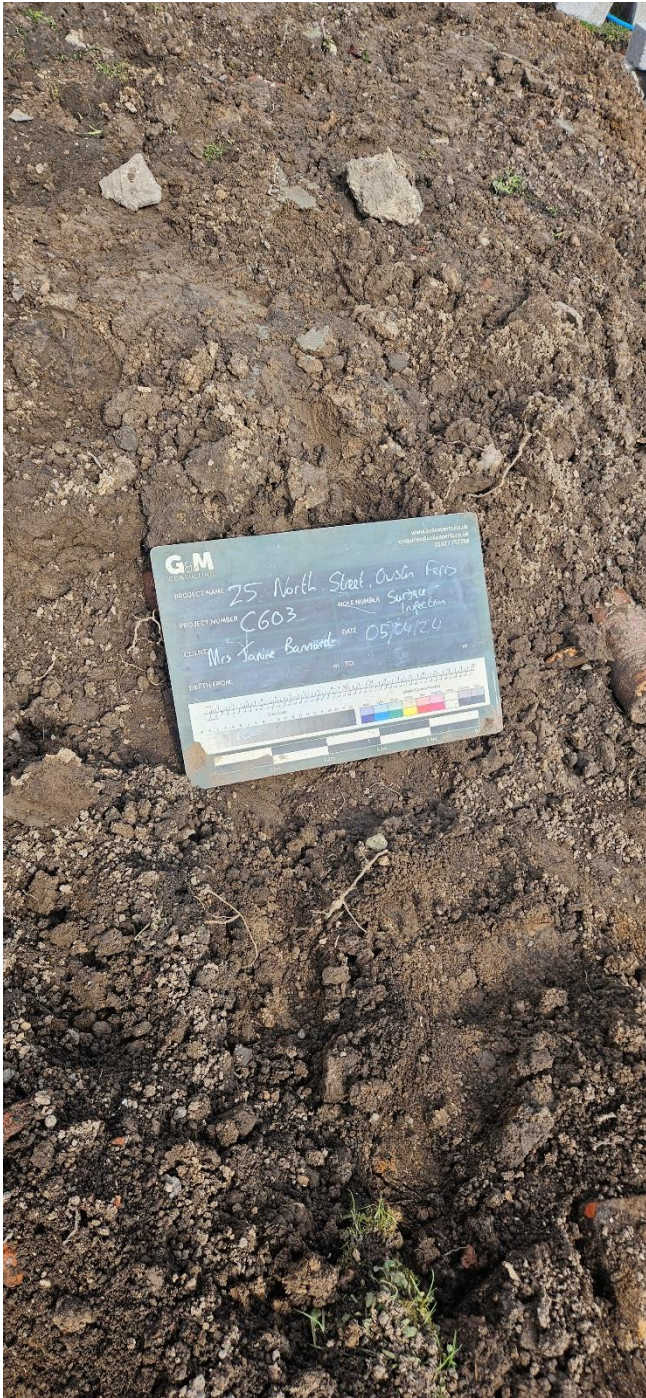
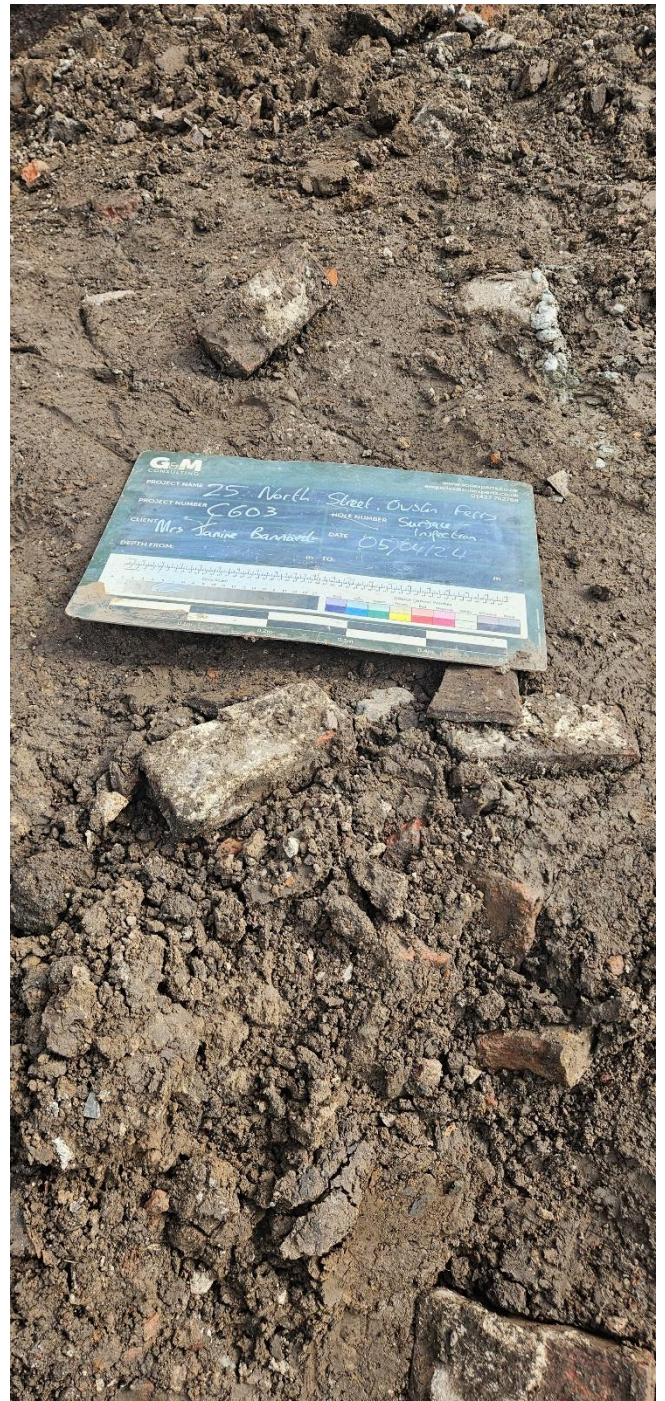
The strata encountered within the excavations, inspected by a geologist from G&M, comprised; a dark brown sandy gravelly clay with a low cobble content, the gravel and cobble content was noted as subangular of brick and concrete. No visual or olfactory contamination was noted within these soils.

Document Name: Site Walkover Photographs:
Showing areas under former barn and
concrete slab floors.

Based on the findings of the inspections, it is considered that the in-situ soils noted below the former barns and concrete slab are similar in composition to the made ground soils noted within the initial phase 2 investigations, and as such the conclusions and recommendations regarding the requirement for clean capping within soft landscaping areas contained this report are still extant and require no further amendment.

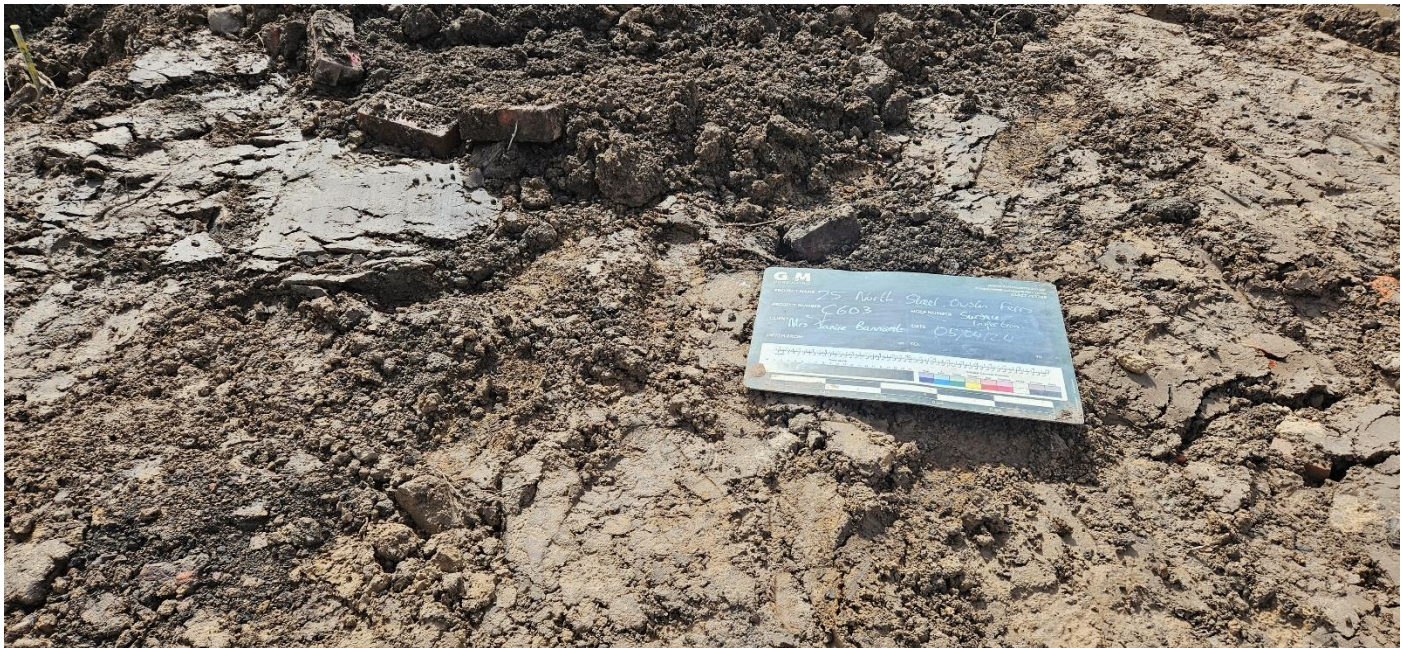
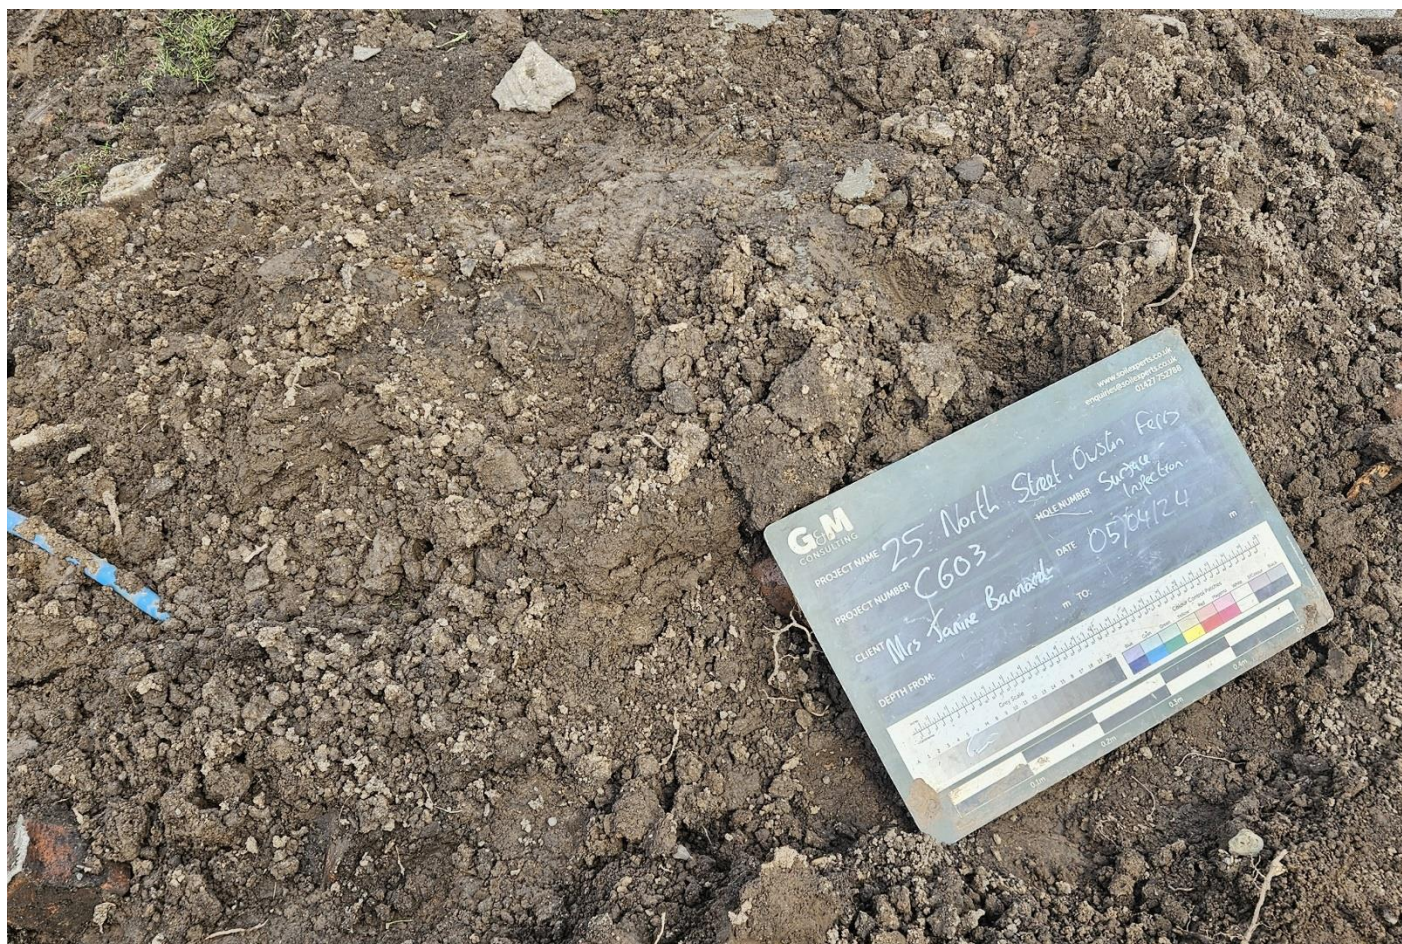
Document Name: Site Walkover Photographs:
Showing areas under former barn and
concrete slab floors.
