Report No: C603/1
Date: December 2023

GEOENVIRONMENTAL APPRAISAL
Of land at
25 NORTH ROAD, OWSTON FERRY, NORTH LINCOLNSHIRE

REPORT NUMBER:	C603/1	REPORT STATUS:	Final
REPORT TYPE:	Geoenvironmental Appraisal		
REPORT DATE:	December 2023		
SITE:	25 North Street, Owston Ferry, North Lincolnshire		
PREPARED FOR:	Janine Bannard		
PREPARED BY:	A Swinbourne BSc. (Hons) FGS, MIEEnvSc, ACIEH.		Senior Engineering Geologist
REVIEWED BY:	G Swinbourne BSc. (Hons) MSc. DIC, FGS		Principal Engineering Geologist

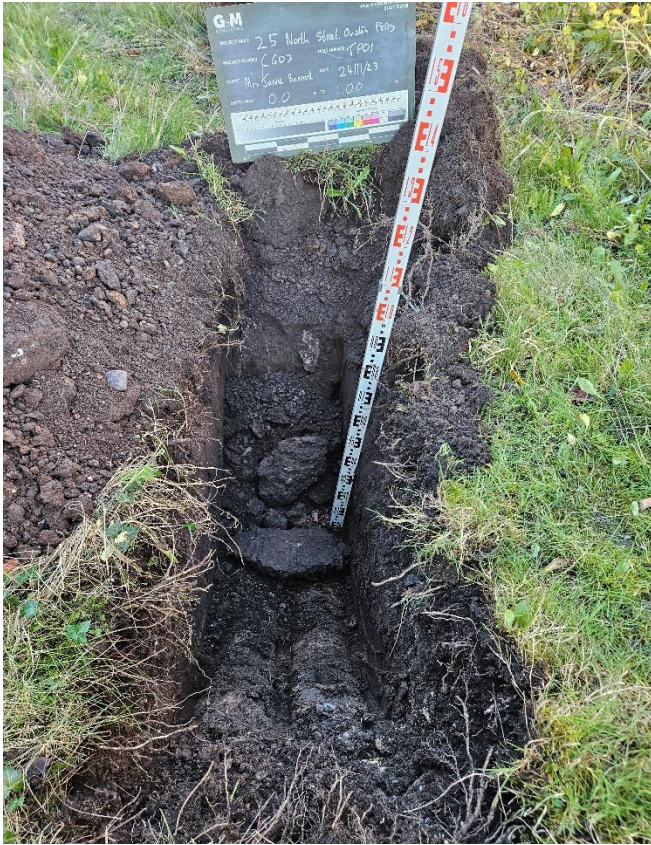
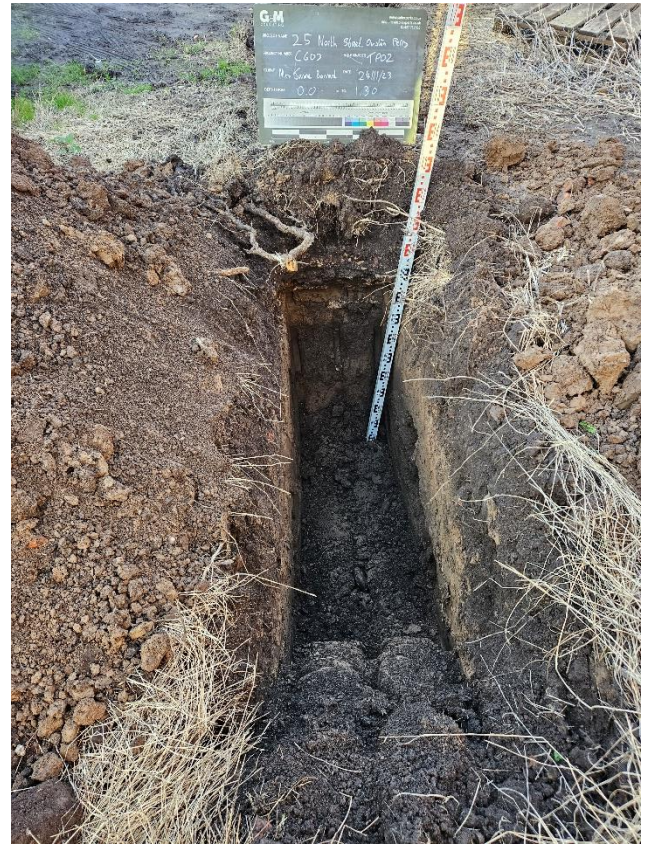
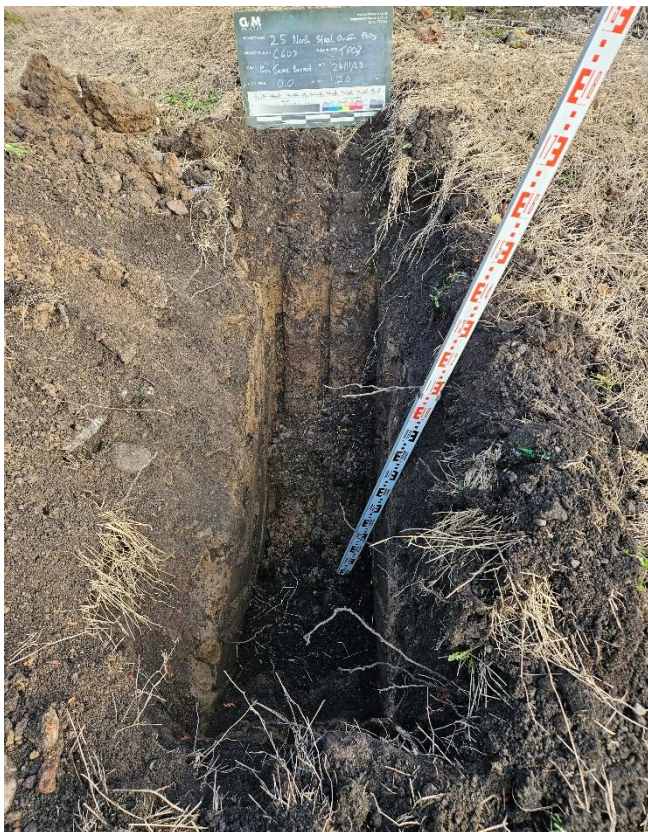
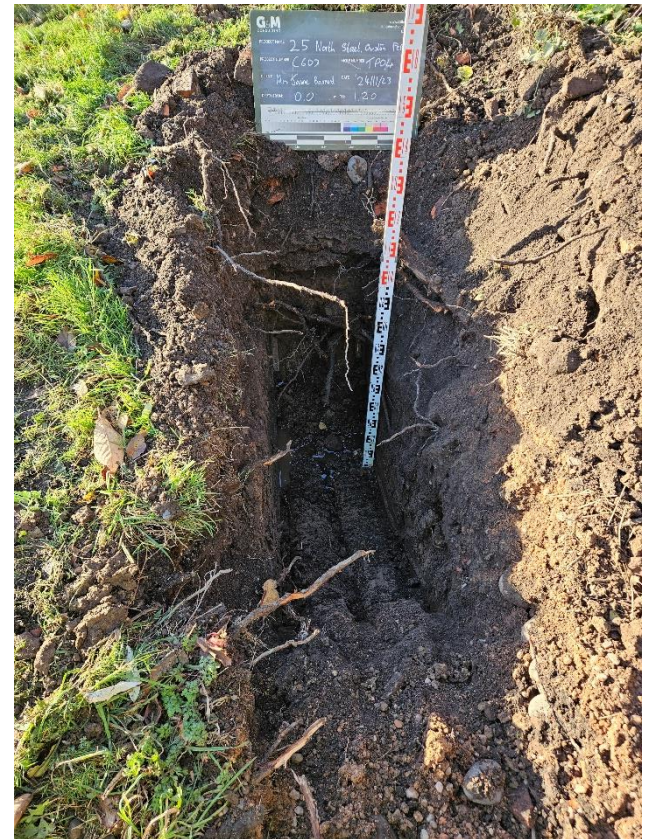
Project Number: C603	Project Name: 25 North Street, Owston Ferry
Client: Janine Bannard	Document Name: Trial Pit Photographs: TP01 (1.00m), TP02 (1.30m), TP03 (1.20m), TP04 (1.20m)

Topsoil was proved in trial pits TP02, TP03 and TP04, to depths of between 0.40m and 0.50m bgl. This material is described as soft, dark brown slightly gravelly silty clay locally with a low cobble content. Gravel is subangular fine to coarse of brick. Cobbles are subangular of brick.

TP01, TP05 and TP06 encountered made ground from surface, comprising dark grey slightly clayey sandy subangular fine to coarse gravel sized fragments of tarmac, brick and rare concrete.

In all trial pits, the topsoil or made ground is underlain by a soft, dark brown slightly gravelly very silty clay, locally very clayey silt. The gravel content is subangular fine of reddish brown mudstone. In TP01, the material did not appear to locally grade to very clayey silt.

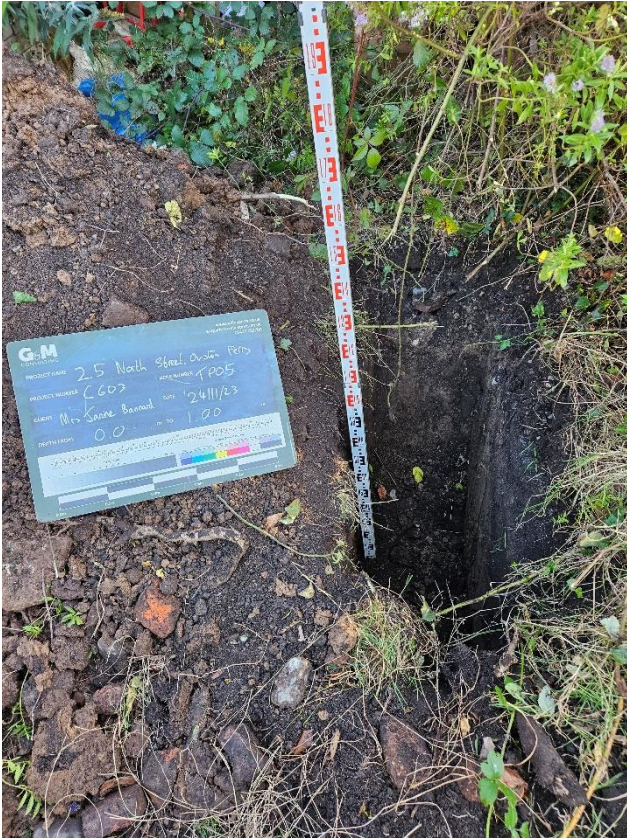
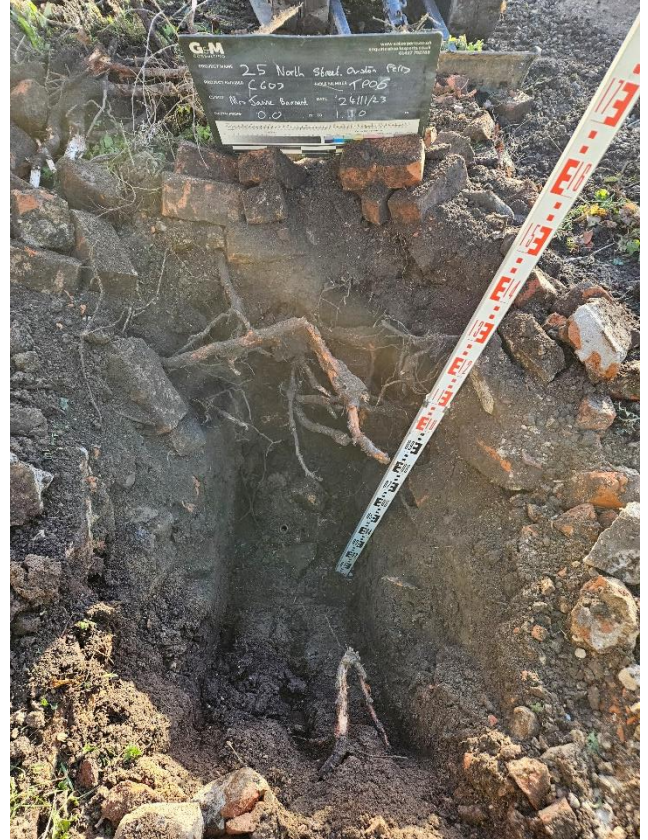
Project Number: C603	Project Name: 25 North Street, Owston Ferry
Client: Janine Bannard	Document Name: Trial Pit Photographs: TP05 (1.00m), TP06 (1.10m).

This deposit was encountered to depths of between 0.30 and 0.40 m bgl. In TP06 a high cobble content was also recorded. The cobbles were noted to be of brick and is likely the floor of the former barn which was located on site.

The PAH speciate Dibenz(a,h)anthracene, was found to be elevated in two samples of the made ground/topsoil (TP05 at 0.10m and TP04 at 0.20m)
