Report No: C603/RS
Date: December 2023

REMEDIATION STRATEGY
for land at
25 NORTH STREET, OWSTON FERRY, NORTH LINCOLNSHIRE

Report No: C603/1
Date: December 2023

GEOENVIRONMENTAL APPRAISAL
Of land at
25 NORTH ROAD, OWSTON FERRY, NORTH LINCOLNSHIRE

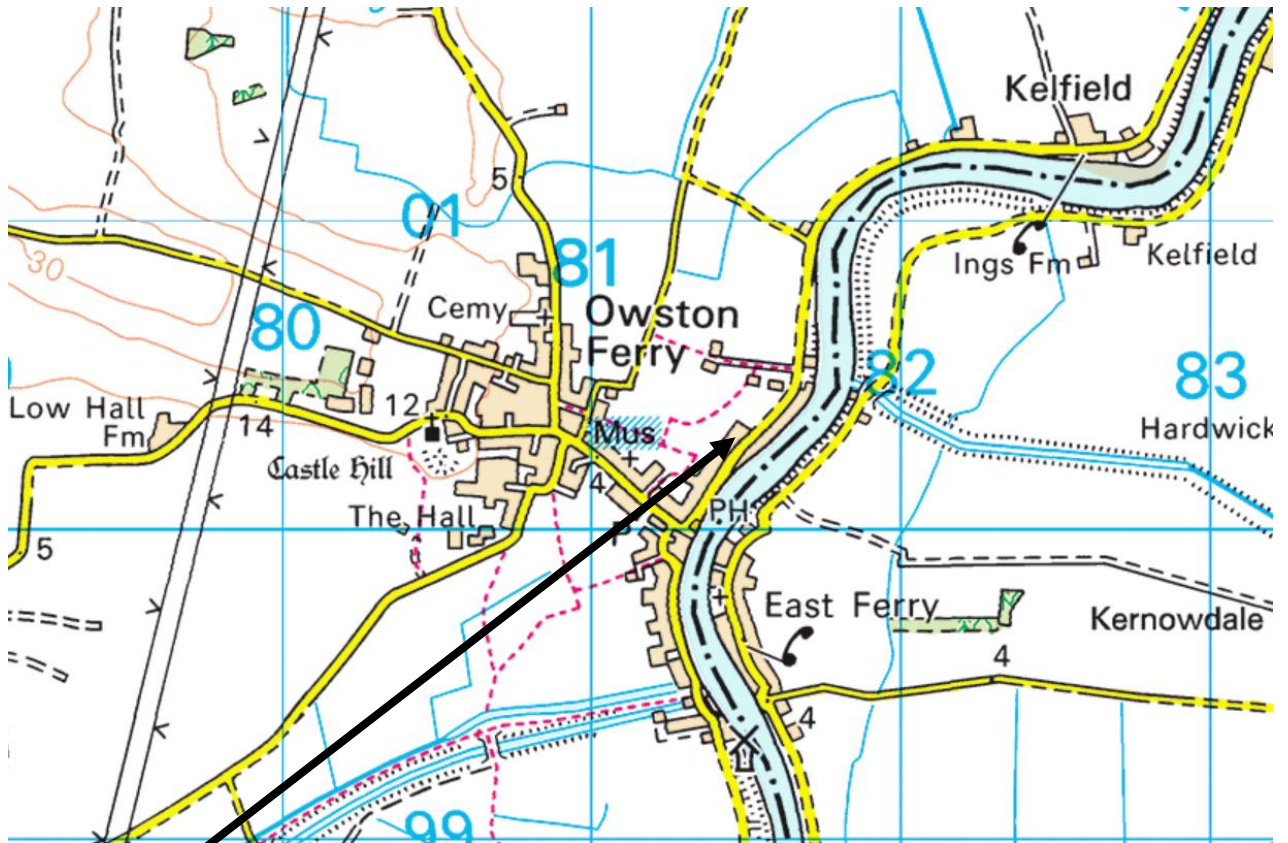
Site Location Plan Drawing No C603/RS/1

The Site

The location of the site is shown on Drawing No C603/RS/1, presented in Appendix A of this report.

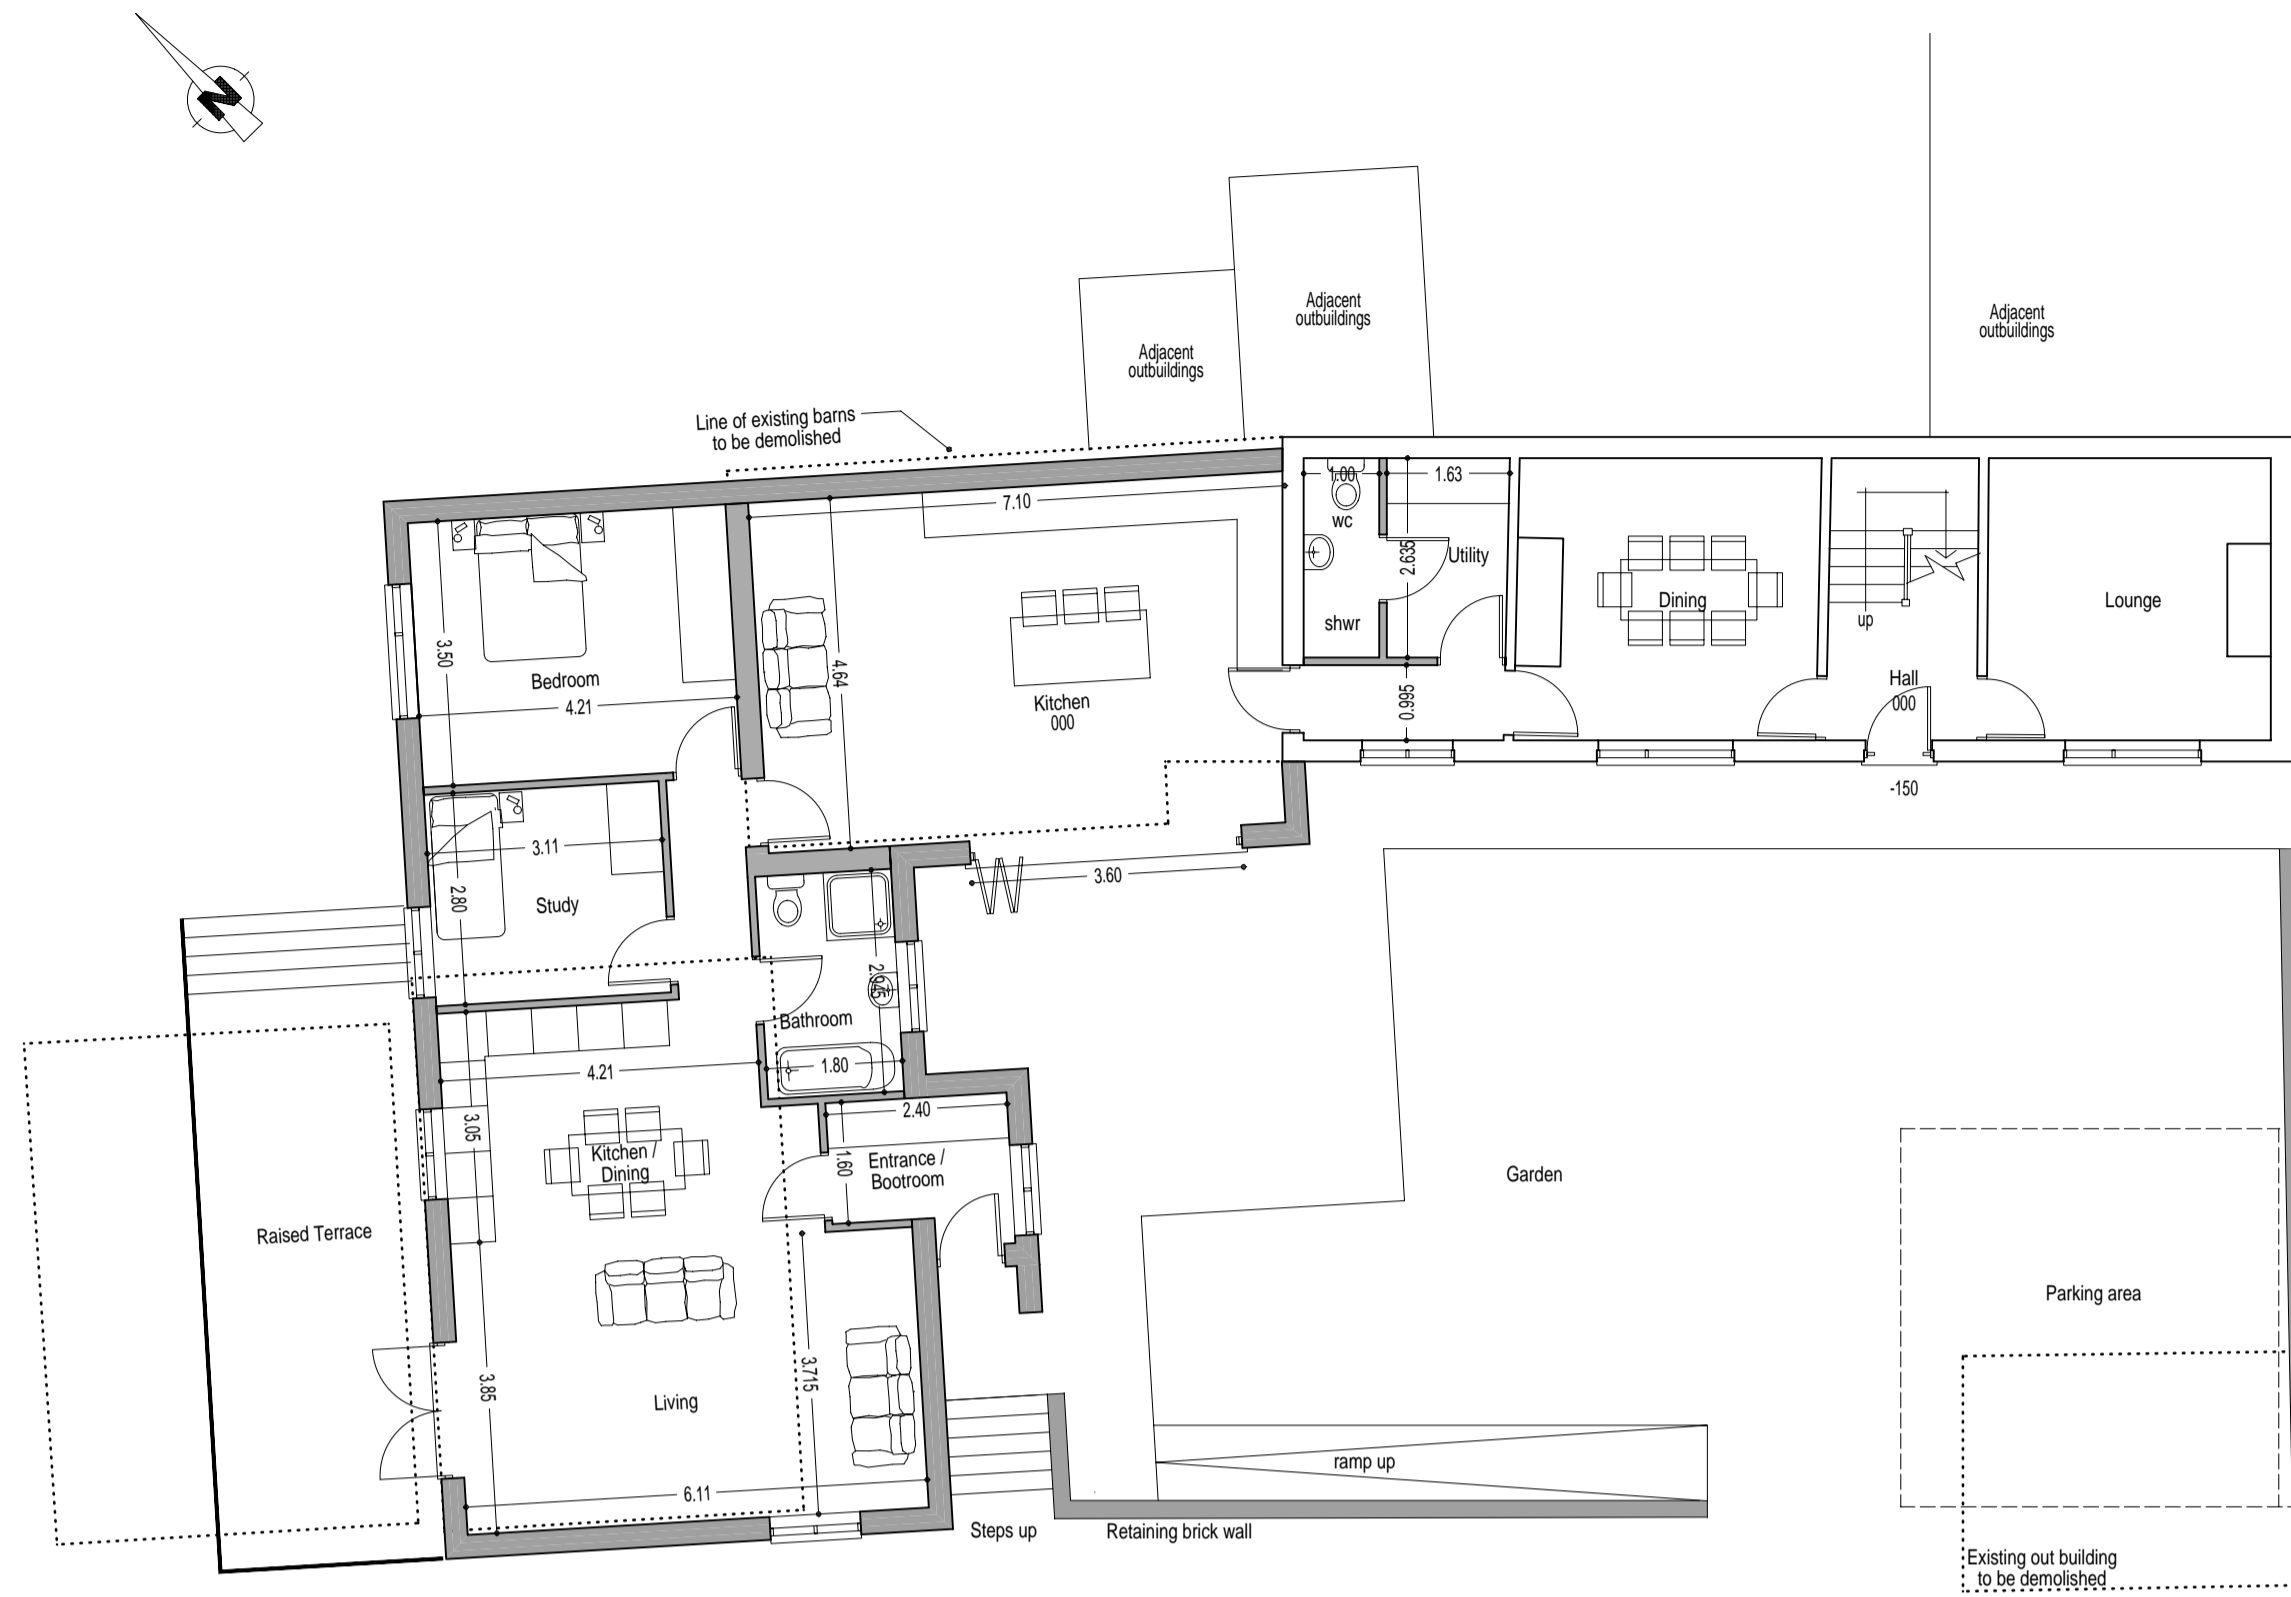
PROPOSED GROUND FLOOR PLAN
1:100

FLOOD RISK MATRIX
As the application site is in Flood Zone 3 the floor levels within the proposed development will be set no lower than the existing levels AND, flood proofing of the proposed development will be incorporated where appropriate in line with the guidance contained in the government document 'Improving the Flood Performance of New Buildings: Flood Resilient Construction'

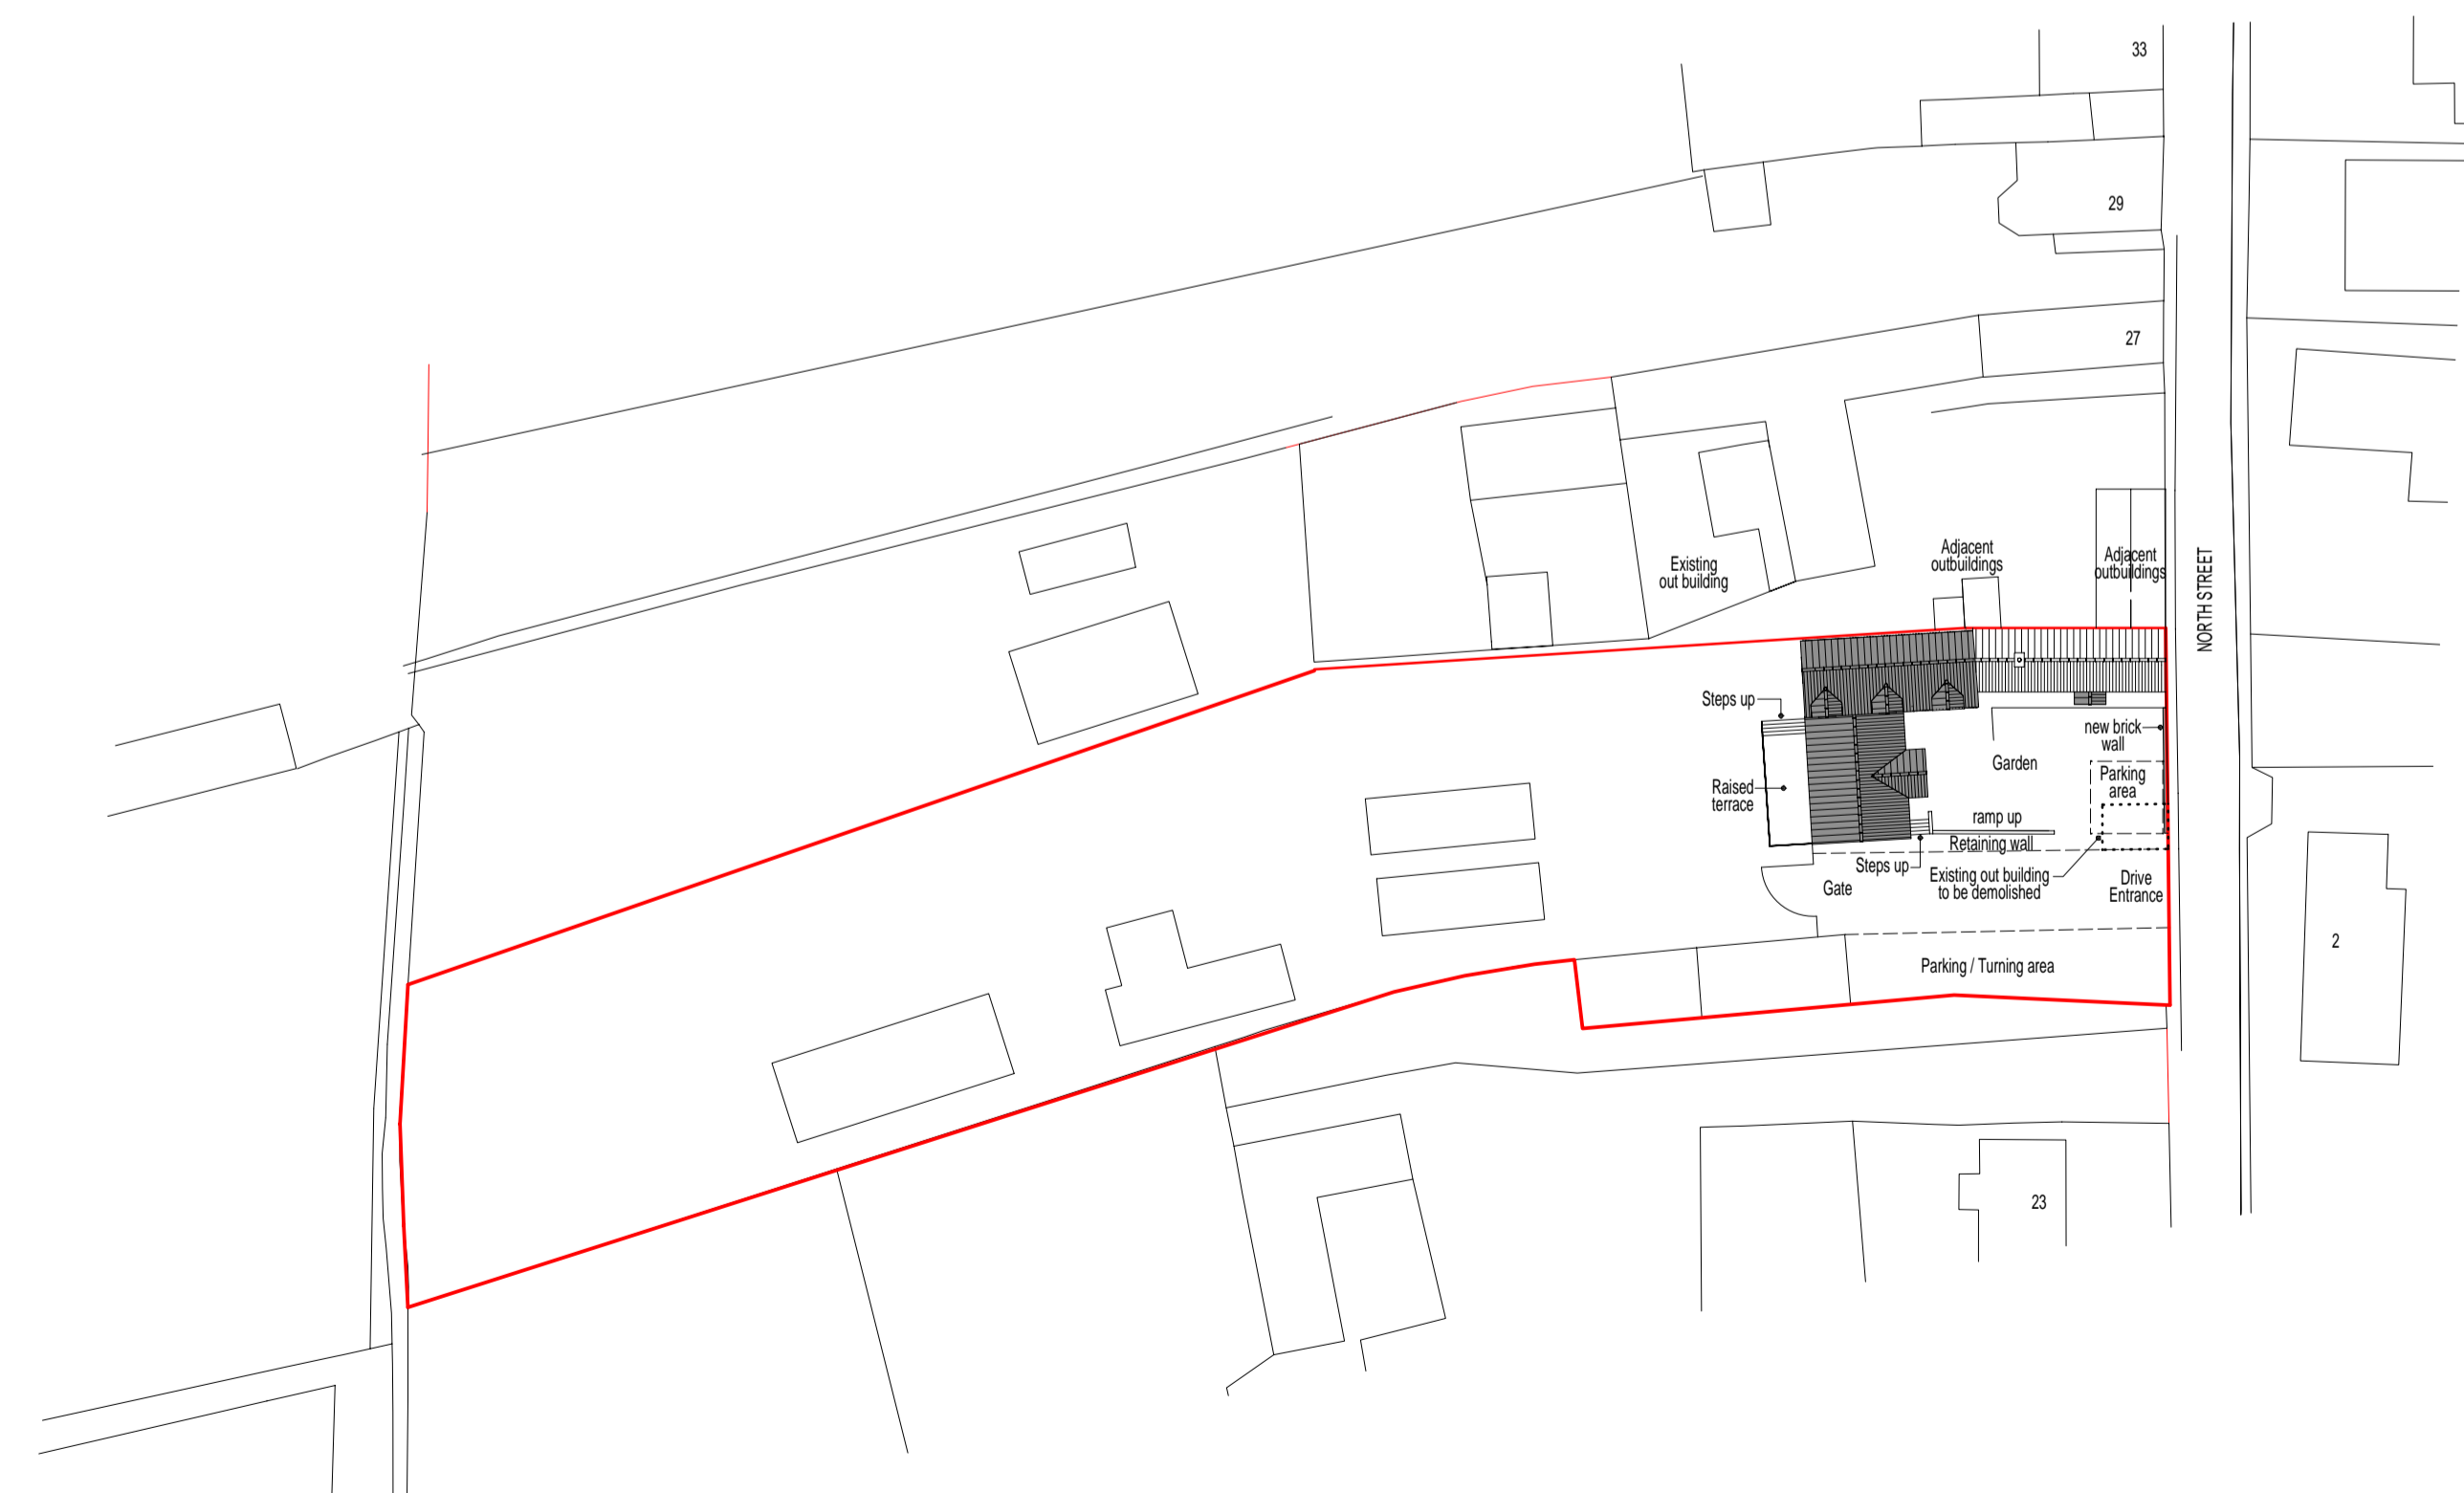
PROPOSED SITE PLAN
1:500

D - Size of proposed extension reduced 04-05-2023

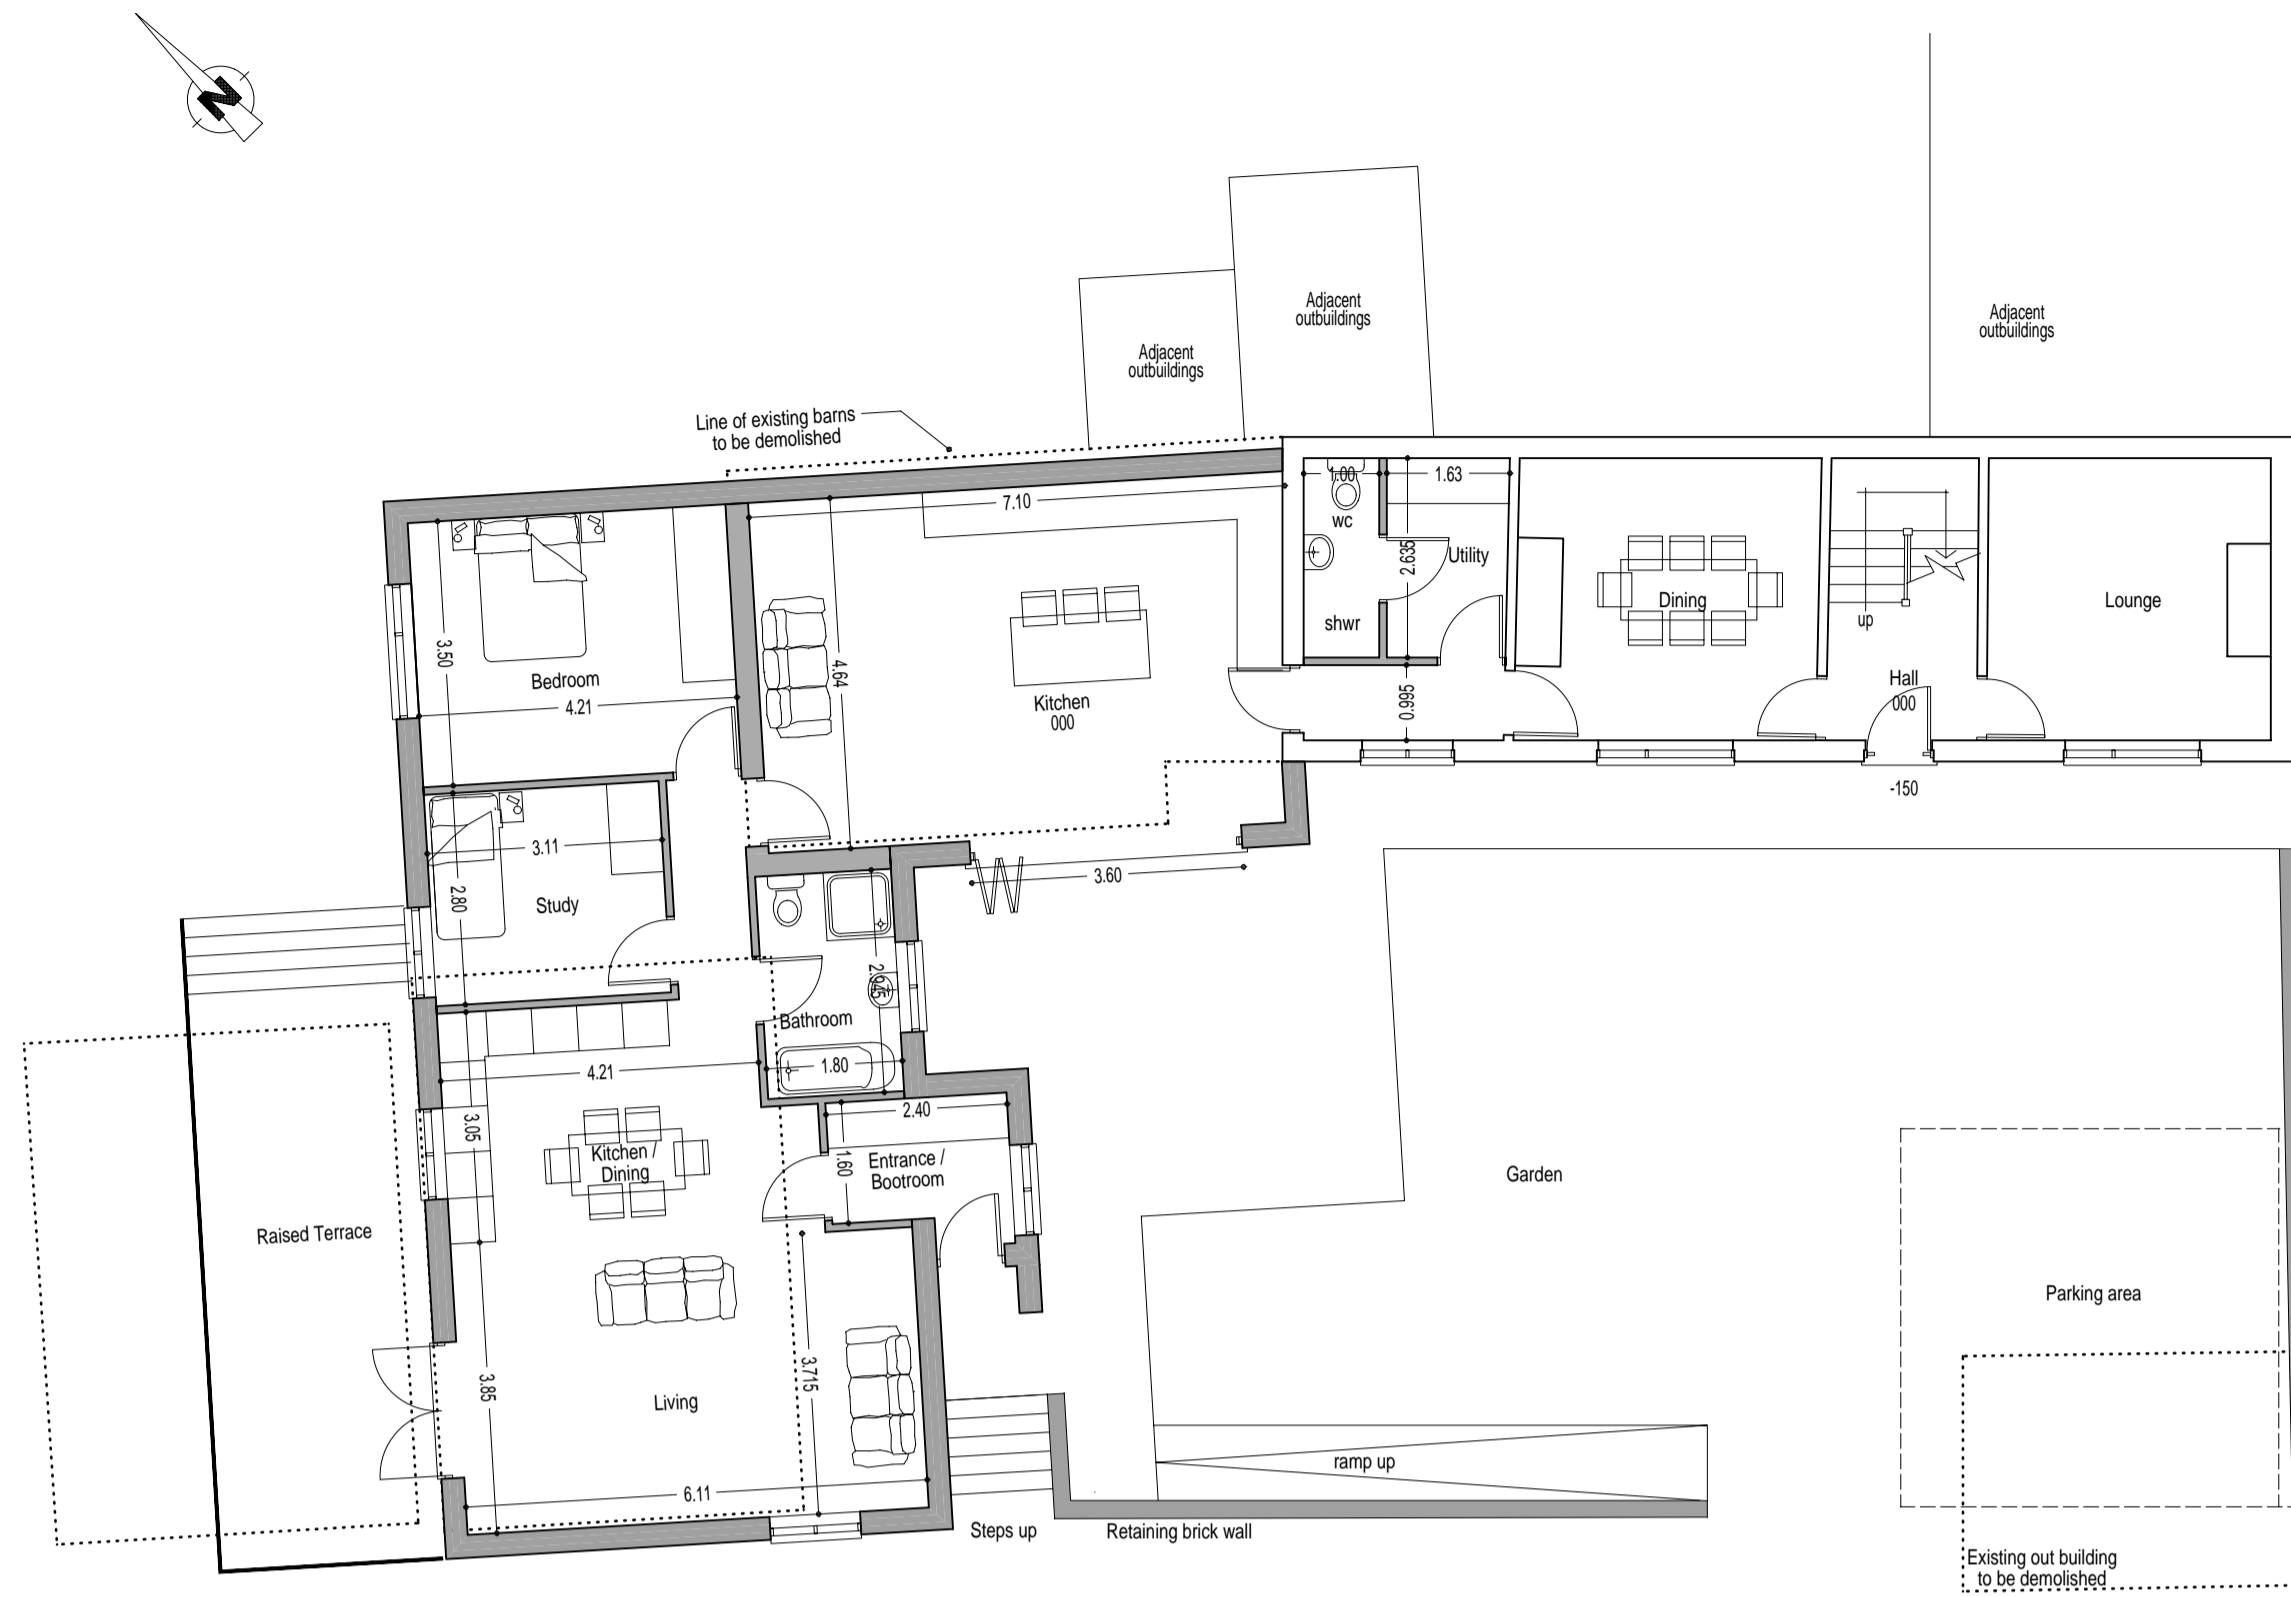
PROPOSED GROUND FLOOR PLAN
1:100

FLOOD RISK MATRIX
As the application site is in Flood Zone 3 the floor levels within the proposed development will be set no lower than the existing levels AND, flood proofing of the proposed development will be incorporated where appropriate in line with the guidance contained in the government document 'Improving the Flood Performance of New Buildings: Flood Resilient Construction'

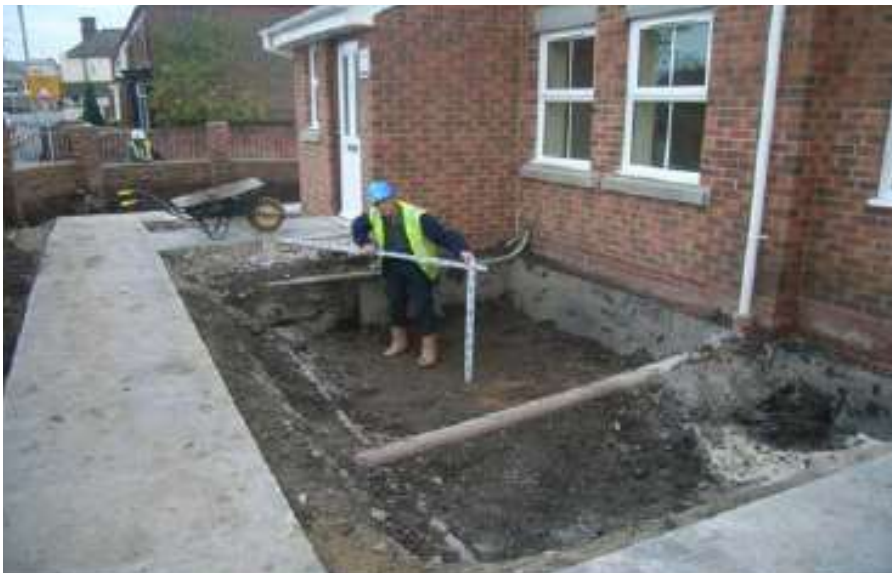
Photograph 4:
Depth check of inert cover within areas of front gardens.

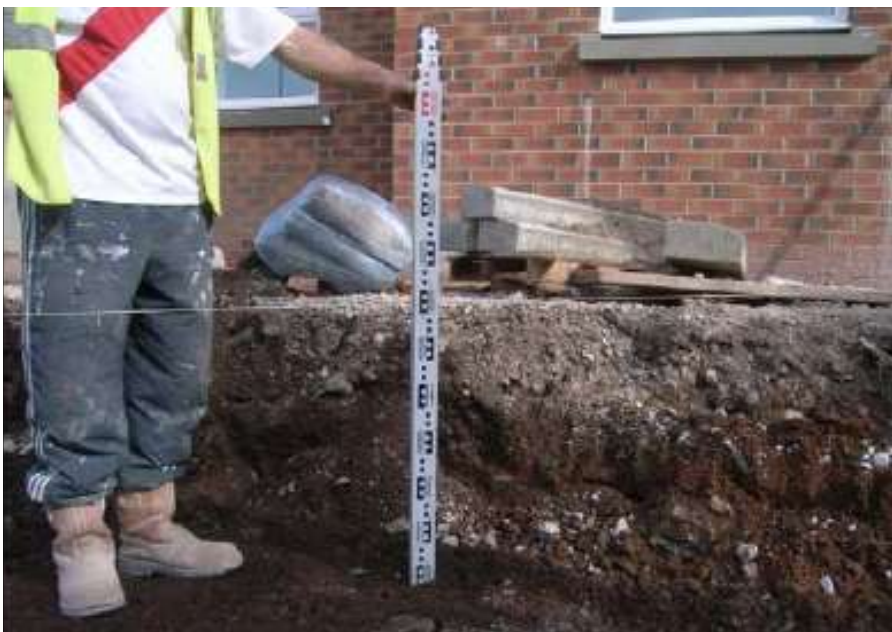
Photograph 5:
Depth check of inert cover within rear gardens. Taut string line spans across excavation.

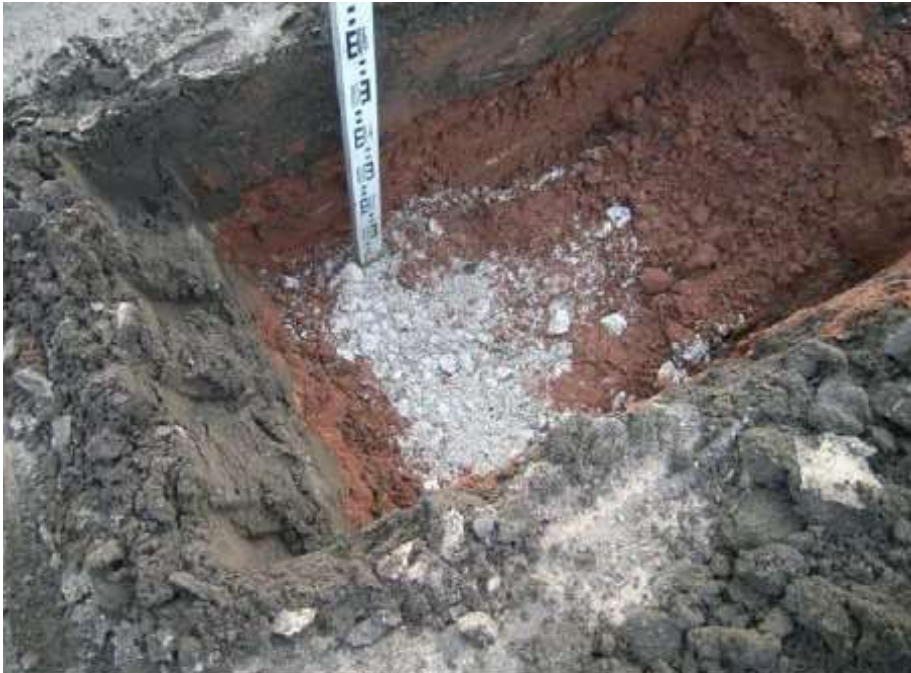
Photograph 8: Excavation within public open space and verification pit showing the presence of a remediation break layer at the base, a crushed sandstone inert fill overlain by topsoil.

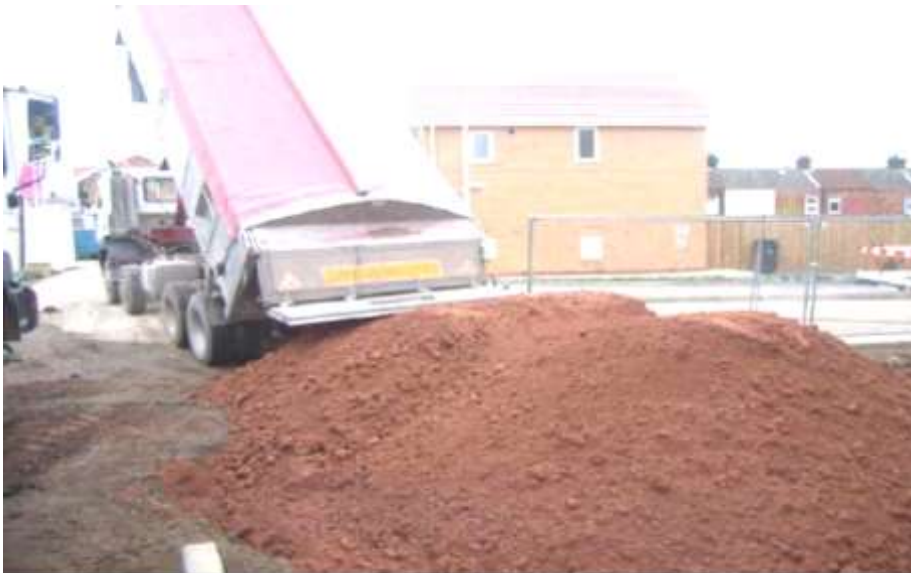
Photograph 9: Inert crushed sandstone being delivered. The spatial area of the remediation can be observed from these photographs (old terrace housing).

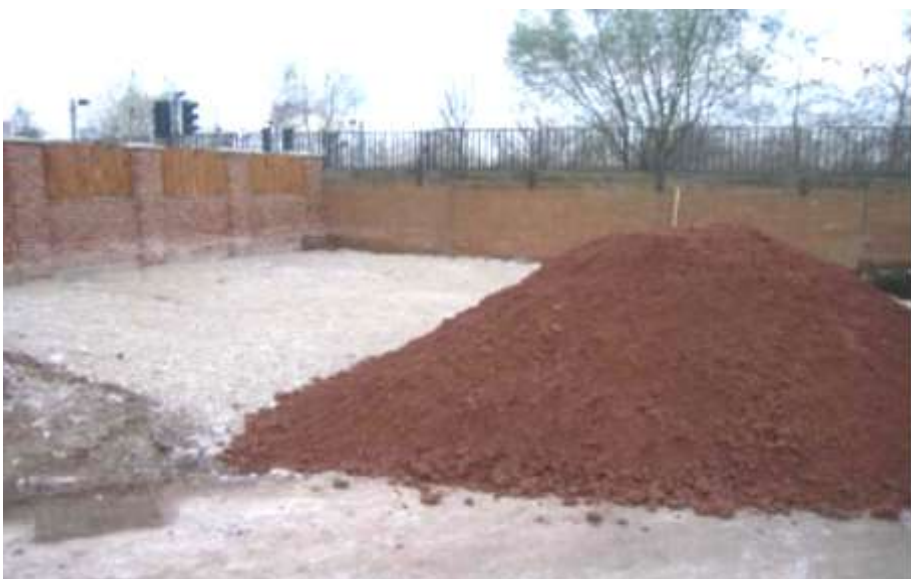
Photograph 10: Inert crushed sandstone being delivered with visible remediation break layer. The spatial area of the remediation can be observed from these photographs (traffic lights).

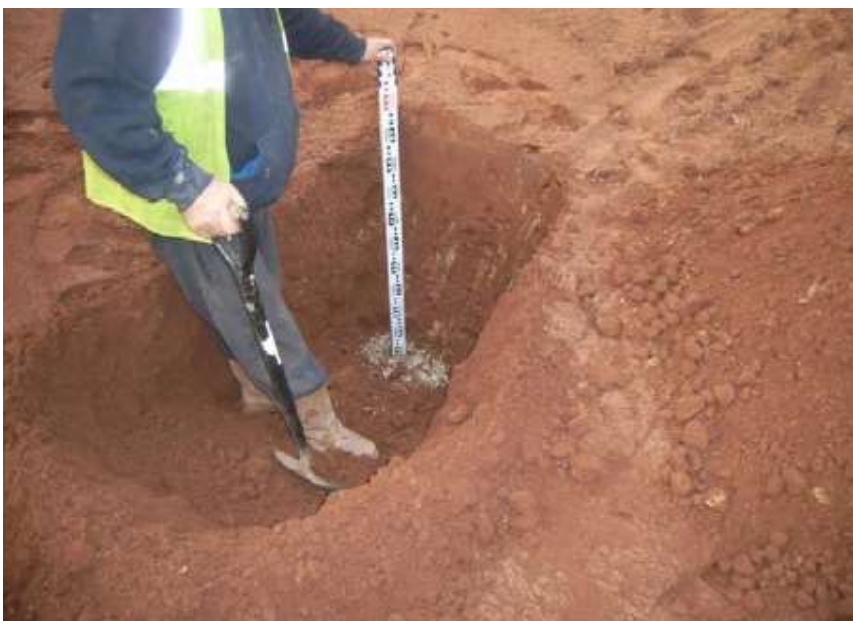
Photograph 12:
Shows the remediation of the rear garden, with a significant depth (1.0m) of inert cover. Remediation break layer visible at the base of the excavation.
