Preliminary Bat Roost Assessment	
For:	Cleveland Build
Site	Development at 22 West Street, West Butterwick, Scunthorpe, DN17 3LA
Report Date:	12 May 2022
Report Reference:	SQ-549

Client:	Cleveland Build
Site Name:	Development at 22 West Street, West Butterwick, Scunthorpe, DN17 3LA
Central Grid Reference:	SE 83229 05879
Report:	Preliminary Bat Roost Assessment
Date of survey:	9 th May 2022
Surveyed by:	Surveying Ecologist: Natasha Estrada BSc (Hons), MRes, MCIEEM Natural England Bat Licence: 2015-12213-CLS-CLS

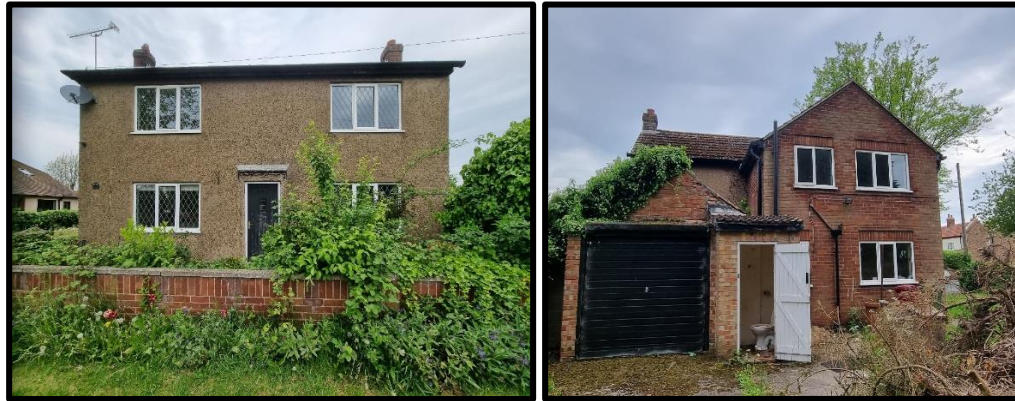
Figure 2: 22 West Street.

- 3.4.1 The building is a detached residential house that fronts onto West Street with a small front garden enclosed by a low brick wall.
- 3.4.2 A gravel driveway to the western elevation leads into the rear of the property where there is an attached garage that is only accessible via the gravel driveway.
- 3.4.3 The building is constructed in traditional brick and mortar; rendering has been applied to the southern and eastern elevations. The roof coving comprises interlocking tiles with a clay tiled ridge. All tiles were recorded as intact throughout the roof profile with no areas of

lifted, loose or absent tiles recorded. Furthermore, moss growth has encroached the roof, largely eliminating any access potential under the roof tiles.

- 3.4.4 The ridge is intact along its length with further moss encroachment recorded eliminating access beneath the ridge tiles. Two chimney stacks are present and whilst water ingress was noted to have swelled the brickwork, no fissures of a size capable of being used by bats were recorded. A small area of lifted lead flashing was recorded on the southern elevation adjacent to the chimney stack.

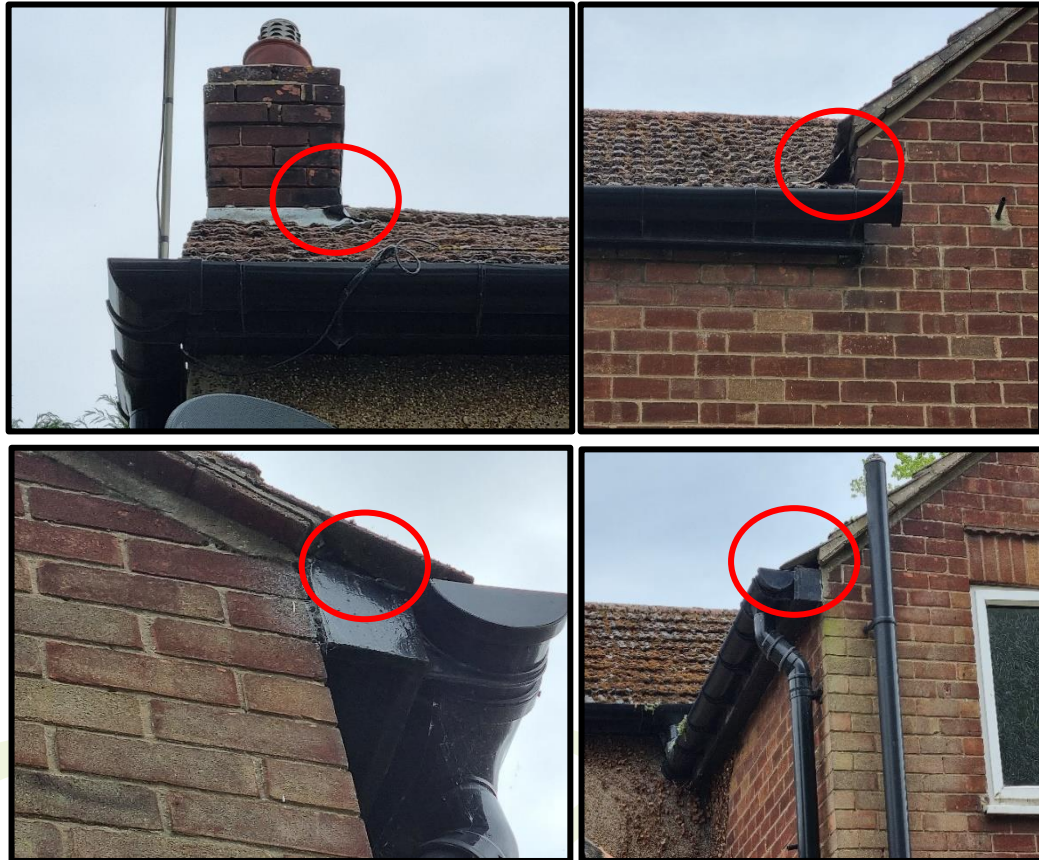
Figure 3: Potential roost features

- 3.4.5 On the northern roof section, there is a hip which at the end of the valley recorded an area of lifted flashing. This area recorded both roost suitability and suitability for nesting birds however, no field sign evidence for either bats or birds was recorded at the time of survey.

- 3.4.6 The fascia boards appear wooden and were recorded as largely intact running flush to the render. One minor suboptimal fissure was recorded on the southwestern aspect at the end of the fascia board. This feature was deemed suboptimal and not of a size likely to provide access potential. A further gap which was recorded as optimal was recorded at the box end on the southern aspect.

3.4.12 For the purposes of assessment, with due consideration to Collins 2016, the building has been classified as containing moderate roost suitability. Further survey effort is therefore recommended to ascertain presence/ likely absence of use of the building by bats for roosting or as a place of shelter.

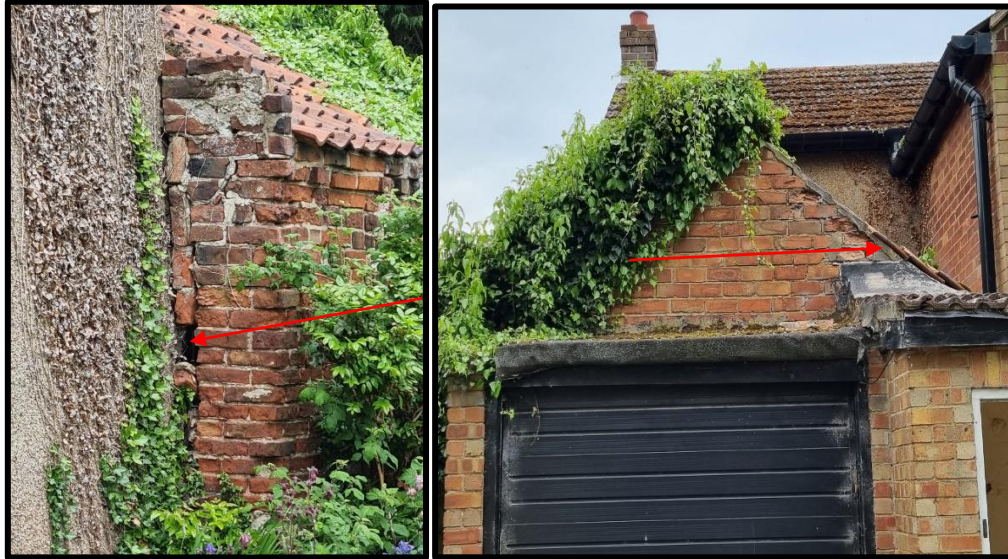
Figure 4: Fissures within the garage.

- 3.4.7 Render and brickwork was recorded as intact and sealed throughout offering negligible roost suitability. Window frames were recorded as wooden and intact and sealed throughout as were the door frames. Access points from pipework were recorded as sealed, offering negligible roost suitability.
- 3.4.8 Located on the northeast of the house is a small red brick garage. The garage has a tiled pan tiled roof with some lifted edges and mortar gaps on the front gable. The roof also supports ivy cover that could disguise or provide some unseen features.
- 3.4.9 The eastern gable was recorded as being fully sealed and intact offering negligible roost suitability. No features capable of providing access directly into the roof void of the property were recorded at the time of survey.
