Phase 3: Remediation Strategy

Worlaby House Farm, Worlaby

Produced for Truelove Properties

Title:	Phase 3: Remediation Strategy Worlaby House Farm, Worlaby
Client:	Truelove Properties
Report number:	0154/4621/P/P3

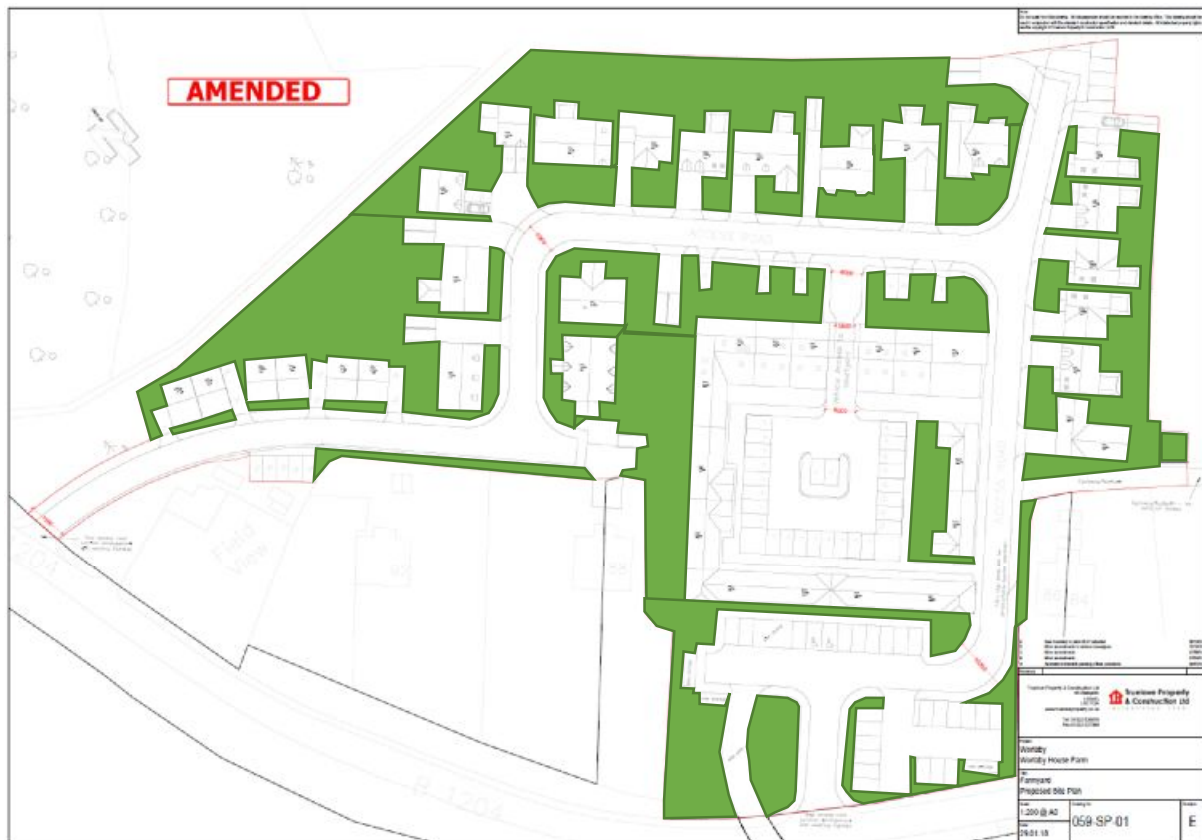
Proposed soft landscaped areas

1. Do not scale
2. Locations of all features are approximate only
3. Background images from Truelove Property drawing number 059-SP-01 Revision e, dated January 2018
4. This drawing should be read in conjunction with the HML Phase 3 Remediation strategy (HML ref.: 0154/4621/P/P3)
5. Soft landscaped areas will require 600mm-thick, clean cover systems

Following successful completion (or before, if necessary) of the structural works, the cover system can be installed in garden and soft landscaped areas (e.g. below lawns or plant beds). This shall be placed to a thickness of 0.60m below final ground levels which is based on current best practice and is recommended by BRE Report 465 (Tedd *et al.*, 2004).

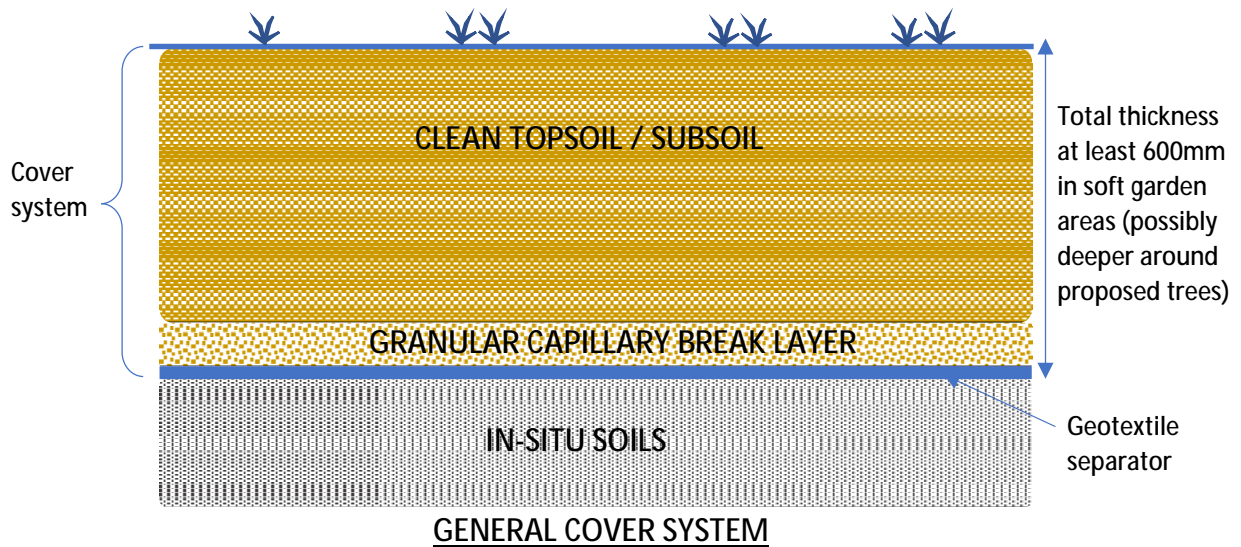
10. Geotextile shall be a suitable separator layer (e.g. Fastrack 1800 or similar)
11. Granular capillary break layer shall be 100mm thick or 3 times nominal diameter of particles

12. Allowance shall be made for increasing the cover system thickness below new trees to accommodate the root ball

A minimum 100mm thickness of granular gravel material, or at least three times the nominal size of the aggregate, whichever is the lesser, shall be placed on the geotextile as a capillary break. This will consist of proven clean inert material, e.g. sampled and tested to the above requirements (in Tables 8 to 10). It is recommended that a virgin material be used from a reputable local quarry.
