Phase 2 (site investigation) report

9a Darwin Street, Kirton in Lindsey

Produced for C & K Builders

Title:	Phase 2 (site investigation) report 9a Darwin Street, Kirton in Lindsey
Client:	C & K Builders
Report number:	1166/4758/P/P2

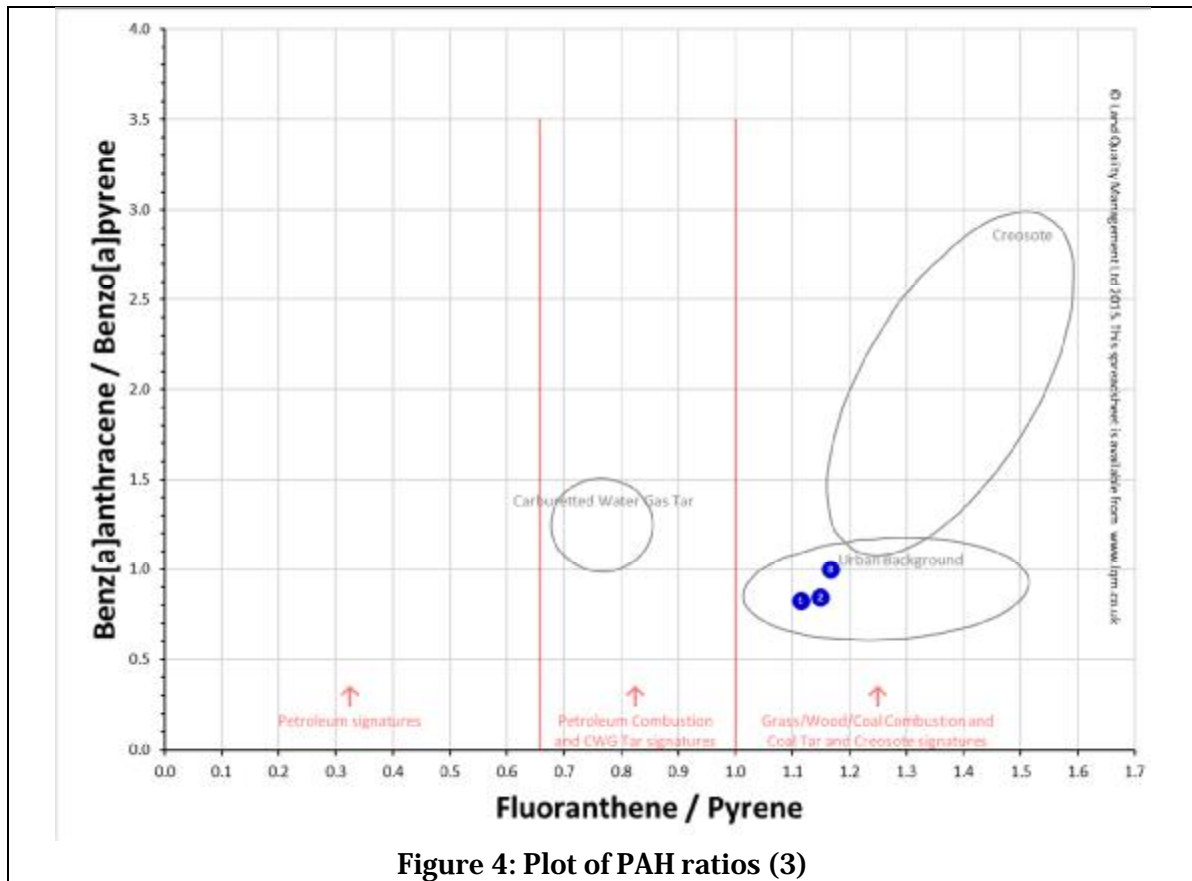
Figure 4: Plot of PAH ratios (3)

Therefore, the source of the PAH contamination in the made ground could be either (A) ash or clinker from burnt wood or coal or (B) coal tar. Given the site history, either source is feasible.

It is noted that the detected PAHs are not of a petroleum signature. Therefore, the results are not a potential indicator of petroleum hydrocarbon contamination.

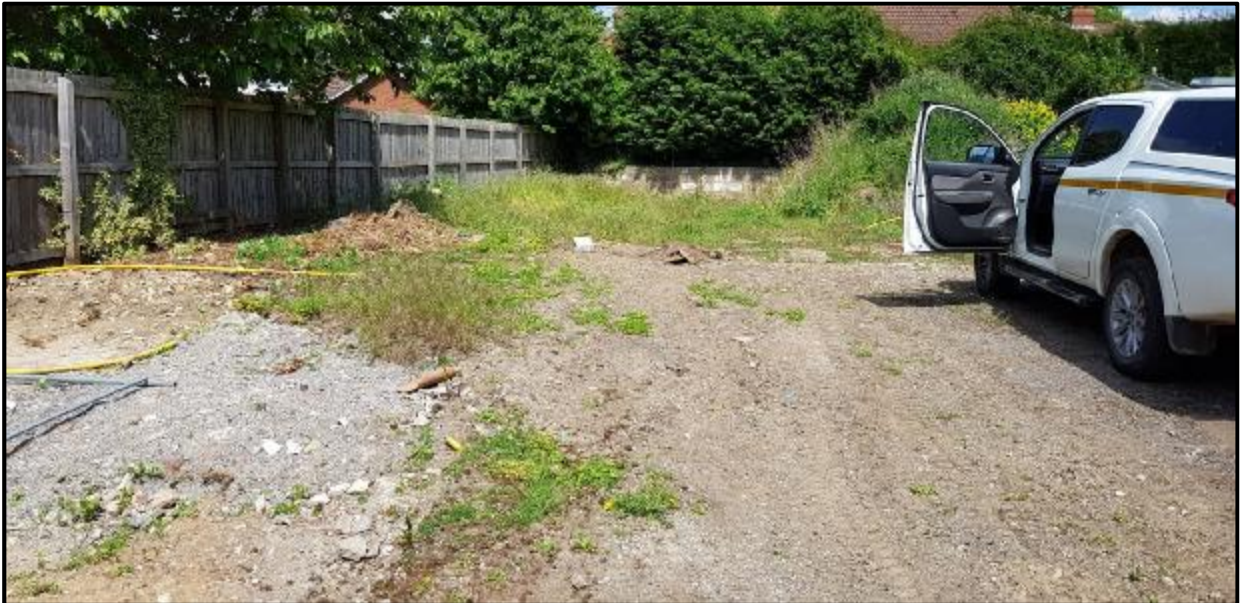
Centre of the site (view to north)
