Arboricultural Report

Principle Formal Arboricultural Report/Survey

Location: land off Main St, Scawby, Nr Brigg, Lincs

Date: 22nd July 2021

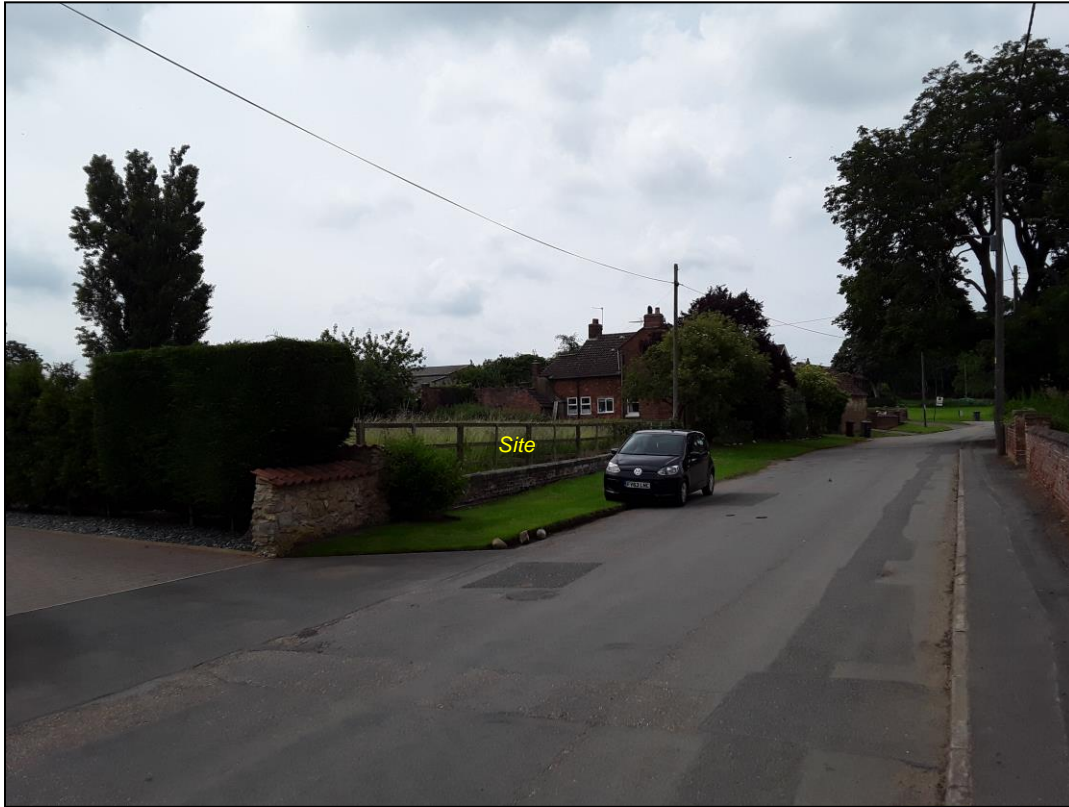
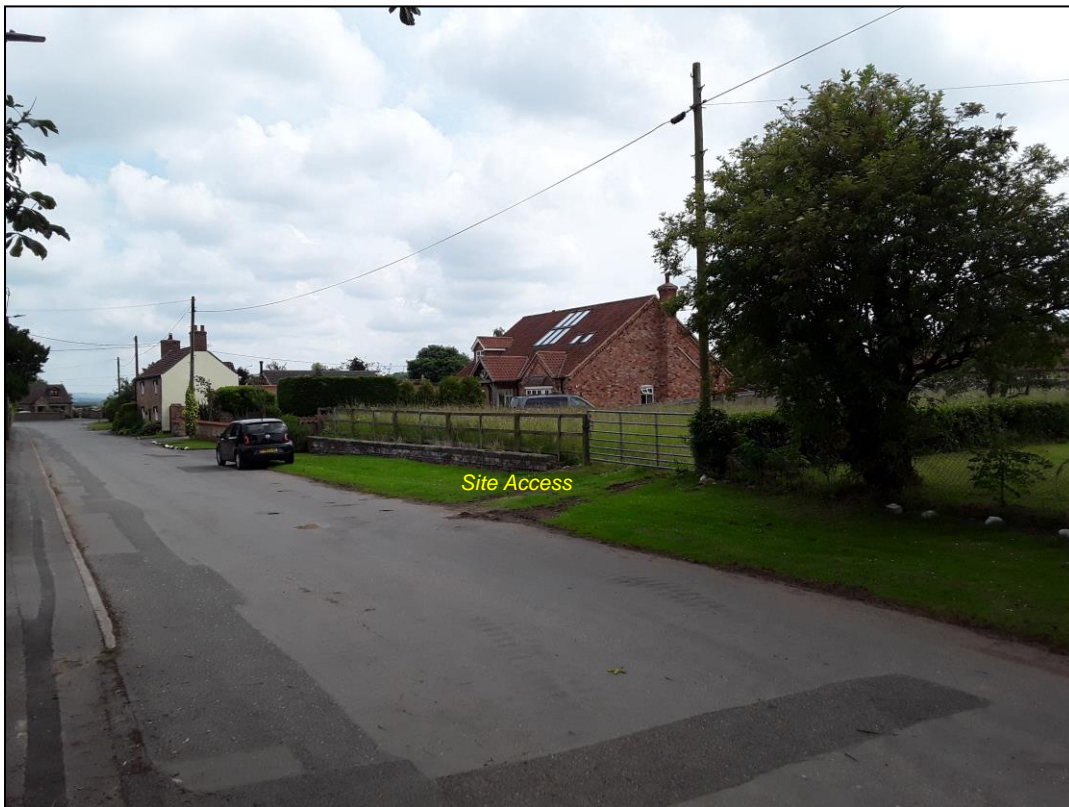
View from Main Street, looking west

View from Main Street, looking east showing the existing access into the site

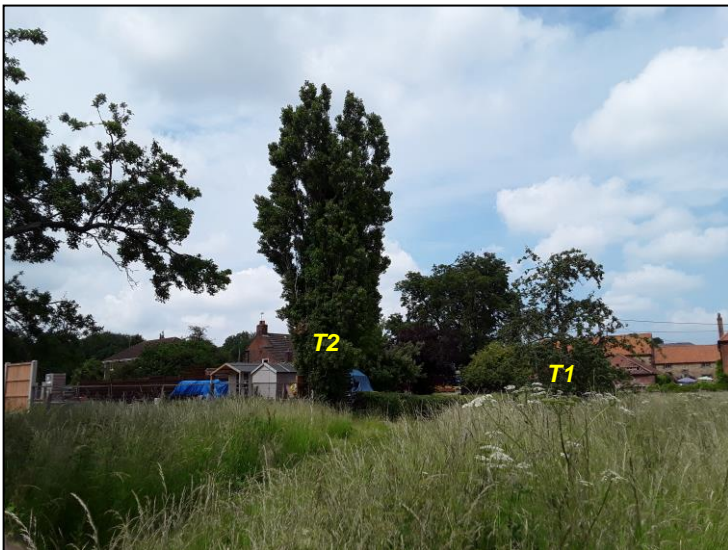
View from the access track looking north towards Main Street

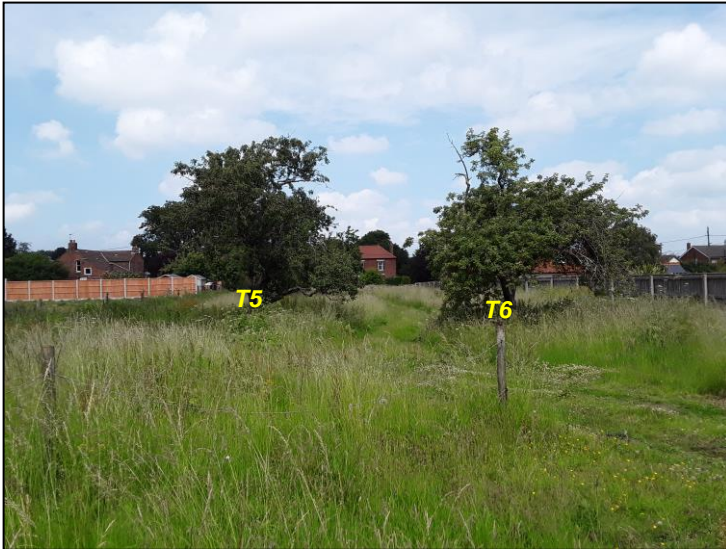
Further into the site, looking north towards Main Street. From here the site area increases. Mostly, the trees positioned along or close to the grass track are of a fruiting species.

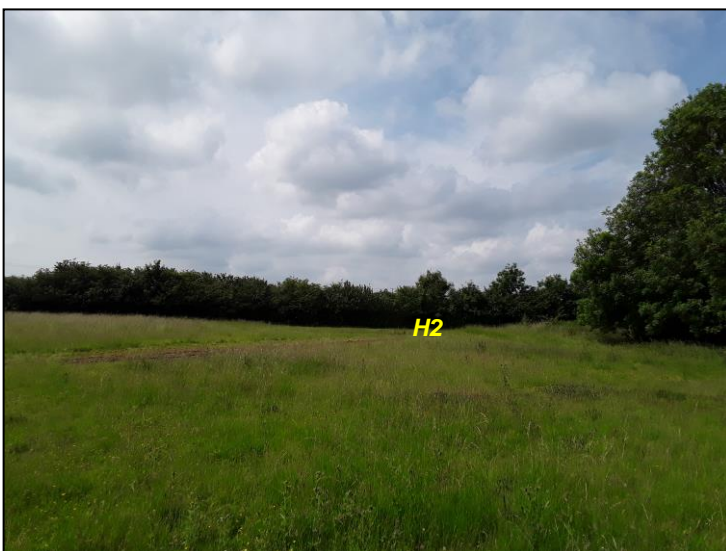
View from the southern boundary looking west towards hedgerow H2. The hedges associated with this site are typically rural in character and species.
