Grange Farm, Roxby
HERITAGE ASSESSMENT
with Design and Access Statement
September 2022

Version 2 – FINAL

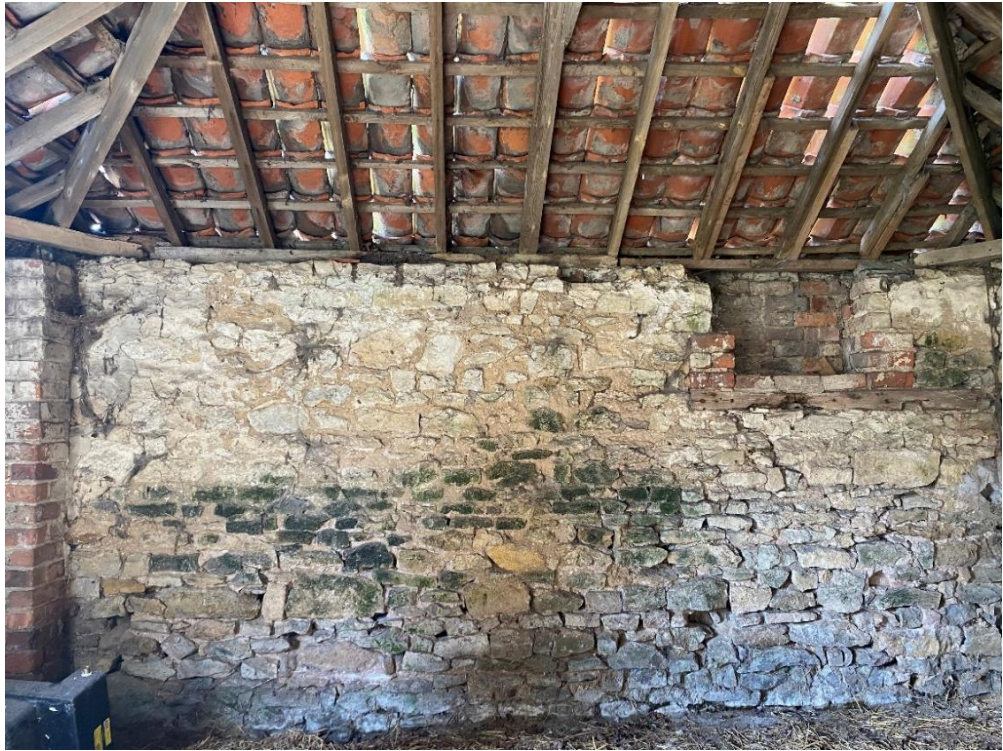
Fig. 21 – Building 1 - the internal southern end – the floor to this building is partially concrete construction

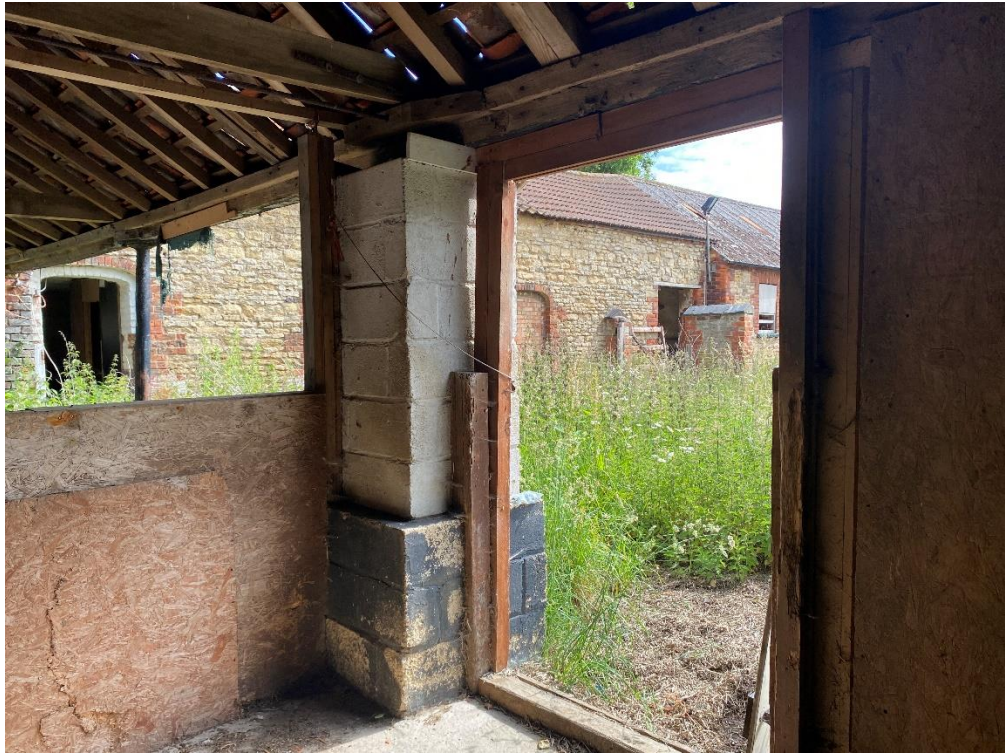
Fig. 23 – Building 1 – a blockwork column to the eastern side

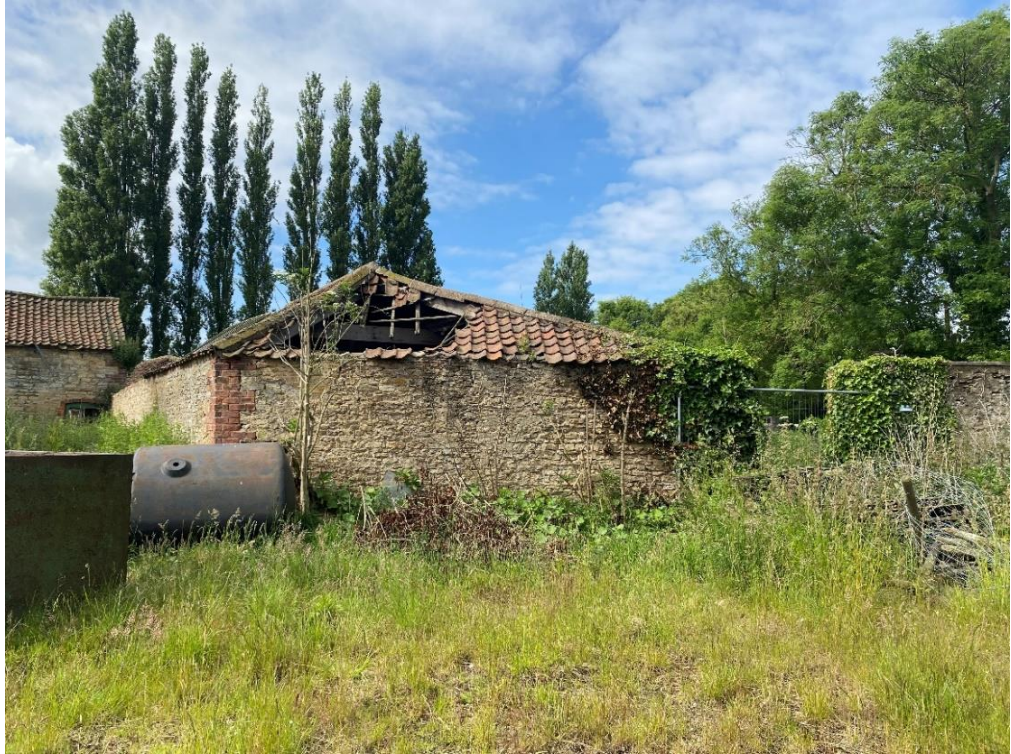
Fig. 25 – Building 2 – northern end, which has an angled plan – walls are rubble stone with brickwork quoins to the external corners

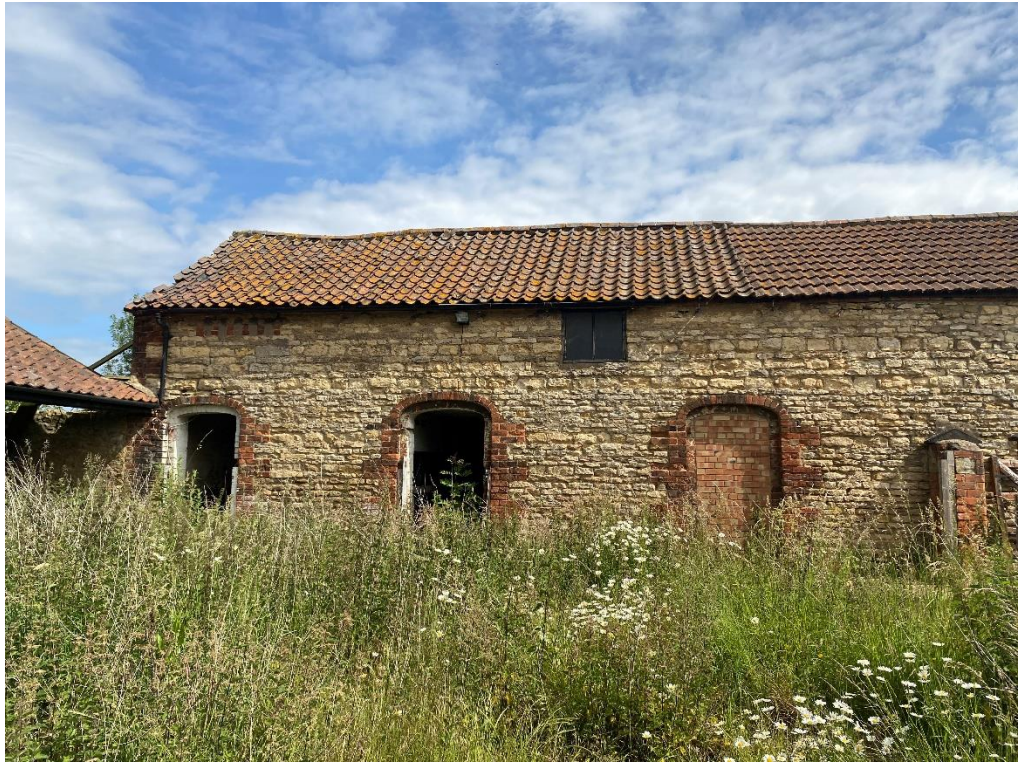
Fig. 27 – Building 3 – south elevation – this is a 2-storey building of stone and brickwork construction under a pantiled covered timber roof with a timber first floor construction

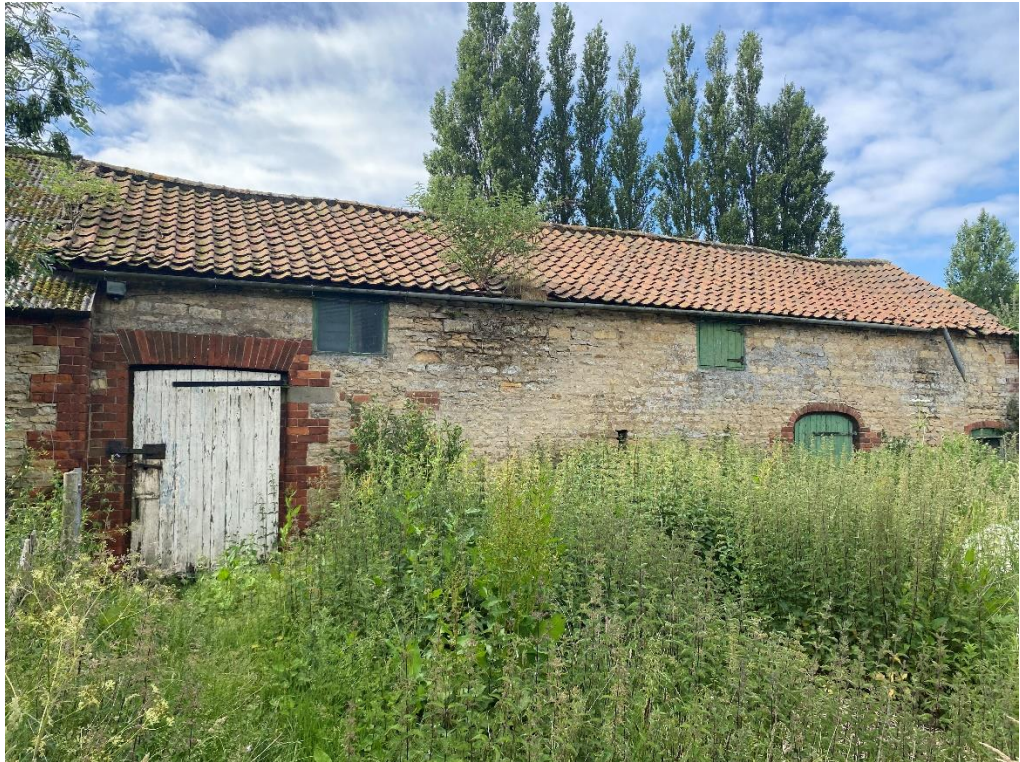
Fig. 29 – Building 3 – north elevation, which has a substantial timber boarded door opening and an arched headed door opening and ground floor windows opening to the western end

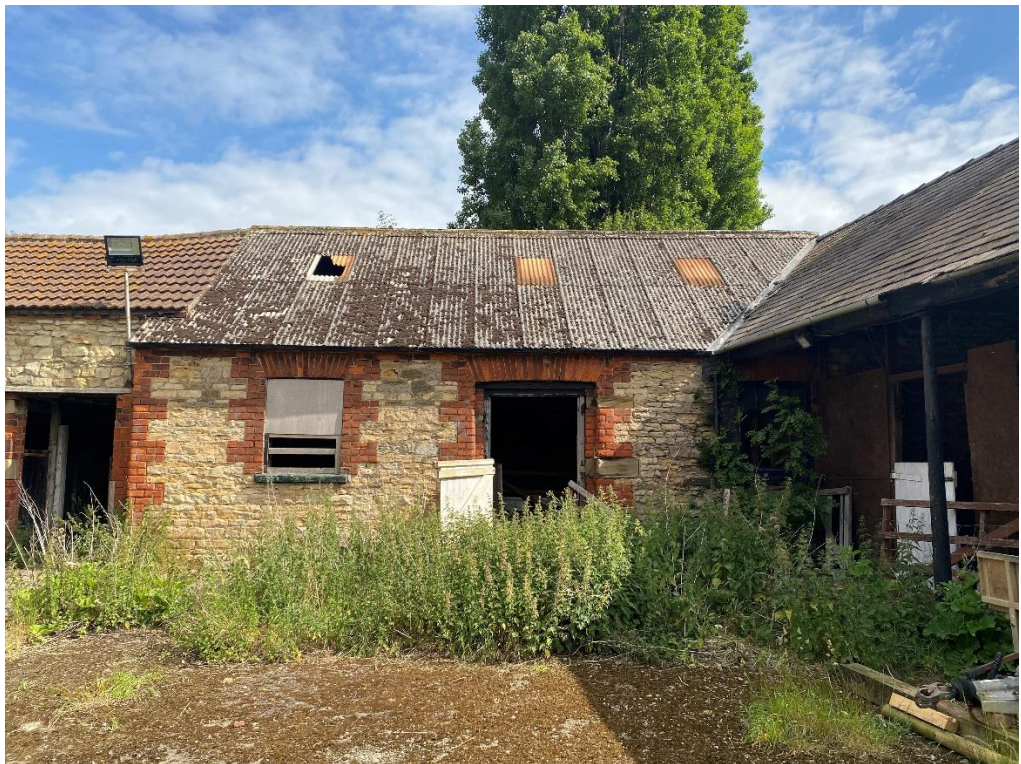
Fig. 32 – Building 4 – south elevation showing the profiled sheet roof covering, rooflights and brick detailing to the door and window openings

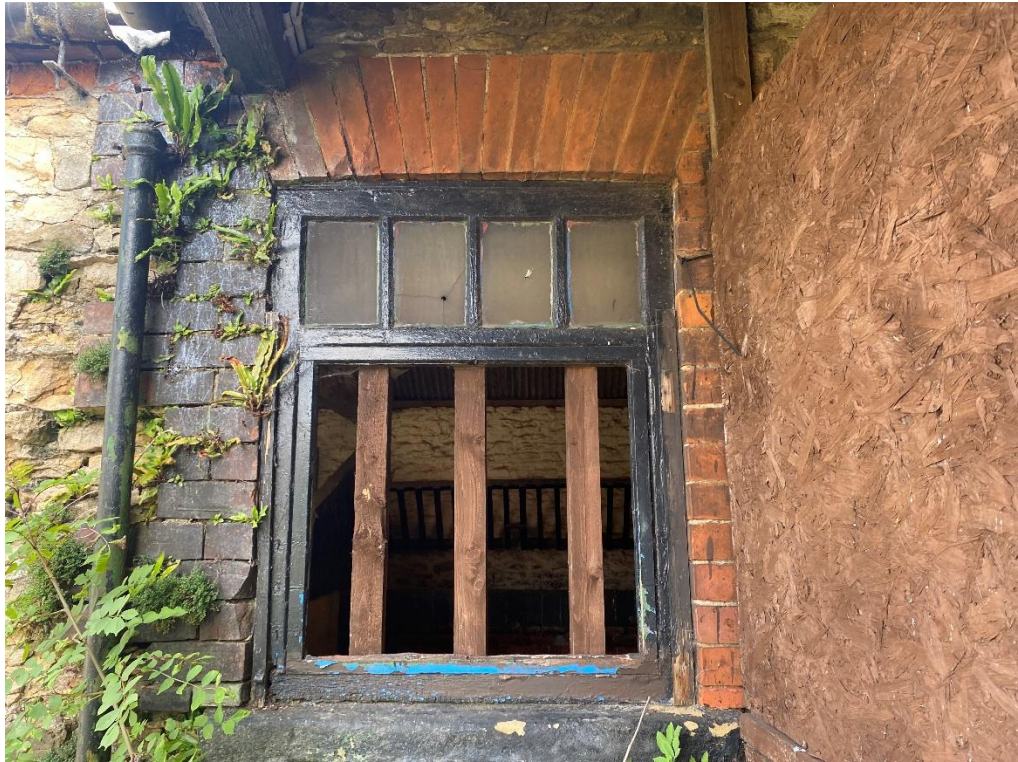
Fig. 33 – Building 4 - a timber window to the south elevation, which sits under the roof overhang of the adjoining building 5.

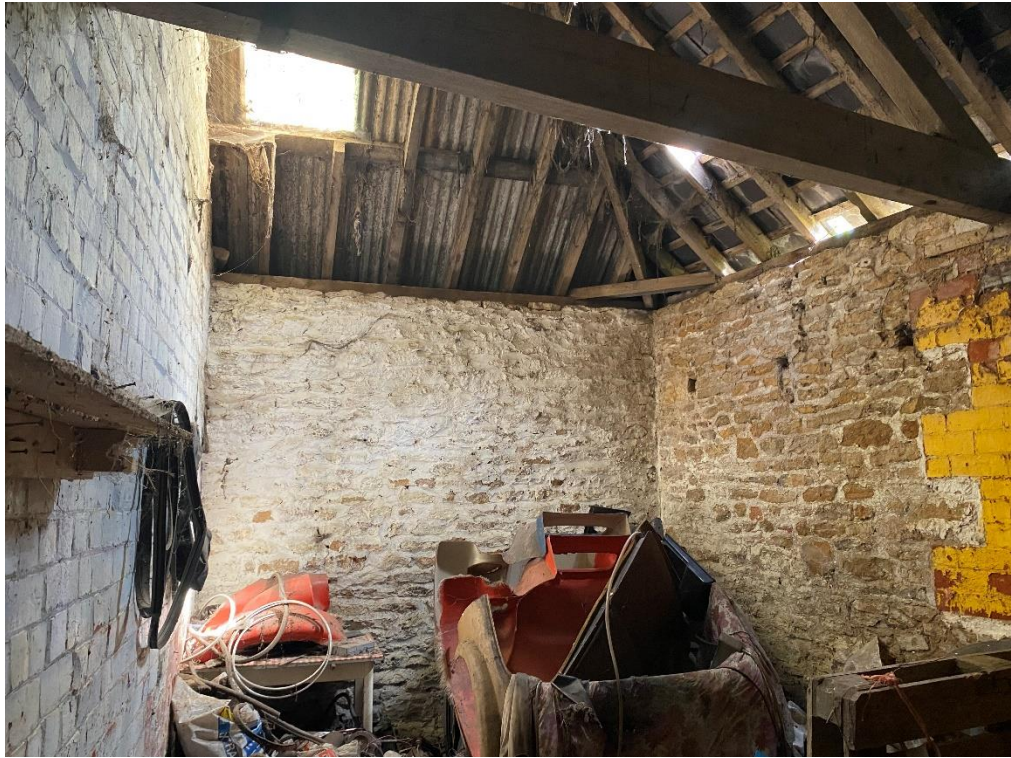
Fig. 35 – Building 4 – part of the eastern end bay – this building comprises a larger main bay accessed to the south off the main yard with an internal door to the end bay shown above

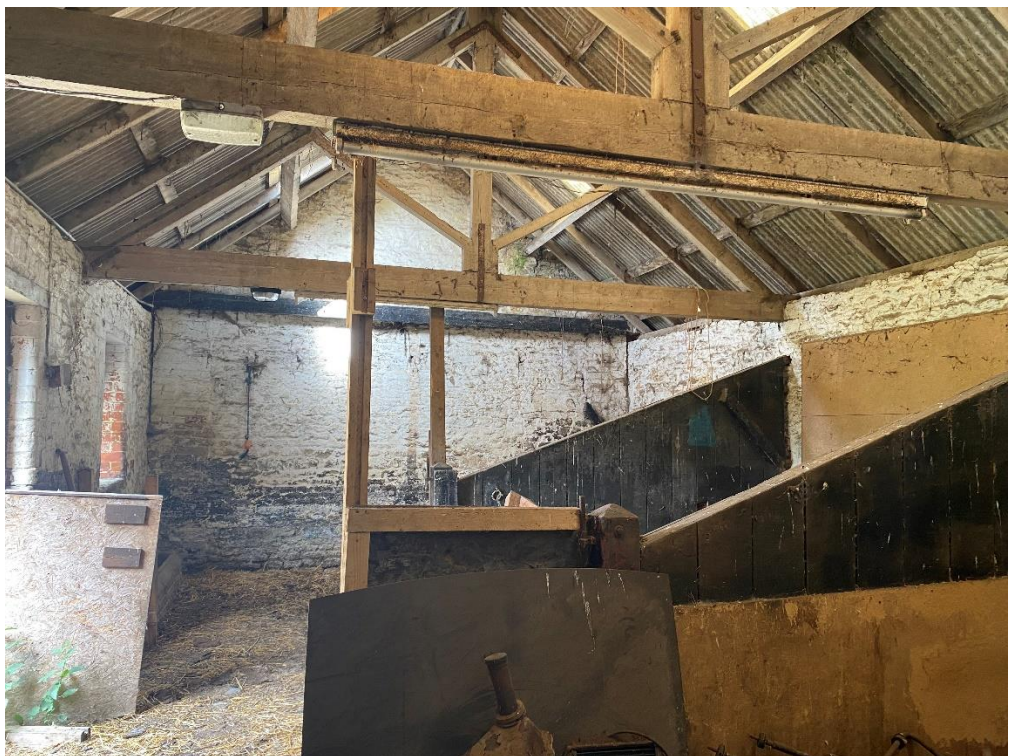
Fig. 36 – Building 4 - the main bay which has a king post timber roof construction and timber stall risers

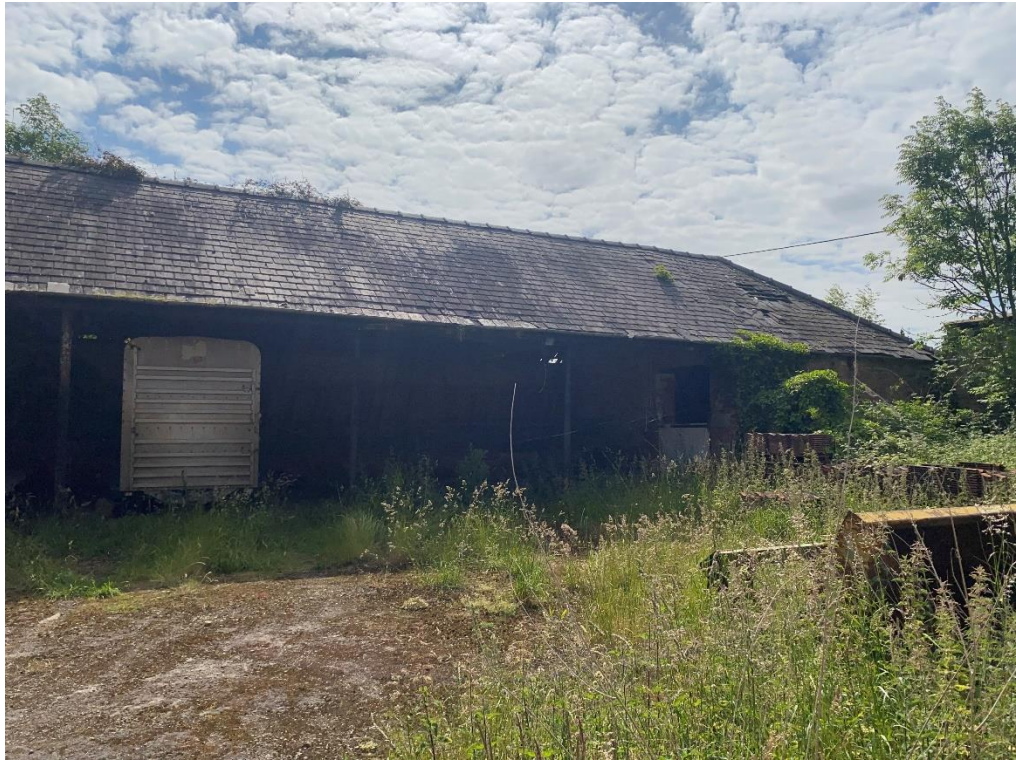
Fig. 37 – Building 5 – west elevation, the northern extents are four open bays with cast iron columns (the fifth northern bay is enclosed with a timber panel wall) – the southern end is a single enclosed bay with stone walls

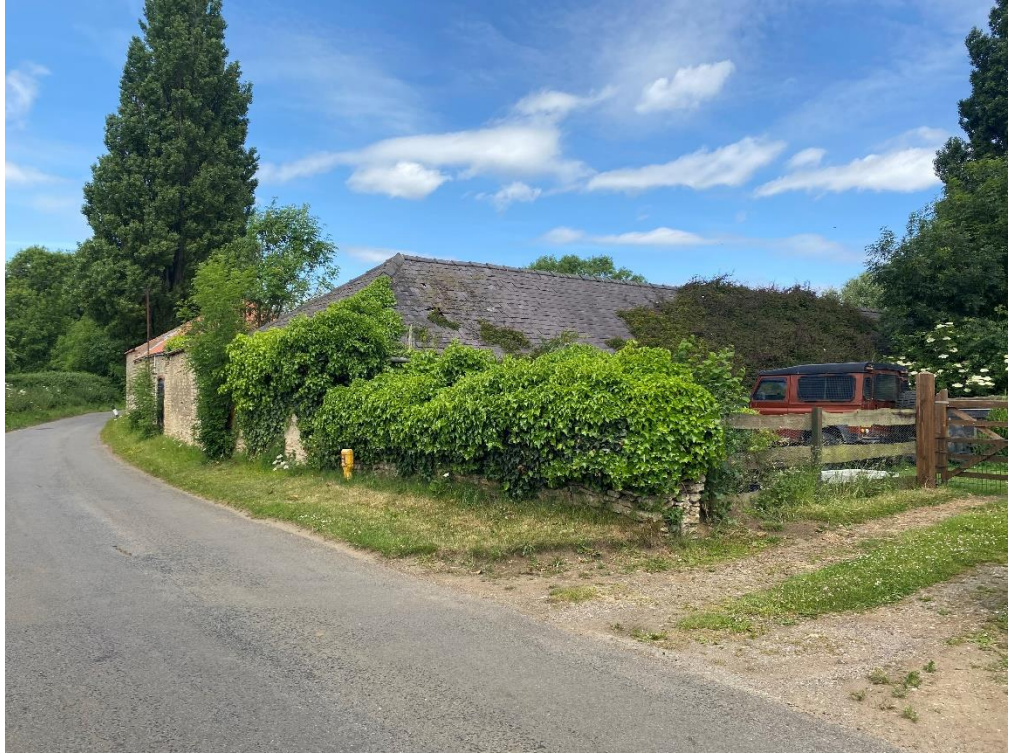
Fig. 39 – Building 5 – the southern end which sits tight to North Street – the roof has a hipped end with a natural slate roof covering

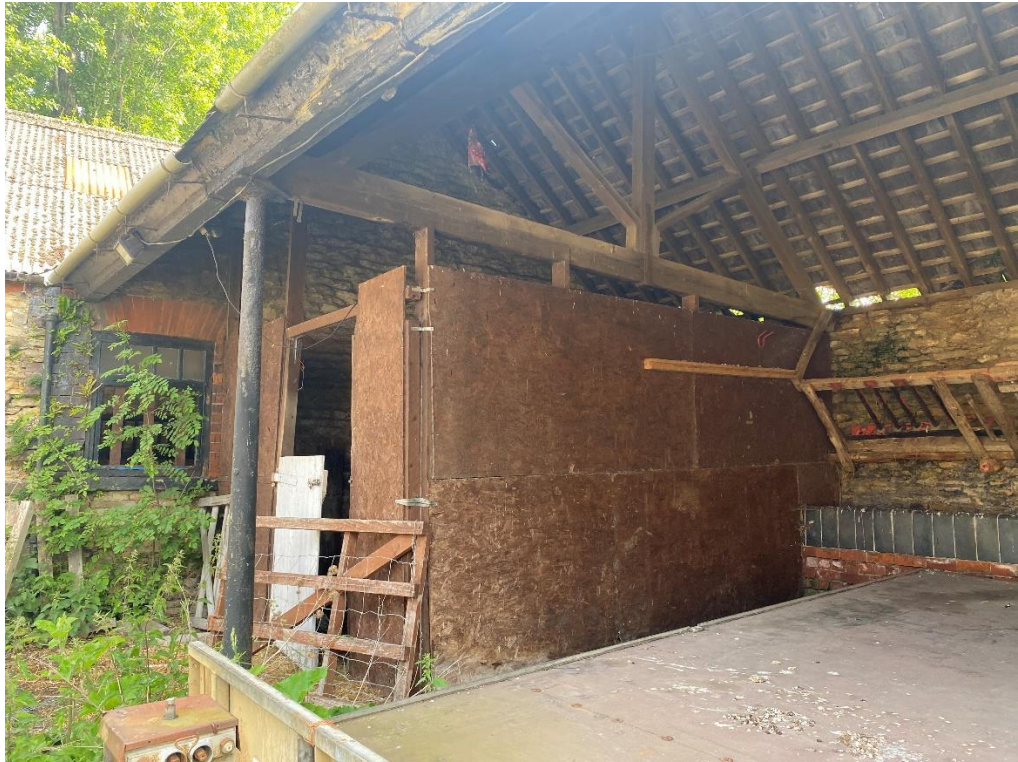
Fig. 43 – Building 5 - the northern bay which is enclosed by timber panels – there is a wooden and brick-built feeding trough along the internal east wall. The roof is supported by King post timber trusses on the lines of the exposed cast iron columns

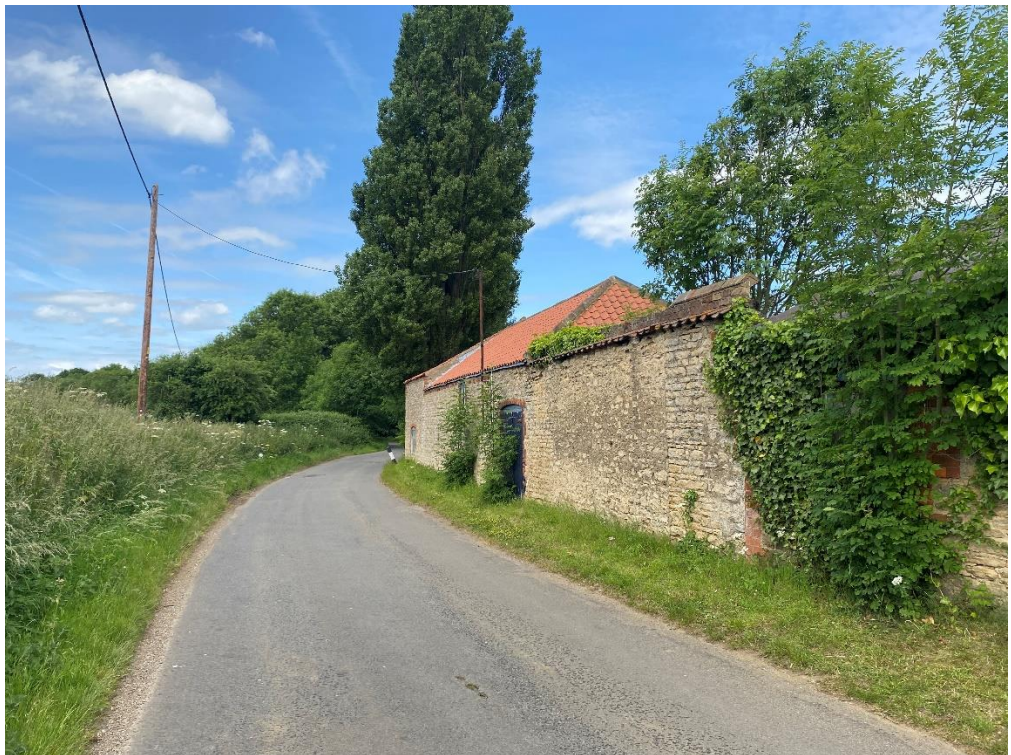
Fig. 46 – Building 6 – part of the south side showing a door opening onto North Street

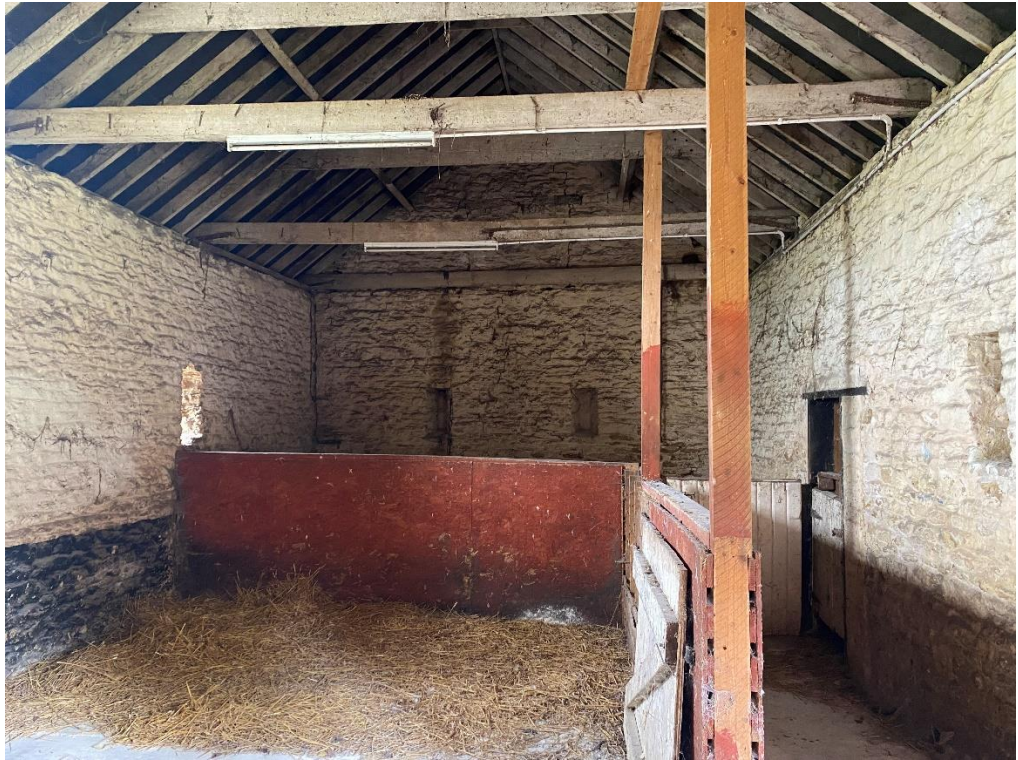
Fig. 47 – Building 6 – the main eastern building which has a timber trussed roof construction with a rough cast concrete floor and stone walls

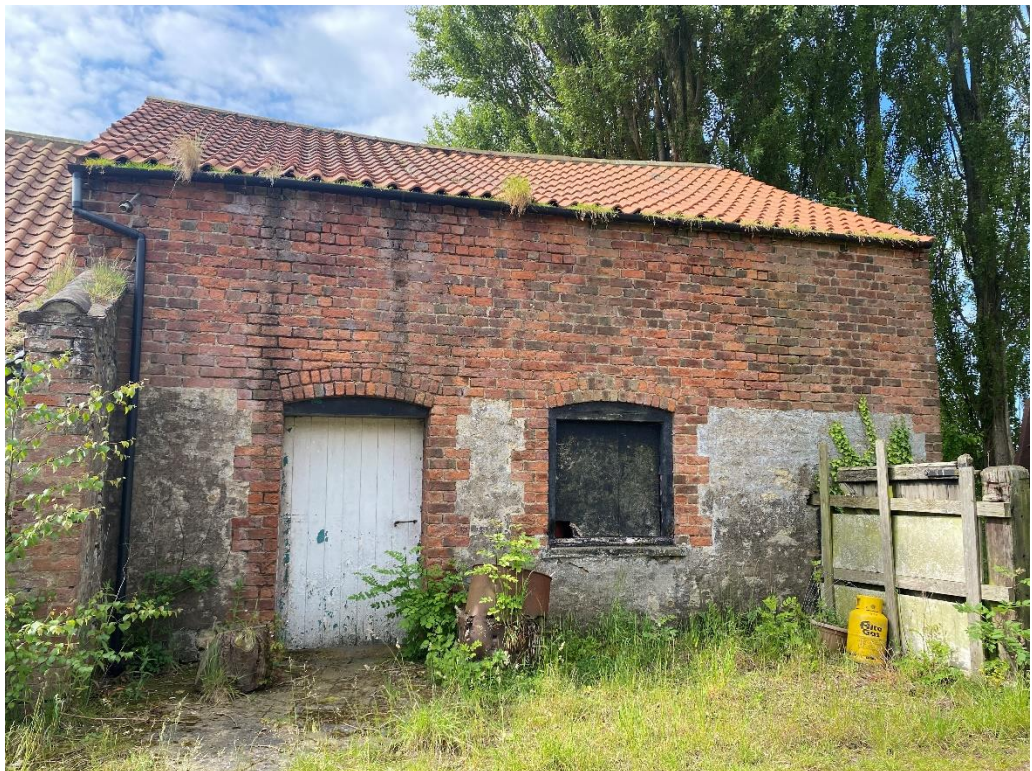
Fig. 48 – Building 6 – north elevation of the western element

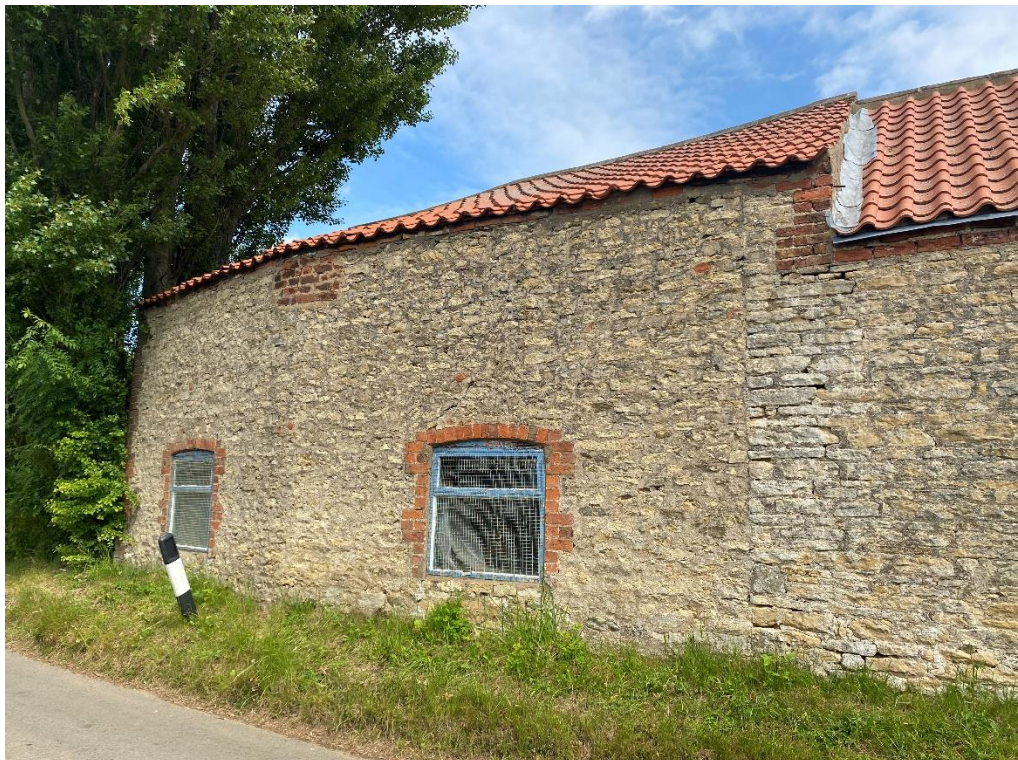
Fig. 50 – Building 6 - the south elevation of the western element – internal access to this building was not possible

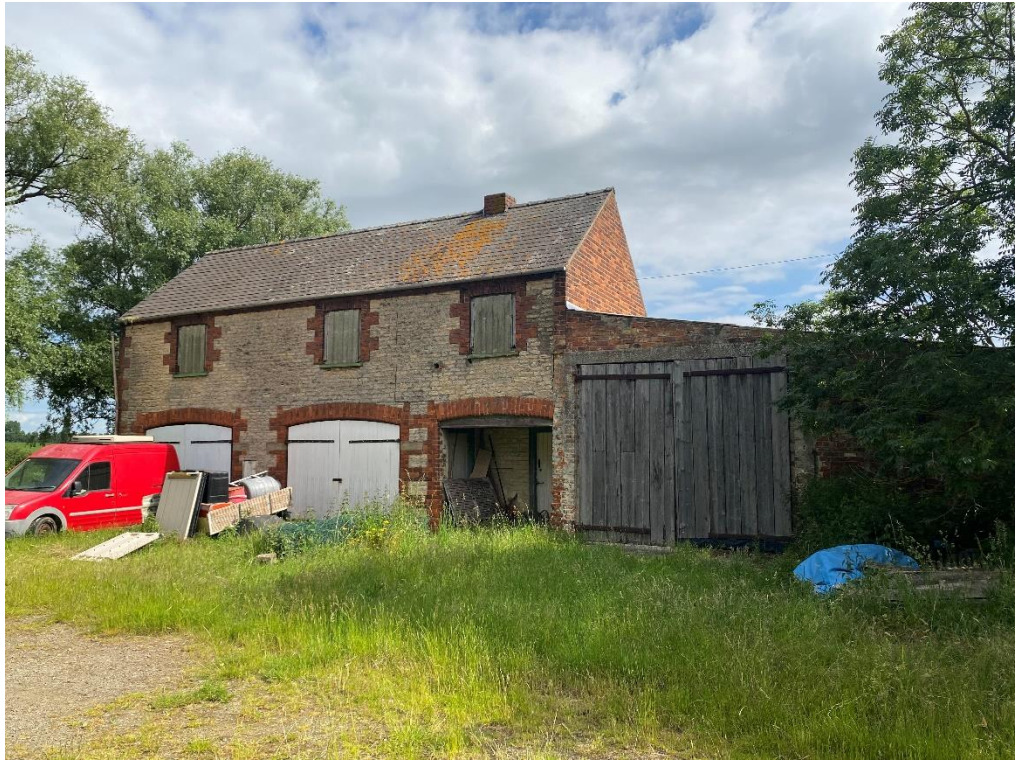
Fig. 51 – Building 7 – south elevation showing a 3 bay layout with arched head cart shed openings and corresponding first floor openings. The roof is slate covered. There is a lean-to side element to the east.

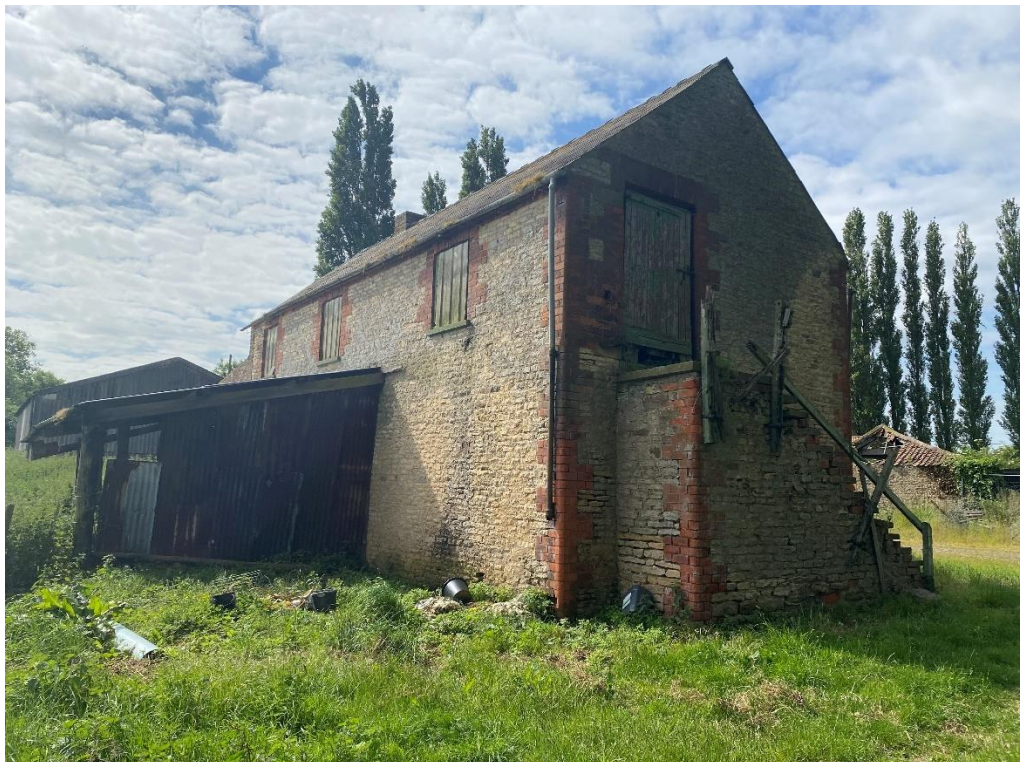
Fig. 52 – Building 7 – showing the west and north sides – there is an open lean-to timber construction to the north side and an external stair to the west side

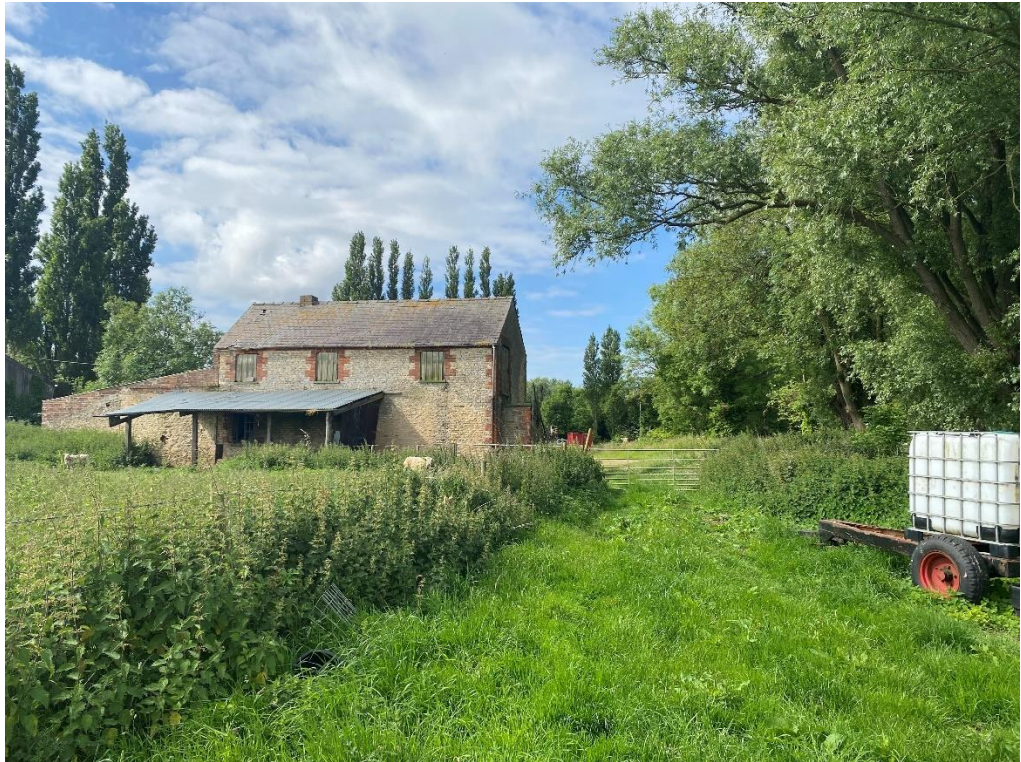
Fig. 53 – Building 7 – the north side - the roof has a natural slate covering

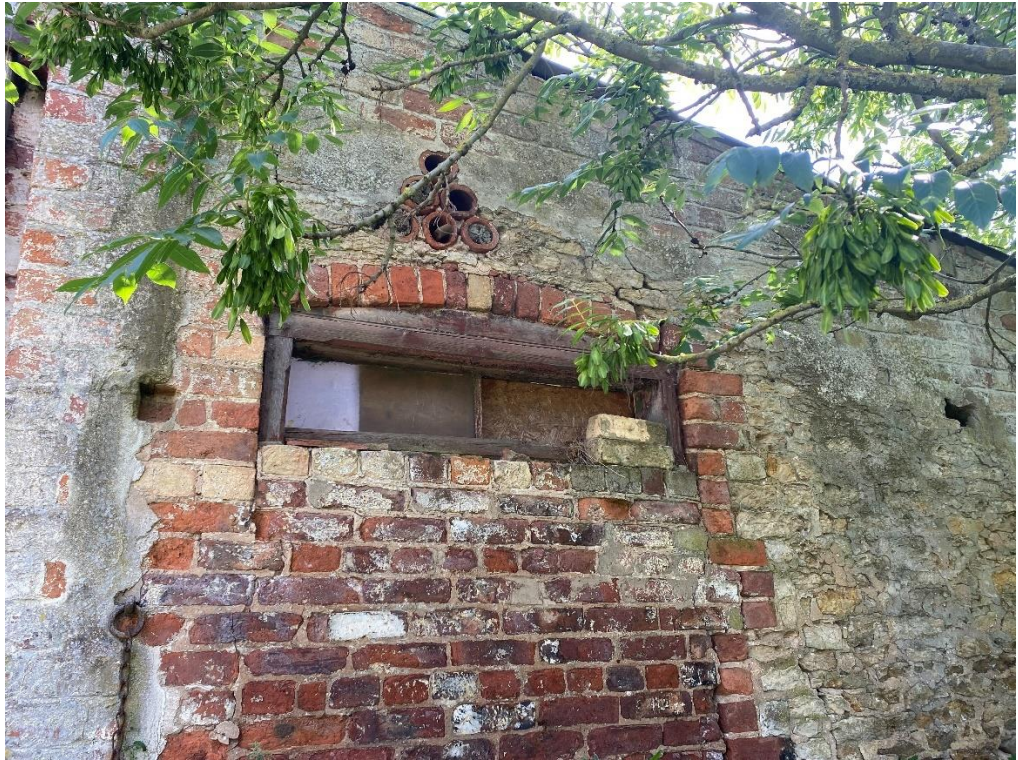
Fig. 55 – Building 7 - part of the lean-to element showing evidence of phasing to an opening

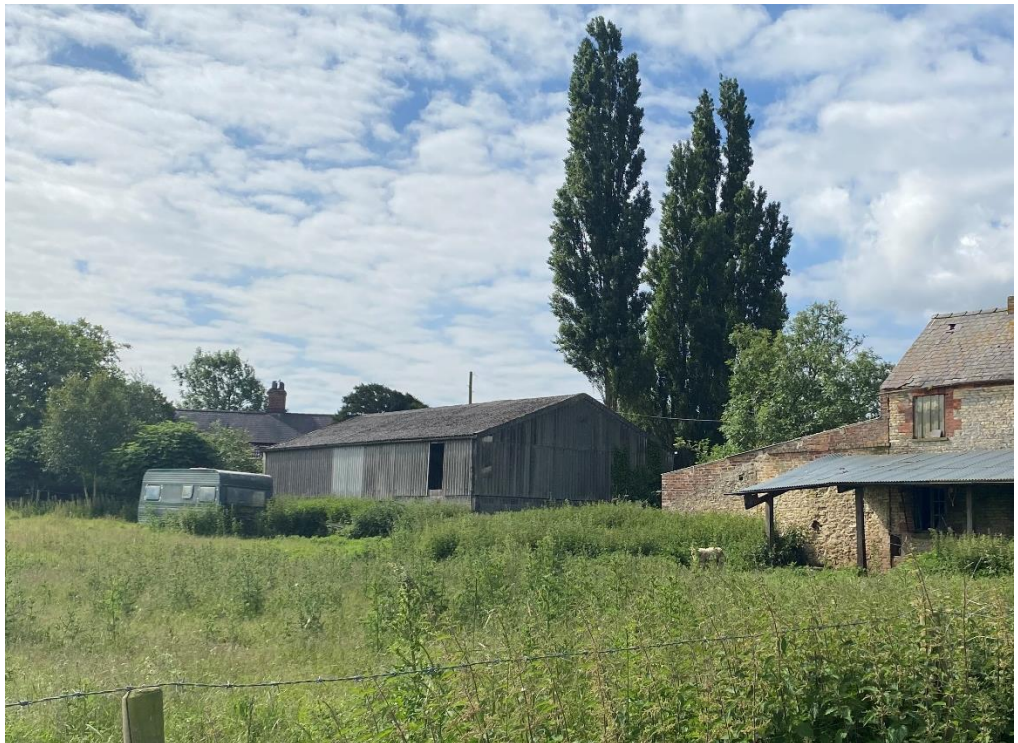
Fig. 56 – Building 8 – as seen from the north

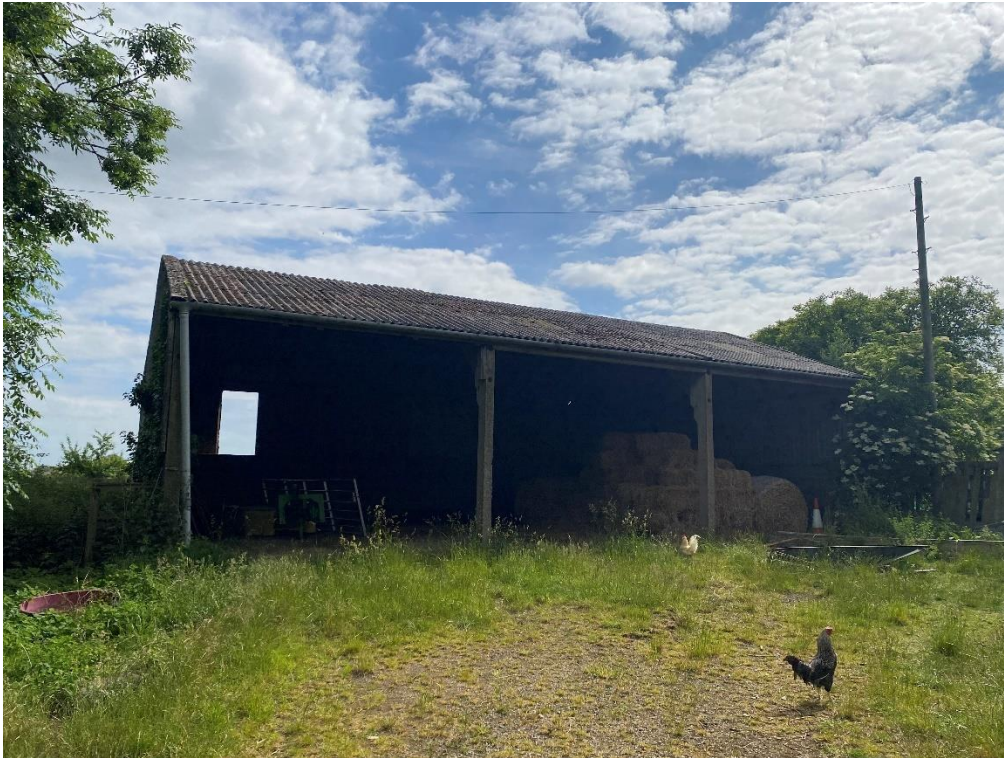
Fig. 57 – Building 8 – the south side of this open shed, which has a prefabricated concrete framed construction – this building does not form part of the application development proposals
