21 June 2024

## Structural and Condition Report (update)

The Tithe Barn, The Hall, Owston Ferry, Doncaster, DN9 1AW.

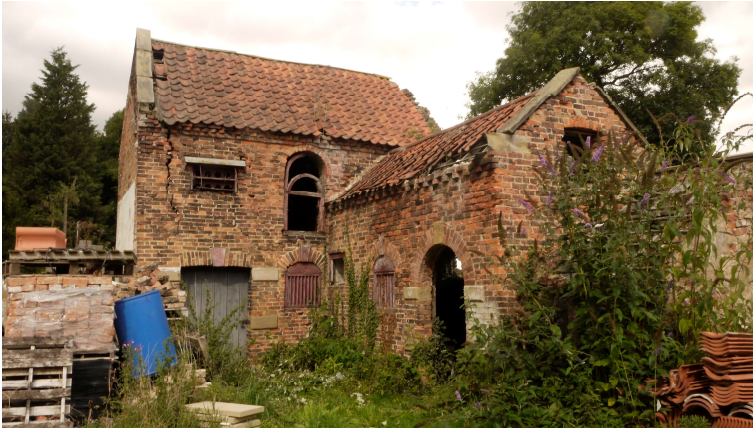
### Listed Dove Cote at Tetley

This is not without precedent, please refer to PA/2022/2017 and LBC PA/2022/2059 for the conversion and extension of listed barn (The Dove Cote at Tetley, Crowle) where the original roof covering has been totally replaced due to on inspection (when internal scaffolding erected) the existing roof timbers being too rotten and woodworm attacked to be saved. Thus a complete new framework was built.

Dove Cote with new roof
