WINTERINGHAM INGS TO SOUTH FERRIBY FLOOD
ALLEVIATION SCHEME

Cultural Heritage Desk-Based Assessment

Environment Agency

16 November 2018

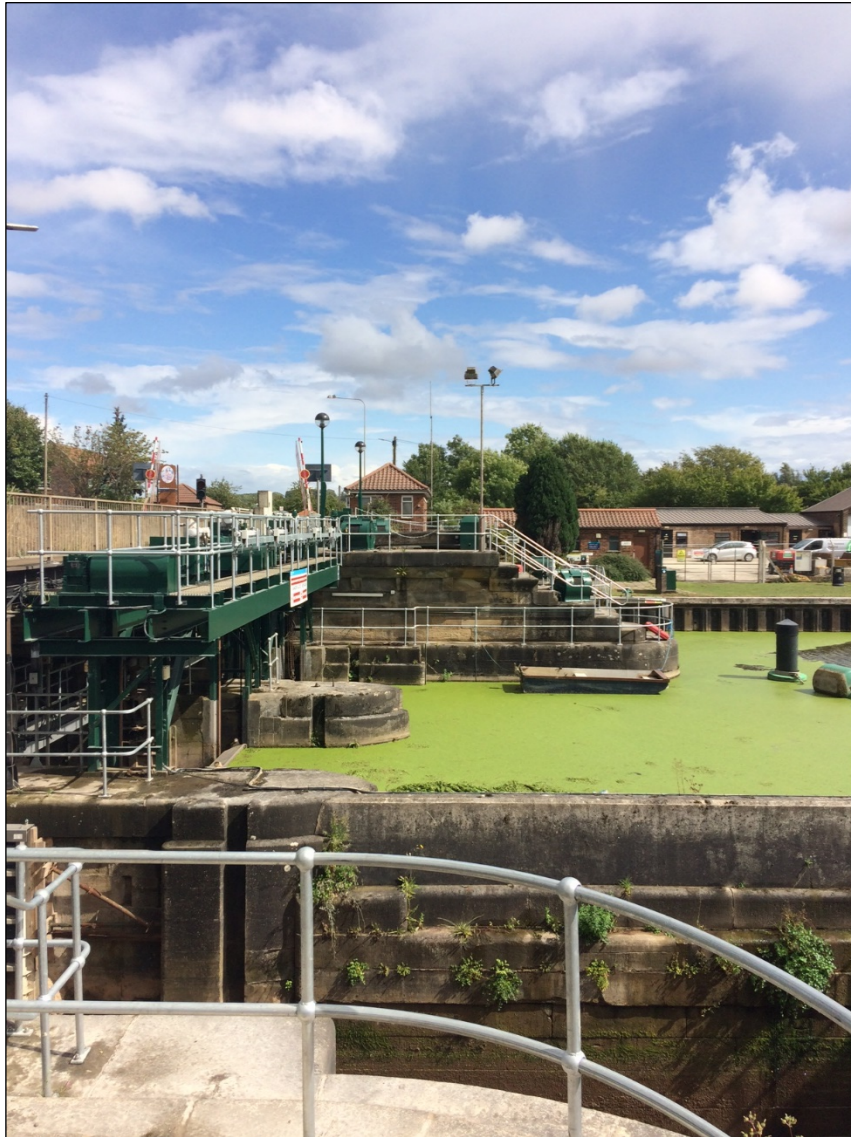
Plate 1: View of Ferriby Sluice (NHLE 1005244) from west

This asset comprises a scheduled sluice and lock over the New River Ancholme (Plate 1) located centrally within the Scheme.

'The modern sluice and lock was built in 1842-44 by Sir John Rennie, on the site of earlier sluices of 1640 and 1769. It separated the New River Ancholme from the tidal River Humber, and incorporated a lock that was crossed by a swing road bridge. This bridge was replaced by a lifting bridge in 1982.'

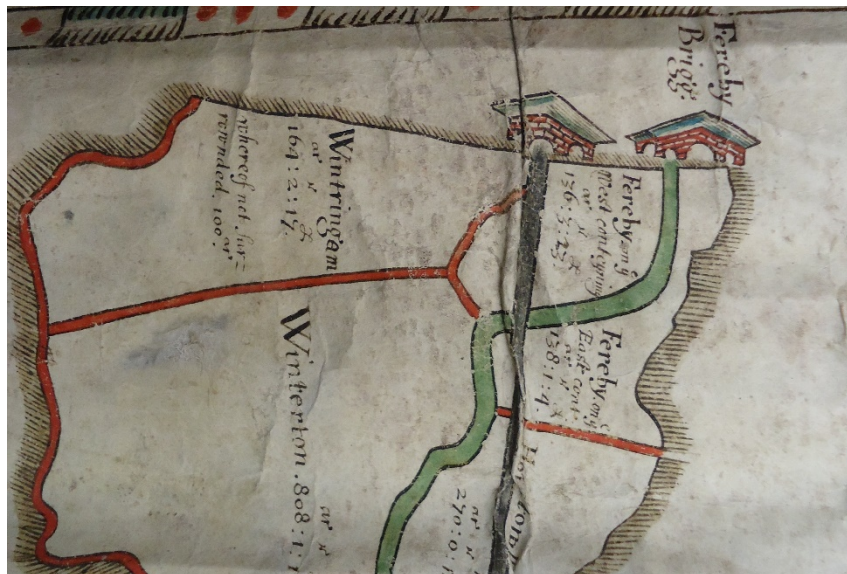
Plate 2: Extract from a plan of the River Ancholme dated 1644

The 1644 Plan of the River Ancholme (Plate 2) does not show the area of the Scheme in any detail, although two bridges are depicted crossing the New River Ancholme and the former channel of the River Ancholme (HER MLS20413) respectively. The map also suggests the former channel of the River Ancholme (HER MLS20413) was still extant as a watercourse at this time.
