**FLOOD RISK ASSESSMENT  
& OUTLINE SUSTAINABLE  
DRAINAGE STRATEGY**

**Residential Development  
Main Street, Sturton**

Qudos Property  
December 2021

<b>Document Reference</b>	RLC/0850/FRA+OSDS01
---------------------------	---------------------

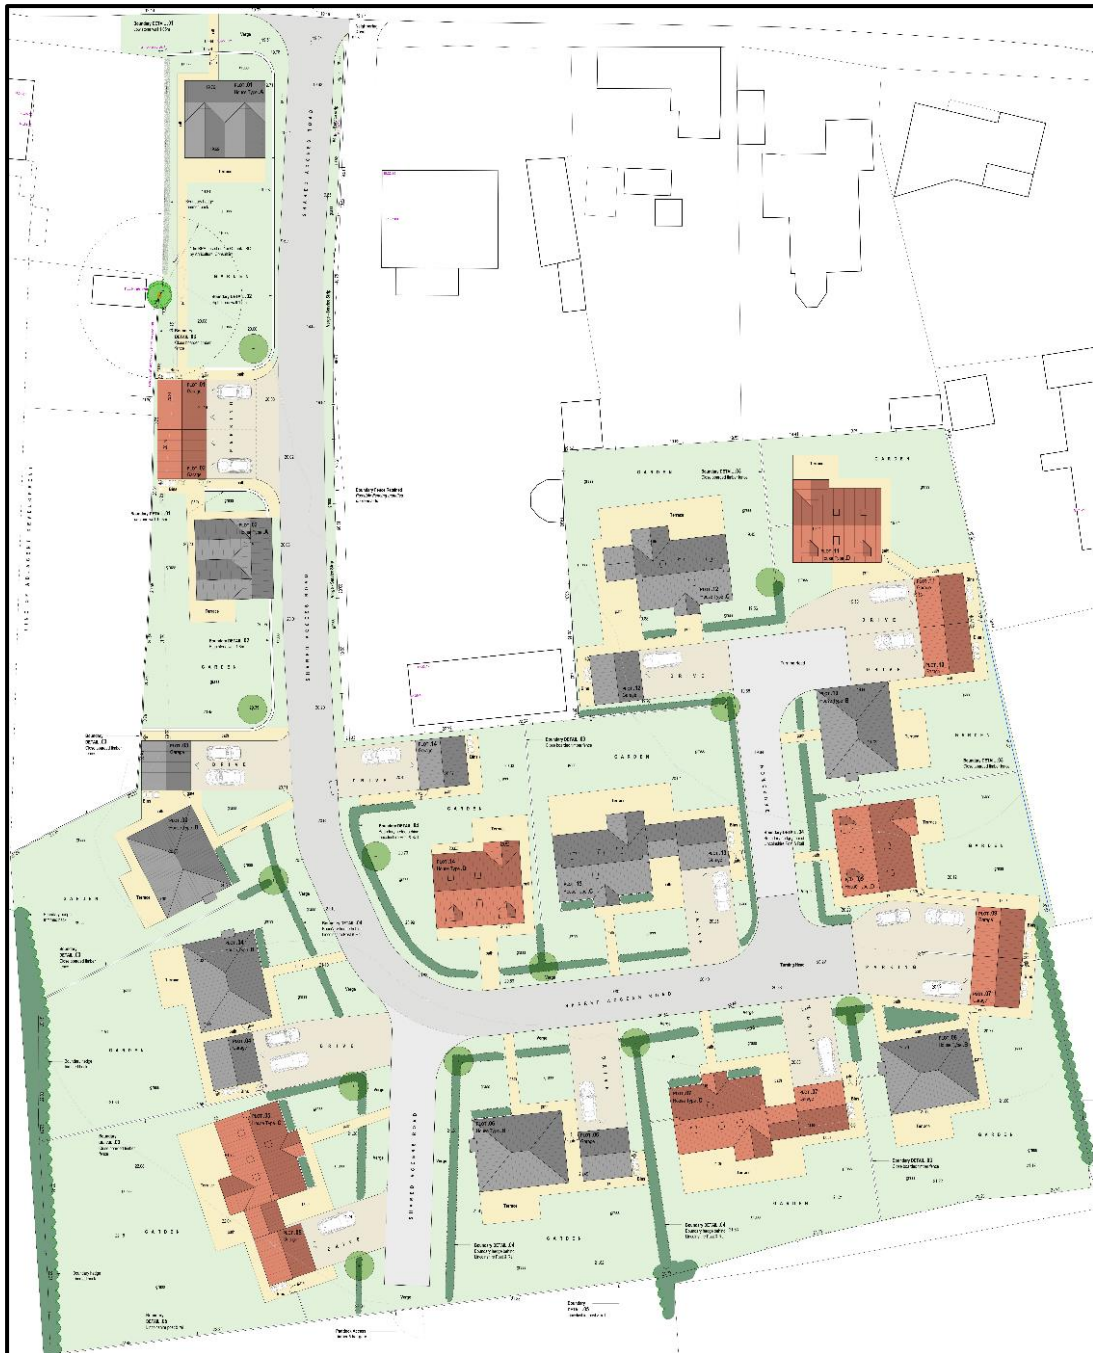
**Figure 1.2 Proposed Plan**

- 1.6 The proposed development consists of a residential development as shown on the extract of the proposed plan below in **Figure 1.2**

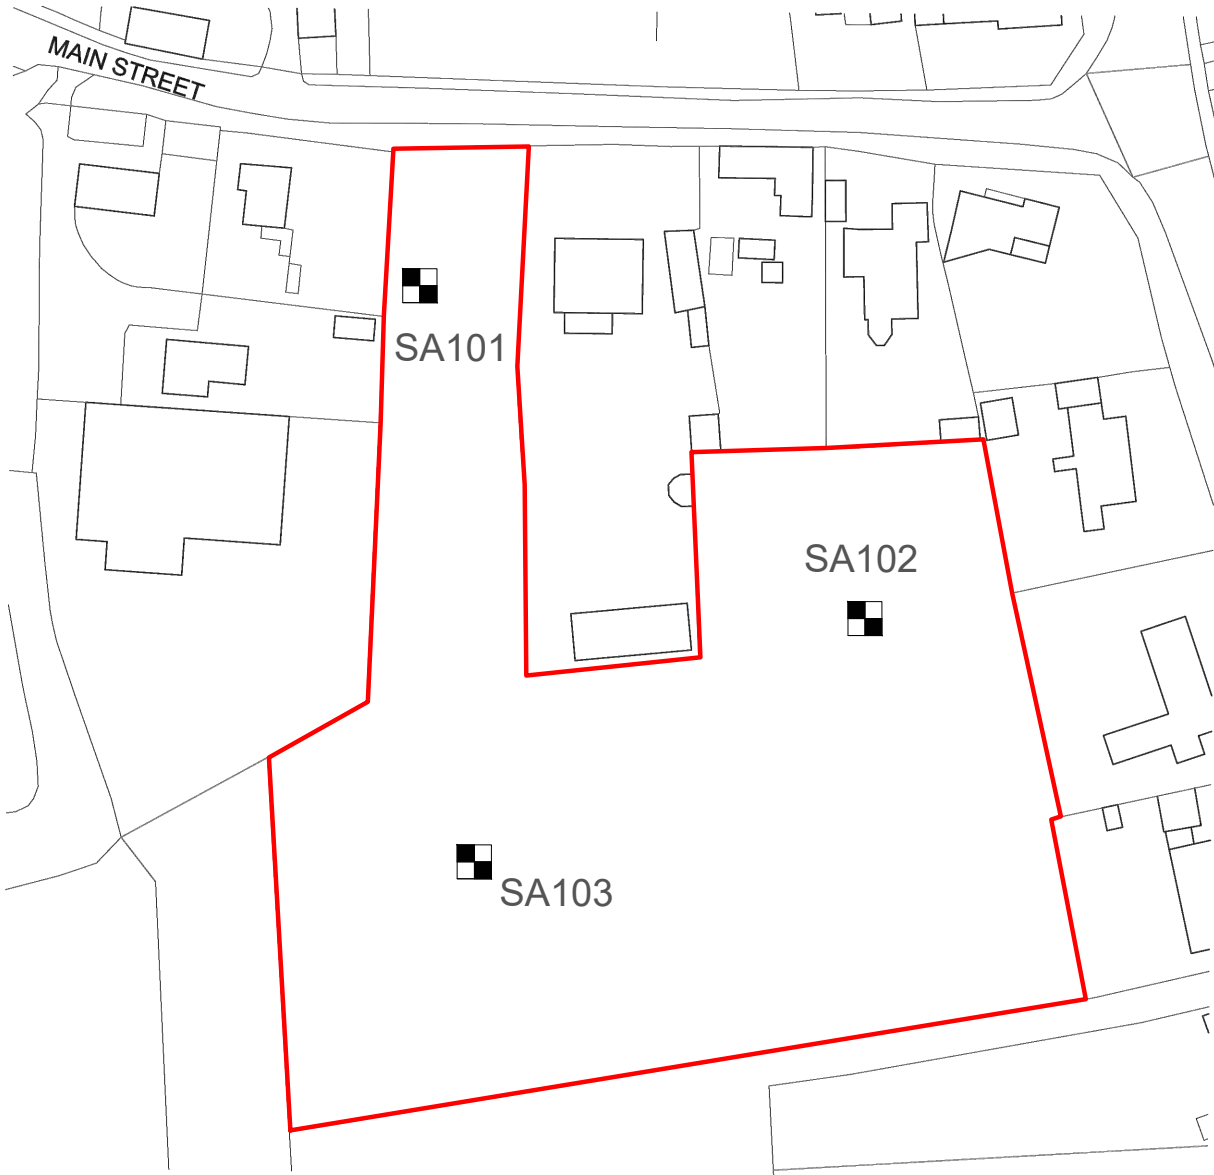
## Figure 2 – Approximate Intrusive Location Plan

The location of the infiltration tests are shown on Figure 2 and the Proposed Development Plan is included as Drawing 2.

Test results are provided in Appendix C and summarised below. The approximate locations of the soakage tests are shown in Figure 2.
