**FLOOD RISK ASSESSMENT
& OUTLINE SUSTAINABLE
DRAINAGE STRATEGY**

**Residential Development
Main Street, Sturton**

**Qudos Property
July 2022**

| Document Reference | RLC/0850/FRA+OSDS01 |

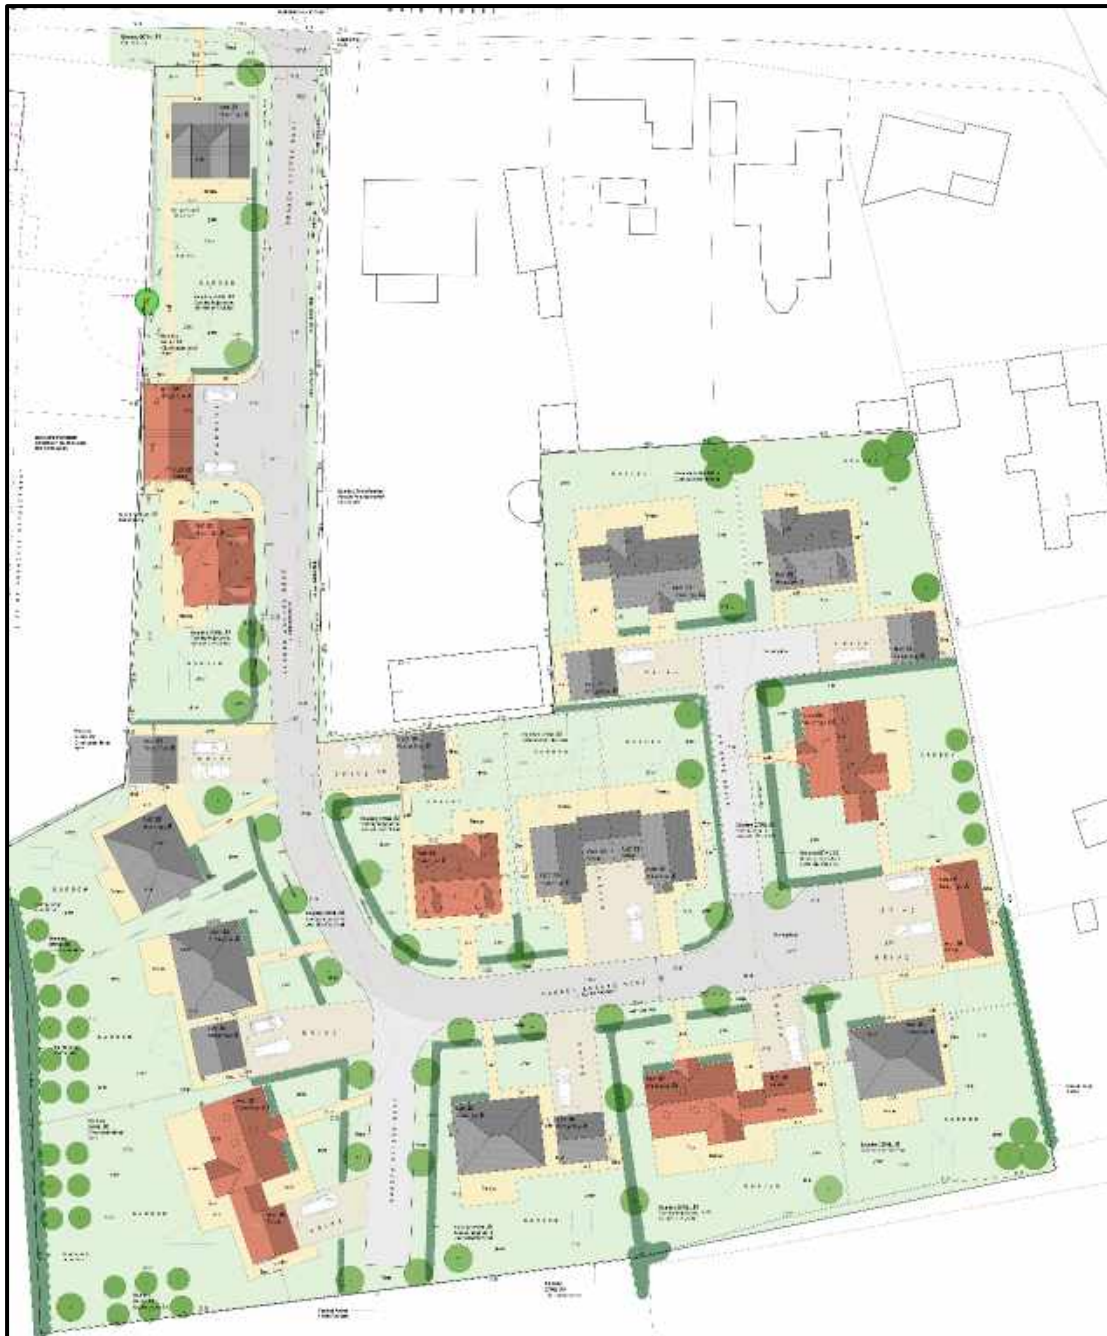
Figure 1.2 Proposed Plan

- 1.6 The proposed development consists of a residential development as shown on the extract of the proposed plan below in **Figure 1.2**

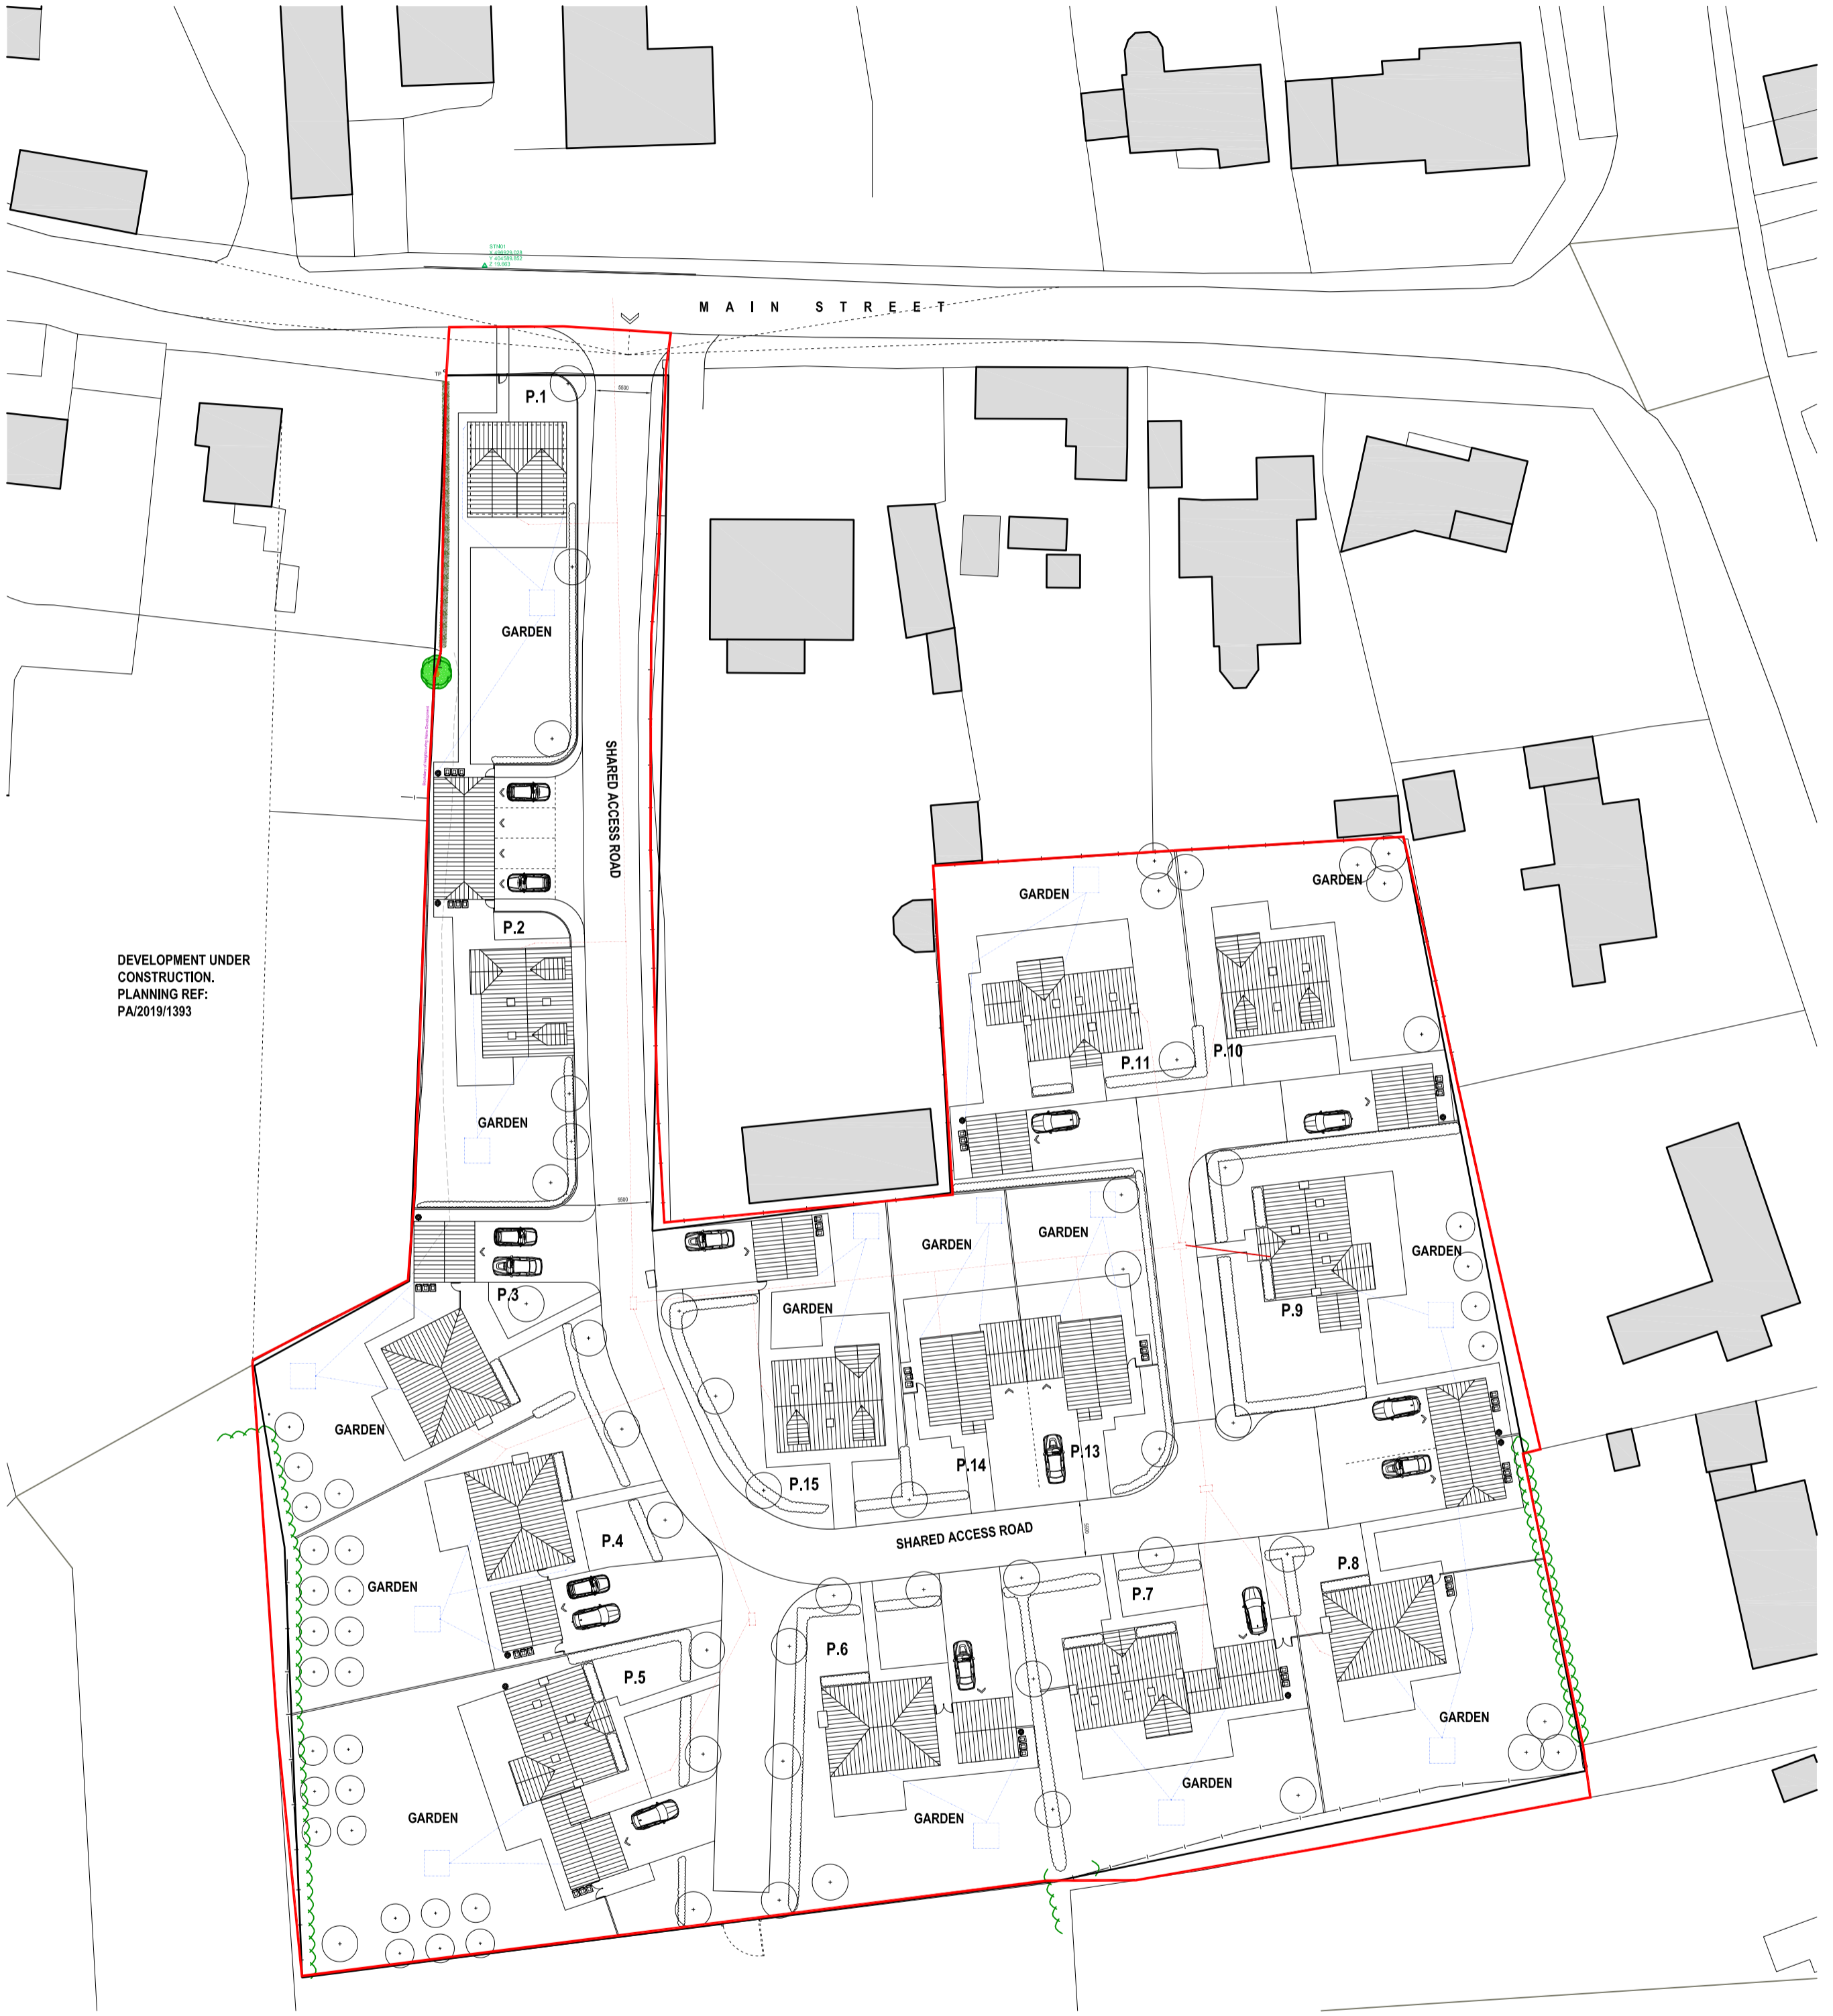
Drawing 2 – Proposed Development Plan

PROPOSED BLOCK PLAN
Scale - 1:500

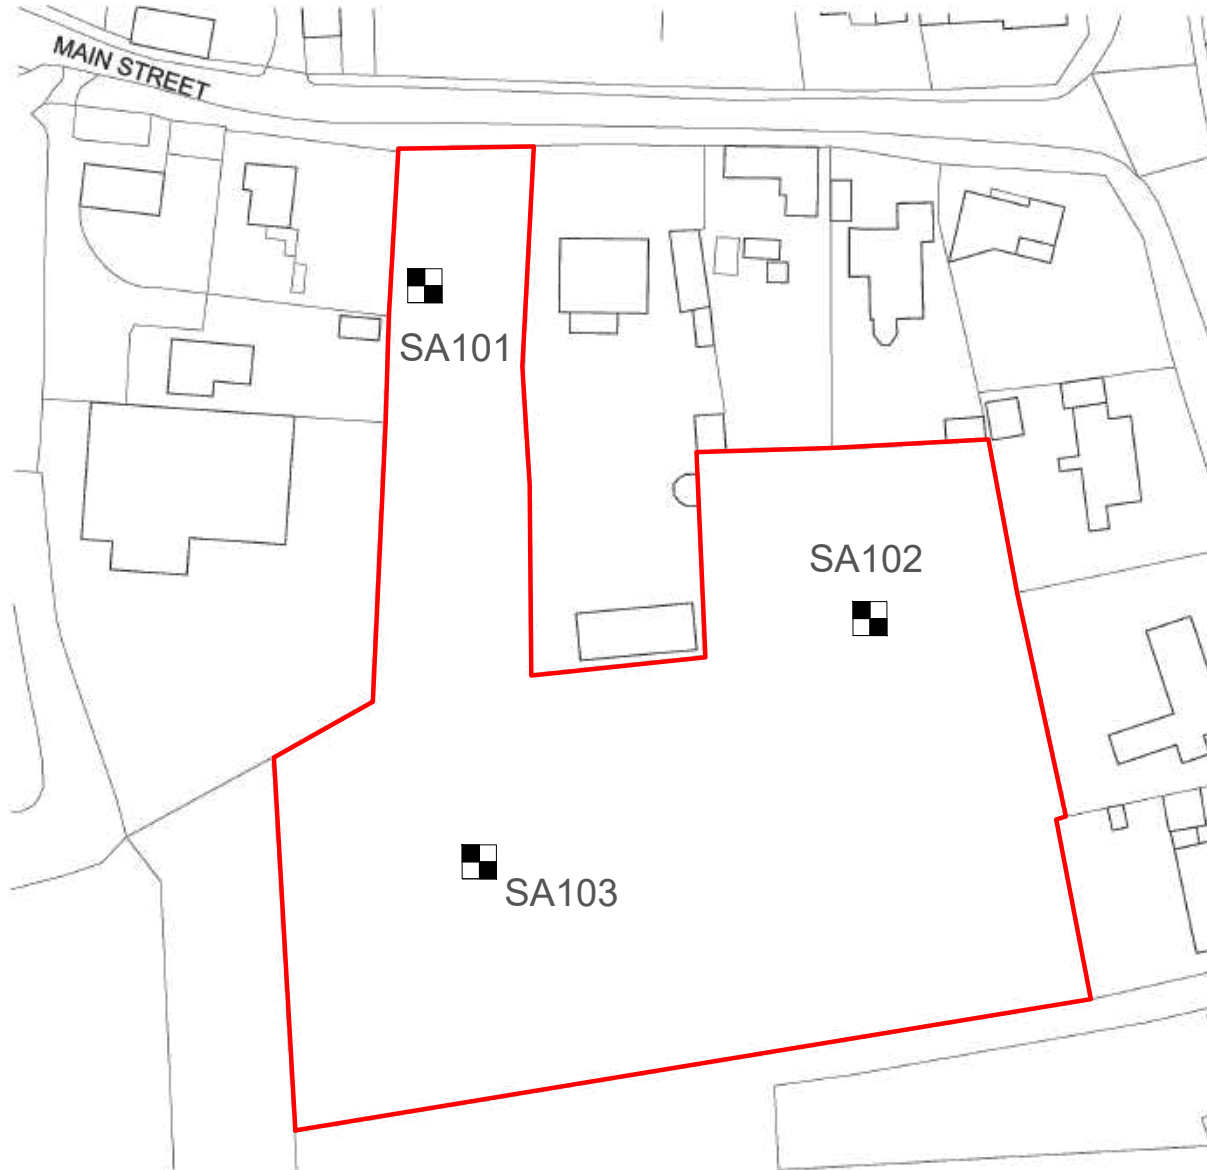
Figure 2 – Approximate Intrusive Location Plan

The location of the infiltration tests are shown on Figure 2 and the Proposed Development Plan is included as Drawing 2.

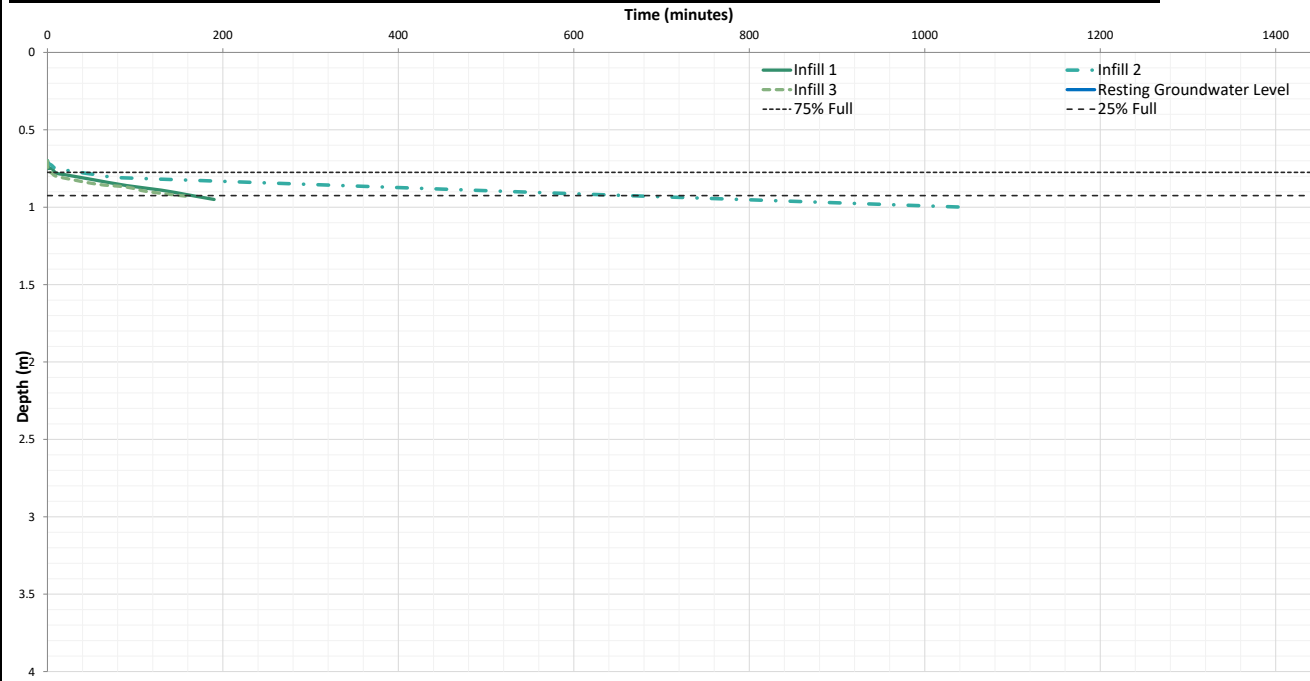
| | units | Infill 1 | Infill 2 | Infill 3 |
|--|---|---|---|---|
| Soil infiltration rate, f = | m/s | 0.00000396 | 0.00000084 | 0.00000494 |

| 8.4E-07 | m/s |
