**Phase 3- Method Statement**

**Mendle Farm, Holme**

<b>Title:</b>	Method Statement Mendle Farm, Holme
<b>Client:</b>	Flynn Architecture c/o Mr J W Richardson
<b>Date:</b>	August 2020
<b>Report number:</b>	1260/5063/P/P3

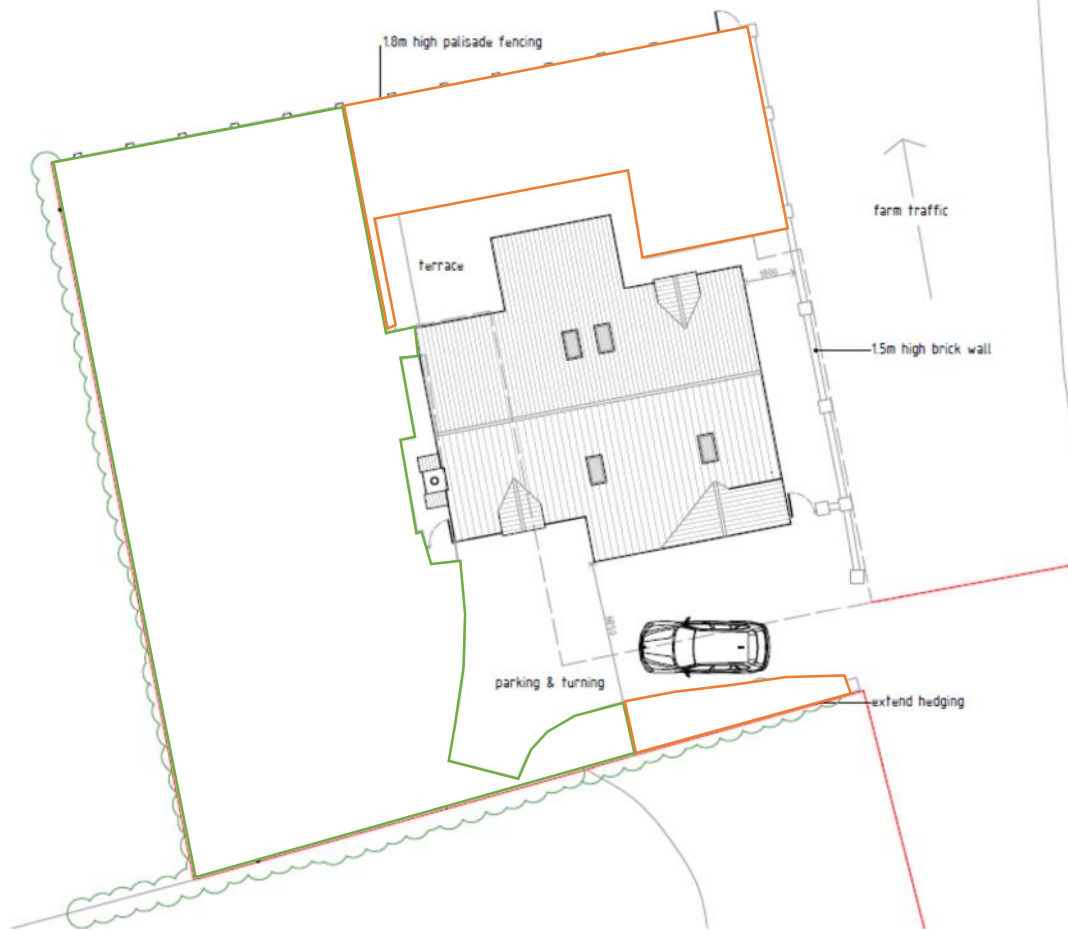
Plan 3

A site plan below shows proposed areas for remediation (orange outlined) and proposed areas of existing grassland to be retained (green outlined).

Area of existing grassland

Area of granular fill / hardstanding proposed to be gardens or soft landscaping (remediation area)

5) Undertake remediation to garden areas identified (orange outlined) within plan 3 in Appendix A.

Gardens are estimated to be 330m<sup>2</sup>. 250m<sup>2</sup> of existing grassland which does not require remediation and about 80m<sup>2</sup> of existing granular fill area which requires remediation. The phase 2 report shows an average depth of granular fill around 0.3m which would give a total of 24m<sup>3</sup> of made ground to be removed.

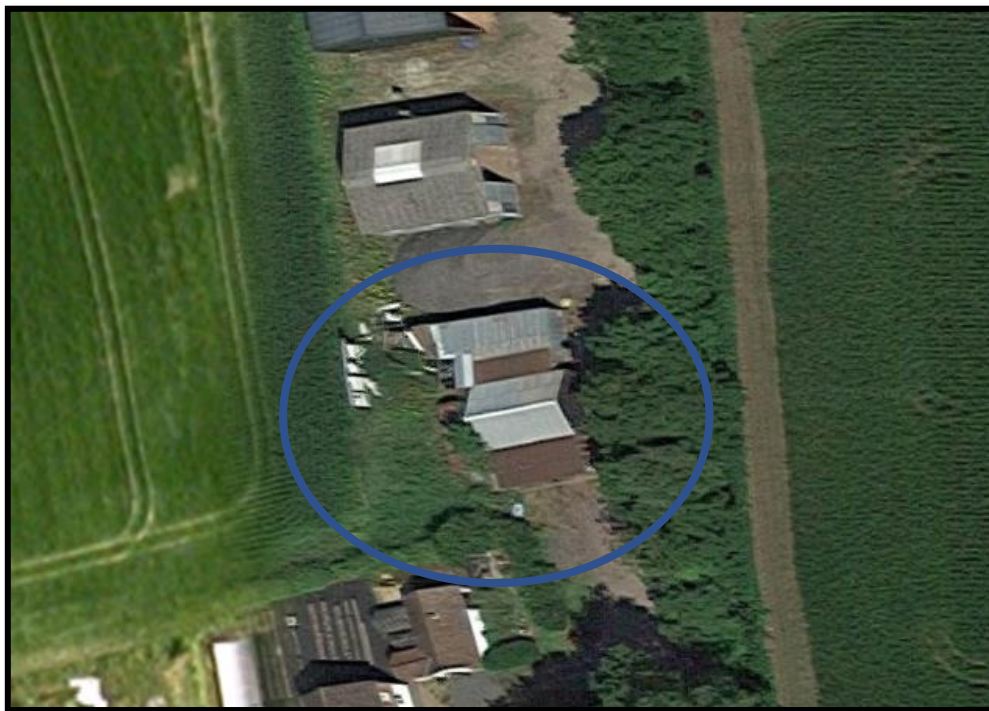
Aerial view

Mendle Farm, Holme – WS/HP location plan	
<p>WS1</p> <p>HP2</p> <p>HP1</p> <p>WS3</p>	  <p>WS2</p> <p>HP4</p> <p>HP3</p> <p>WS4</p>
<p>Plan 1</p>	<p>March 2020</p>

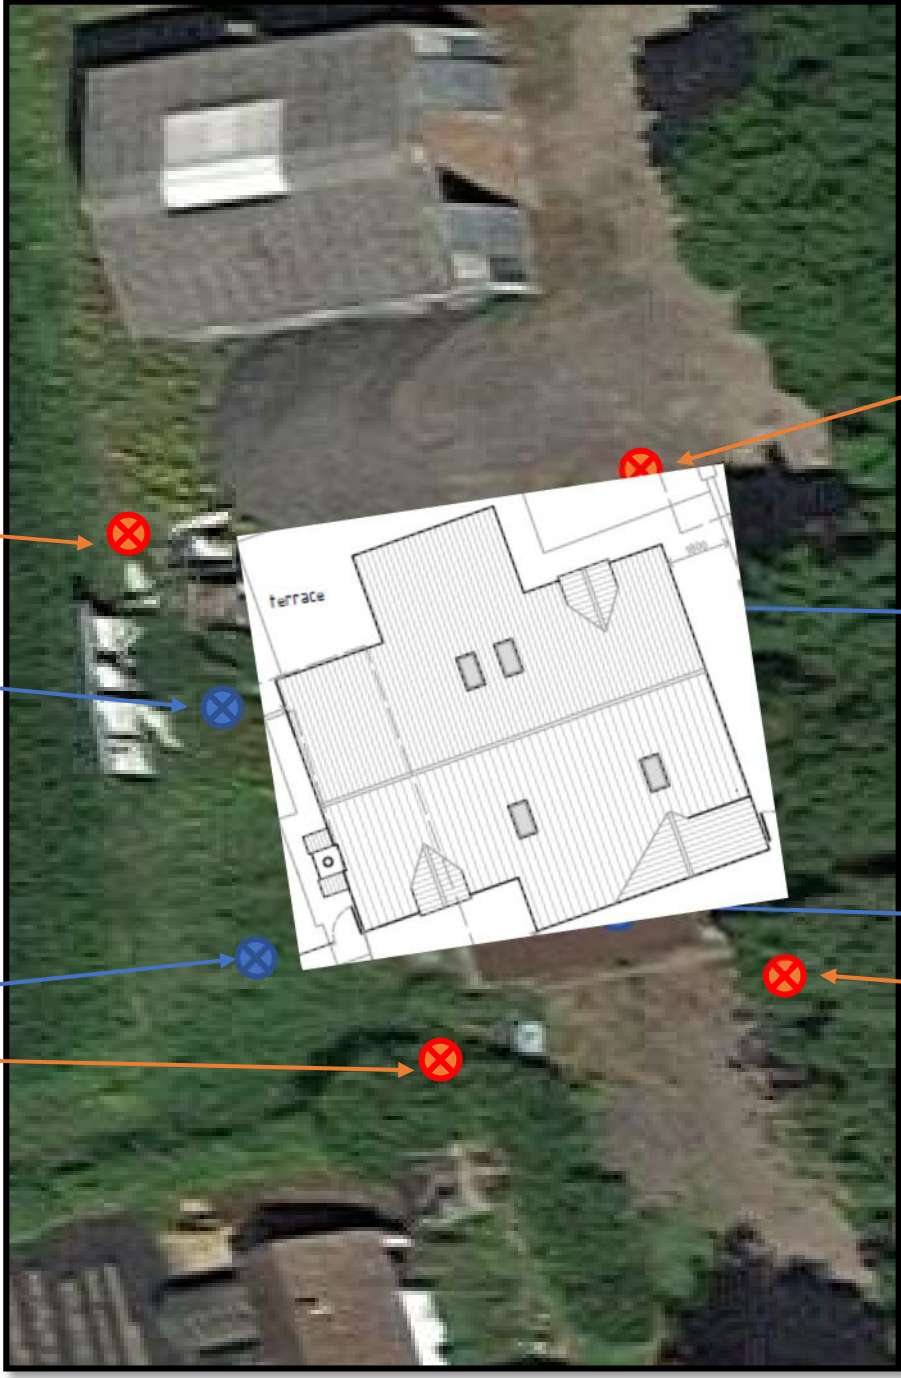
<p>WS2</p> <p>HP4</p> <p>HP3</p> <p>WS4</p>
<p>Plan 2</p>	<p>March 2020</p>

Mendle Farm, Holme – Estimated location		
<p>WS1</p> <p>HP2</p> <p>HP1</p> <p>WS3</p>

A location plan of all sample locations is included within appendix A.

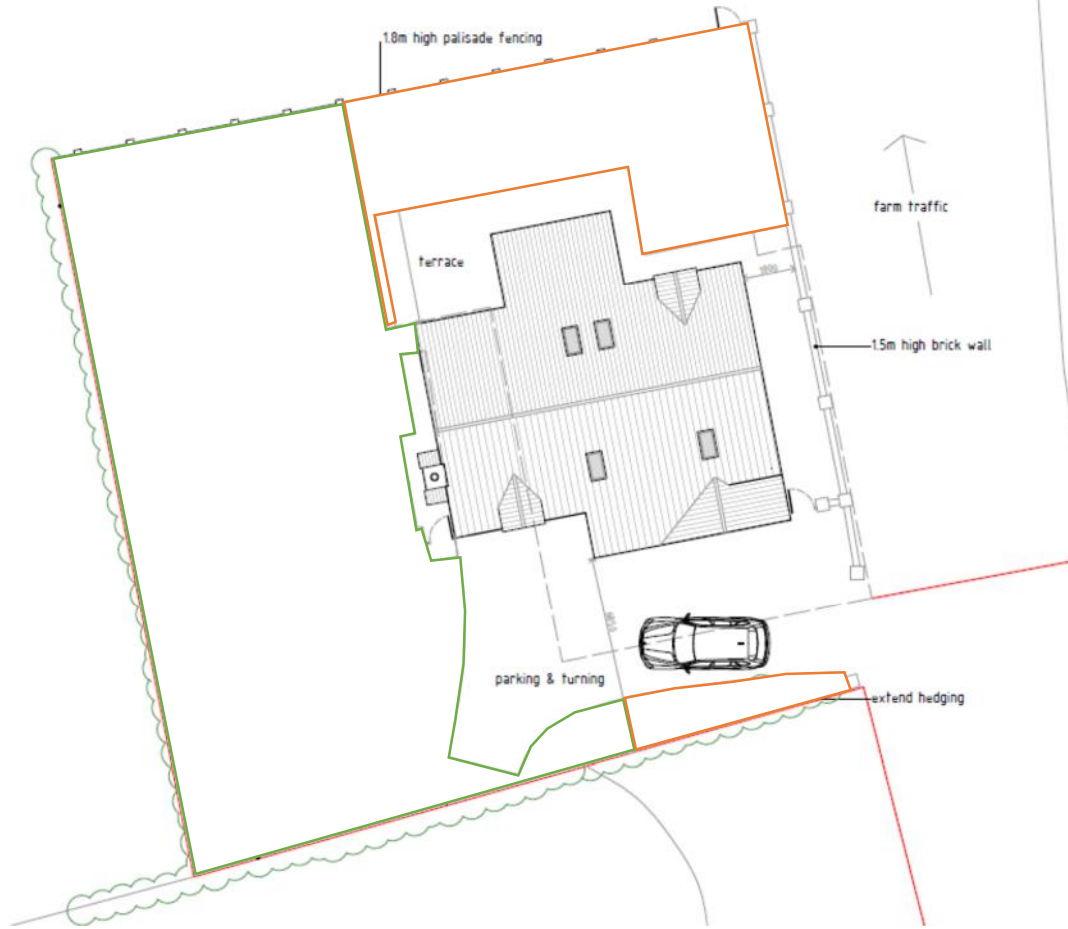
Plan 3

### Mendle Farm, Holme – proposed development plan

Area of existing grassland

Area of granular fill / hardstanding proposed to be gardens or soft landscaping (remediation area)
